Province of British Columbia  
MINISTRY OF ENERGY, MINES  
AND PETROLEUM RESOURCES

Report of Inspector of Mines  
Reclamation and Permitting  
(Issued pursuant to Section 15 of the *Mines Act*)

Inspection No.: 80236  
File: 18070-02-09  
Mine No.: 0100291  
Permit No.: M-18  
Emp/Cont: 0 / 0  
Orders H&S: 0 RECL 3  
Stop Work: 0

Mine Name: Cassiar  
Location: Northwest of Jade City  
Owner: Ernie Hatzl

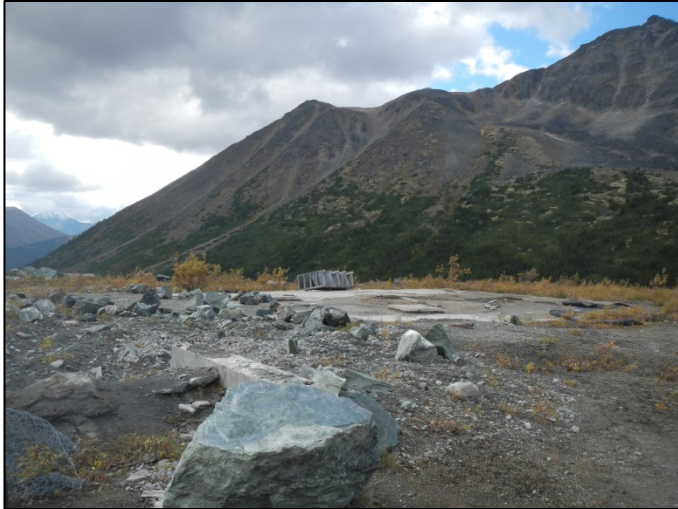
The concrete plant has been demolished and removed from site. The concrete pad remains and the general area has been used for a jade sort and storage yard in the past; scattered jade was observed (Photo 1). An area of pallets and bagged asbestos in poor condition is also located in the vicinity (Photo 2). It was discussed that there are plans to remove the bags and materials and recontour the area. It was discussed that reclamation of this area will require implementation of appropriate health and safety procedures for workers handling the asbestos.

Photo 1. Foundation of concrete plant. Note scattered jade.

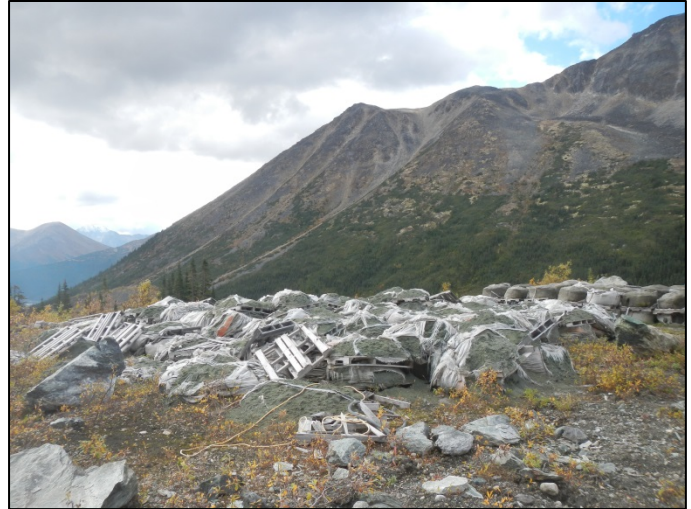
Photo 2. Open bags of asbestos and pallets

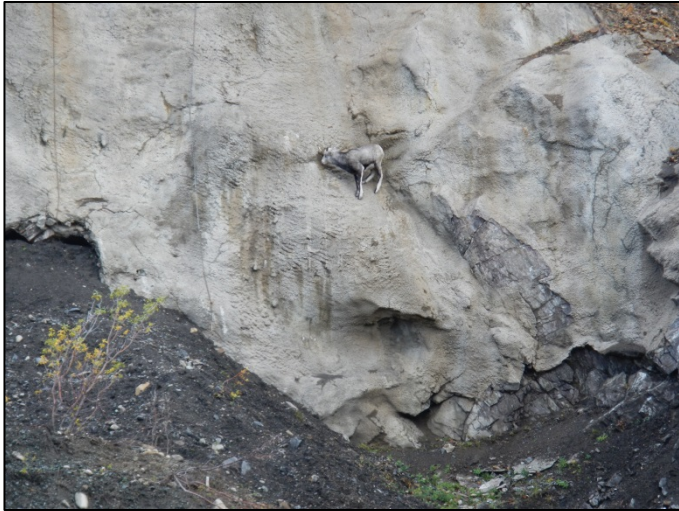
A sheep was on the shockcrete above the portal at the time of the inspection (Photo 3).

Photo 3. 1465 Portal. Note sheep on shockcrete.

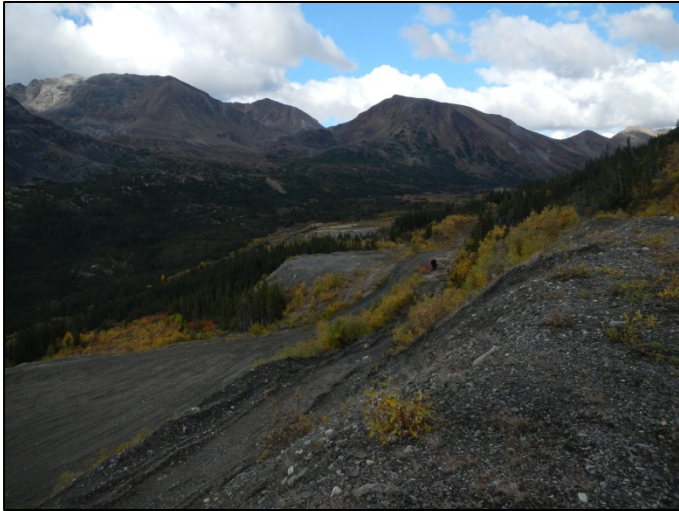
The 5 storey high Tramline building was used as a loading point for ore onto the tram cars. The hopper was located on the 1465 Portal area and a conveyor took the ore to the load out facility. The building has been completely demolished and the footprint has been recontoured in preparation for revegetation (Photo 4 and 7).

This area is one of the sites (discussed above) which may receive additional site preparation to create a more natural topography and promote microsite development. It was stated that at a minimum the area will be ripped prior to seeding.

Photo 4. North end of former Tramline Building site from the 1465 Portal

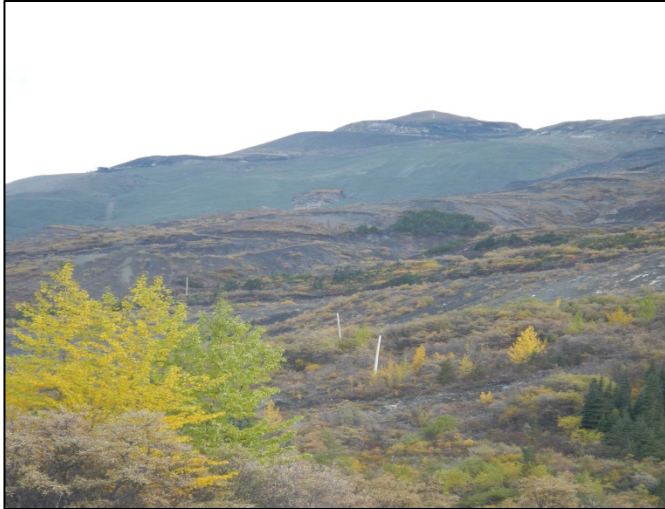
The waste dumps and disturbed landscape below the dump areas range from sparsely vegetated to completely void of vegetative cover at higher elevations (Photo 5). Although the slopes were only observed from the bottom, they did not appear to be ravelling or failing. There was a small slump observed above 1465 Portal (Photo 6). Site personnel explained that plans were being designed and will be implemented to divert surface water in the area to avoid future failures. The slump was observed from the 1465 Portal area only.

Photo 5. Waste Dumps above 1465 Portal.

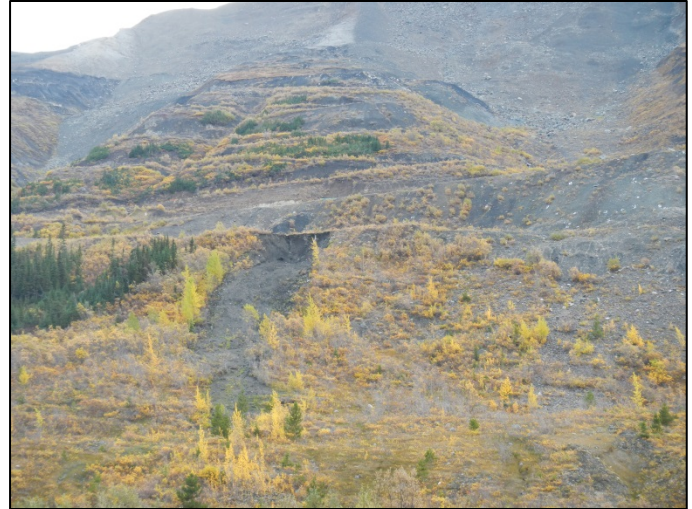
Photo 6. Slump above 1465 Portal

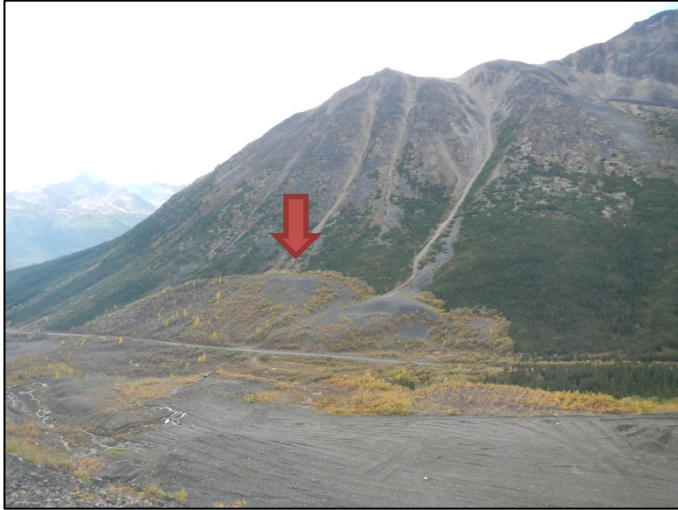
*Photo 7. Slide run out area at arrow showing vegetation establishment. South end of graded Tramline Building site in foreground.*

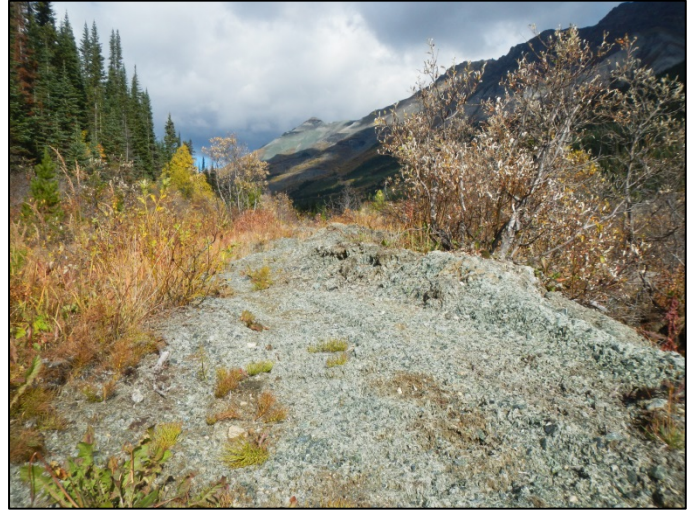
Berms of loose ore material were observed at points along the former tramline (Photo 8). It was explained that the berms occur at certain points along the length of the line and were created by ore spilling from the tram cars. A decision about how these berms will be reclaimed has not been made.

*Photo 8. Berm of spilled ore along tramline.*

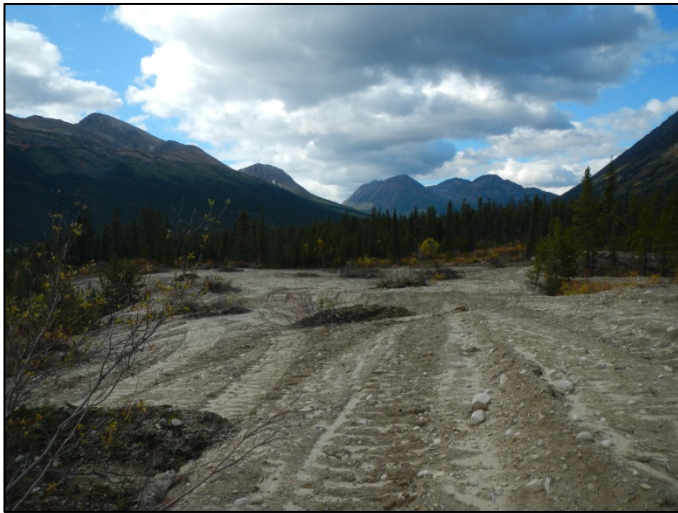
*Photo 9. Direct placement of native vegetation on overburden cover of former Boneyard.*

survived the winter and leafed out this season. Monitoring results of this method of direct placement should be included in Annual Reclamation Reports. See repeat order 1.

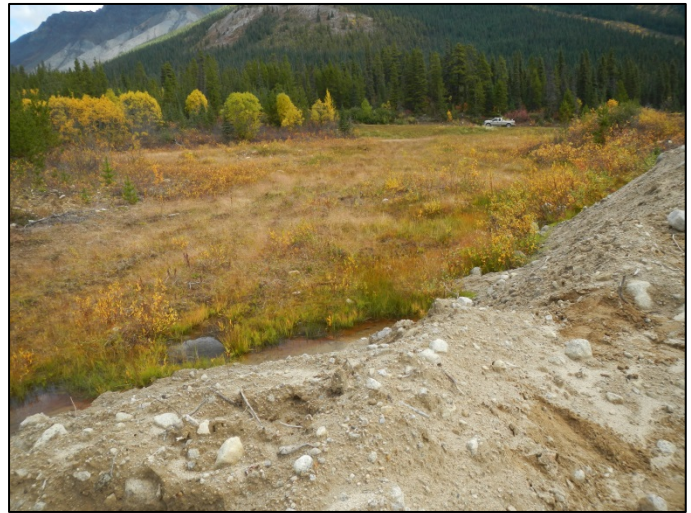
It was explained that the area directly adjacent to the overburden cover had revegetated naturally over the past 3 to 4 years (Photo 10) and that the overburden would be left to do the same. It was discussed that vegetation cover on the overburden would be monitored for the next few years and seeding would occur if natural ingress did not occur as expected. The area of the Boneyard where natural ingress has occurred since 2014 appeared to have considerable coverage of native species including sedges and shrubs. A single common tansy plant was identified as well as some scentless chamomile near the road.

*Photo 10. Natural vegetation established over 3-4 years. Berm of overburden placed last year in foreground.*

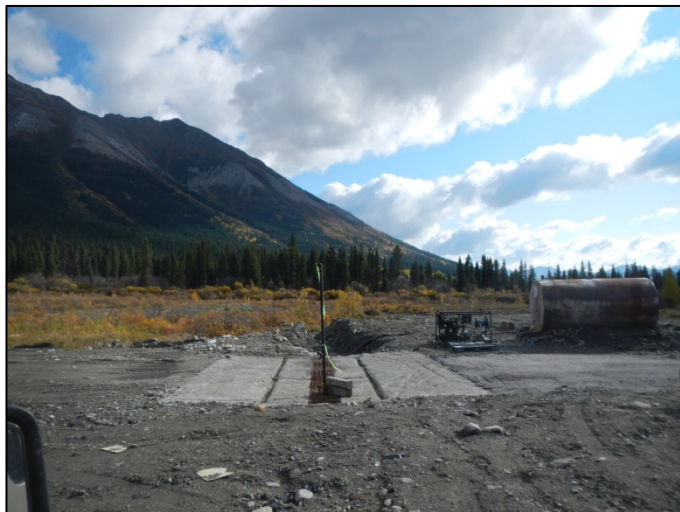
Photo 11. Truck wash.

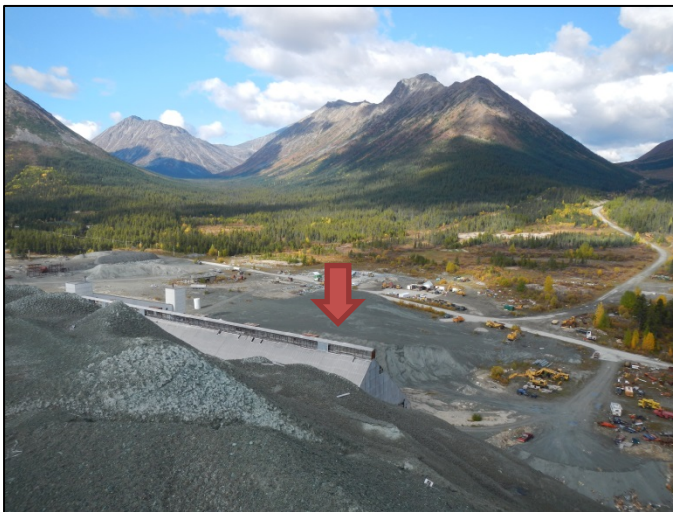
Photo 12. Mill area overview looking north. Arrow is top of dry rock storage building.

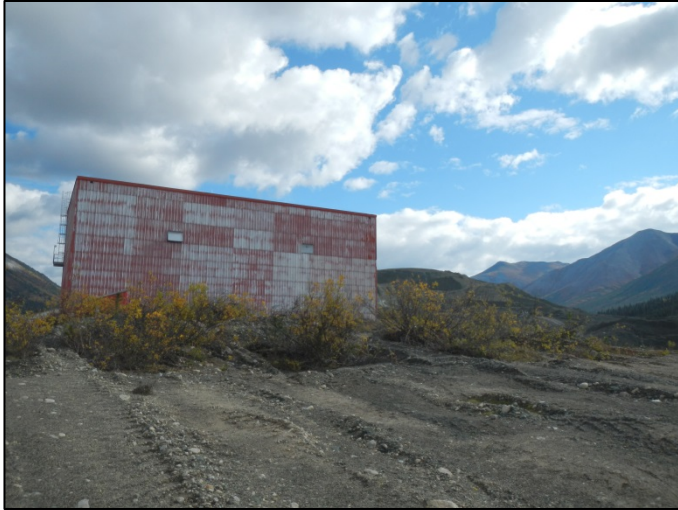
Direct placement of plots of native ground was observed near the tramline terminus building. The approach ramp has been recontoured and seeded (Photo 13).

*Photo 13. Tramline terminus building and directly placed native ground and vegetation plots*

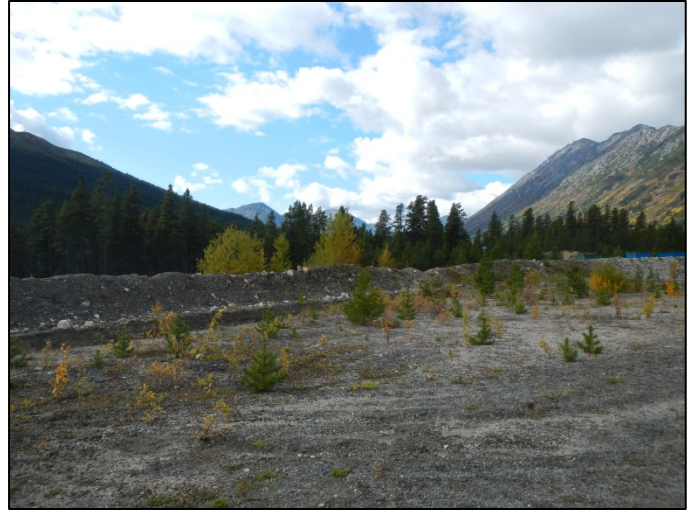
Natural ingress of black cottonwood and pine was observed adjacent to the warehouse foundation (Photo 14).

*Photo 14. Natural ingress near warehouse foundation.*

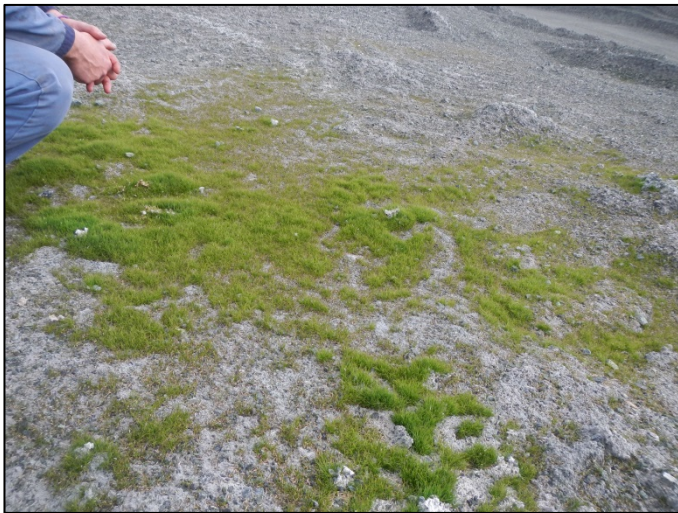
Approximately five weeks prior to the inspection, the top eastern end of the pile was heli-seeded using a grass mix with a high percentage of red fescue. Grass has sprouted and one patch was observed to have germinated at a visibly dense rate (Photo 15); however, the density is low across the majority of the seeded area. It was stated that success of the seeding will be monitored over the next few growing seasons.

*Photo 15. Recent heli seeding results on tailings*

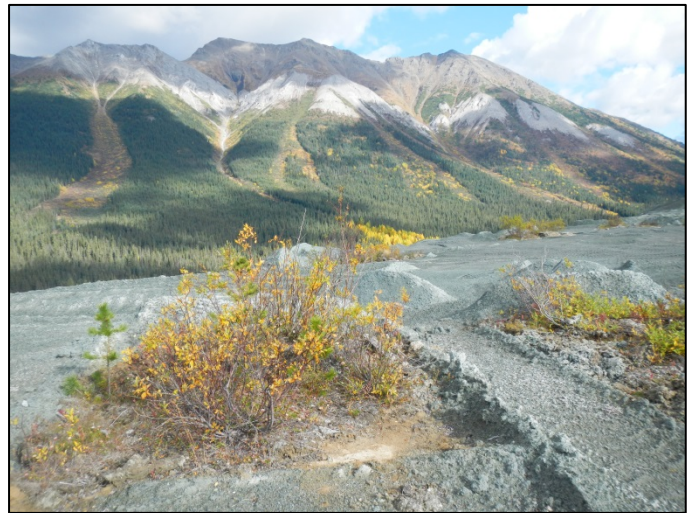
The method of direct placement of native ground “islands” has also been used on the upper portions of the tailings and some of these areas have been in place for multiple years. At the time of inspection, the plots were supporting native vegetation, including willow and pine (Photo 16). EMPR looks forward to receiving the monitoring results of this method in subsequent Annual Reclamation Reports.

*Photo 16. Native ground direct placement plots on top of tailings.*

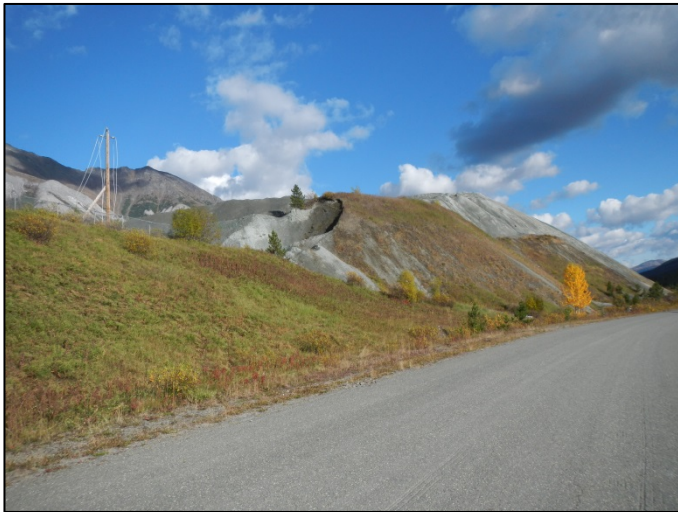
There is an area that supports vegetation on the eastern end of the pile where the older tailings are located (Photo 17). It was explained that an overburden cover was likely applied at this location prior to hydro seeding and hand seeding applications (thought to have been completed in the late 1970s).

*Photo 17. Revegetation on older slopes of the Tailings Pile*

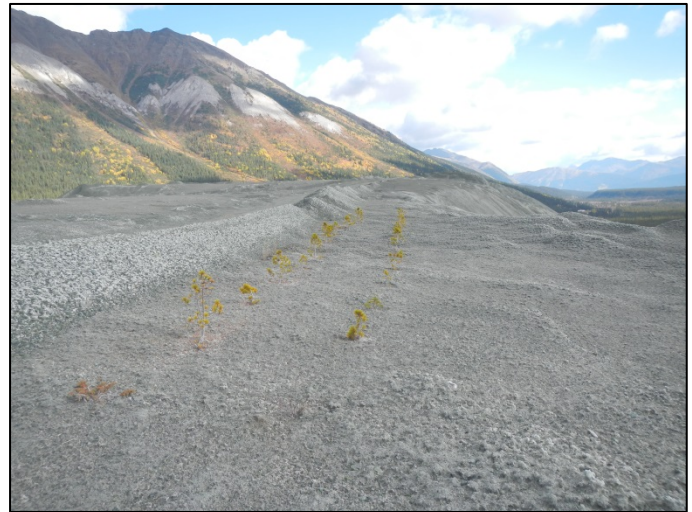
In limited areas on the top of the tailings, small plantations of lodgepole pine and Englemann Spruce have been trialed. As noted in the 2016 Reclamation Inspection Report, the seedlings are showing signs of stress and stunted growth, but most have survived so far and some plantations are believed to be 10 years old (Photo 18). It was discussed that natural growth rates in this area are also likely to be slow.

*Photo 18. Pine seedlings on tailings.*

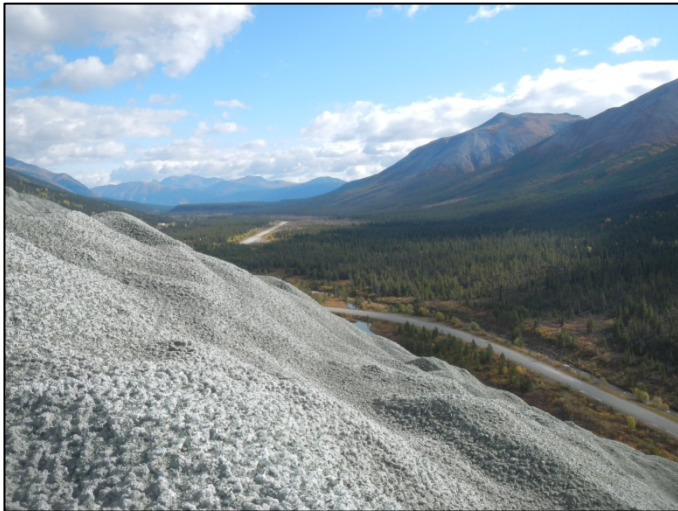
Although the majority of the Tailings Pile is not vegetated (Photo 19), there was no sign of dust deposition on the surface of the pile. It was discussed that the area is generally very wet during the summer and the tailings do not dry out sufficiently to generate dust.

*Photo 19. Typical view of tailings pile slope. Note surface texture in foreground.*

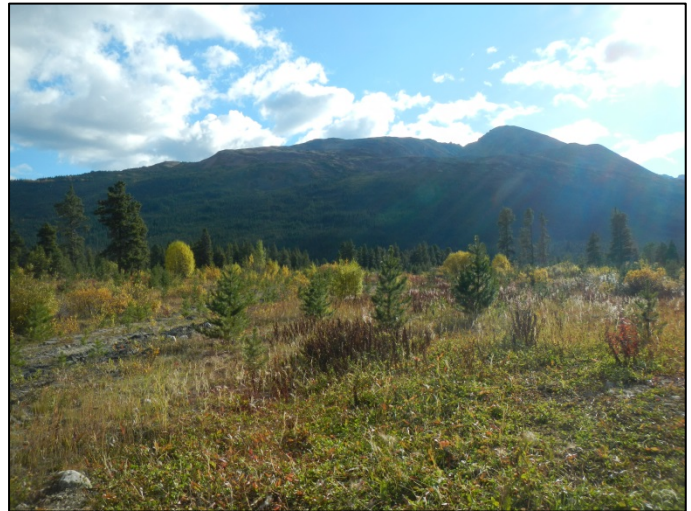
A driving tour through the former town site was conducted. Natural ingress of native vegetation including pine, black cottonwood and numerous native shrub species was observed (Photo 20). No planting has occurred on the town site; however some footprint disturbances, such as that of the church, will receive an application of seed. The paved road is still in place for access, but most of the cement sidewalks have been ripped up. It was discussed at the pre-inspection meeting that several collapsing sewage tanks have been removed from the site.

*Photo 20. Cassiar town site revegetation.*
