Report of Inspector of Mines - Reclamation

Mine Name/Number	Willow Creek Mine 0900118	Visit Date	2019-07-15
Type of Mining	CS. COAL - SURFACE	Location	
Latitude/Longitude	55.61984, -122.22384	Northing/Easting/Zone	548881, 6164043, 10U
Manager	Dudley Miller	Permittee	Conuma Coal Resources Limited
Phone Numbers	(250) 242 3764	Address	PO Box 2140 Tumbler Ridge BC V0C 2W0
Email

Area Inspected 1: Active Mining Areas (4N1/4N2 Pits, North Waste Rock Dump)

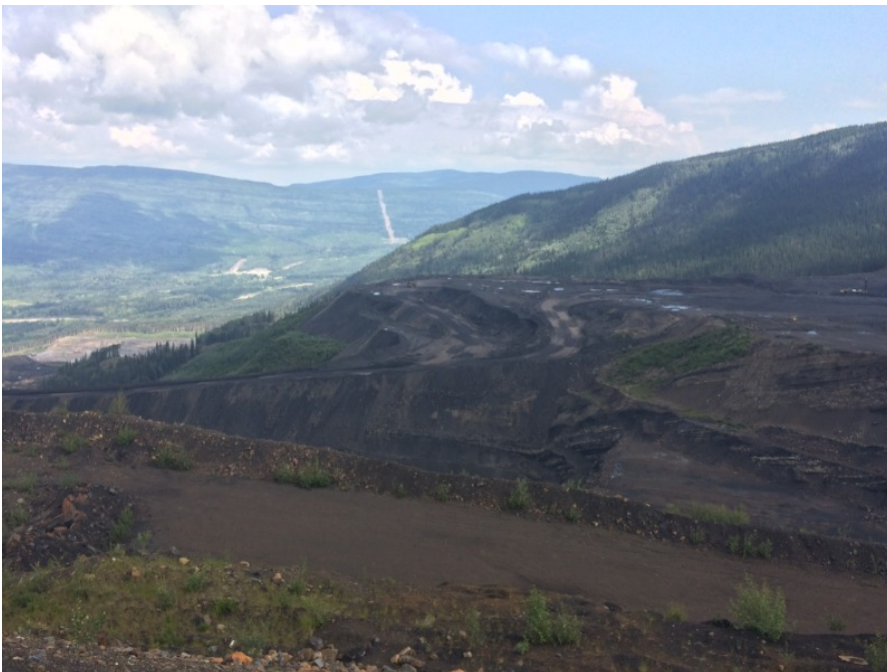
Active mining was occurring in the 4N1 and 4N2 Pits. The 4N1 Pit is currently being mined at the 686 m elevation and will be mined down to approximately 578 m over the next two to three years. The 4N2 pit will eventually be connected to the 4N1 Pit at approximately the 750 m elevation.

Waste rock was being hauled and placed near the 1140 m elevation of the North Waste Rock Dump. The proposed 760 Dump Coarse Coal Reject (CCR) Encapsulation area was observed from an adjacent bench. Site staff provided a general overview of the proposed mine plan amendment, which is currently being reviewed by EMPR.

Photo 1 - Active mining in the 4N2 Pit (middle right) and 4N1 Pit (middle left),

viewed from the North Waste Rock dump looking northeast.

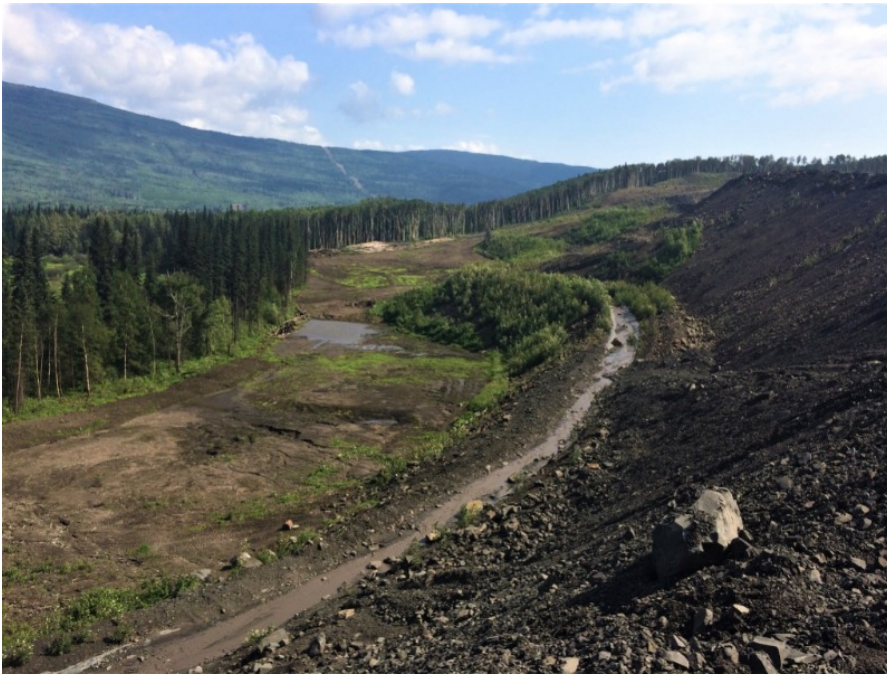
The proposed 4N1 Pit Haul Road was observed from the western point where it would be tied into the existing road. Site staff gave an overview of its general alignment to the Inspector.

A discussion of the importance of a Sediment and Erosion Control Plan to address the installation and operation of the road, in the absence of a runoff collection ditch adjacent to the roadway was discussed during the inspection. Conuma is currently clarifying the long-term plan with the proposed road. It is currently approved as a temporary road that would need to be removed before the end of operations.

Photo 2 - Proposed 4N1 Pit haul road area looking east. The existing east/west diversion ditch conveys water from the pit the North Pond.

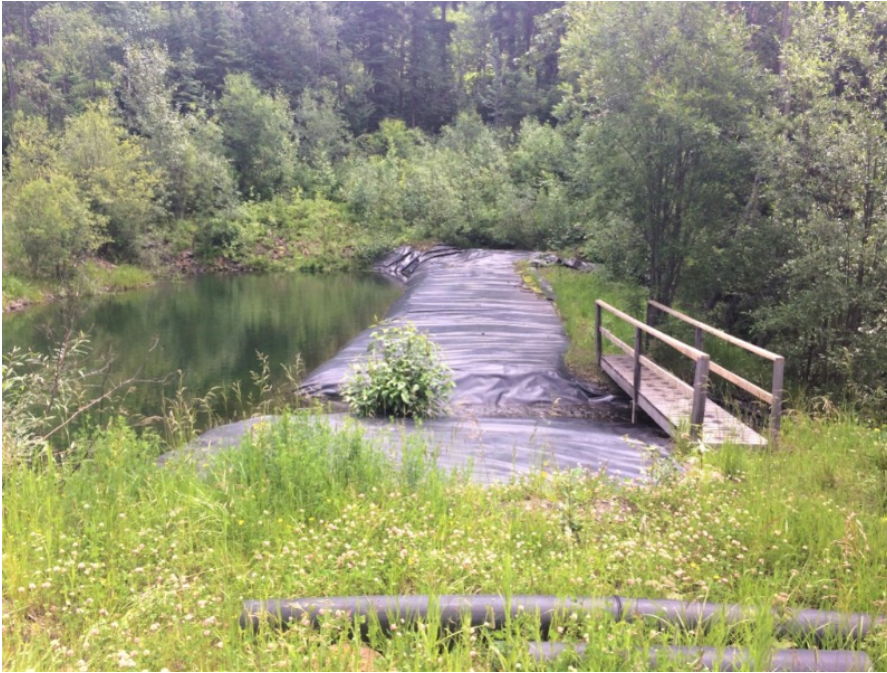
A significant build up of sediment was observed adjacent to the pond inlet. Site staff indicated that attempts in 2018 to dredge the pond proved ineffective. A second attempt to dredge the pond will be undertaken later in 2019.

During the inspection, a collection of old pipes were observed between the road and the sampling point. One of the pipes extended down the slope of the X Pond discharge point, terminating within the bed of the waterway approximately 5 m down gradient. During the close-out meeting, site staff indicated the the pipes would be removed within the next week.

Photo 3 - The outlet of X Pond. Samples are collected from the foot bridge.

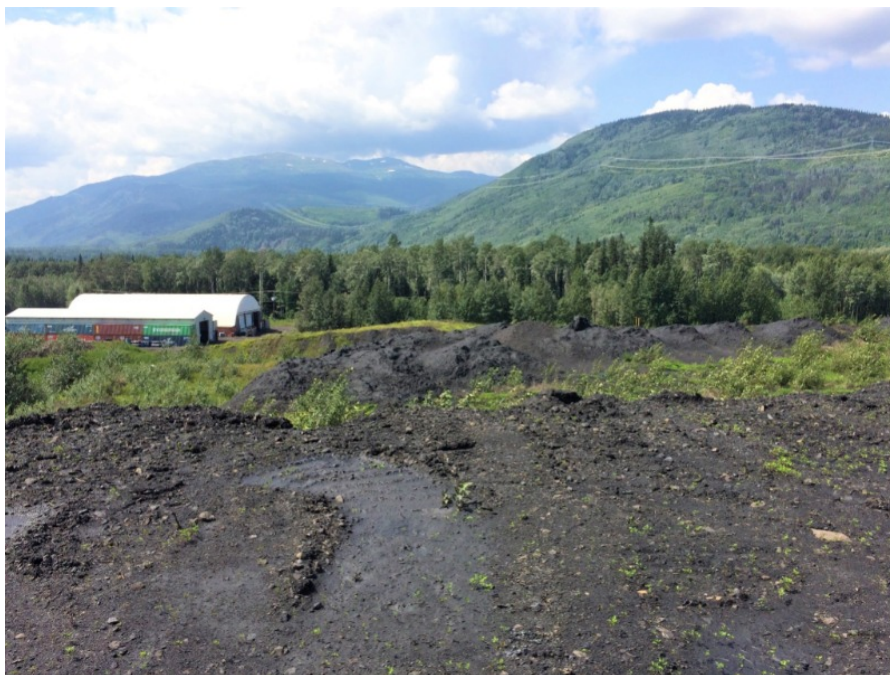
The inspector discussed the continued non-compliance associated with the FCCR Coarse Coal Reject (CCR) pile with site staff. It is understood the Conuma intends to submit a permit amendment application within the next few months to address the outstanding 2017 Geoscience Inspection Order. EMPRs expectation is that the application will include the permanent disposal of the CCR material such that the long-term loadings risk to the environment is adequately addressed.

Photo 4 - The FCCR CCR Pile looking west from the top of the pile.
