Province of British Columbia  
MINISTRY OF ENERGY AND MINES  
Report of Inspector of Mines  
Reclamation and Permitting  
(Issued pursuant to Section 15 of the *Mines Act*)

Inspection No.: 65419  
File: 18040-02-09  
Mine No.: 0100079  
Permit No.: M-241  
Emp/Cont: 0 / 0  
Orders H&S: 0 RECL 19  
Stop Work: 0

**Mine Name:** Yellow Giant Gold Project  
**Location:** Banks Island, Skeena MD / 53.370, -130.148  
**Owner, Manager:** Dirk Meckert

### Inspection Report

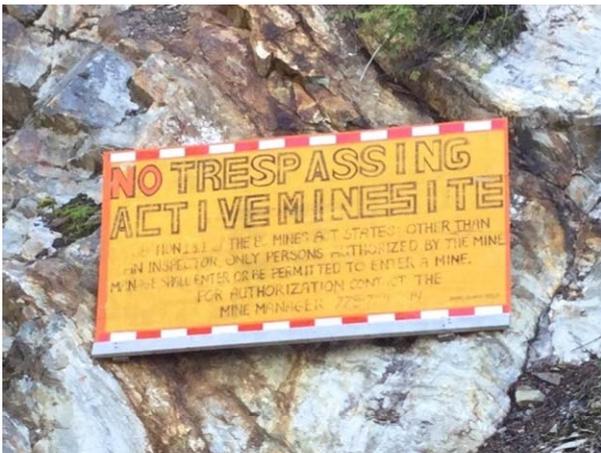
Currently, access to the site is via helicopter, float plane or boat. A barge landing and small wooden dock are located approximately 1.3 km southwest of the Tel mine site. During the inspection, MEM noted a large sign posted at the landing warning visitors not to enter. A gate or other physical barriers to access was not in place.

Photo 1: Sign at barge landing

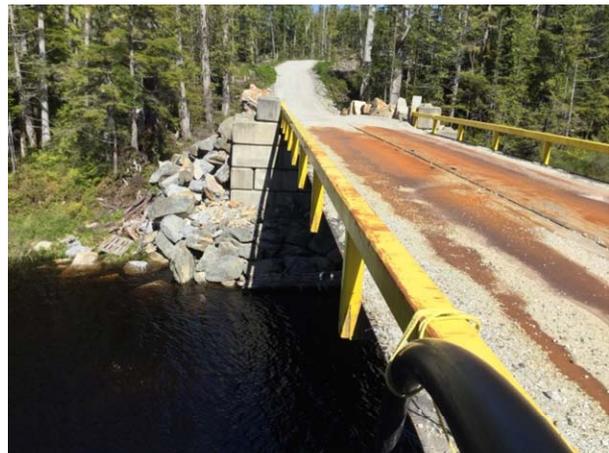
Three metal bridges are present along in Discovery road. Bridges consists of metal decked structures supported by concrete lock block and rock abutments. Two bridges were measured to be approximately 12.5 m in length. The third bridge was 18.5 m in length, crossing a narrow lake.

Photo 2: Bridge crossing Sproat Lake

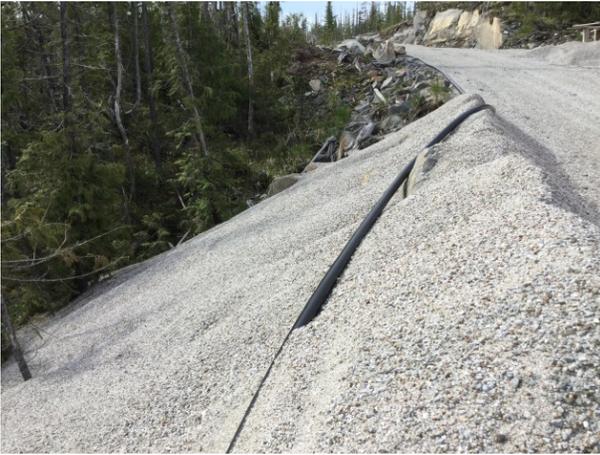
Several deep fills are present along the Discovery road, the first of which is present where the road crosses a drainage between Doug Lake and Sproat Lake. Another deep fill has been partially constructed where the road crosses a creek in a well-incised gully. Currently the road dips down into the gully, crossing the creek with a wood box culvert and then steeply ascends the other side. In order to widen the road and remove the steep slope into and out of the creek crossing, coarse rock has been dumped into the creek channel on one side of the gully. Due to the mine shut down, this work was never completed.

Photo 3: Deep fill between Sproat and Doug Lakes

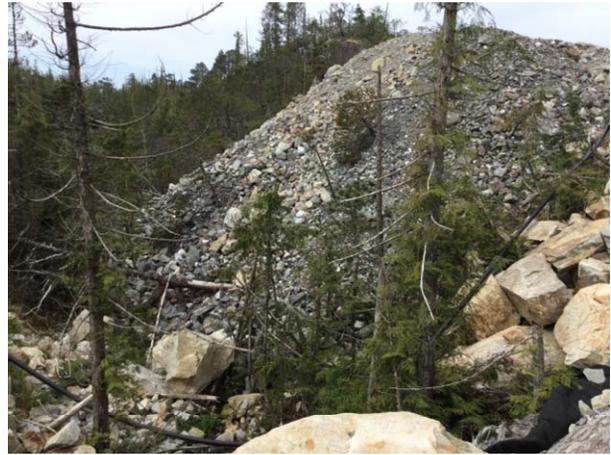
Photo 4: Deep fill into creek channel

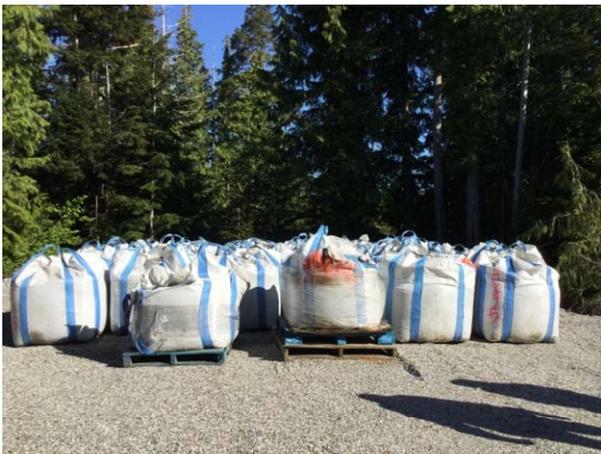
Photo 5: Concentrate stored near barge landing

7. In order to prevent the generation and release of poor quality drainage to the receiving environment, **Permit M-241 condition D.3.(d)(vi)** requires that sulphide concentrate be kept in waterproof bags in a covered facility prior to shipment off site. Thirty nine bags of concentrate were being stored near the camp, approximately 100 m from the barge landing. Although the concentrate was contained in waterproof bags, the material was not covered. **The Mine Manager shall ensure that all concentrate bags are contained in a covered facility. This issue shall be remedied immediately.**

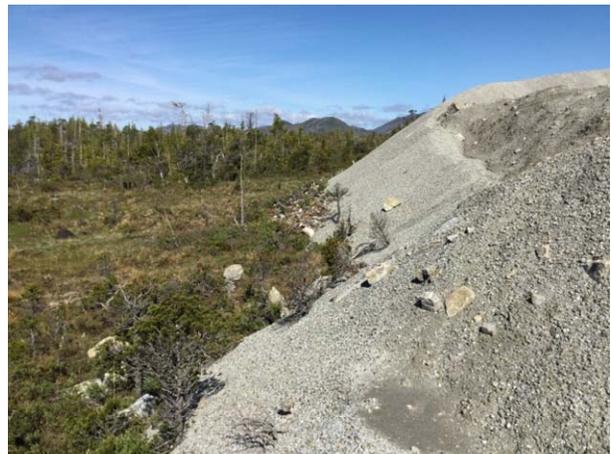
During the inspection the low grade ore stockpile, situated on the west side of the Tel road approximately 120 m south of the plant site, was noted to be perched on the edge of an adjacent quarry which was full of water. The toe of the pile was in the water. Mr. Meckert indicated that none of the stockpiled material had been deposited in the quarry itself. The west side of the stockpile bordered the environment and was roughly 30 to 40 m from an unnamed lake. No site water containment had been established. Based on rough measurements of the stockpile at the time of the inspection, an estimated 2400 m<sup>3</sup> of low grade ore may have been stored at this location. It was not determined if the soil from the footprint had been salvaged prior to placement of the waste rock.

Photo 6: Low grade ore stockpile

12. Upon observation of the low grade ore stockpile, surface instabilities were evident. Though the low grade ore stockpile is not permitted, permit conditions pertaining to waste rock facilities are applicable while the material remains stockpiled. **Permit M-241 condition C.2.(a)** requires that visual inspections of the crests and slopes occur to ensure that stability and erosion control objectives are achieved. Further, pursuant to **Permit M-241 condition C.2.(a)**, the side slopes of the low grade ore stockpile are to be developed at 2:1 in accordance with the application. The slope gradients were not measured during the inspection, however, the surface instabilities observed could indicate that slopes are steeper than permitted. **The Mine Manager is asked to assess the surface instabilities observed and provide recommended actions that should be taken to control erosion on this mine component. This information is required in the Mine Manager's response.**

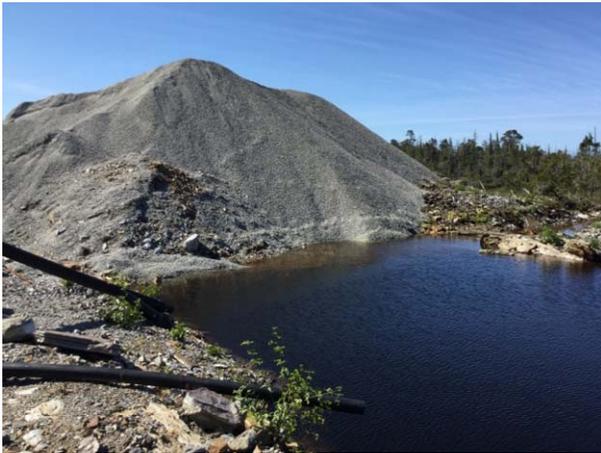
Photo 7: Low grade ore stockpile adjacent to quarry

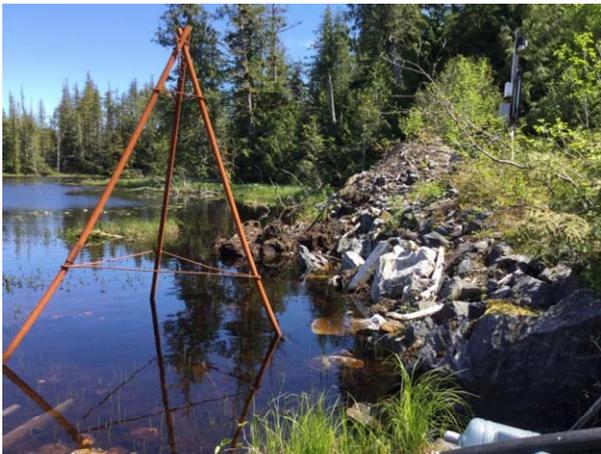
Mr. Meckert indicated that PAG material associated with exploration and mining of the property, which occurred in the 1970's and 80's, is located in or adjacent to Sproat Lake, approximately 60 m northwest of the Tel portal. PAG materials associated with site activities in the 70's and 80's have also been deposited in or adjacent to a wetland approximately 100 m northwest of the Bob portal. Mr. Meckert indicated that most of the material at the Bob site had been removed and processed in the mill. Some of the material in the wetland was excavated and placed on the waste rock dump at the Bob site. In addition, a few truckloads of material may have gone to the Tel site and the barge landing.

Photo 8: PAG material near the Tel portal

14. **Permit M-241 condition D.3.(d)(iii)** specifies that PAG is not authorized to be stored on surface for longer than 4 weeks. **The Mine Manager is asked to locate all PAG materials on site and provide a map with the locations and volumes of these materials. This information is required in the Mine Manager's response.**

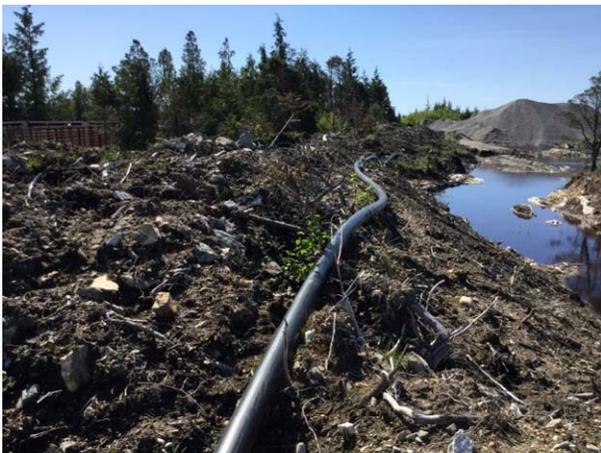
The largest soil stockpile located at the southwest corner of the Tel mine site has been disturbed by excavations which were intended to be sedimentation ponds. The excavation links the soil stockpile area to an adjacent quarry which has filled with water and in which portions of the low grade ore stockpile have encroached. MEM understands that the area was never used as a sediment pond. During the inspection, MEM noted significant staining associated with fuel/oil spills in the adjacent truck shop area. Given the proximity of the spill and the large stains present, it is possible that the soil stockpile has been contaminated.

Photo 9: Soil stockpile near low grade ore stockpile

15. **Permit M-241 condition D.6.(c)** specifies that soil stockpiles must be located in areas that minimize handling requirements, provide adequate accessibility, and optimize sediment control options. **Permit M-241 condition D.6.(f)** specifies that stockpiled soil shall not be used as fill. **The Mine Manager is asked to locate all soil stockpiles on site and provide a map with the location and volumes of these materials. In this provision of information, the Mine Manager is asked to provide details regarding burial of any stockpiled material and/or placement of materials that inevitably precludes its use for reclamation purposes (i.e., it can no longer be retrieved). This information is required in the Mine Manager's response.**

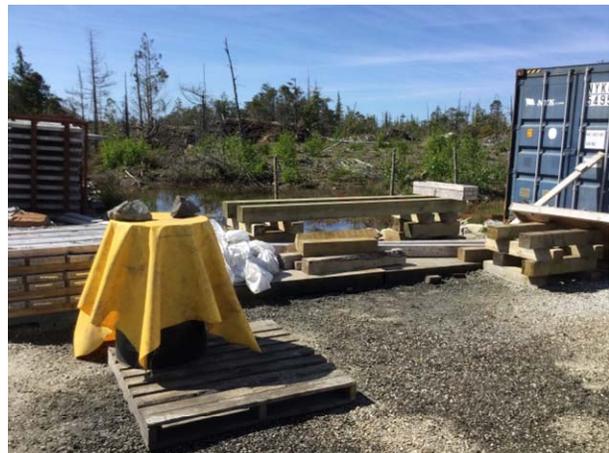
Photo 10: Fuel spill adjacent to soil stockpile

barrels of fuel, which had been removed prior to the inspection, had been stored at this location. Fuel from the open barrels had become displaced by rainwater, spilling to the ground adjacent to a large soil stockpile.

9. During the inspection, MEM noted evidence of spilling of fuel and oil at the Truck shop which was located adjacent to a large soil stockpile. Portions of the stockpile had been excavated to create a secondary sediment pond. **Permit M-241 condition D.6.(b)** requires that stockpiles be protected from erosion, degradation and contamination. Prior to using this material for reclamation purposes, the stockpile must be sampled representatively to assess the extent, magnitude, and nature of the contamination. **Prior to initiating soil replacement activities on-site, the Mine Manager shall ensure the soil materials are appropriately characterized to ensure the quality is suitable for reclamation purposes to meet the end land use and capability objectives for the site. The Mine Manager shall implement measures immediately to ensure that all soil stockpiled on-site is protected from any on-going sources of contamination and erosion.**

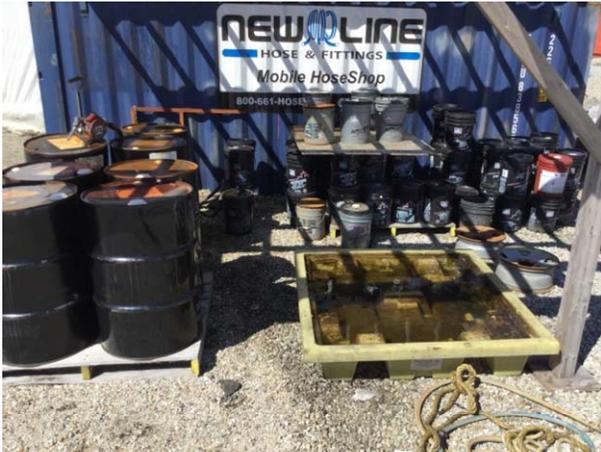
A cache of fuel barrels and oil was being store outside of the truck shop. Water had ponded on the top of the barrels, causing them to rust. A large stain was visible approximately 10 m south of the area. Mr. Meckert indicated that several

Photo 11: Fuel and oil stored near truck shop

1. An inspection report dated September 3, 2015 ordered that secondary containment be in place for all fuel storage tanks >230L. No secondary containment was observed during the inspection. **Section 9.9.1** of the Health, Safety and Reclamation Code for Mines in British Columbia (Code) requires that all liquid hydrocarbon products be stored within a containment that minimizes the possibility of accidental discharge to the environment. **Code Section 2.3.4** requires that potentially hazardous materials be properly contained. The Mine Manager shall ensure that appropriate secondary containment measures are implemented for all storage tanks and containers present on-site holding hazardous or potentially hazardous materials. Secondary containment capacity should be 110% of the capacity of the storage container/tank. This requirement applies to containment of persistent leaks from mobile equipment and vehicles that are on-site. **This non-compliance shall be remedied immediately.**

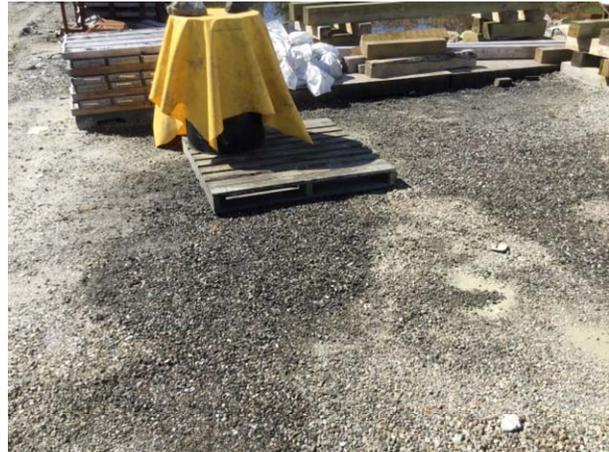
Photo 12: previous spills at truck shop

3. MEM noted evidence of a number of spills and found several vehicles and pieces of equipment that were actively leaking. Pursuant to **Code Section 2.3.7**, spills or releases of hazardous waste materials shall be cleaned up as soon as possible by persons trained to safely handle the waste material and wearing any necessary protective clothing and equipment to safeguard their health and safety. The Mine Manager shall ensure all spills that have occurred on-site are cleaned up as per Code requirements and ensure any active leaks or future spills are similarly addressed. Contaminated absorbent or soil materials shall be appropriately contained and stored for disposal at appropriate off-site facilities. **The Mine Manager shall ensure this issue is remedied immediately.**

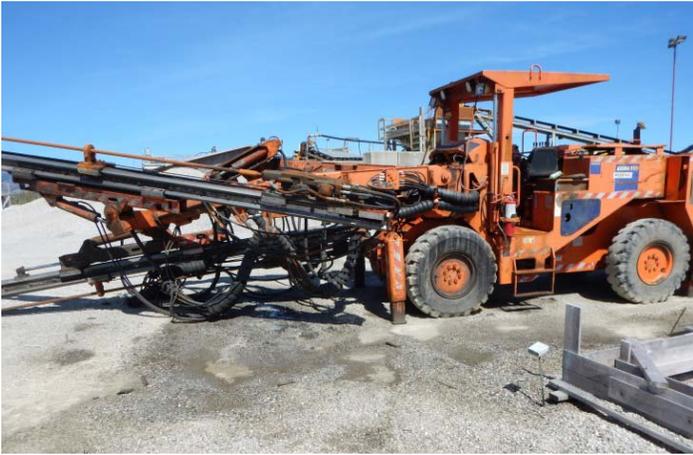
Spills from equipment left on site were noted in a number of areas. MEM did not observe any attempt to abate leakage of fluids from parked equipment. When asked if spill kits were available on site which could be used to address the issue, Mr. Meckert indicated that the only way to address the issue would be to mobilize a mechanic to site to repair the equipment or to have the equipment removed. He indicated that neither of these options was possible given the current financial circumstances.

Photo 13: Fluids leaking from drill near truck shop

MEM placed drip pans and absorbent pads under several pieces of equipment and requested Mr. Meckert place absorbent pads under a grader and two rock trucks which were also leaking. MEM also requested that Mr. Meckert monitor equipment and fuel tanks regularly and implement corrective actions in the event that a spill or leak is discovered.

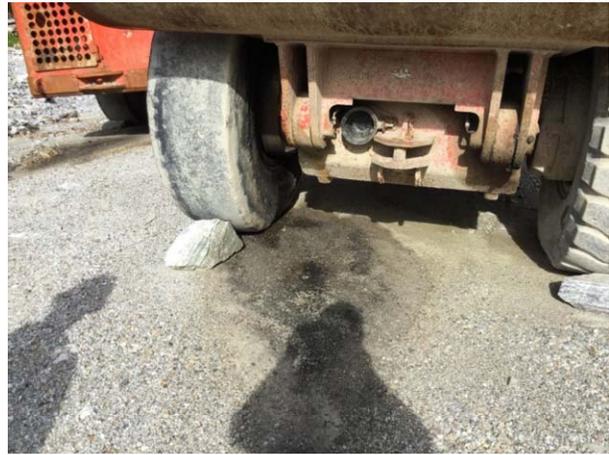
Photo 14: Spill under rock trucks at Tel portal

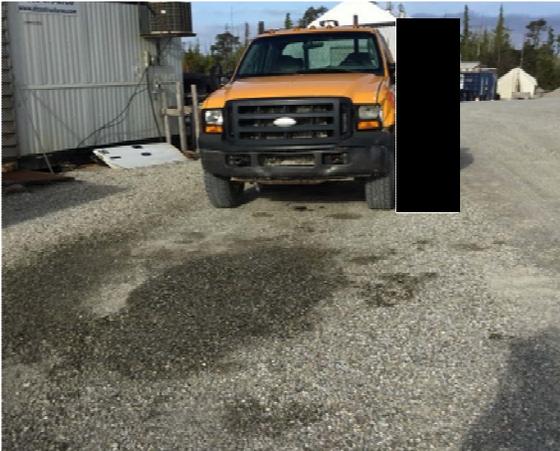
The diesel truck used during the inspection was leaking oil. A large stain was noted in front of the office building at the Tel site, where the truck is regularly parked. When asked if there was another vehicle that could be used, Mr. Meckert noted that the truck is one of the only functional diesel trucks on site and it is necessary to use it as there is only a limited supply of gasoline on site which is needed for generators and other applications. MEM placed a drip pan under the vehicle and requested that Mr. Meckert keep the pan in place while the vehicle is parked.

Photo 14: Oil leaking from truck

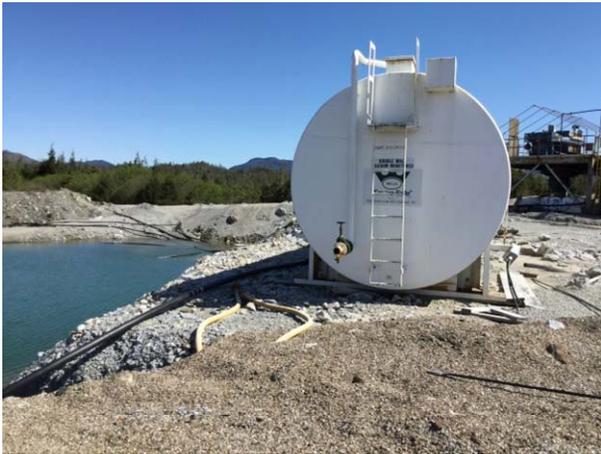
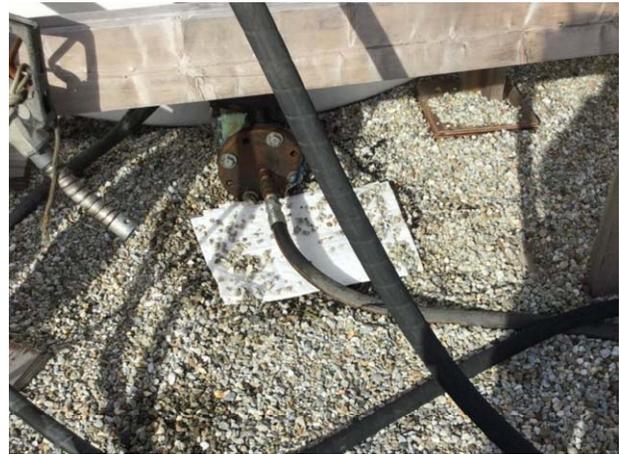
Several fuel tanks were noted at the camp and Tel sites. Mr. Meckert estimated that 35,000 to 40,000 L of fuel was in the tank by the camp. Another tank, adjacent to the sediment pond at the Tel site, contained an unspecified amount of fuel and was leaking. An absorbent pad was in place; however the pad was saturated and fuel was leaking to ground. MEM replaced the absorbent pad. Due to the low proximity to the ground, it was not possible to place a drip pan to capture the leaking fuel. Due to the close proximity to the sediment pond (approximately 10 m), it is possible that water in the pond may now, or in the future be contaminated.

Photos 16 and 17: Leaking fuel tank adjacent to sediment pond. Note that the leak is on the far side of the fuel tank in the photo on the left. This photo is intended to show the proximity of the tank to the adjacent pond.

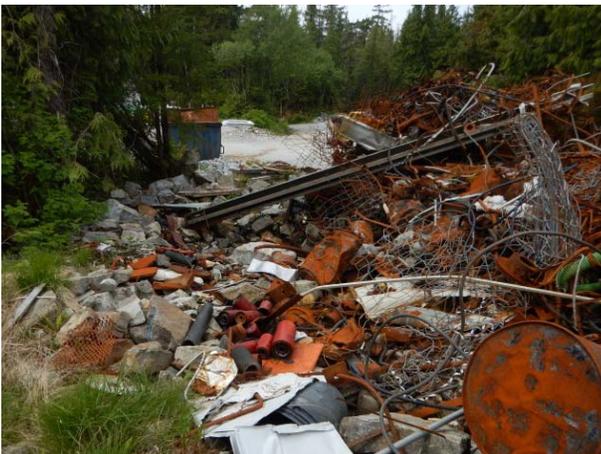
Used fuel filters were found in a scrap metal pile at the camp site. Oil was leaking to ground.

Photo 18: Scrap metal pile containing used oil filters.

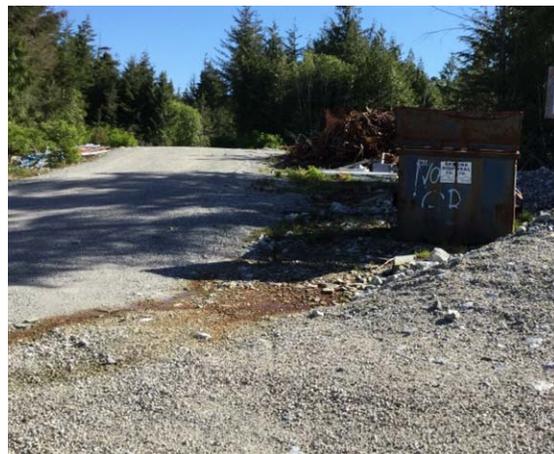
Photo 19: staining adjacent to pile

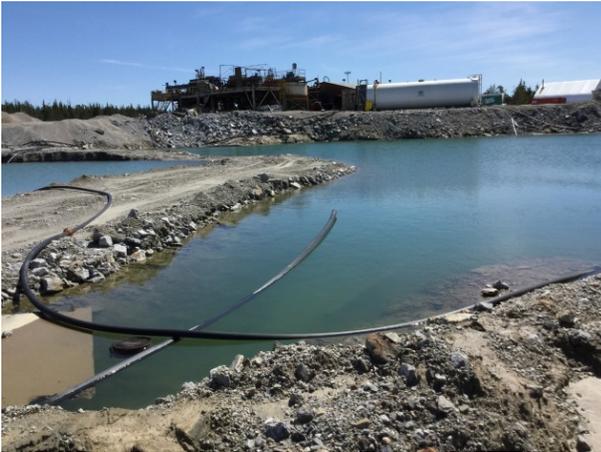
As per MEM direction, pumping of site water to the sediment ponds at the Tel site, and discharge of site water to Barge Channel was stopped as of July 15, 2015. As a result, sediment ponds were at capacity and Mr. Meckert indicated that they overtop, discharging to adjacent wetlands during rainfall events.

Photo 20: Sediment pond full of water

5. The sediment control pond at the Tel site was full, with less than 1m freeboard. **Permit M-241 condition C.3.(b)** requires that a minimum of 1.0 m freeboard below the spillway be maintained to prevent accidental release of sediment laden water. The September 3, 2015 inspection report closed this part of the mine to prevent its unauthorized use. The operational requirements to maintain the freeboard of the pond continues to be a requirement for the sediment control pond facility. Similarly, the seepage from the Bob stope is currently uncontrolled and appropriate actions are required to contain this water on-site. **The Mine Manager shall consider options to remedy these issues (i.e., maintenance of adequate freeboard of the sediment control pond and control of Bob seepage water through the site water management works) and provide the options analysis and preferred option in the Mine Manager's response to this report. The chosen option must meet the objective of ensuring best practices in environmental protection are implemented and maintained.**

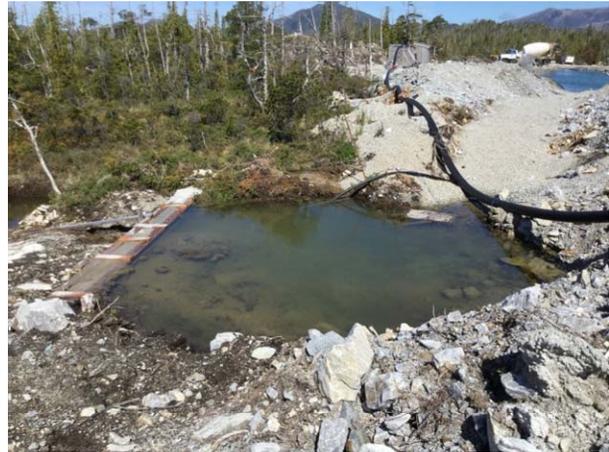
Photo 21: Small pond overflowing concrete dam.

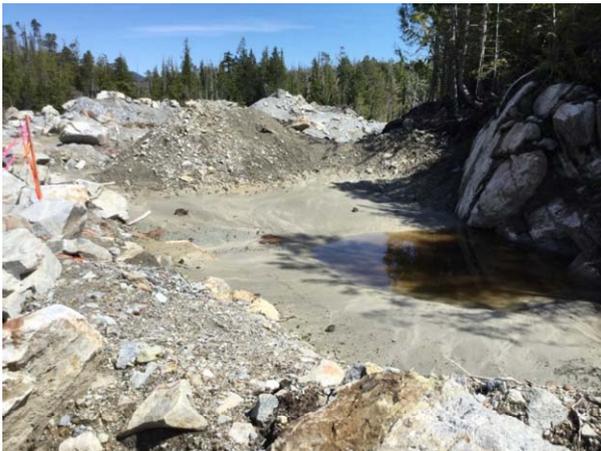
Tailings had deposited into a vent raise and the collapsed stope at the Bob site. The tailings in the vent raise were not covered and remain exposed at surface. Water from this area drains into the collapsed Bob stope, which was filled with water, covering the deposited tailings. Mr. Meckert indicated that nothing other than flocculent was used to thicken the tailings prior to deposition. He was unsure why tailings were deposited into the vent raise, indicating that this occurred when he was away from the site.

Photo 22: Tailings in the Bob vent raise

6. **Permit M-241 condition D.3.(d)(v)** requires that flotation tailings be stored on surface no longer than four weeks. Tailings stored at surface are to be kept in a covered facility to prevent the generation and release of poor quality water to the receiving environment for no more than 4 weeks. All flotation tailings shall be backfilled in the underground Tel Mine workings. MEM noted that tailings have been deposited into portions of the Bob stope, which had collapsed, resulting in an opening to the surface. The stope has currently filled with water, covering the tailings. Adjacent to the stope, tailings have also been deposited in the Bob vent raise. Tailings in this area were located at surface and were uncovered. This Bob Zone is not an authorized location for tailings storage/disposal. At this time, this inspector is aware that milling and underground activities are not authorized. **The Mine Manager shall ensure that tailings located on surface are covered to prevent infiltration and appropriate measures are taken to contain any run-off from the tailings while it is stored on the surface. This issue shall be remedied immediately.**

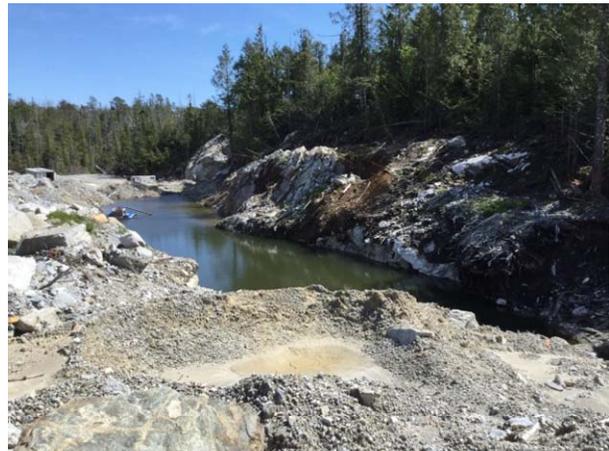
Photo 23: The water filled Bob stope.

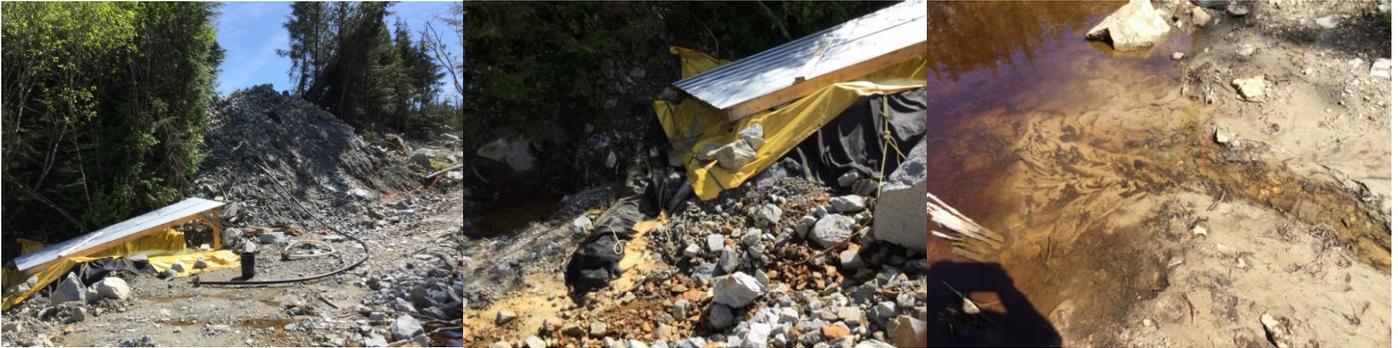
Seepage from the old Bob portal which was being collected in a seepage pond was discharging uncontrolled to the environment.

Photos 24, 25, and 26: The series above shows the seepage collection pond collecting water from the old Bob stope, seepage escaping out the back of the pond, and flowing to an adjacent wetland.

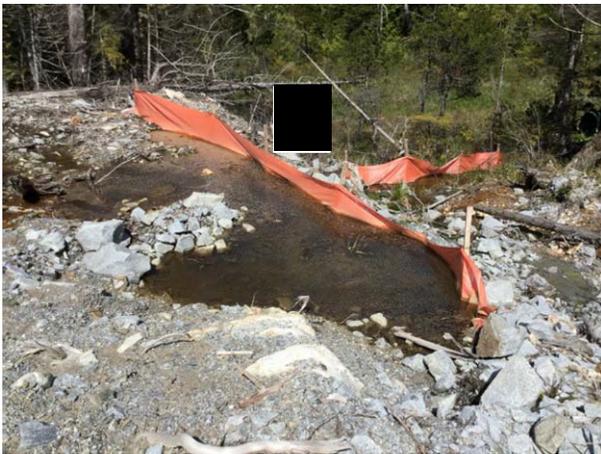
At the eastern end of the Bob site, tailings which discharged to the environment (a wetland) during the 2015 spill remain in place. At the same location, water from the Bob site was seeping from the edge of a gravel pad into the environment, via a silt fence. Water was collecting behind the silt fence which likely overtops during rainfall events.

Photo: 27 Seepage from Bob discharging to environment

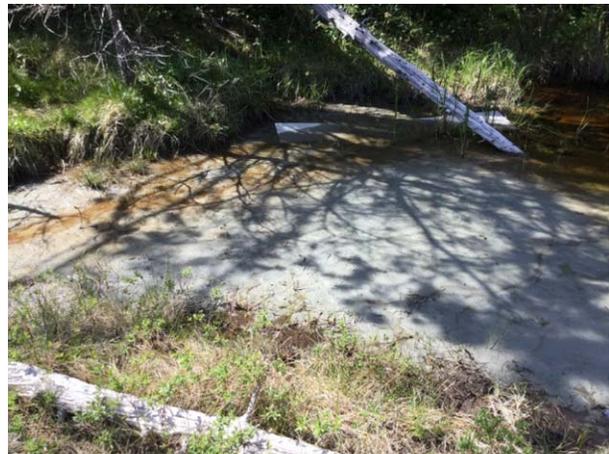
Photo 28: Tailings deposited in wetland

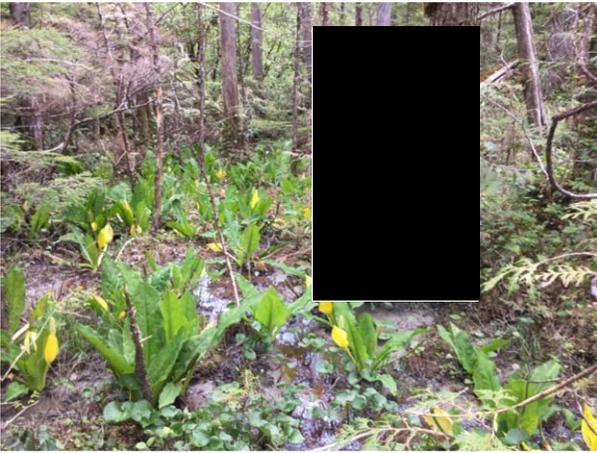
Drill cuttings released to the environment at the Discovery site remain in place. Sediment was observed to have deposited on the forest floor and flowed into an unnamed creek, extending toward Hepler Lake.

Photo 29: Drill cuttings deposited in creek

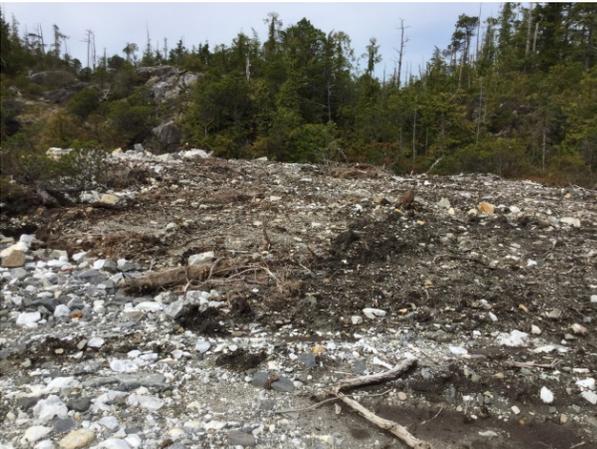
The sediment pond that had been excavated at Discovery as a temporary measure to contain site water had been filled in and soil replaced to a depth of approximately 10 to 30 cm. Mr. Meckert was not certain if sediment in the pond had been removed prior to infilling of the pond. MEM noted brown seepage a few meters down grade of the filled pond which flowed toward Englishman slough.

Photo 30: filled in sediment pond at Discovery

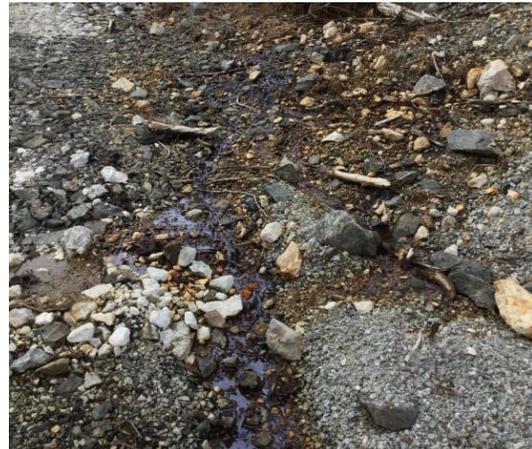
Photo 31: seepage near filled sediment pond

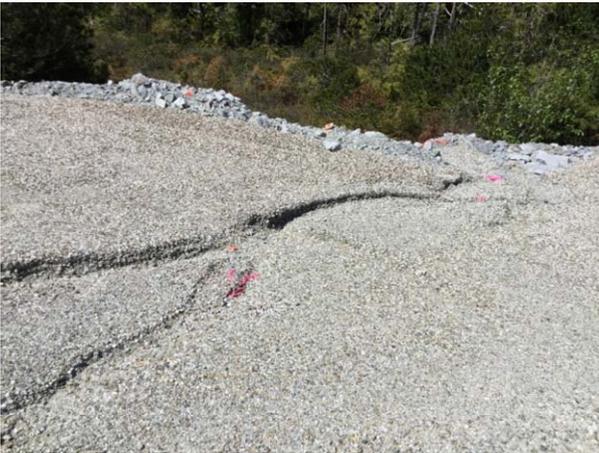
Evidence of erosion was present throughout the site. Rilling and erosion of the road grade was observed on the Tel, Bob and Discovery roads and at the Tel portal. Evidence of rilling of the low grade ore stockpile was also noted. Erosion and sediment control supplies were observed on site in a storage area near the Tel site, and evidence was noted of some attempts to control sediment release. A silt fence had been erected at the Bob site and adjacent to the Tel portal road at a stream crossing. A sump lined with geotextile cloth had been excavated near the Tel portal. Evidence of significant erosion was noted on the long, steep Tel portal access road, with water and sediment running down the road into the portal. Active water management at the site had ceased and sediment ponds at the Tel site were full and overtop during heavy rainfall events.

Photo 32: Example of road erosion

16. **Permit M-241 condition D.5.(c)** specifies that appropriate inspection must be conducted of sediment and erosion control structures to ensure sediment-laden run-off is suitable contained on-site. MEM interprets this condition, in conjunction with the site's erosion and sediment control management plan, to mean that measures will be taken to contain run-off on-site and monitoring activities will occur to ensure that this is occurring at all times. **The Mine Manager is asked to provide in the response to this inspection report activities that occur on a routine basis that address these permit requirements and provide comment regarding how site personnel respond when run-off is found to not be contained on-site.**

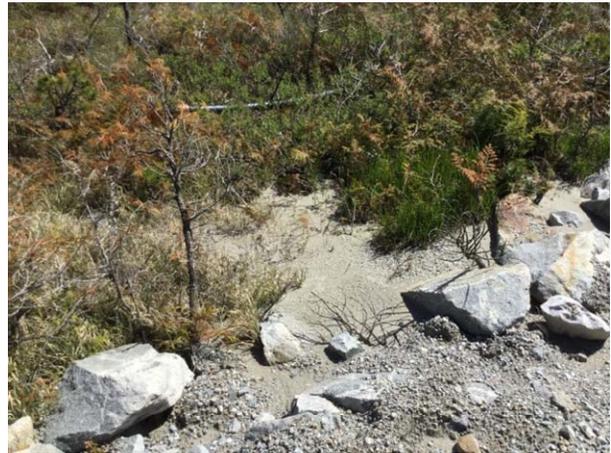
Photo 33: Deposition of sediment adjacent to road

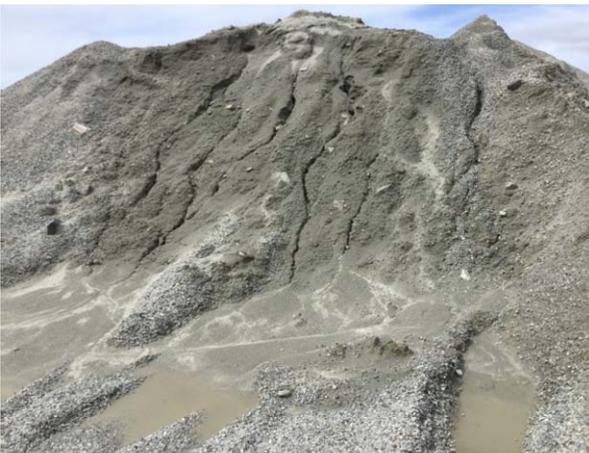
Photo 34: Erosion of the low grade ore stockpile

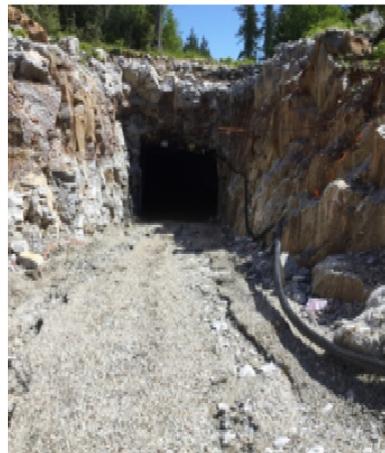
Photo 35: Riling of road surface at Tel portal
