Report of Inspector of Mines - Reclamation

Mine Name/Number	Copper Mountain (Similco)	Visit Date	2019-07-30
Type of Mining	MS. METAL MINE - SURFACE	Location	
Latitude/Longitude	49.33111, -120.53417	Northing/Easting/Zone	679150, 5467190, 10U
Manager	Eric Dell	Permittee	Copper Mountain Mine (BC) Ltd.
Phone Numbers	(250) 295 4735	Address	PO Box 1400 Princeton BC V0X 1W0
Email			
Inspector	Victoria Stevens, INSPECTOR	Accompanying Inspector	Adrienne Turcotte, MLWS, A.Ag., Inspector;
Address	441 Columbia Street Kamloops, B.C. V2C 2T3		
In Attendance			
Copies to

Report Date: 2019-08-08

Area Inspected 1: 2018 Resloping and Seeding Research Trials above Administration building

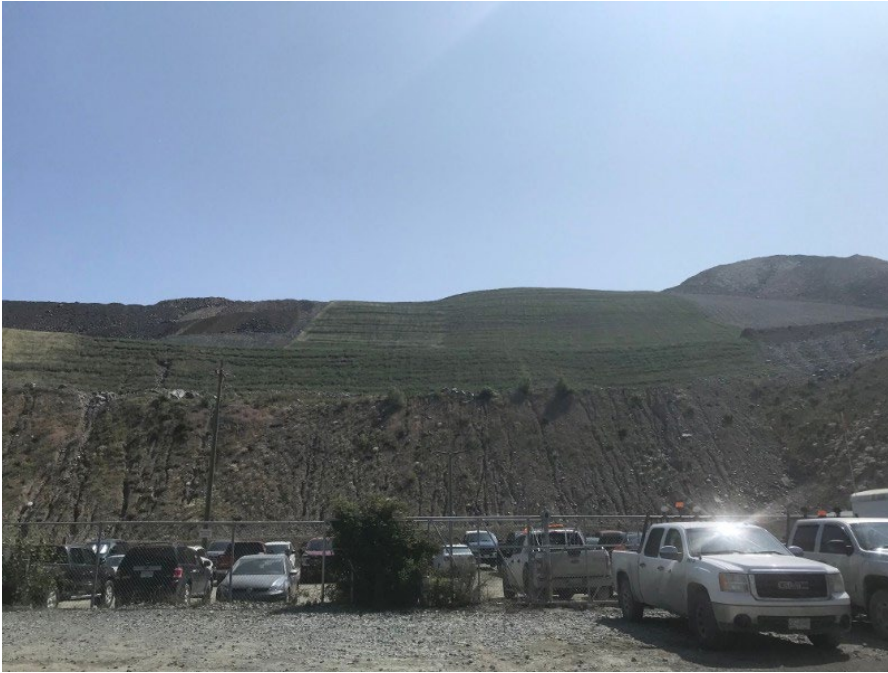
There are gaps in the treated area that have not germinated, and this is attributed to application error during hand seeding. These areas will be infill seeded and seed mix application methods will be reviewed by site staff. Monitoring has been undertaken by Nutrigrow and an early learning is that the seed mix contained too much fall rye. On June 16, 2019, a significant rainfall event resulted in the rilling observed in the seeded areas. Site staff reported that there was no significant rilling observed during snowmelt and freshet.

2018 Reclamation research trial which is testing both site-preparation techniques and seed mixes on biosolids-amended soils

With the response to this report, please provide details on the reclamation monitoring program for the trials, including details about frequency, plot specifications, methods used and parameters measured, data interpretation and reporting, metal uptake monitoring and adaptive management.

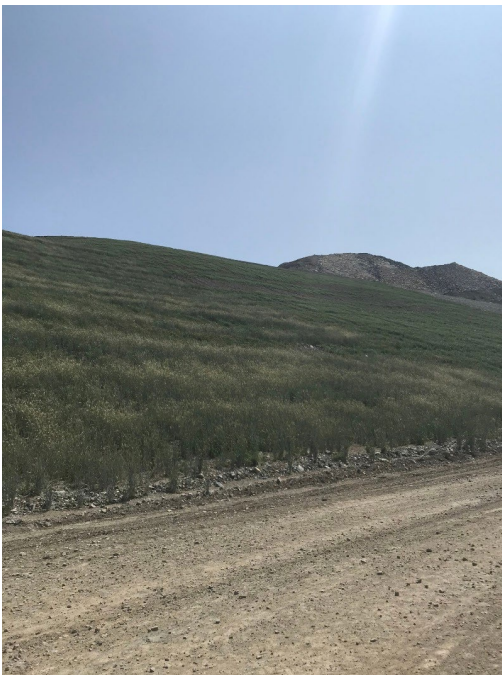
Upper slope of research trial which has a smoother site preparation technique and 3 different mixes of seeds

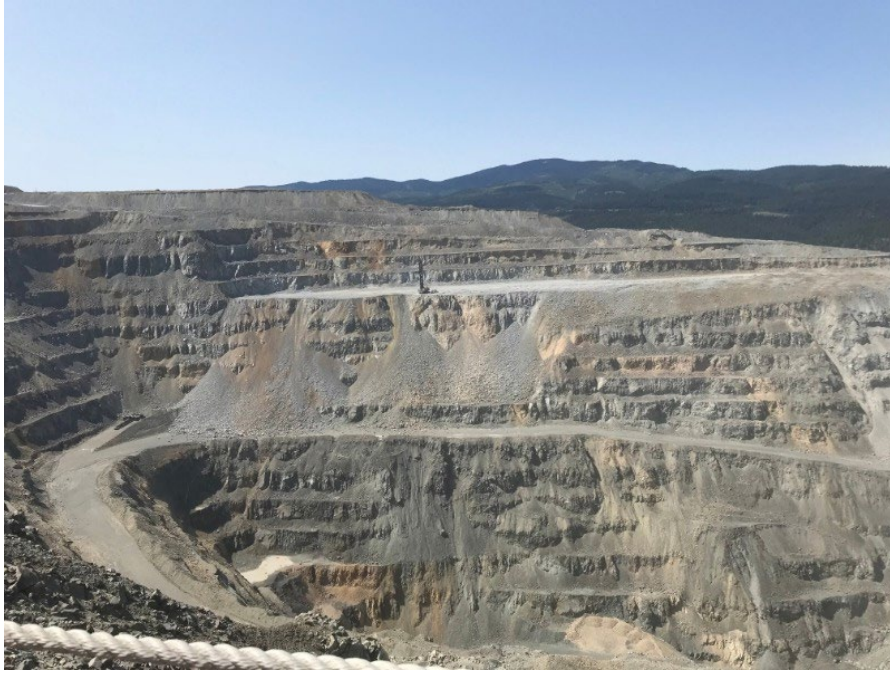
Pit 3 which is being used as a temporary short-haul area but will continue to be mined down

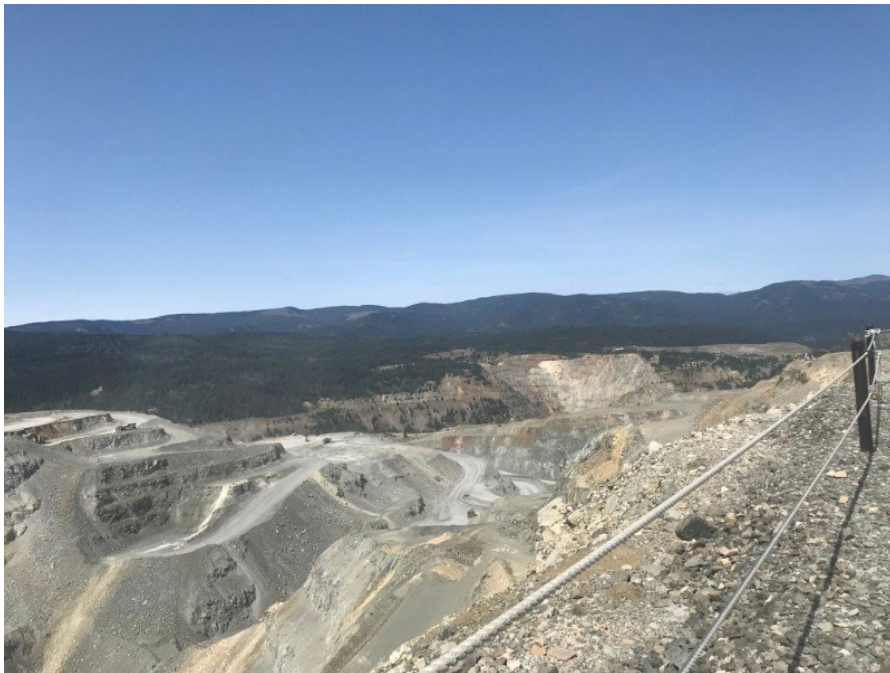
Looking from Pit 3 to Pit 2 with Ingerbelle pit in the far background

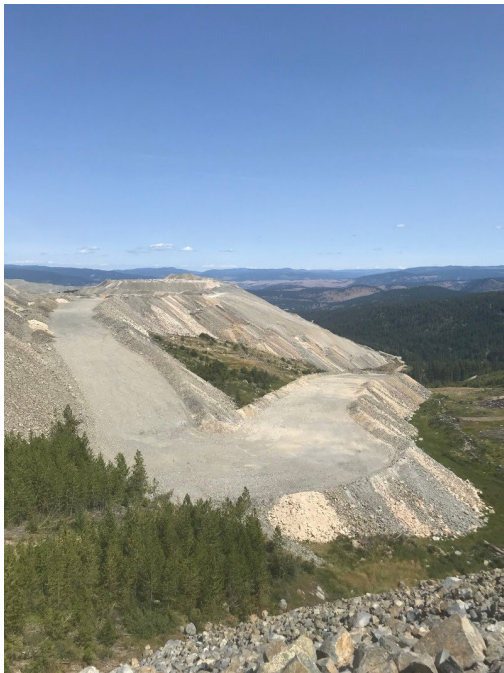
The long slope in the background as been resloped with a rough surface texture and will be seeded in 2019

With the response to this report, please provide a summary of the activities completed to date for this area, if this area is part of a research trial, information on future planned activities, including revegetation and monitoring, and a description of the goals for this trial area.

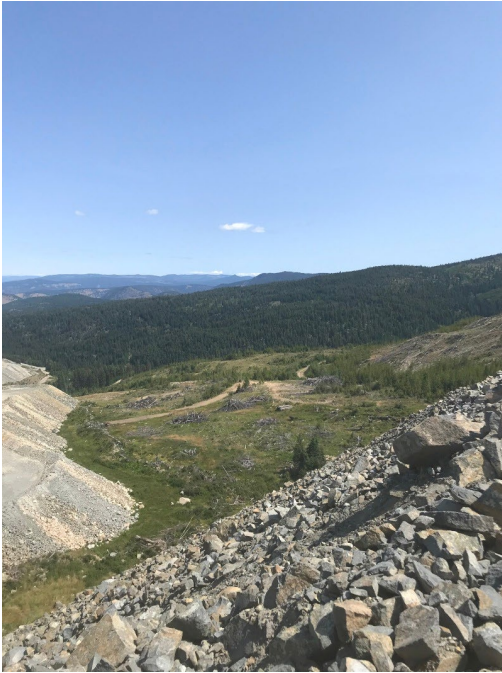
A soil windrow can be seen below the access road and piles of coarse woody debris have been stockpiled for use in reclamation activities. This area will be salvaged for soil and CWD as mining advances.

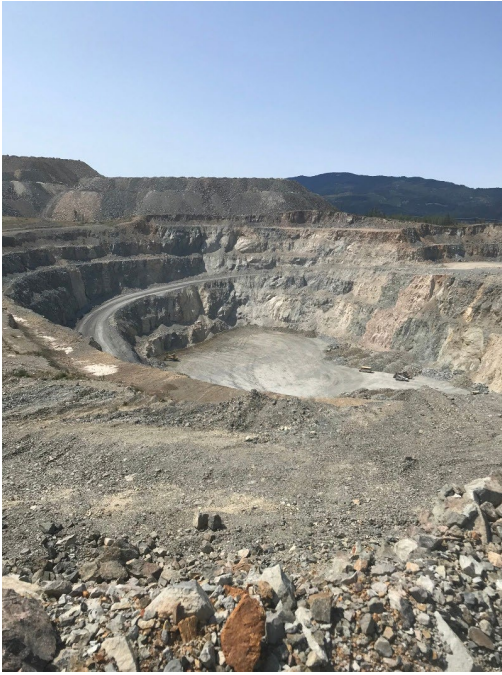
Oriole Pit is currently being backfilled with waste rock

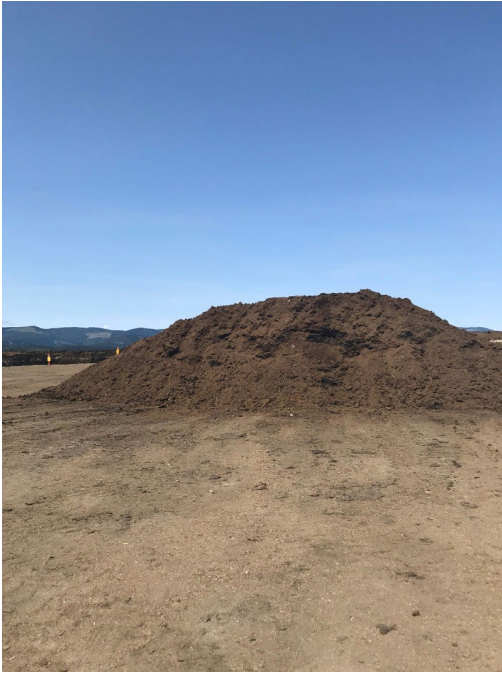
Pile of amendment consisting of biosolids and sawdust mixed together

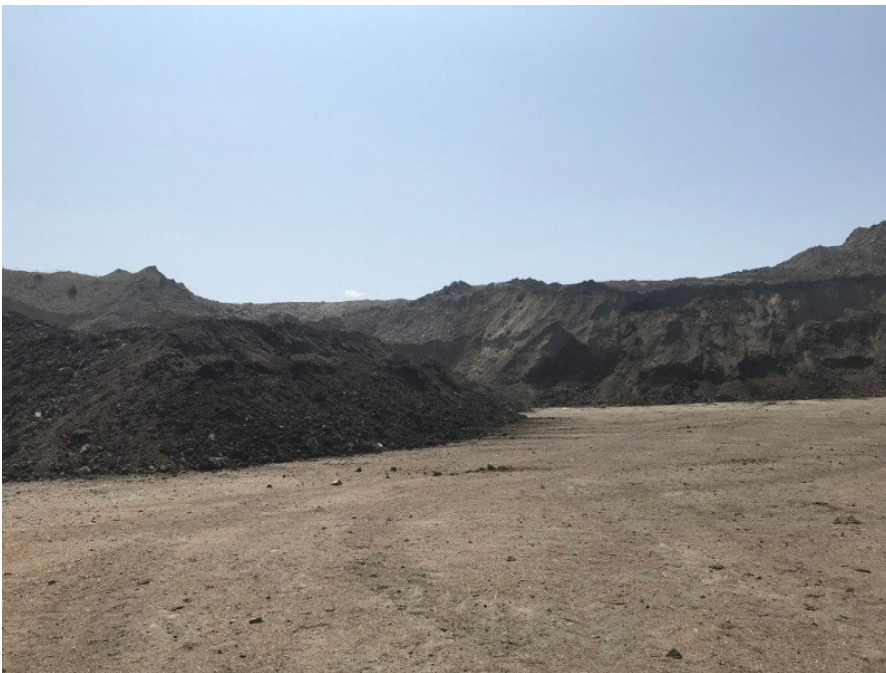
On the right is the South Soil Stockpile and on the left is the finished soil stockpile made of a mix of amendment and salvaged soil

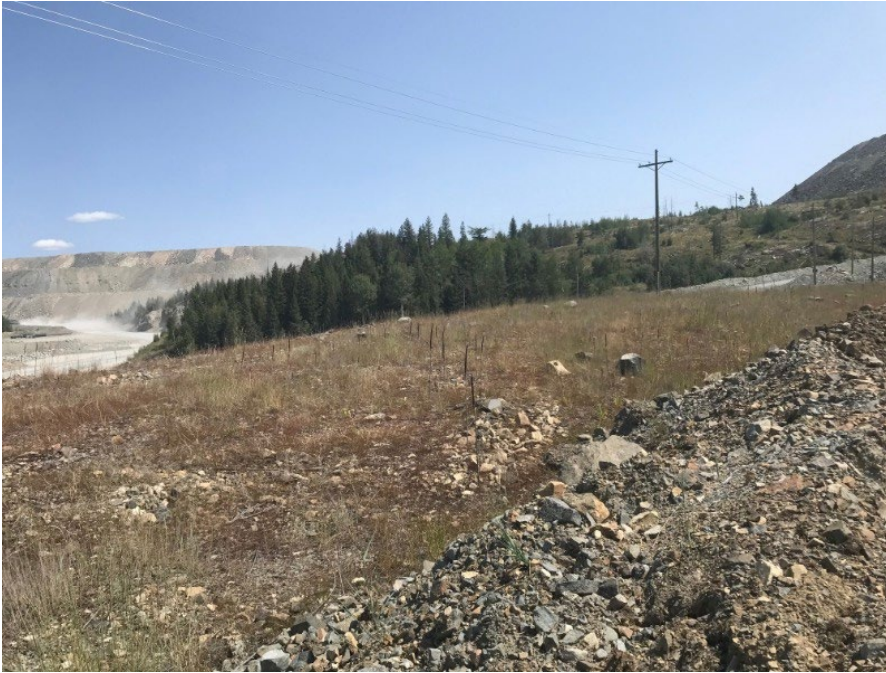
A revegetated area, seeded in the early 1990s, is located adjacent to the Nutrigrow South Soil Production Facility under some powerlines. Invasive species were observed in this area, including an abundance of mullein.

Area of reclamation from early 1990's adjacent to South Soil Stockpiles

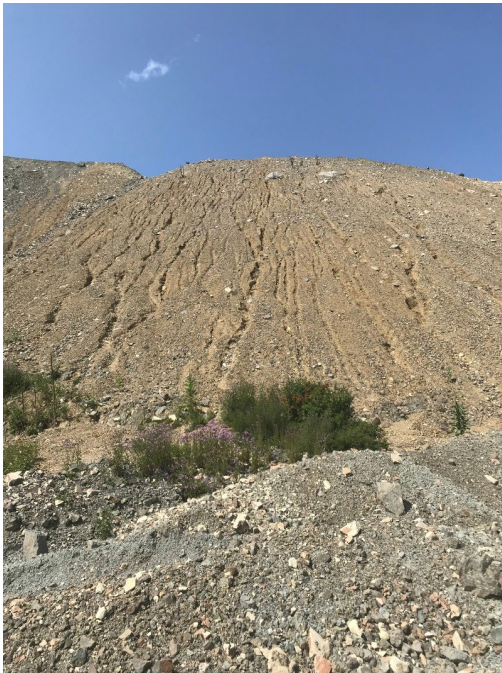
The Virginia Soil Stockpiles are not vegetated for erosion control and have experienced rilling erosion. CMM has indicated that previous attempts at revegetation were not successful.

Virginia Soil stockpile has not been successfully vegetated but is often disturbed for use in biosolids-amended soil production. Invasive plants have been identified on the stockpiles, predominantly at the base of the stockpile. Berms have been placed along the base of the stockpiles to capture any sediment run-off.

CMM should undertake remedial action to protect the stockpiles from further erosion.

In the response to this report, please outline what remedial action will be undertaken to protect the Virginia Soil Stockpiles from further erosion and fulfill the permit condition D.9.(f)

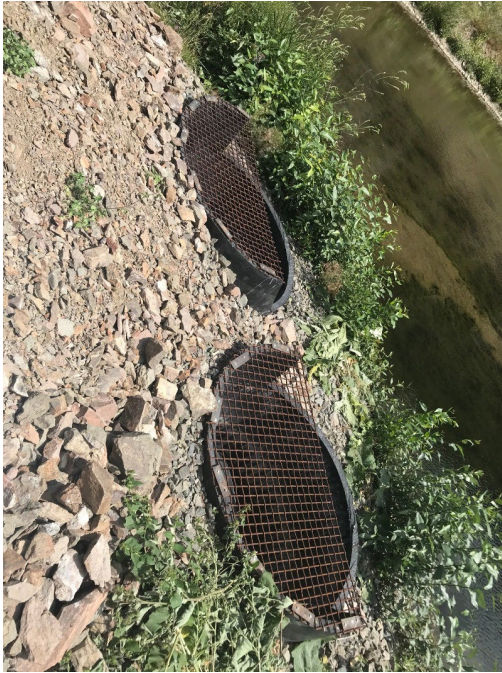
Two high water outflow structures on the settling pond were observed to be only partially screened and inspectors and site staff noted that workers and animals/birds could fall into, or become trapped in, the outflow pipes. The pipes are easily accessible from the access road.

Open outflow pipes on Wolfe Creek Diversion settling pond present a safety hazard to workers and wildlife.

The current design of the outflow pipes presents a hazard to workers . The design of the screening should be reviewed and controls put into place to mitigate the hazards to workers and wildlife.

With the response to this report, please advise EMPR how the hazard will be mitigated and provide photographs of the mitigations once in place.

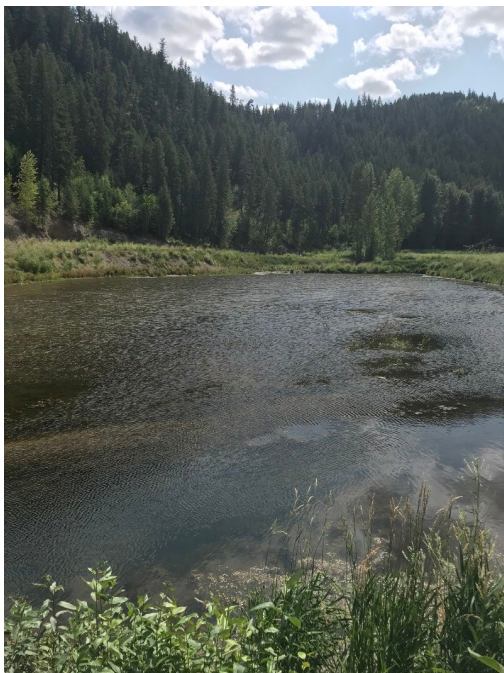
Completed settling pond as part of the Wolfe Creek diversion project. At present, it is open to fish passage but will undergo a fish salvage and be closed off to fish

passage once appropriate permits are in place

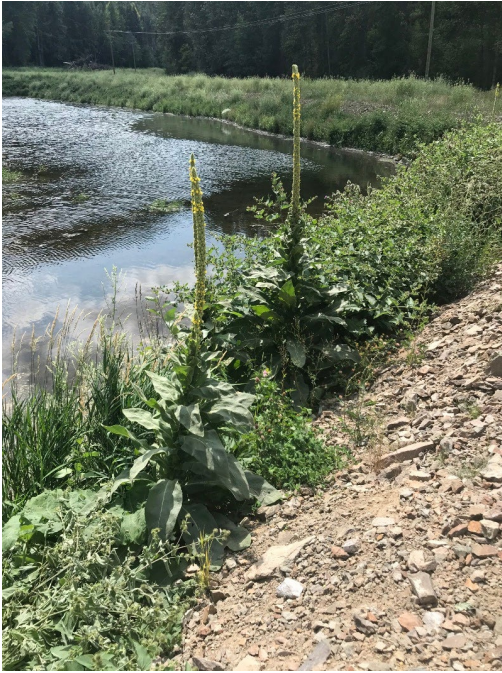
Mullein observed on embankment of settling pond. It was apparent that an invasive plant removal crew had tried to access the mullein for mechanical removal but could not safely access it.

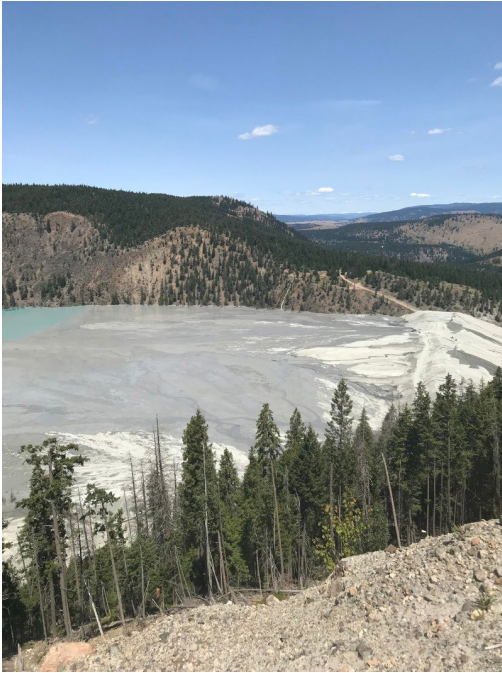
East end of TSF tailings beach. The small waterfall in the mid-background on the forested slope is the seepage return circuit.

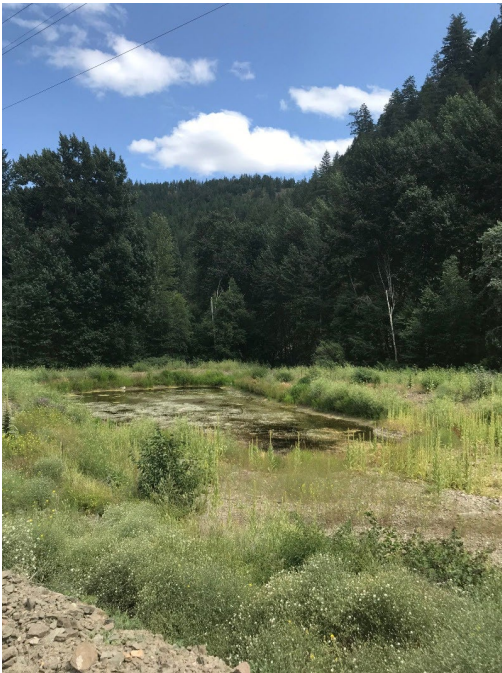
Settling pond below East Dam. Several species of invasive plants were observed around the settling pond.

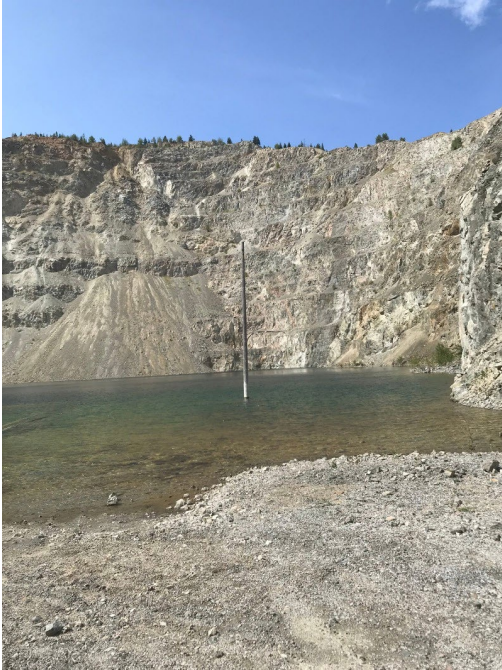
Ingerbelle Pit which is proposed for restart

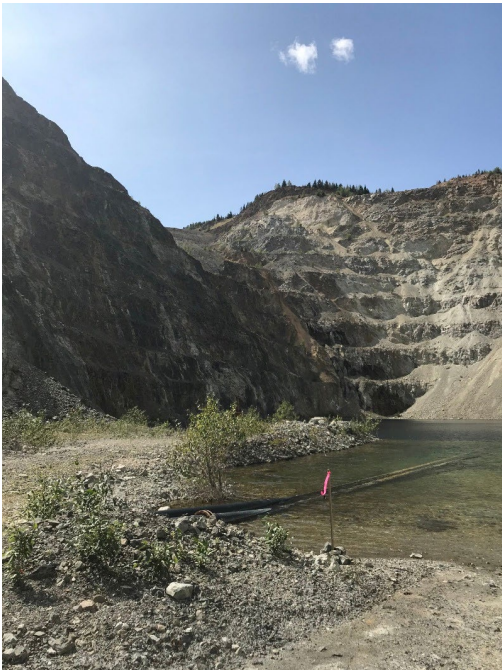
An upper lobe of the Ingerbelle Pit was previously backfilled
