ADMINISTRATIVE PENALTY
PENALTY ASSESSMENT FORM

FILE NO: 2017-16

Barkerville Gold Mines Ltd. (BGM)

Failure to comply with Section 2.6.7 of permit PE12601 (Permit) – Water collected in existing pits or underground workings may be transferred to the Main Zone Pit or Tailings Storage Facility for storage while mining, milling or underground exploration is underway.

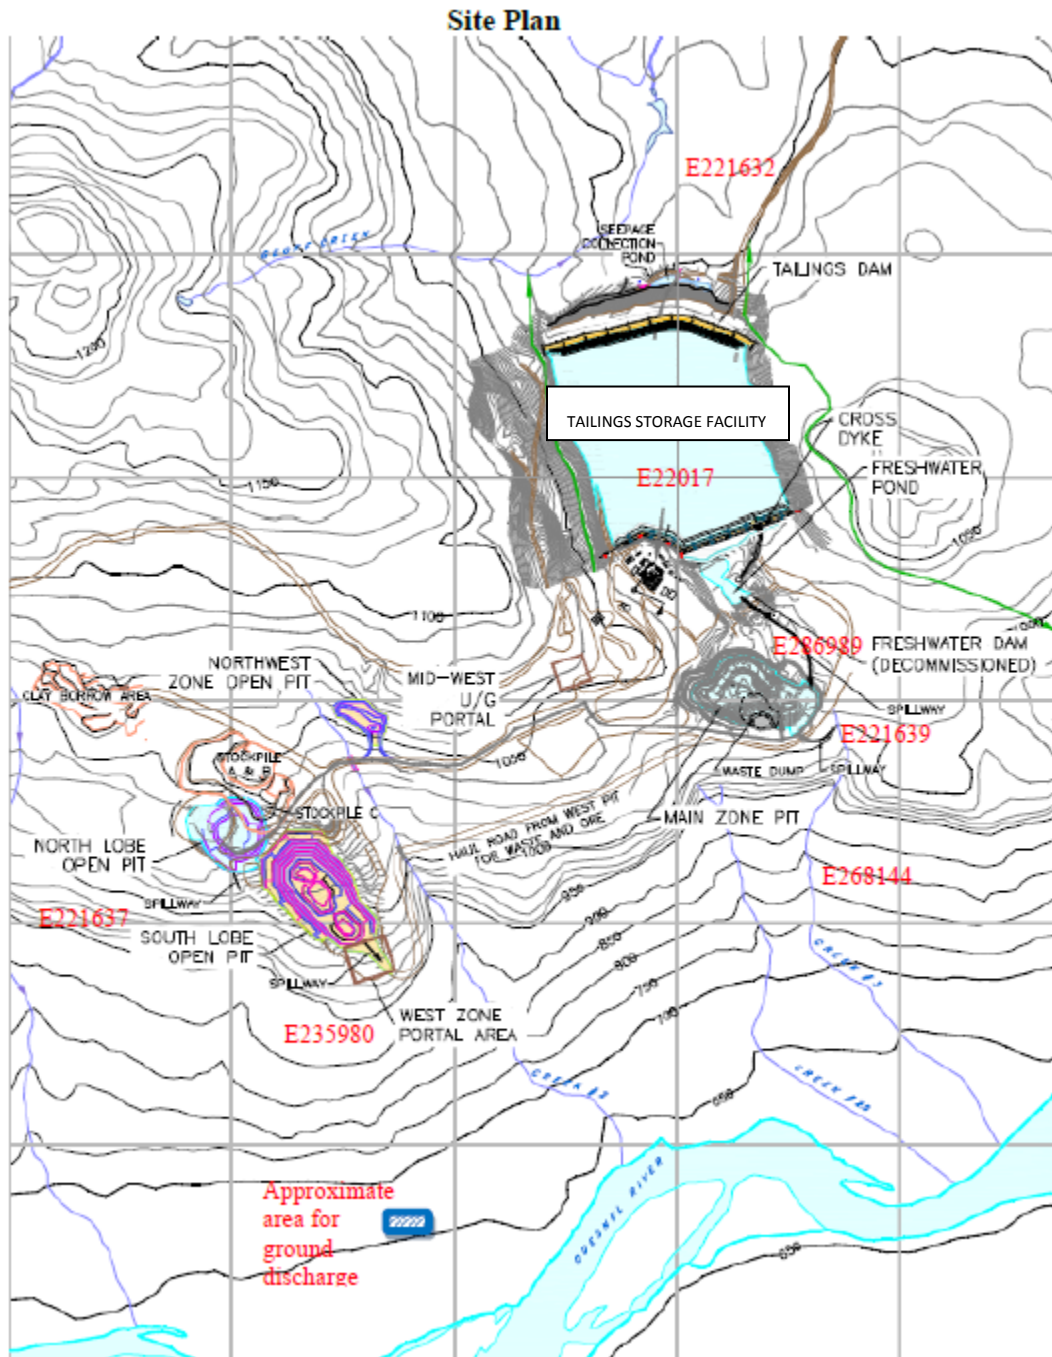
Image 1: Site Plan from Permit 12601

12. There are a number of historical open pits on site (Image 1: Site Plan), one of these is the Northwest Zone Open Pit (NWZP). Accumulated surface water in these pits is considered to be mine impacted and must be handled in accordance with the Permit.
