## Johnny Mountain Mine

### ***Mines Act Permit M-178 Annual Reclamation Report for 2019***

April 2020

Project No.: 0539378-0001

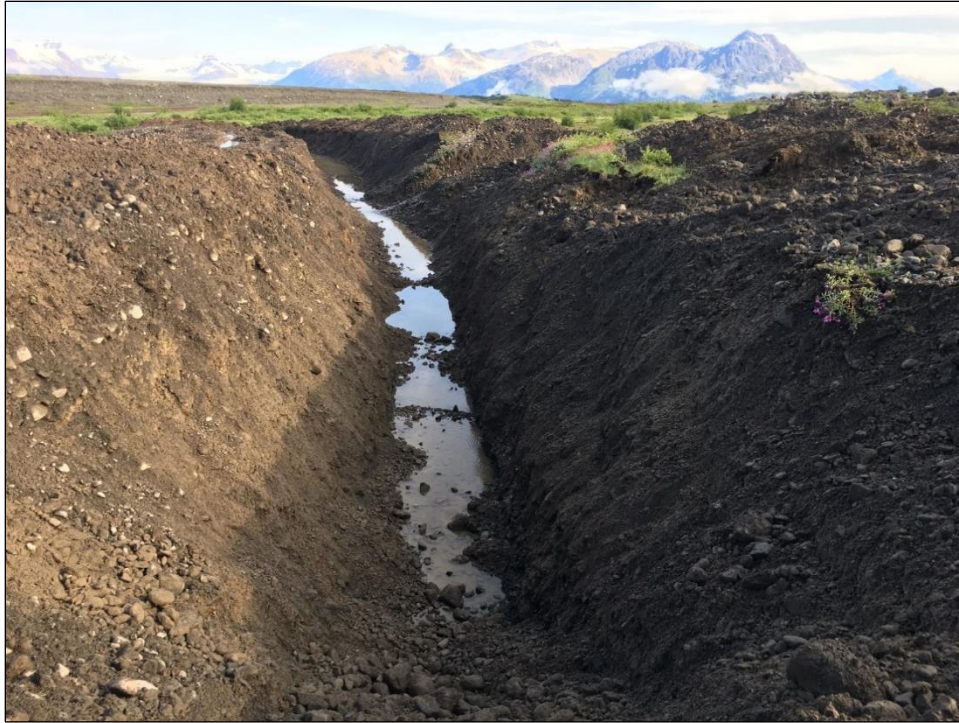
For 2019, drainage improvements were made by diverting water from infiltrating the in-situ Hydrocarbon Remediation Area. To alleviate infiltration of groundwater into the area, a diversion ditch was excavated on the east (higher elevation) side of the Old Tank Farm (Photo 3.1-1). The purpose of the diversion ditch was to divert ground water north around the area. This diversion helped de-water the In-situ Hydrocarbon Remediation Area and reduce the amount of groundwater infiltration through the site and into the interceptor ditch west (lower elevation) of the area. The diversion ditch will remain in place until the area is no longer required as an in-situ remediation area for hydrocarbon contaminated soils.

*Photo 3.1-1: Diversion ditch excavated on east (higher elevation) side of Old Tank Farm in 2019.*

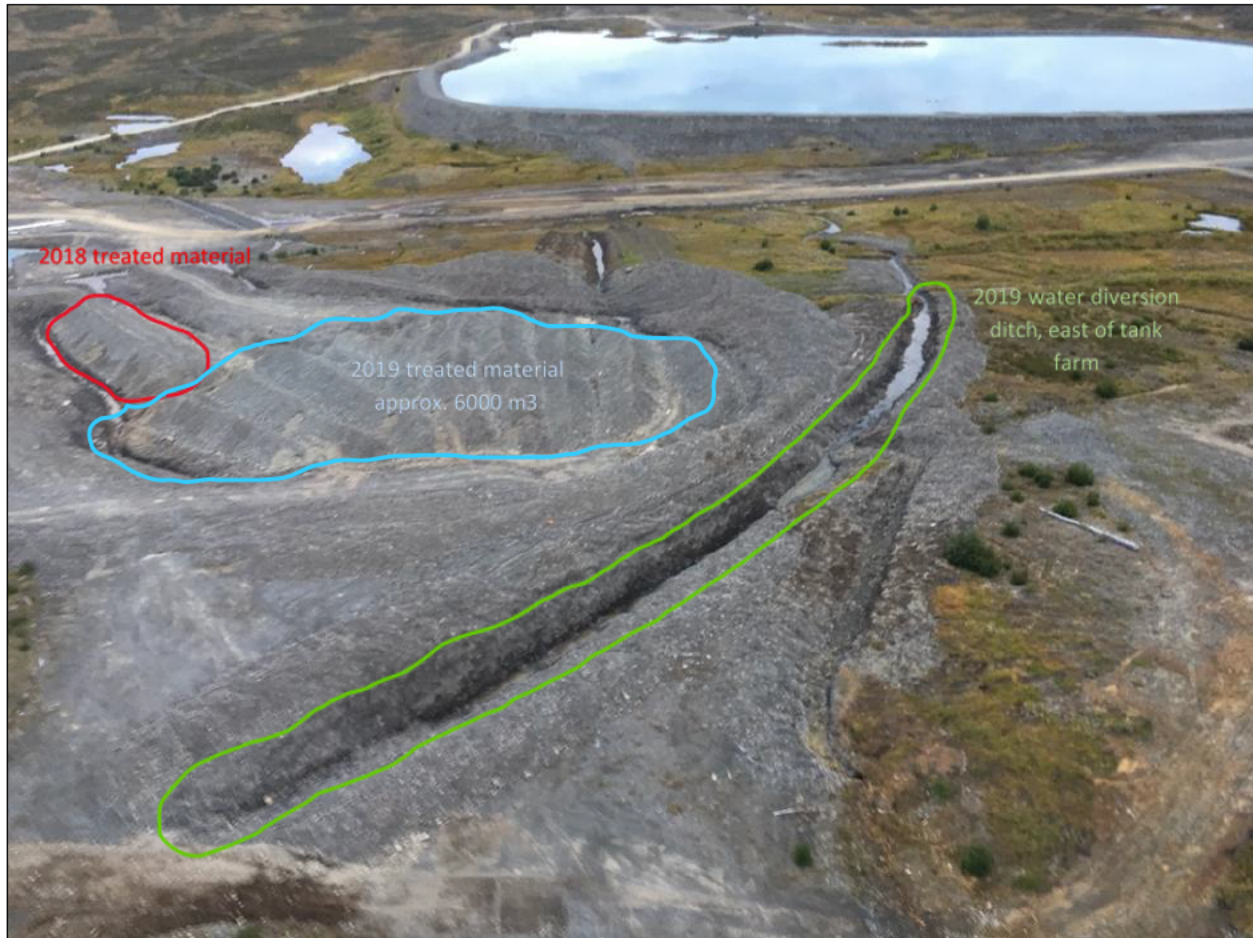
*Photo 3.1-2: Aerial View of the In-situ Hydrocarbon Remediation Area - Hydrocarbon Contaminated Soil Treatment.*

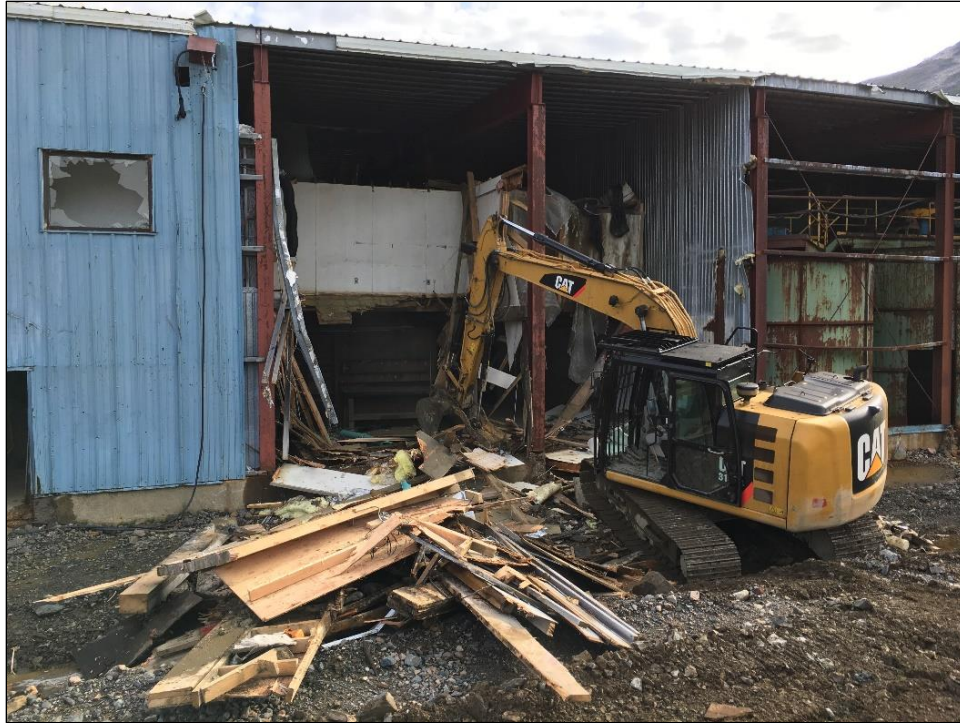
On July 25, 2019 (using a CAT 312 excavator), deconstruction of the interior wooden walls and beams began (Photo 4.1-1).

*Photo 4.1-1: Mill Building - Wooden construction waste piled and burned.*

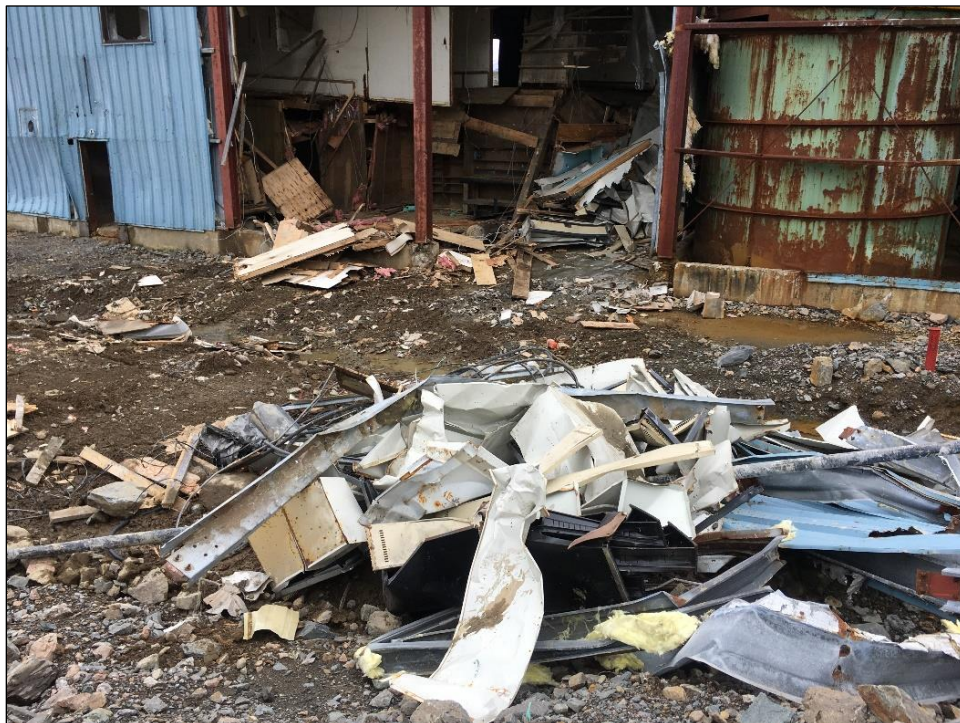
All non-painted wood, wood beams, plywood and construction waste were high piled south of the Mill Building and burned. All other inert and non-toxic waste (wire, steel pipe, PVC pipe, insulation, cladding and painted wood) were hauled to the upgraded Main Landfill and disposed of (Photos 4.1-2 and 4.1-3).

*Photo 4.1-2: Steel construction waste hauled to Main Landfill.*

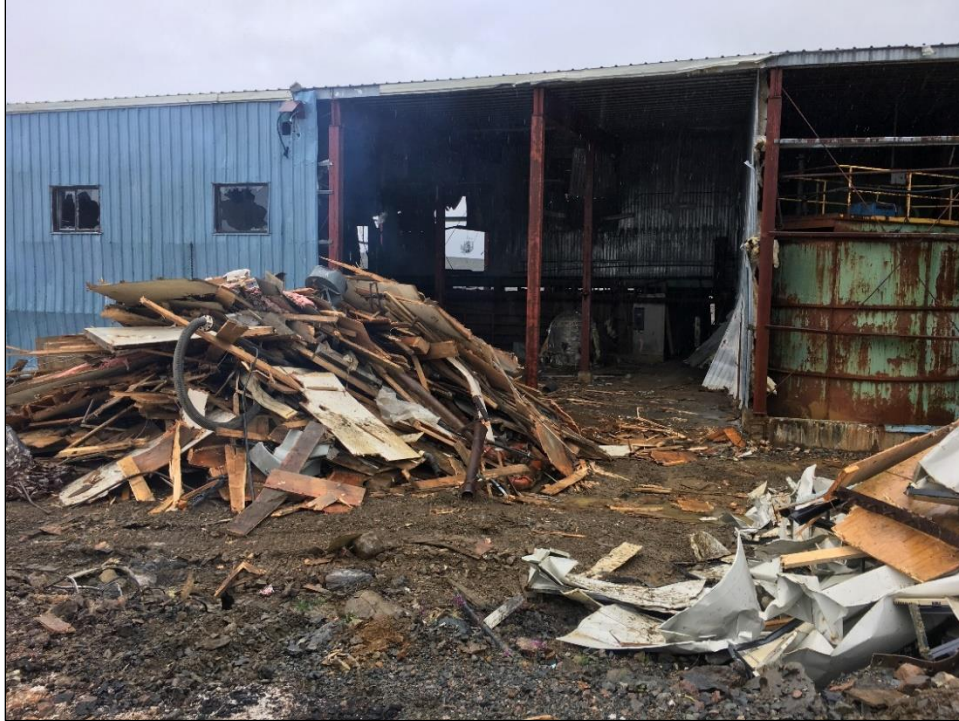
*Photo 4.1-3: Construction waste sorted and disposed of appropriately.*

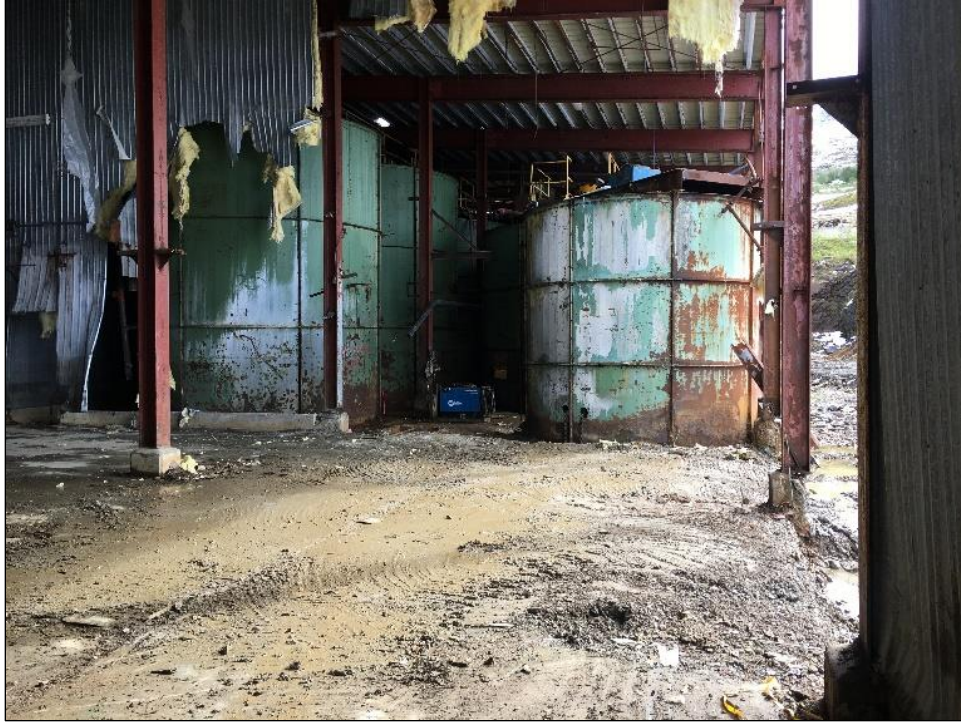
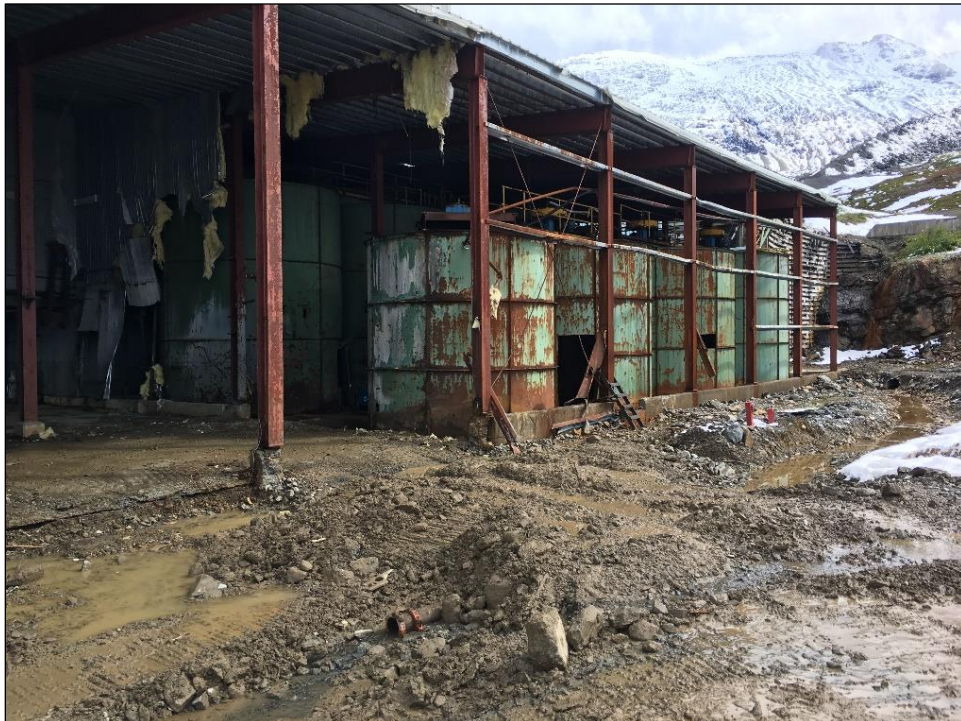
*Photo 4.1-4: Cyanide tanks within Mill Building.*

*Photo 4.1-5: Cyanide tanks within Mill Building.*

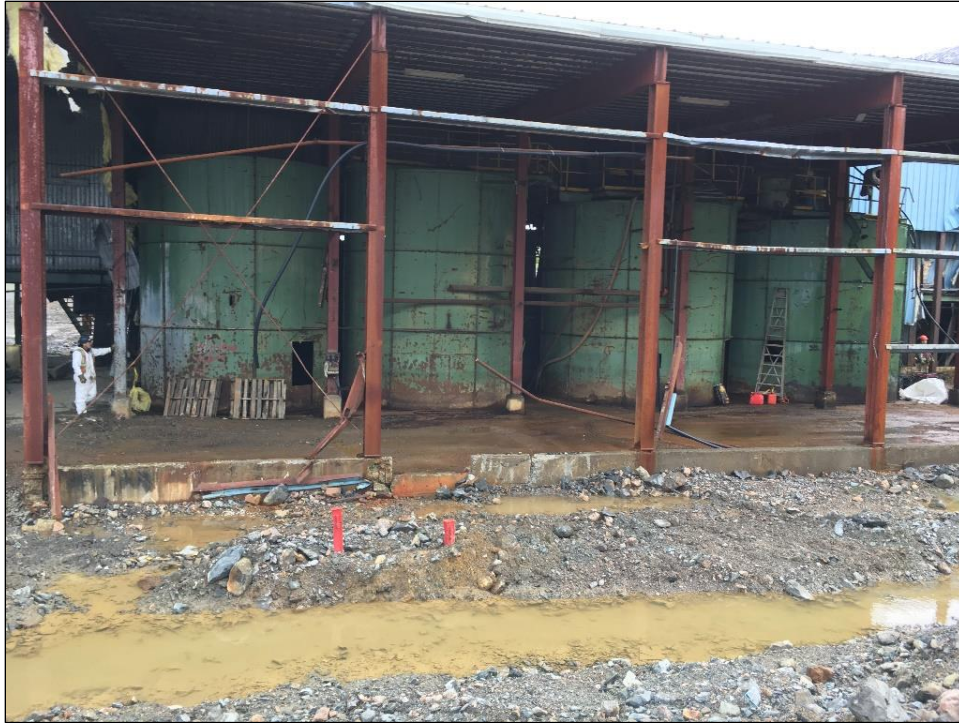
*Photo 4.1-6: Cyanide tanks being deconstructed inside Mill Building.*

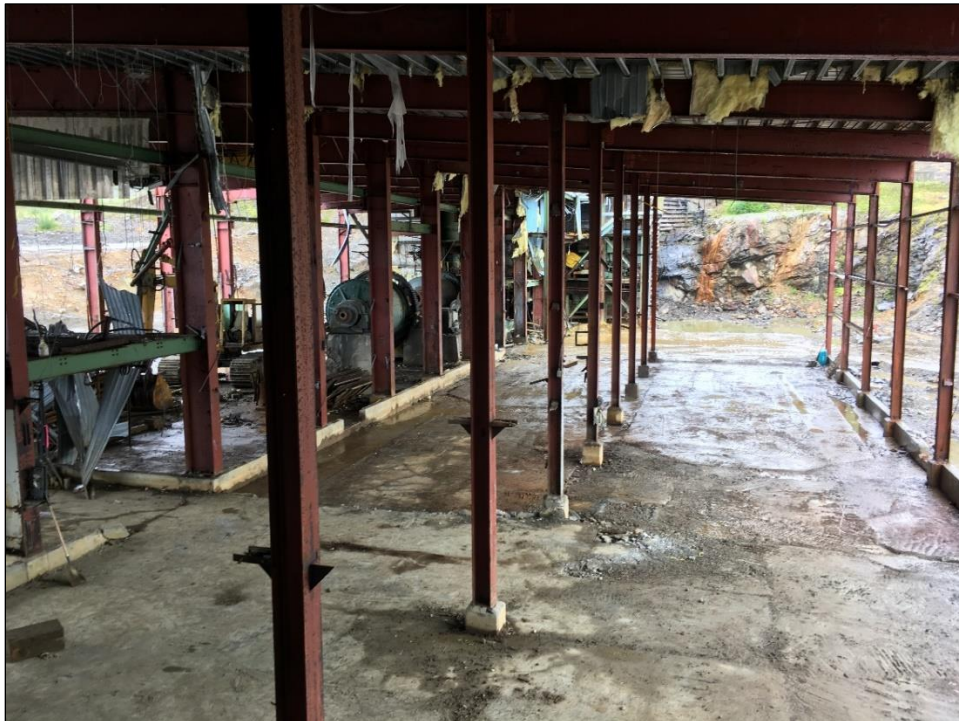
*Photo 4.1-7: Cyanide tanks removed from inside Mill Building.*

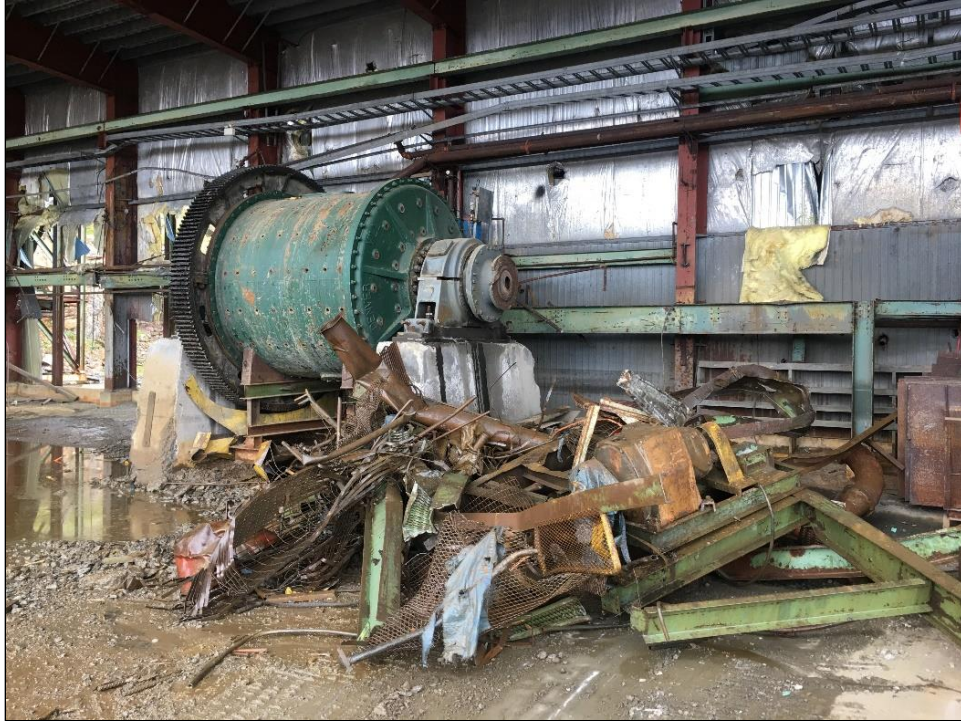
*Photo 4.1-8: Steel waste hauled to Main Landfill.*

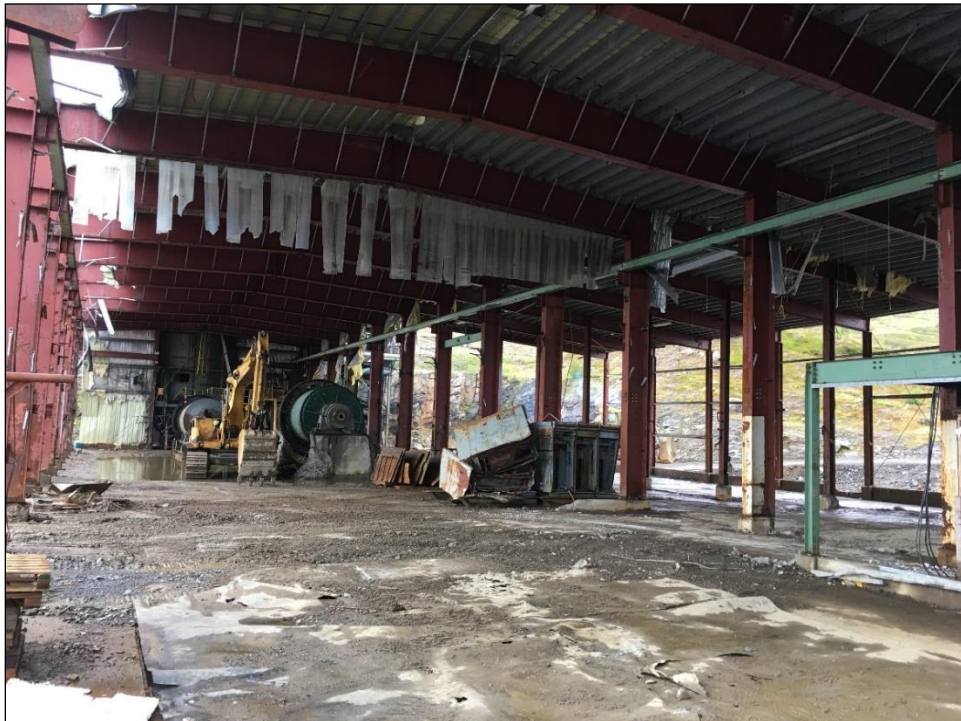
*Photo 4.1-9: Mill building after waste removed.*

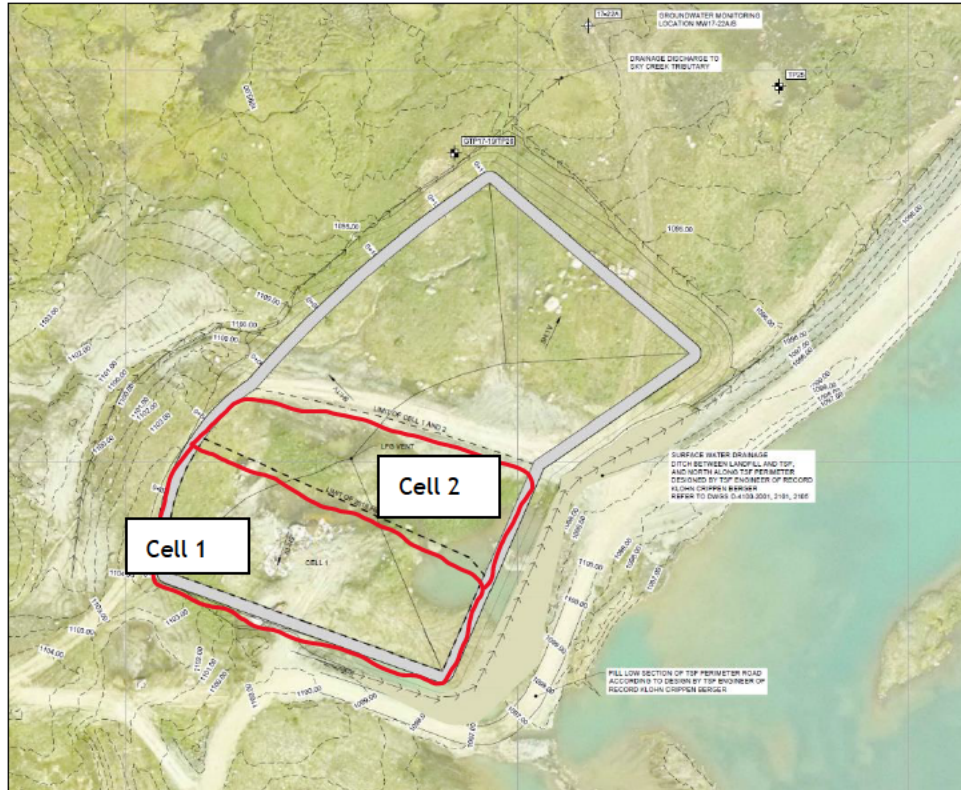
*Photo 4.1-10: Additional Gravel added to Base Elevation (1,098 m) - Cell 2, 2019 season (Dwg. 52655B-001).*

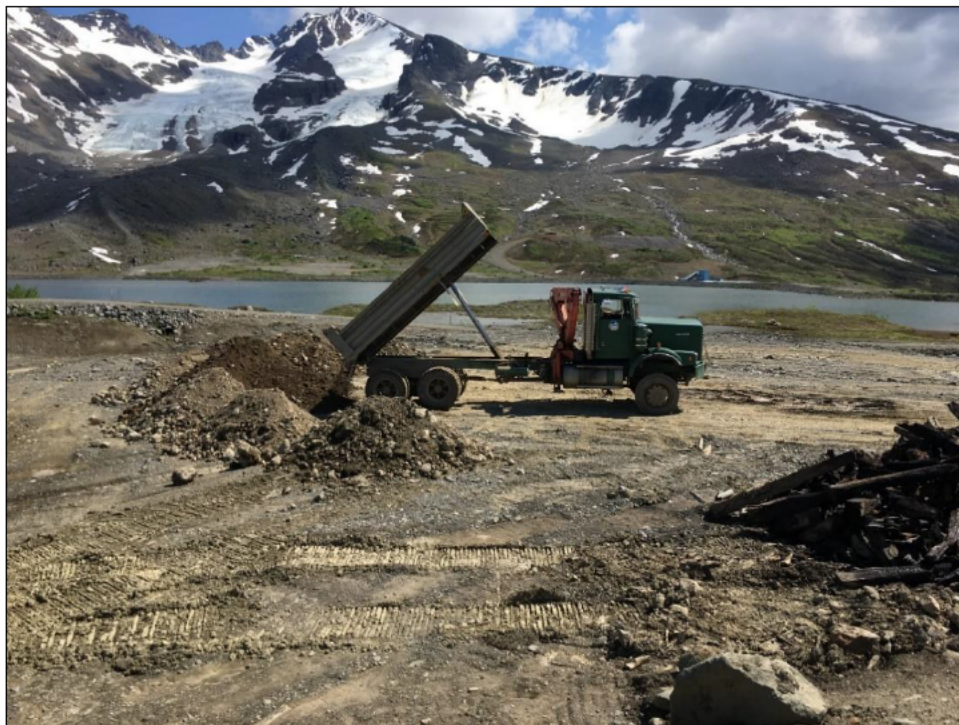
*Photo 4.1-11: Gravel placed in Cell 2 for base levelling course (July 1, 2019).*

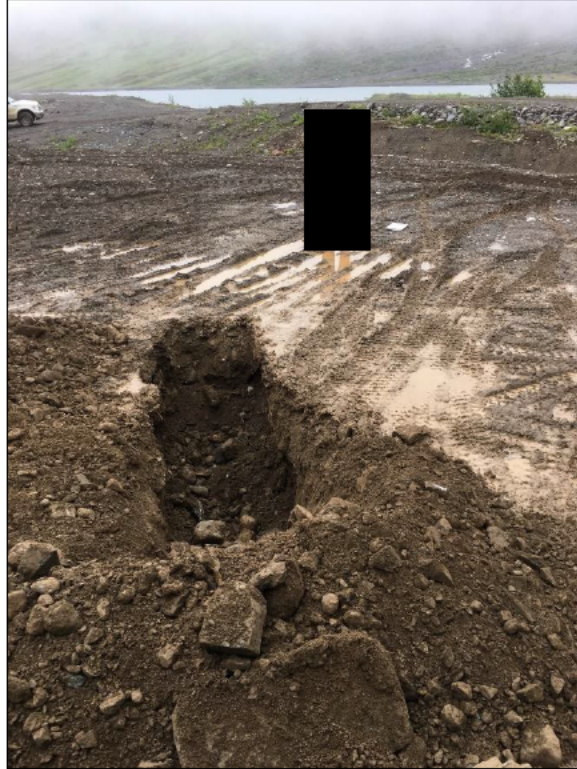
*Photo 4.1-12: Test Pit - Cell 2 location to ensure adequate depth of levelling base course.*

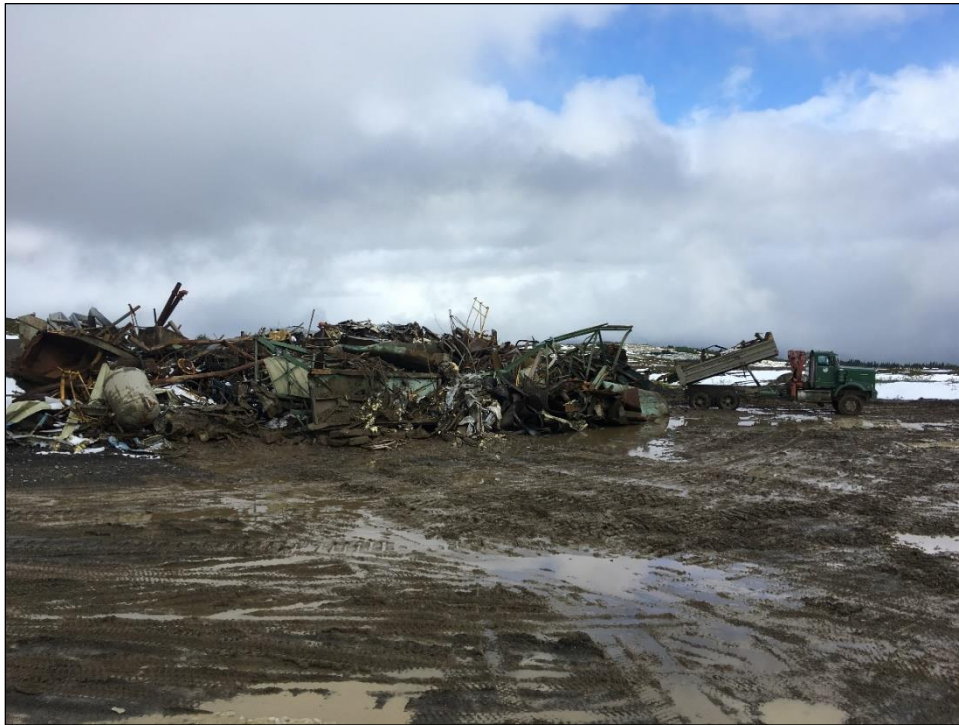
*Photo 4.1-13: Waste material placed in Main Landfill - 2019 season.*

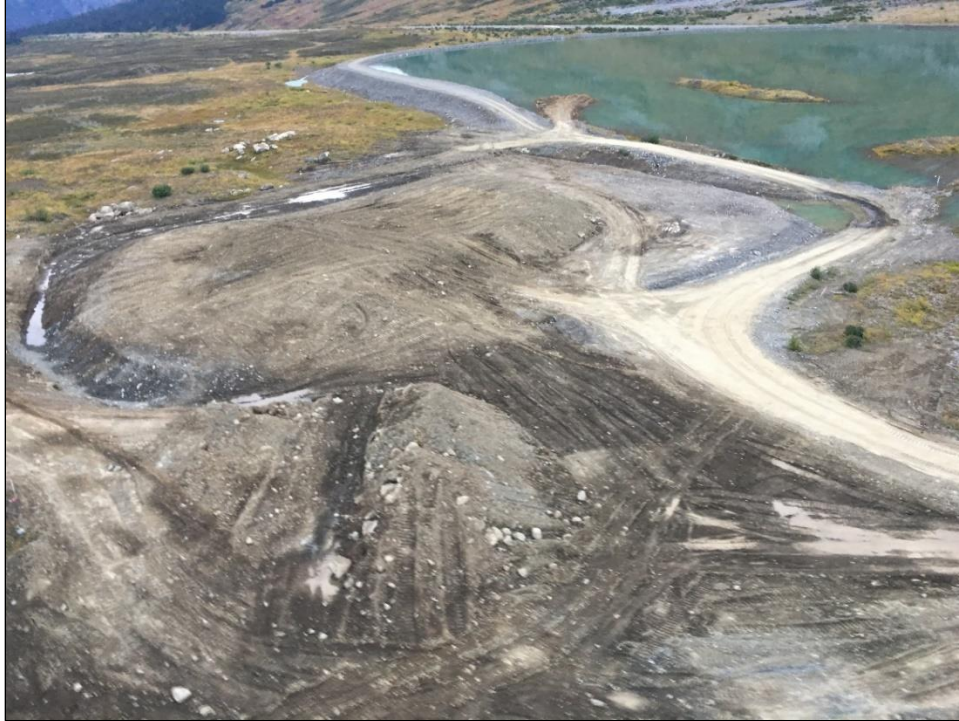
The waste material placed in the Main Landfill during the 2019 season was covered with mineral soils, free of boulders and organic material, to a minimum depth of 300 mm and compacted ensuring positive surface water flow away from Main Landfill location (Photo 4.1-14). All surface runoff water was directed toward a perimeter ditch then then into the TSF.

*Photo 4.1-14: Main Landfill Area - Waste material covered with mineral soils to a minimum depth of 300 mm.*

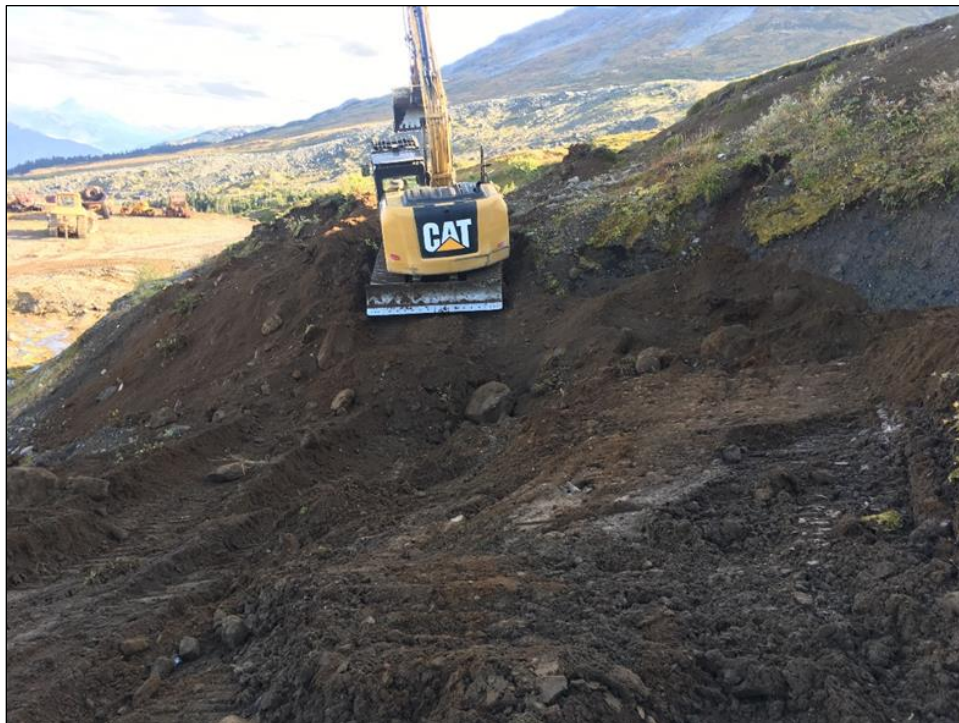
*Photo 4.1-15: Portal 11 - Additional Grading Required above Portal Entrance.*

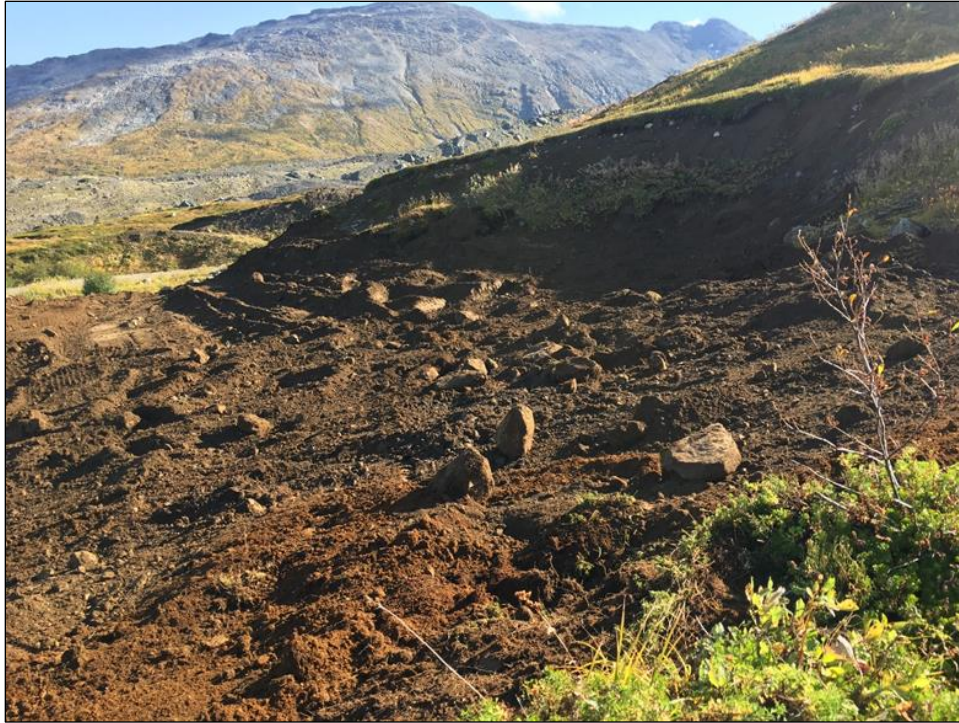
*Photo 4.1-16: Portal 11 - Surface left rough and loose - seeded with reclamation seed mix.*

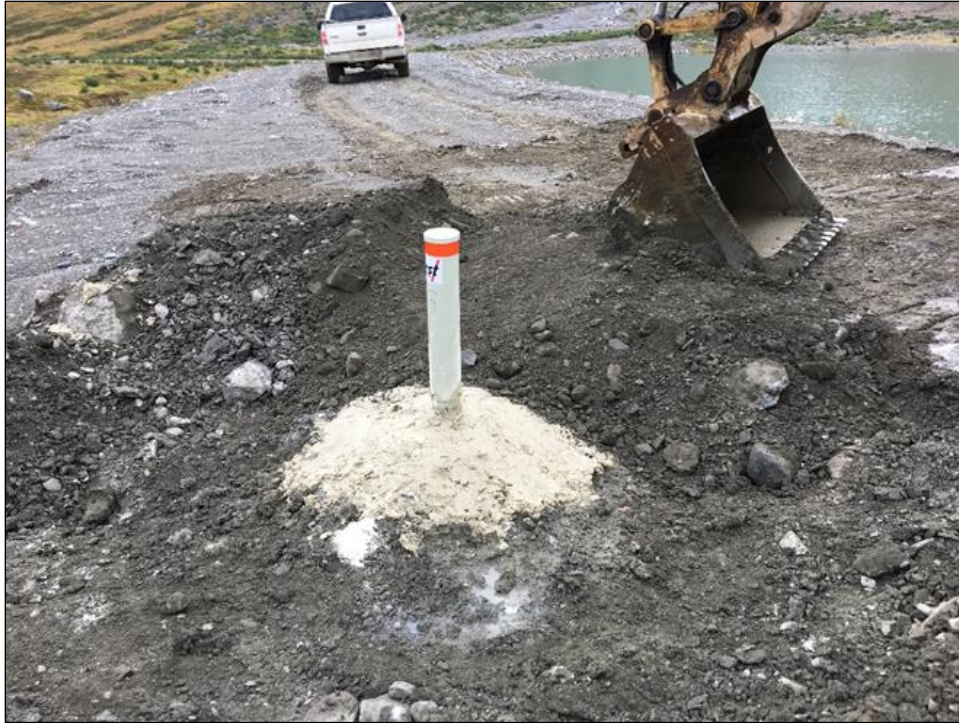
Anomalies in the data recovered from DH17-02 and DH17-05 have been observed over the last two seasons by KCB and appear to be related to rain events on the JMM site. To eliminate the chance of water infiltrating the piezometer stand pipes, bentonite was added around the collar of DH17-02 and DH17-05 in the 2019 season (Photo 4.1-17).

Photo 4.1-17: Bentonite added at base of DH17-05.

Using the CAT 312 excavator, gravel material was removed from the base of the two suspect piezometer and bentonite added to the standpipe collar to prevent surface water infiltrating the stand pipe.
