Report Number: 199271

Re: Warning Letter, Unauthorized Discharge, 5084 Island Hwy S, Union Bay, BC V0R 3B0, Effluent

On October 27, 2022 Ministry of Environment and Climate Change Strategy (Ministry) Environmental Protection Officer Kyle Lynch (Officer) conducted an onsite inspection of the Deep Water Recovery Ltd.(DWR) facility located at 5084 Island Highway South, Union Bay (Facility) which functions as a marine vessel dismantling and waste disposal operation. In attendance during the inspection was the registered owner and operator of DWR, Mark Jurisch (Owner).

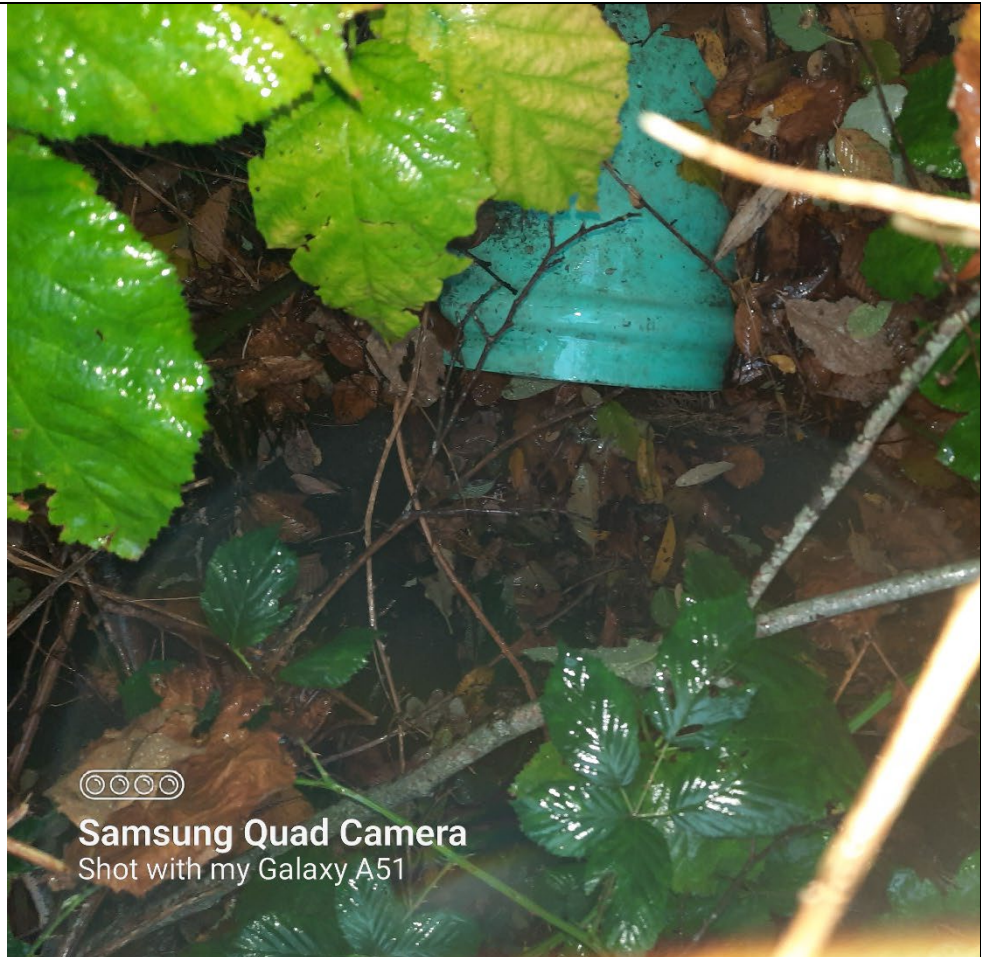
Photo 1:

Deepwater Recovery
North –

Basin was discharging
from the top of the
system at the time of
inspection.

Actions to be taken:	Cease discharge until getting an active authorization is in place for the operation.
----------------------	--

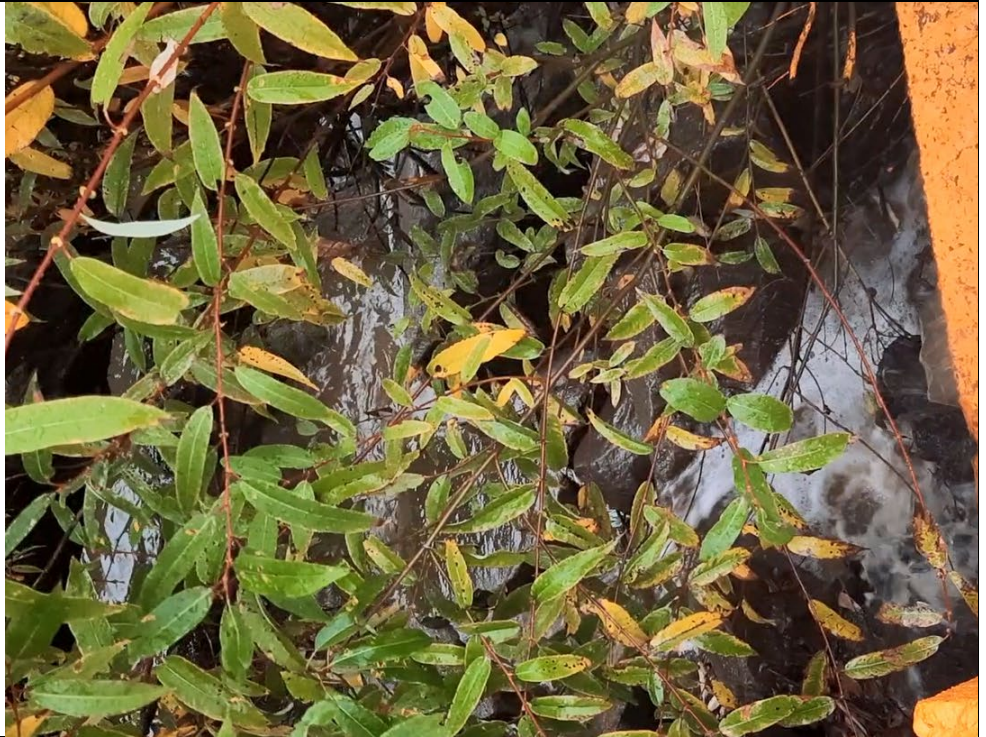
Photo 2:

Deepwater Recovery Central – Basin was discharging from the top of the system at the time of inspection.

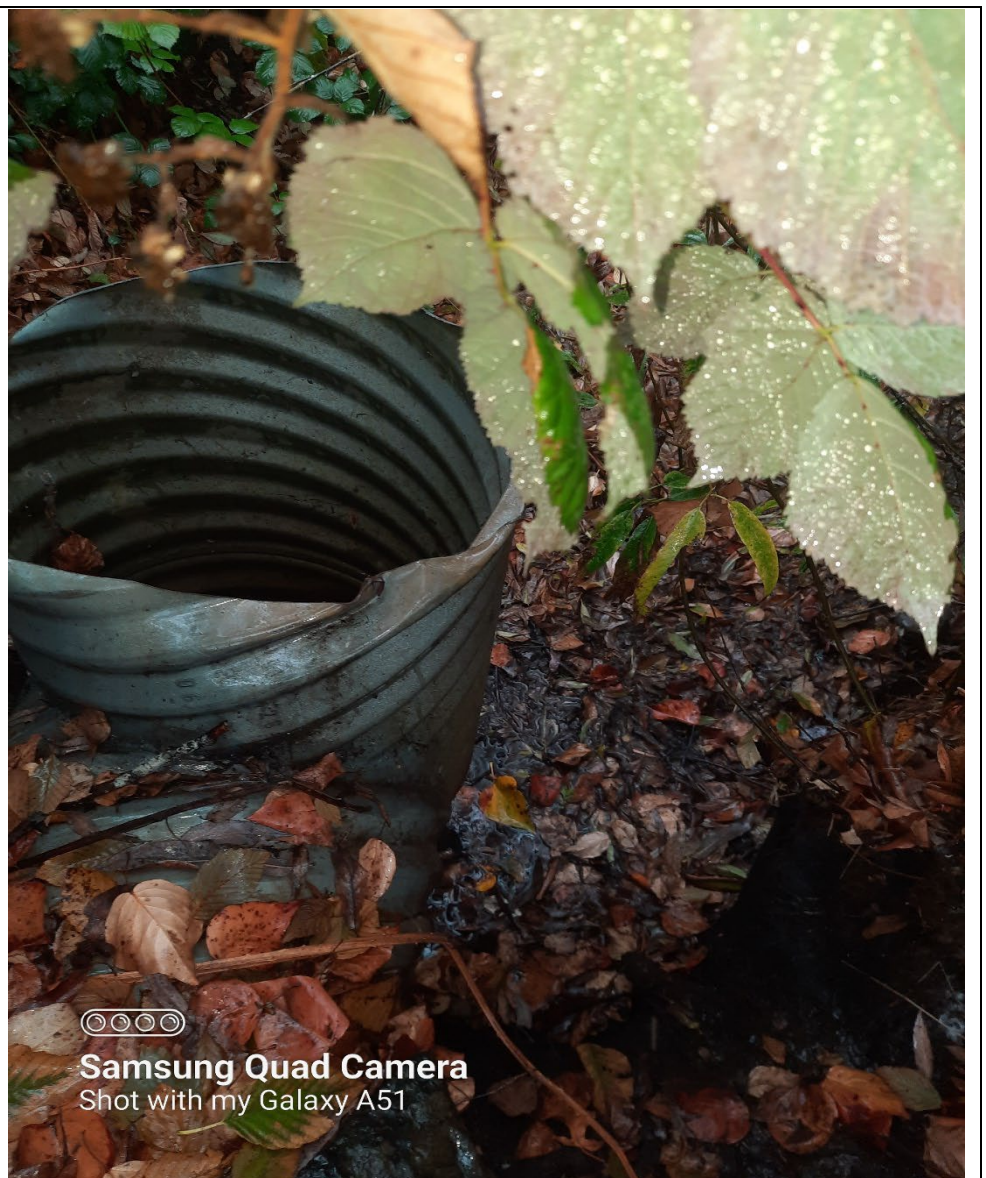
Photo 3:

Deepwater Recovery South – basin did not contain sufficient effluent at the time of inspection and was not sampled.
