## POST-WILDFIRE NATURAL HAZARDS RISK ANALYSIS OF THE 2023 MCDOUGALL CREEK WILDFIRE (K52767)

| Dated: | January 4, 2024 |
| Presented To: | Ministry of Forests – BC Wildfire Service |
| CGL Project # | 23-0106 |

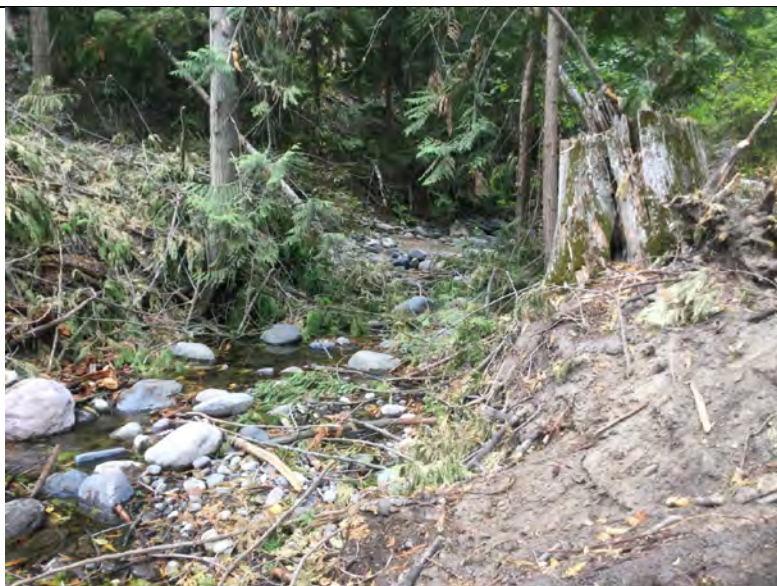
Photo 1: McDougall Creek fire guard crossing at POI (view upstream).

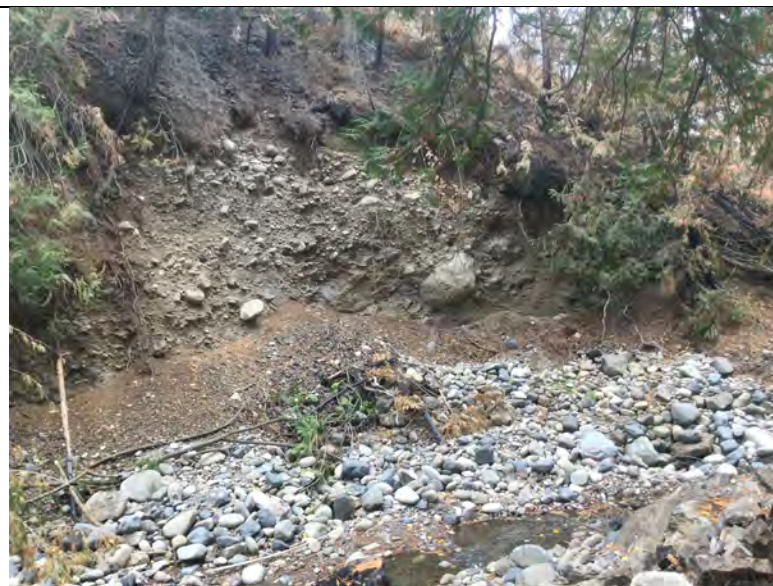
Photo 2: McDougall Creek lower canyon with abundant sediment sources to the channel (McDougall-1).

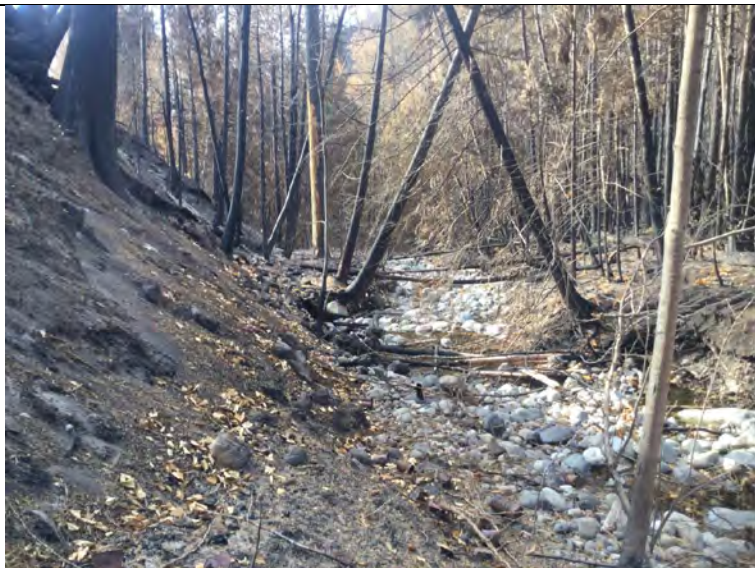
Photo 5: Middle reaches of McDougall Creek with burned riparian forest and connected to steep, burned valley side slopes (McDougall-2)

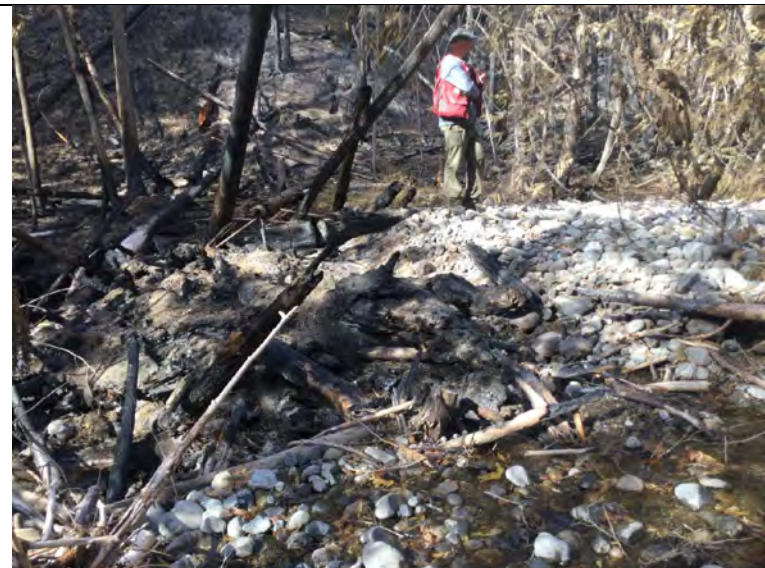
Photo 6: Sediment wedge (200-300 cubic metres) in McDougall Creek (McDougall-3)

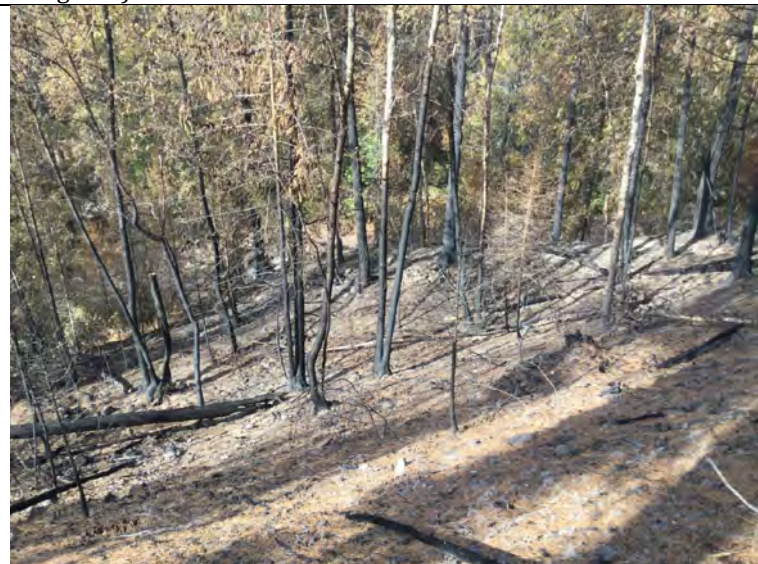
Photo 8: Moderate burn severity along riparian forest and adjacent slopes. Note scattered green canopy, needle cover mantling soil surface, and weak soil-water repellency (McDougall-5).

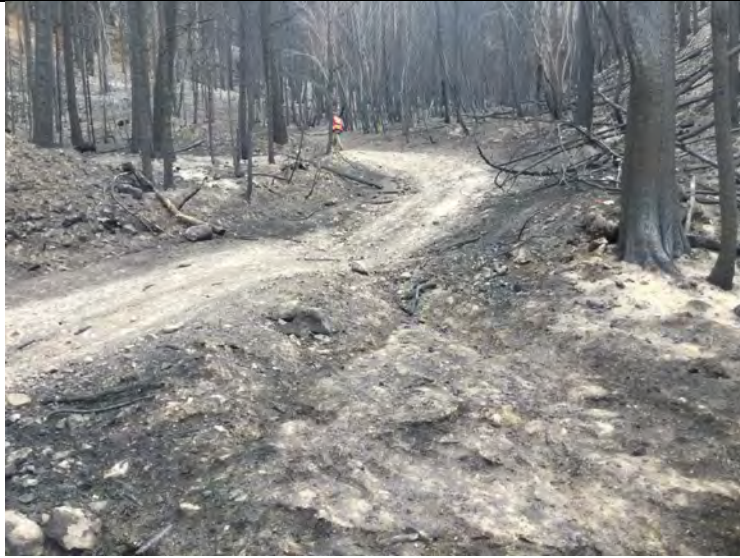
Photo 9: High vegetation burn severity area, with observed sediment-laden runoff along road and variable soil-water repellency (McDougall-6)

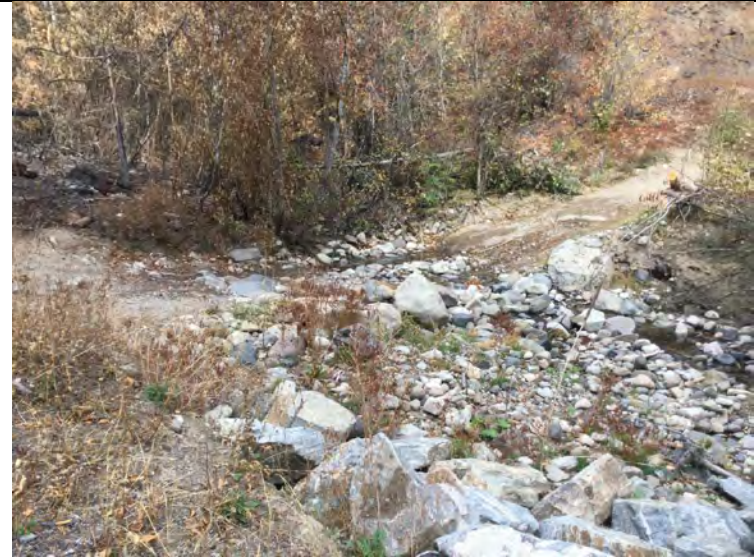
Photo 10: Deactivated road crossing on Tributary 1 channel (McDougall-7)

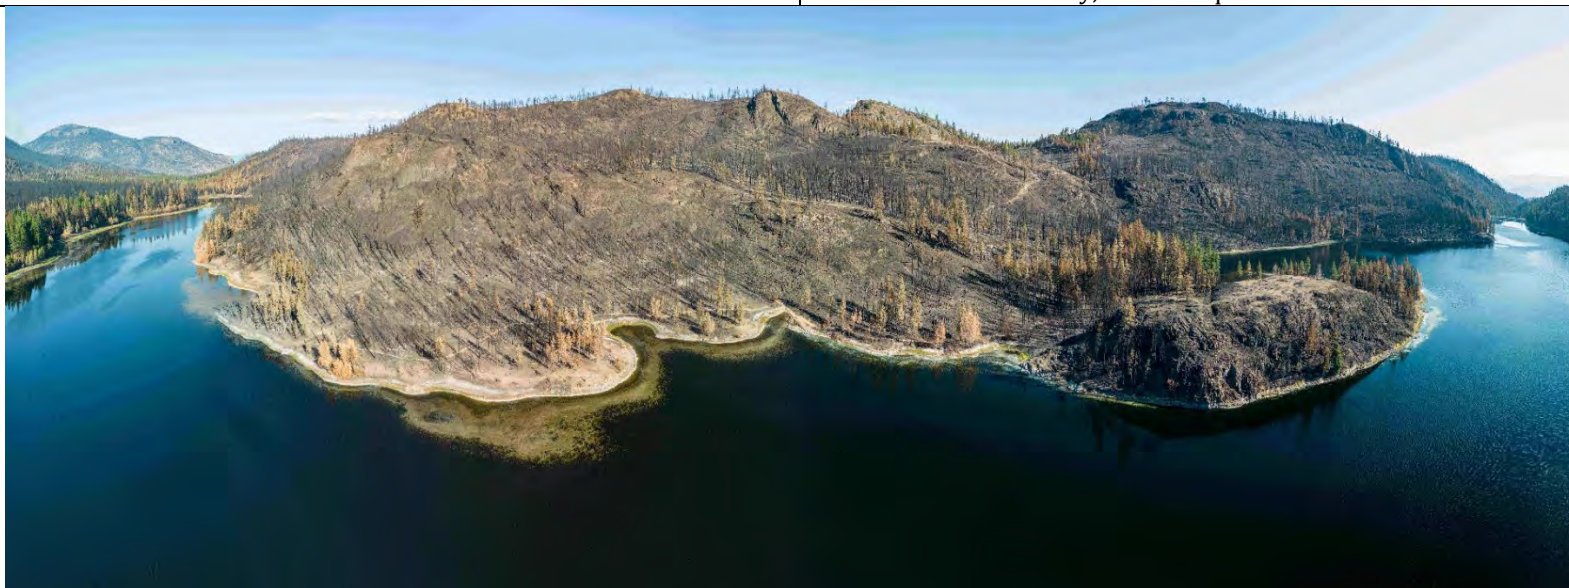
Photo 3: Panorama view of the burned slopes on the south side of the Rose Valley Reservoir. (Photo Credit: S. Wensley, Larratt Aquatic)

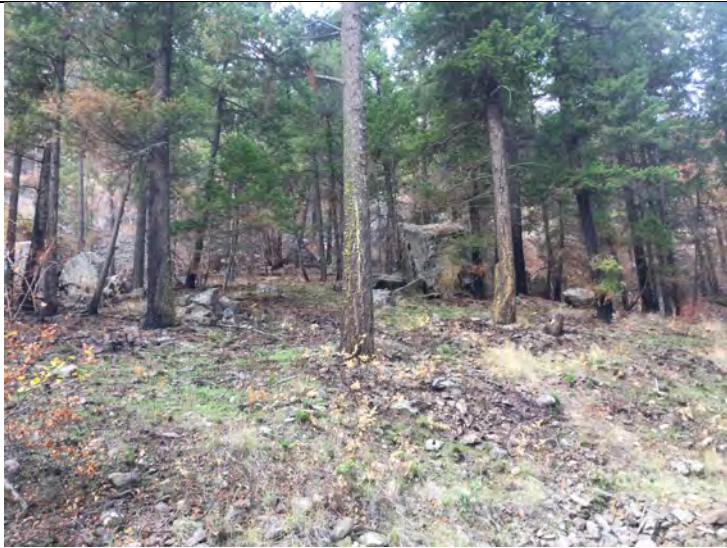
Photo 1: Upper Faulkner Creek along Rose Valley Dam Access Road – Pre-existing rockfall hazard along west side of road (Faulkner-1).

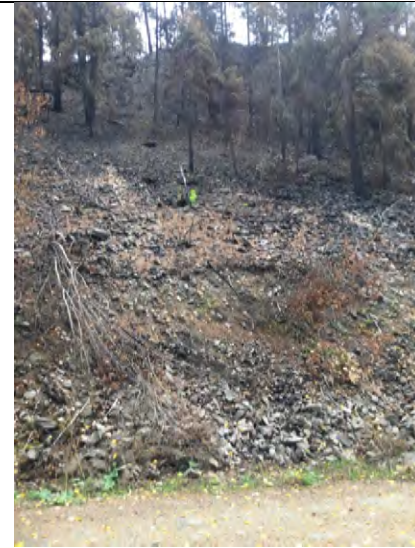
Photo 2: Upper Faulkner Creek along Rose Valley Dam Access Road – moderate to high burn severity along 250 m long section of steep colluvial slopes on east side constitutes increased rockfall hazard (Faulkner-2).

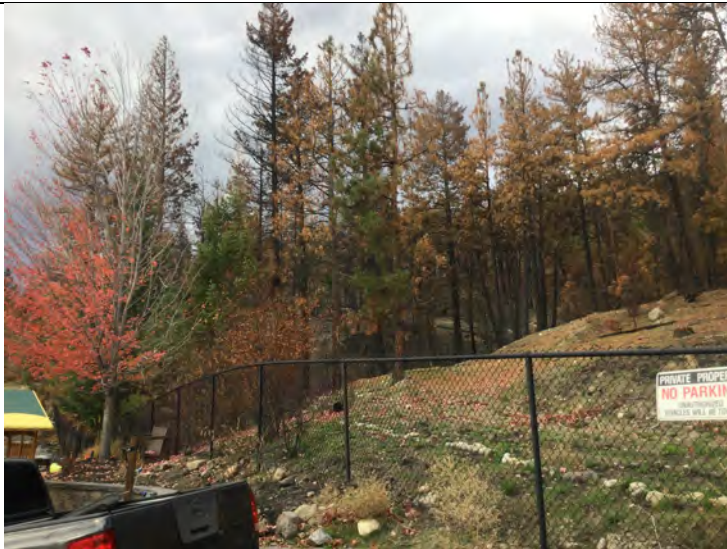
Photo 3: Moderate severity burn upslope of Rosalee Lane strata development. Note burned swale directing flow towards homes (Faulkner-3)

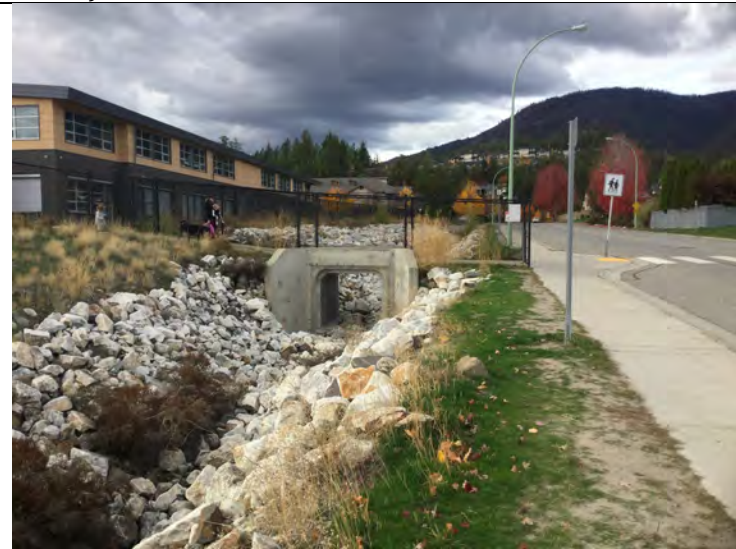
Photo 4: Rock-lined channel and concrete culverts on Faulkner Creek in front of Mar Jok Elementary School (Faulkner-4).

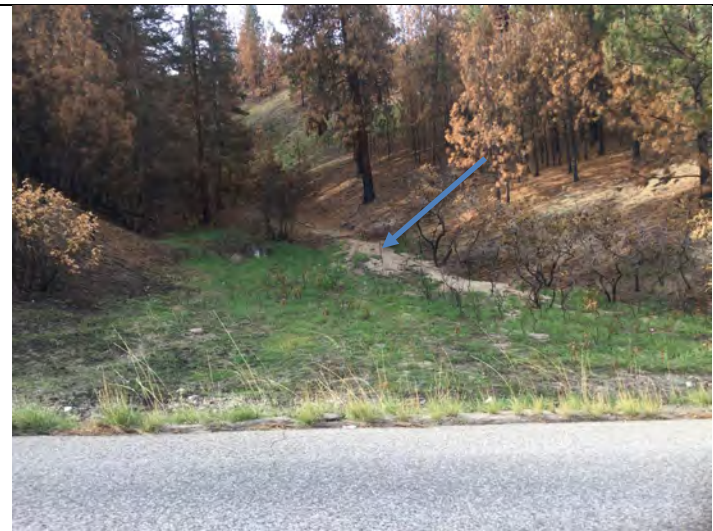
Photo 6: Burned gully, view upslope from Bear Creek Road. Note recent sediment movement in gully (arrow) (Keefe-2)

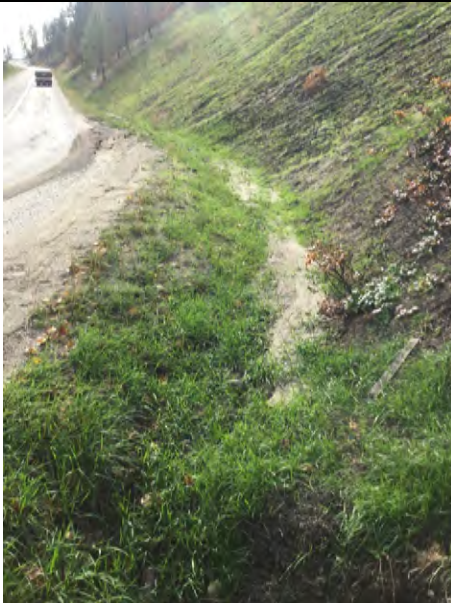
Photo 7: Sediment-filled ditchline along Bear Creek Road, at Westside Road (Keefe-3)

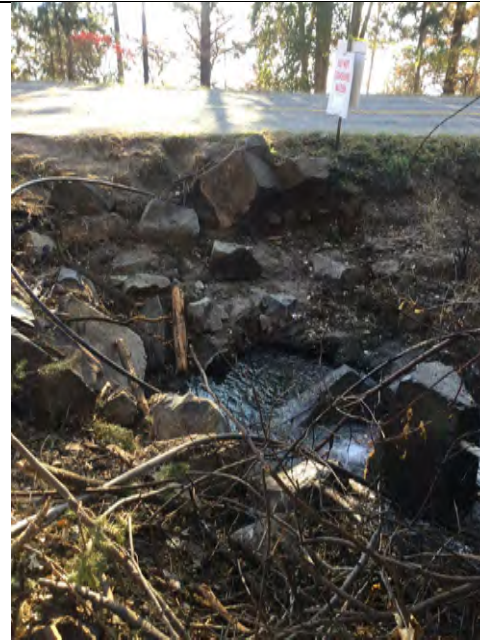
Photo 10: Lower Luluwap Creek crossing at Westside Road (damaged 600 mm culvert) (Lower Luluwap-1)

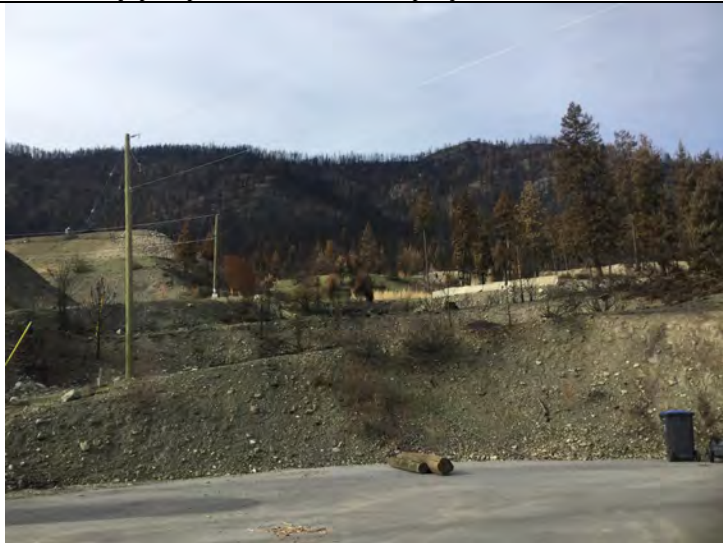
Photo 11: View upslope from end of Petterson Road towards Upper Luluwap Creek catchment area. Note, thick sand and gravel sediments (Upper Luluwap-1)

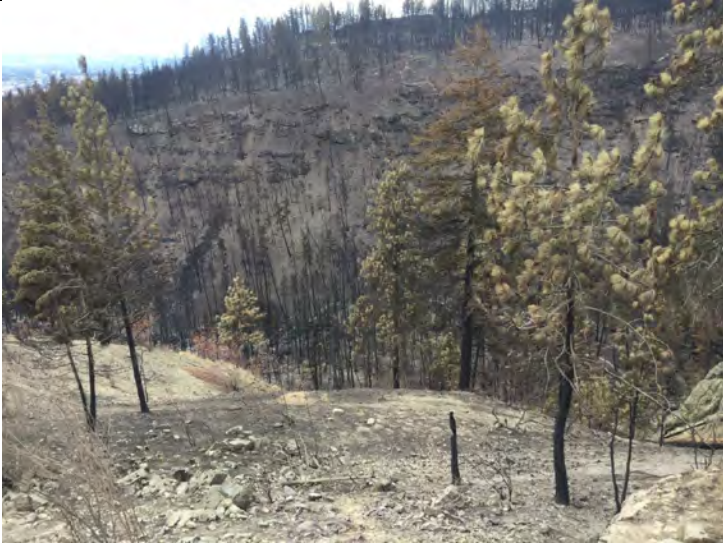
Photo 3: View south from Bear Lake Main FSR to the severely burned bedrock slopes along Lambly Creek. Elevated rockfall and shallow landslide hazard. (Lambly-3)

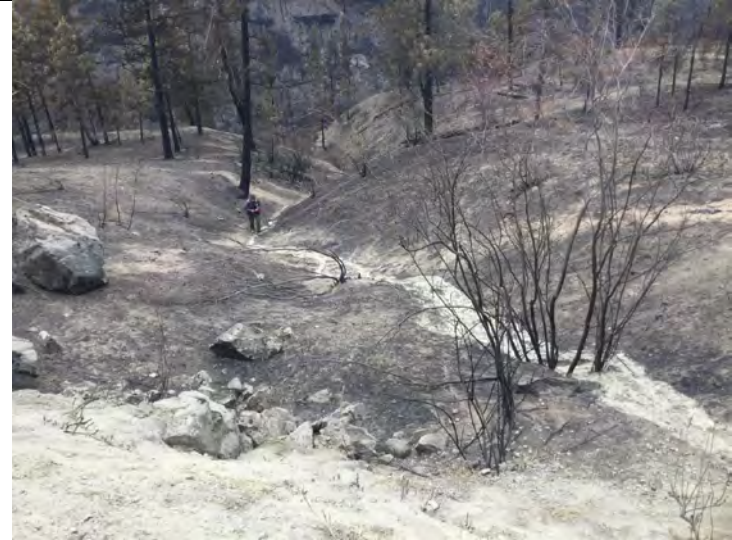
Photo 4: Sediment-laden flow downslope of Bear Lake Main FSR. Noted culvert crossing is plugged with sediment (Lambly-4)

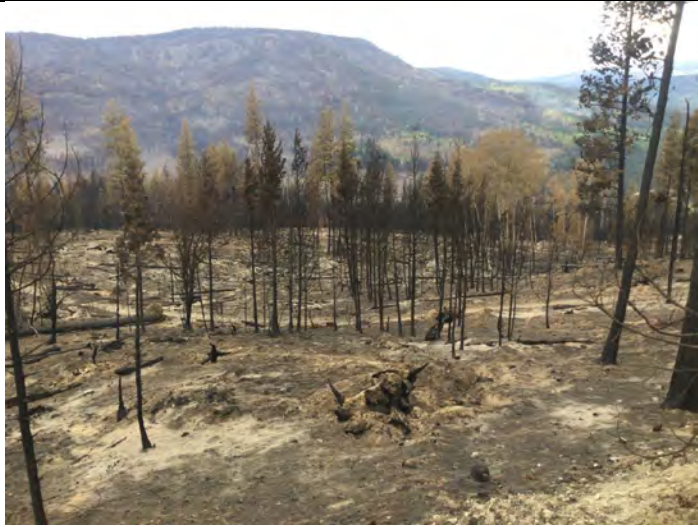
Photo 5: Moderate to high burn severity in cut block along upper slopes on north side of watershed in OHV Trail area. Hazards include windfall, root holes, and exposed soils (Lambly-5)

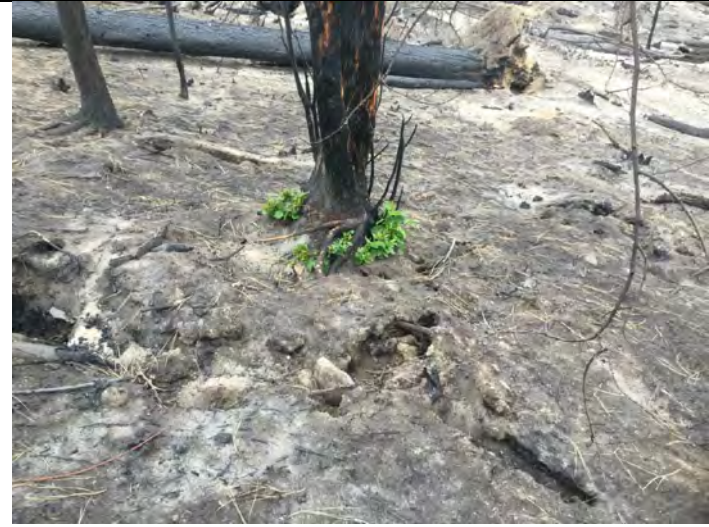
Photo 6: Moderate burn severity in cut block (Lambly-5). Note vegetative recovery.

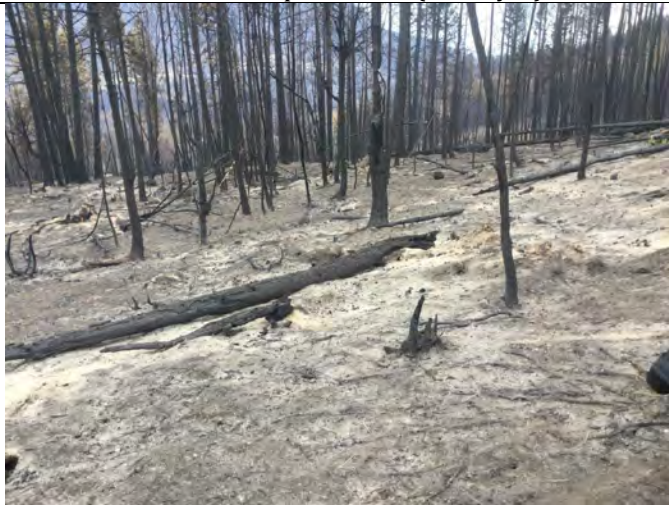
Photo 7: High burn severity in mid-watershed area on south side of Lambly Creek near cut block (accessed by helicopter) (Lambly-9)

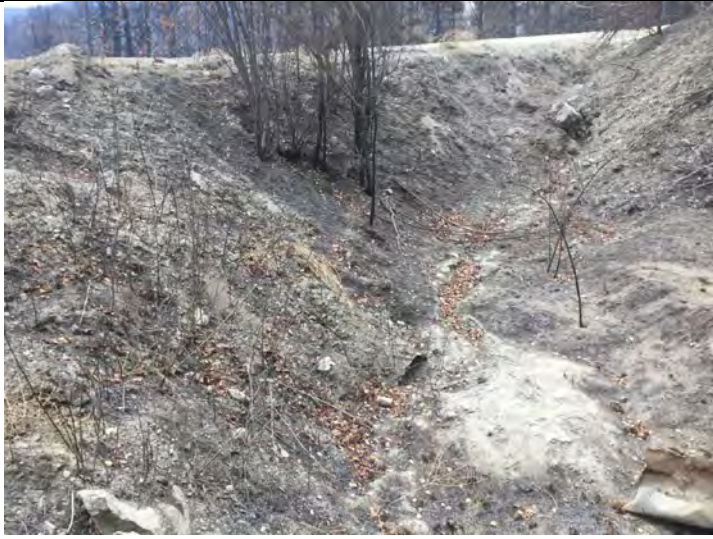
Photo 8: Mostly plugged culvert inlet on upslope side of Bear Lake Main FSR at Blue Grouse Creek crossing (Blue Grouse-1)

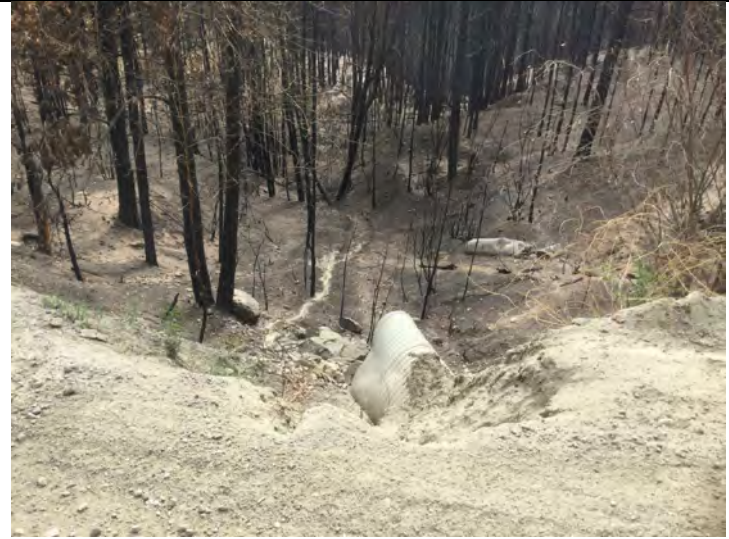
Photo 9: Culvert outlet and burned slope below Bear Lake Main FSR at Blue Grouse Creek crossing (Blue Grouse-1)

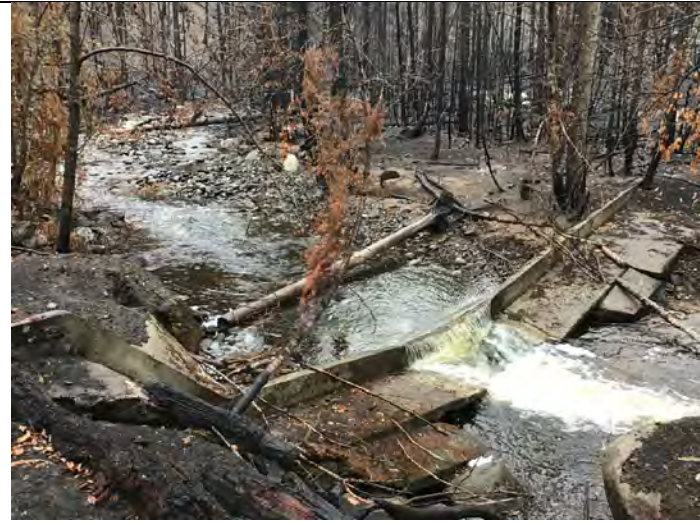
Photo 13: Lambly Creek channel upstream of diversion, view of old weir structure. Note burned riparian forest in floodplain (Lambly-7)

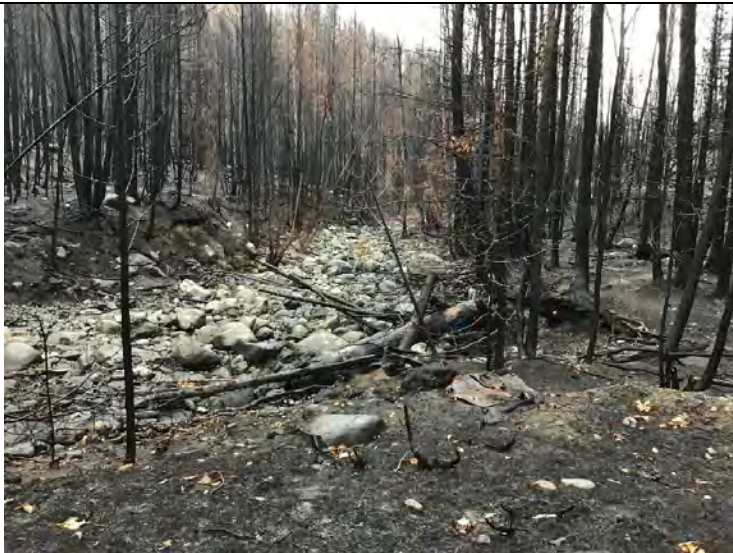
Photo 14: Lambly Creek channel downstream from diversion. Note undercut banks, abundant substrate sediment, and burned riparian forest (Lambly-8)

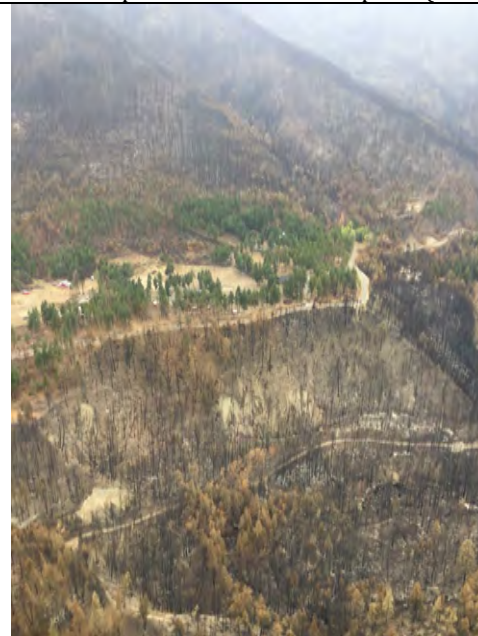
Photo 15: View of steep burned slopes below Bear Creek Road. Water pipeline ROW is visible along toe of slope adjacent to Lambly Creek (Bear Ck Rd-1)

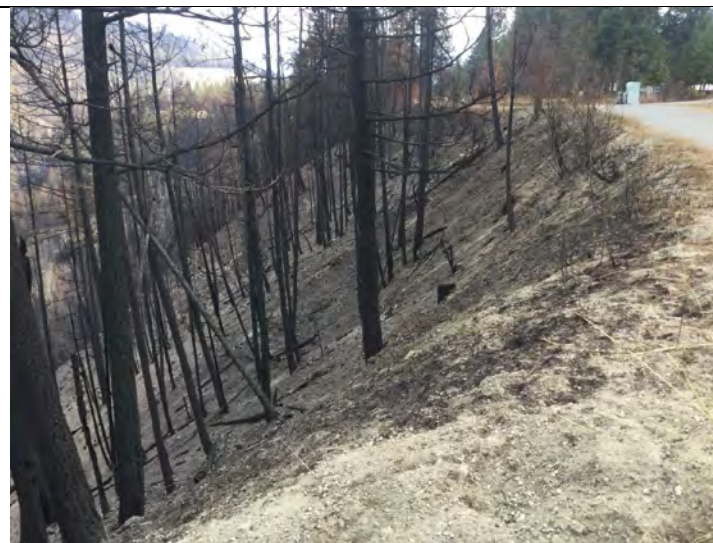
Photo 17: View along edge of burned steep slopes below Bear Creek Road (Bear Ck Rd-1)

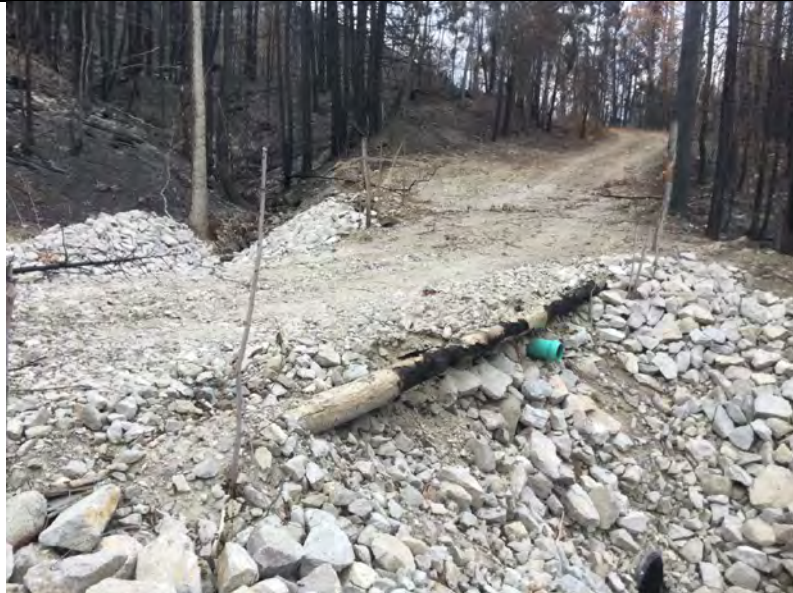
Photo 22: Cedar Creek crossing at Water Pipeline (500 mm plastic pipe and 200 mm plastic pipe). Note, burned log stringers. (Cedar-1)

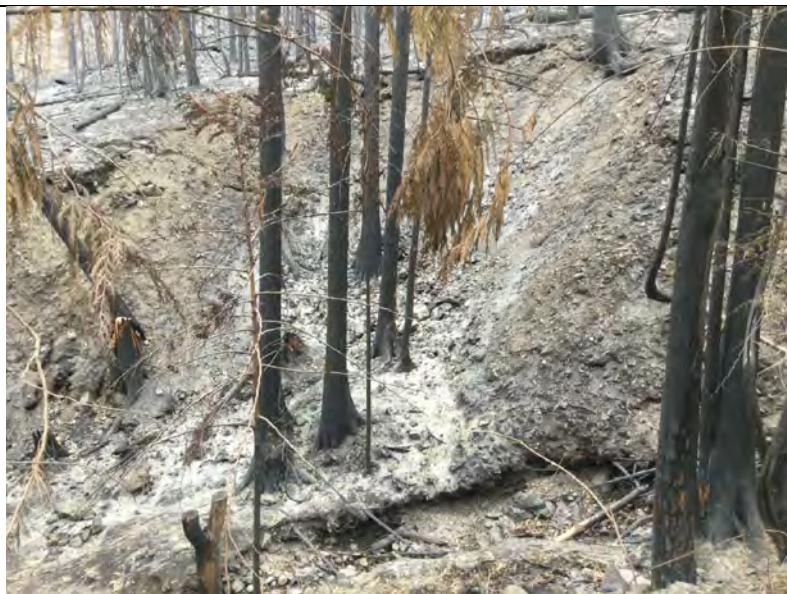
Photo 24: Incised section of Cedar Creek, downslope of Bear Creek Rd. Note shallow landslide activity and eroded streambanks (Cedar-2)

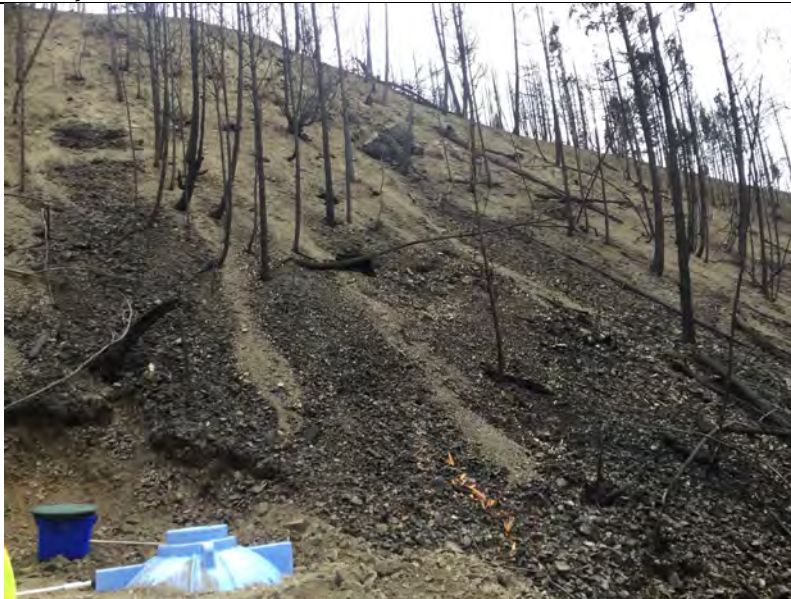
Photo 30: View of slopes adjacent to Cedar Creek Tributary, which is an ephemeral channel. Note small-scale soil erosion along slope (Cedar Trib-1)

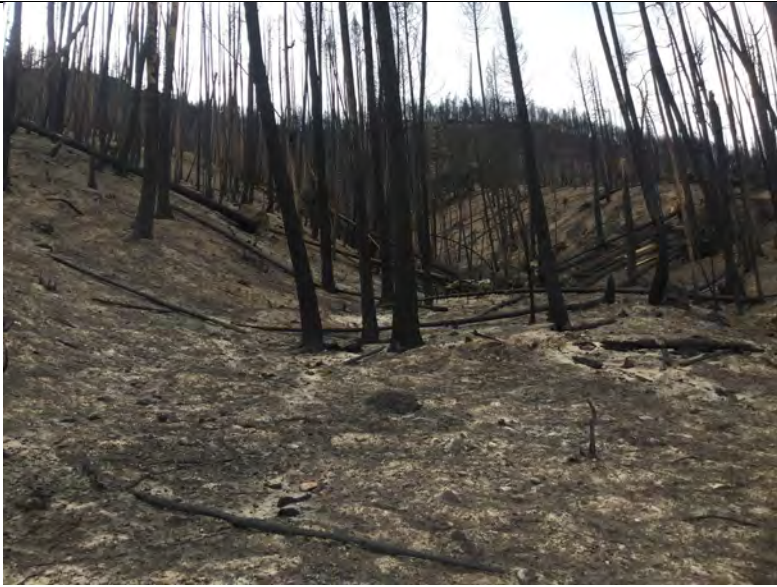
Photo 32: View upslope to gully on Lambly Trib 2 showing shallow colluvial deposits across fan area (Lambly Trib 2-2)

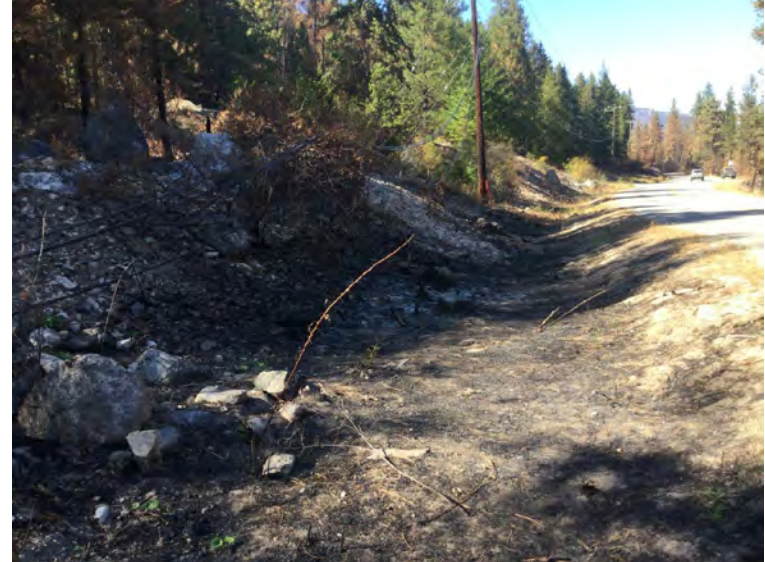
Photo 4: Example of wide ditches along Westside Road that can capture and detain sediment-laden runoff from burned slopes above (Westside-1)

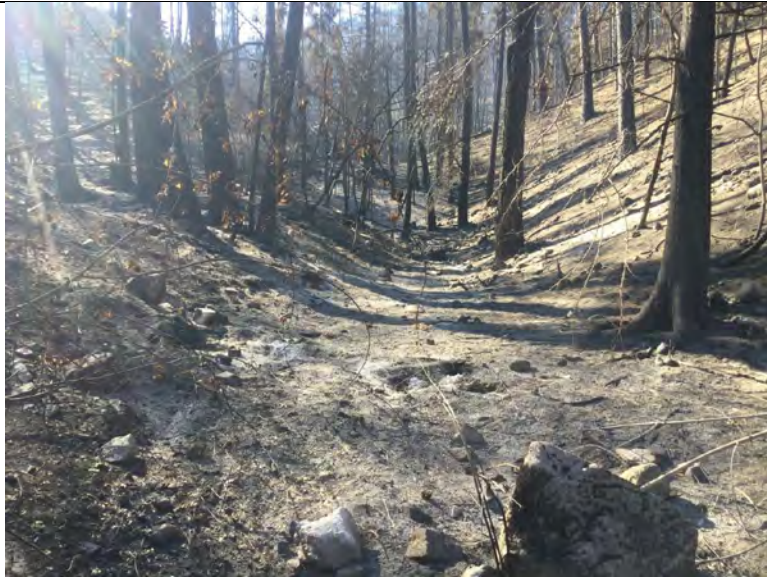
Photo 5: Severely burned gully along Cedar Gulch Creek upslope of Westside Road (Cedar Gulch-1)

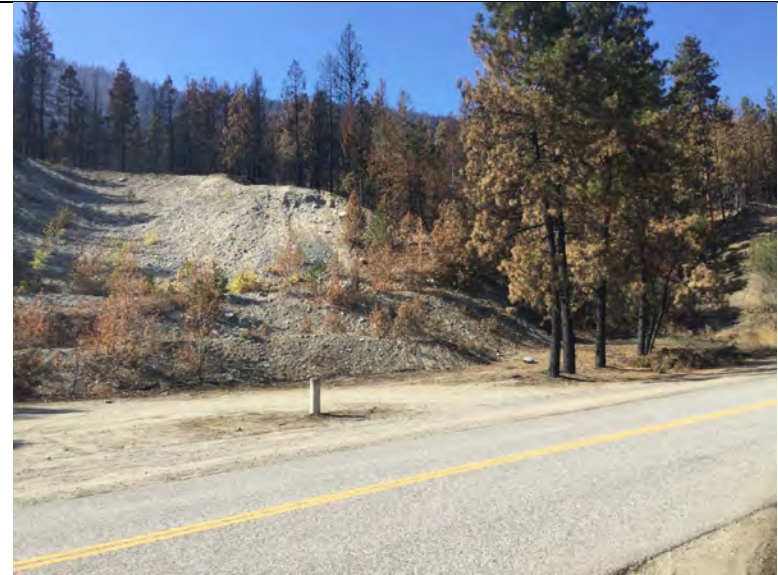
Photo 6: View of thick sand and gravel deposits along Cedar Gulch at Westside Road (no culvert) (Cedar Gulch-1\_

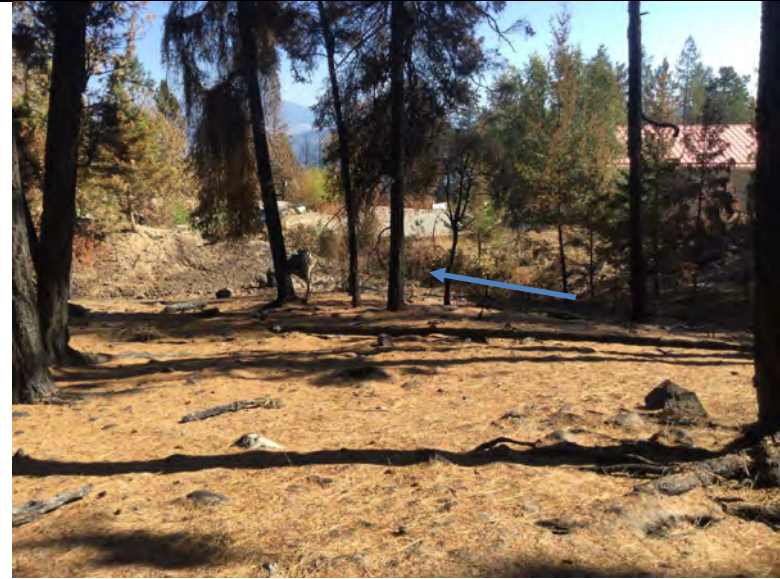
Photo10: View downslope towards Wilson's Landing Fire Hall (red roof) along the depositional fan area upslope of Westside Road (Wilson-1). Culvert is located at arrow.

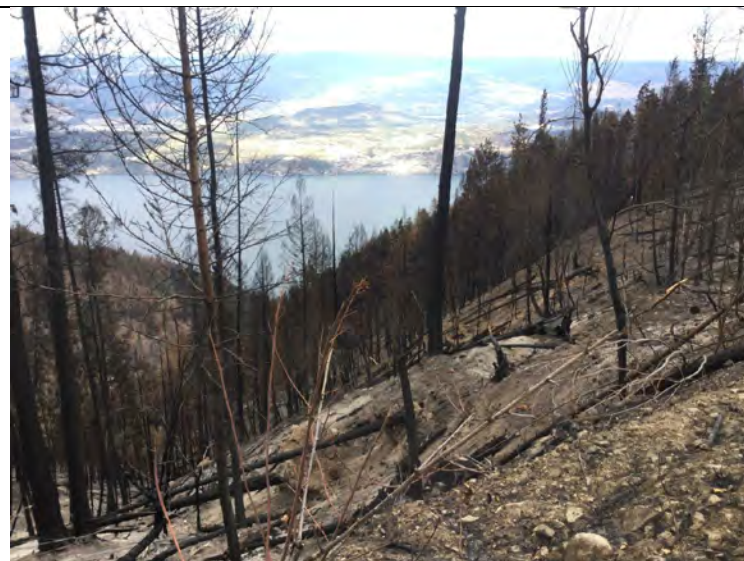
Photo18: Steep (50-75%) slopes into the Wilson Creek gully. Note abundant soil disturbance from windfall. Small debris slides observed in area (Wilson-8)

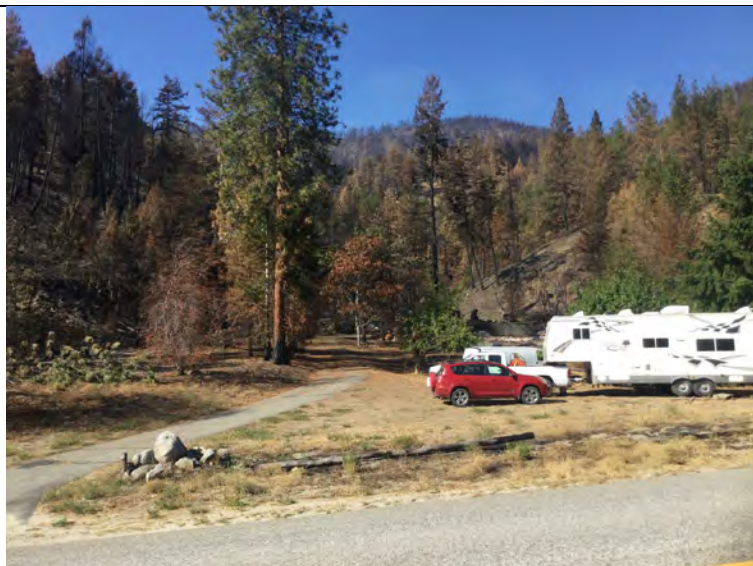
Photo 15: View upslope from Westside Road into Oldman Creek catchment (Oldman-1). The inlet to a 500 mm culvert is buried.

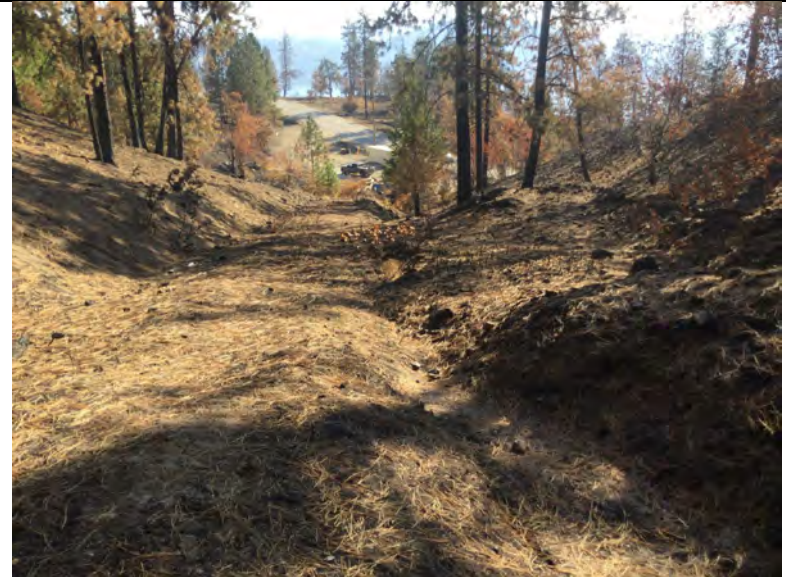
Photo18: View downslope along Jennie Creek towards Westside Road. Direct connectivity to the road area downslope (Jennie-1)
