Post-Wildfire Natural Hazard Risk Assessment for the Downton Lake Fire (K71649)

Report by

Cordilleran Geoscience
PO Box 612,
Squamish, BC
V8B 0A5

Draft: November 22, 2023
Final: December 14, 2023

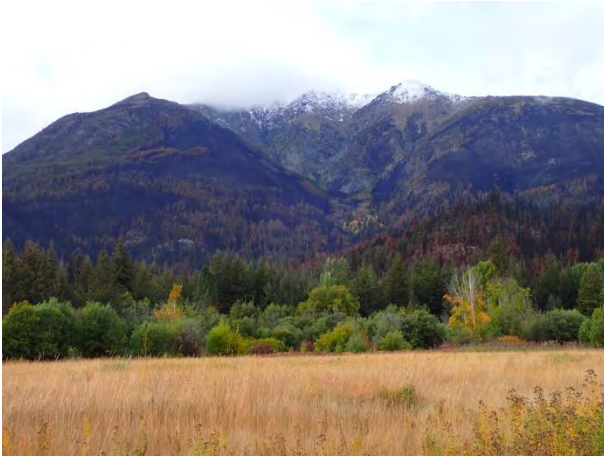
Photo 1. View WNW up Penrose Creek from Lajoie Lake showing high burn intensity on the faces either side of the drainage.

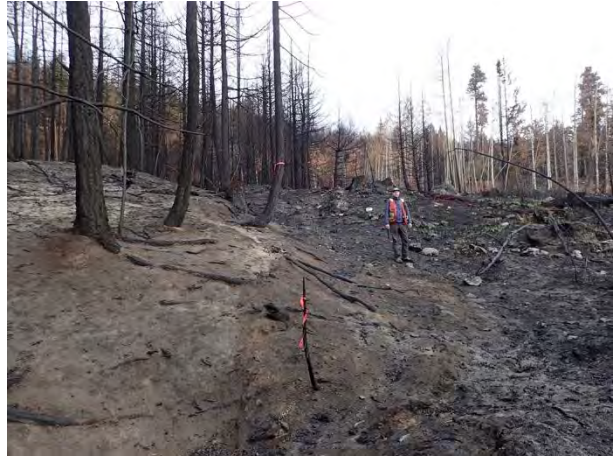
Photo 6. Contrast between tephra covered surface on left and recent debris flow deposits on right on Penrose Creek.

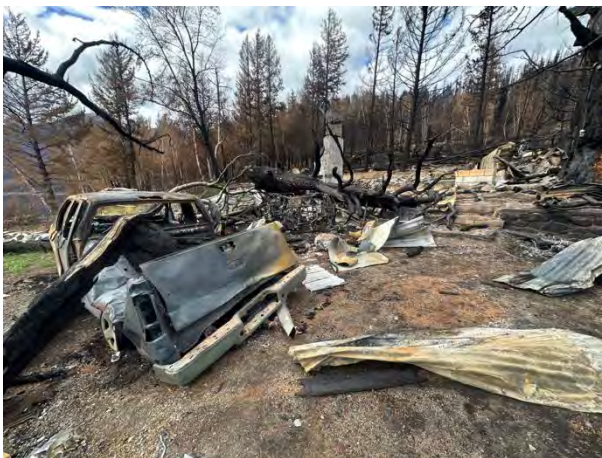
A fire tornado (Figure 6E) is a rare phenomenon, requiring a combination of high ambient heat, very low relative humidity and dew point temperatures, and fanning winds (Figure 5). On the evening of August 17th, originating off Gun Lake, the fire tornado touched down at 13770 Gun Lake Road West (509974 m E, 5637022 m N) creating a damage corridor 300 m in diameter with the vortex throwing trees from the perimeter in to the center, with a few large diameter trees snapped indicating Storm Force (Force 10; 89-102 km/hr) or greater wind speeds (Photos 9, 10).²

Photo 9. Burnt structure on 13770 Gun Ck Rd West, affected by fire tornado. Note thrown and snapped trees and thrown roofing metal.

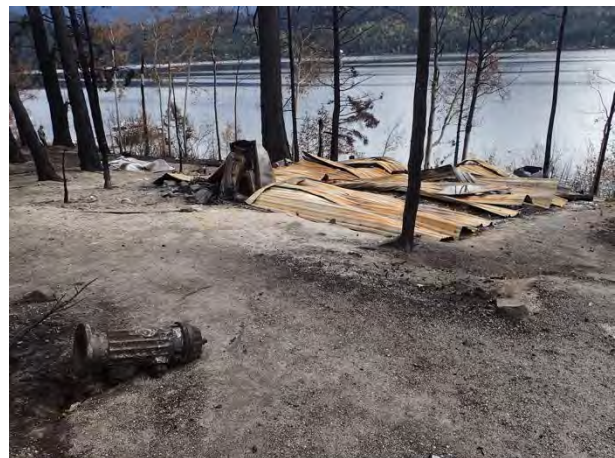
Photo 10. Burnt structure in area outside fire tornado. Roofing falls directly down on foundation.

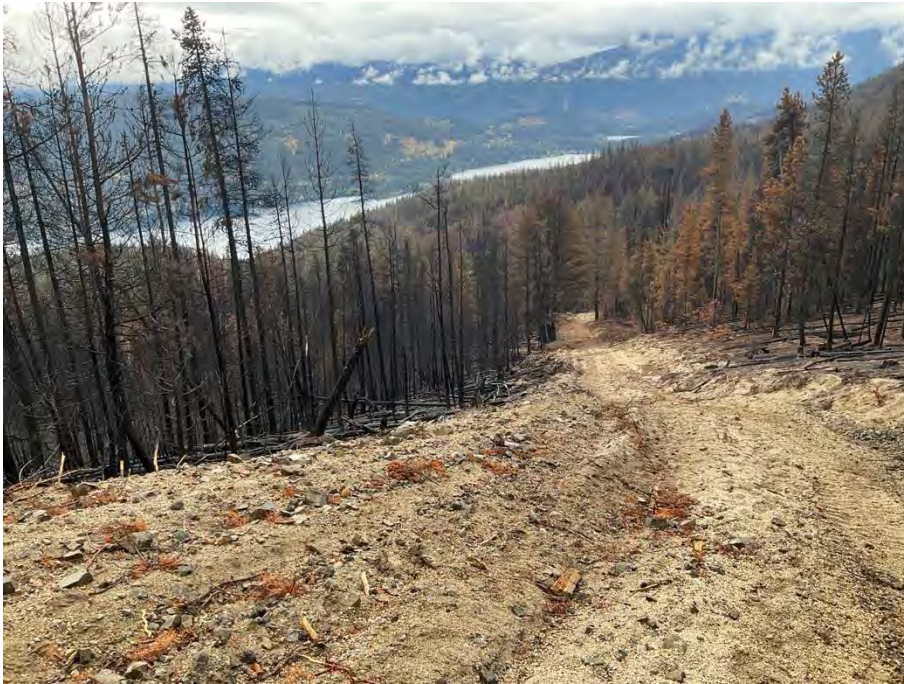
A large number of firebreak roads were constructed within the Downton Lake fire boundary (Map 1). Typically, due to the urgency of the situation, firebreak roads are not constructed to forest road design and construction standards. In the Downton Lake fire boundary, most cross gentle (<30%) to moderate (30-50%) slopes, where drainage is the only concern (Photo 11). However, some cross moderately steep (50-70%) and steep (>70%) slopes where partial benching and endhaul would be prescribed in planning and design. In these areas water control and fillslope stability are of concern. As such, firebreak roads require deactivation measures appropriate to the terrain they cross and the risk they present to elements at risk downslope.

Photo 11. Firebreak road running straight downslope over moderate (30-50%) sloping terrain.

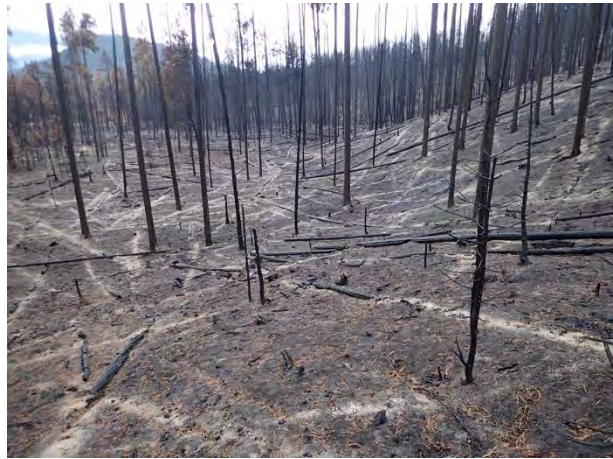
Photo 13. High vegetation burn severity with white stripes indicating locations of fully consumed coarse woody debris.

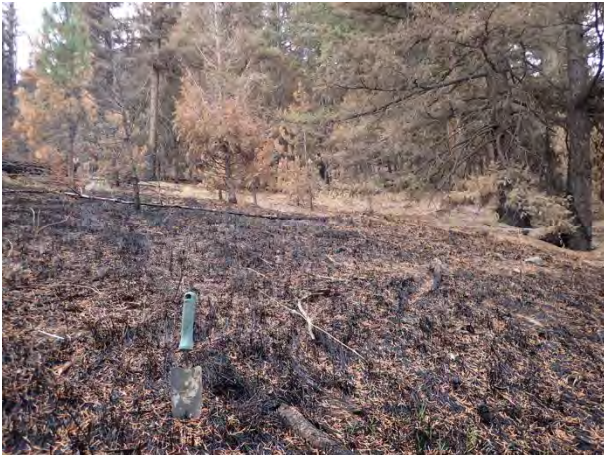
Photo 14. Moderate vegetation burn severity with trees burned and dead, needles remaining, understory mostly burned.

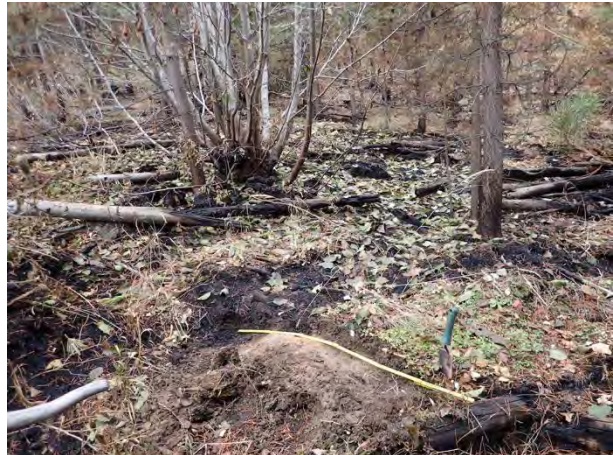
Photo 15. Low vegetation burn severity with canopy and trunks partially burned, understory lightly or patchily burned.

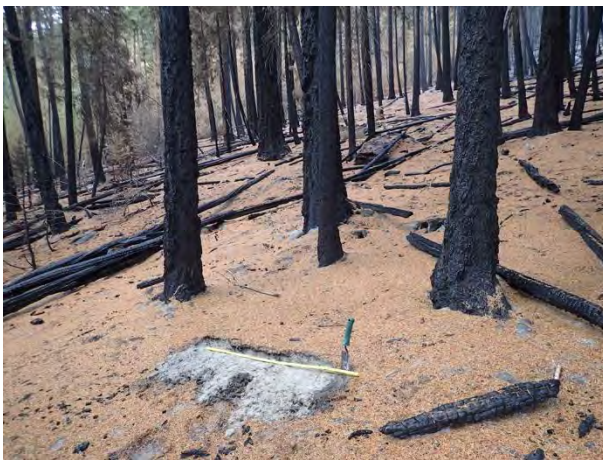
Photo 16. TP19. Moderate soil and vegetation burn intensity. Note the needle drop.

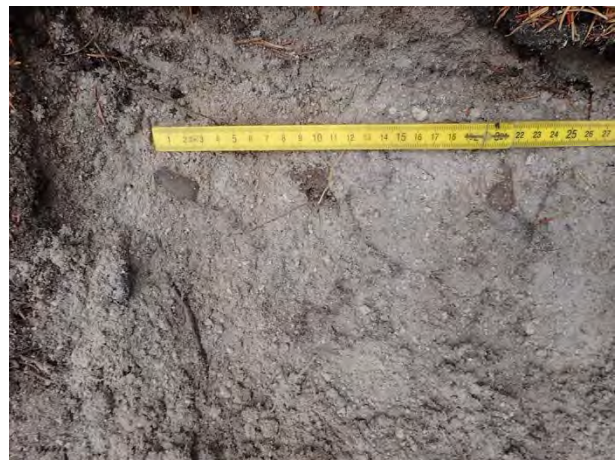
severity (Appendix 3), we found moderate to high water repellency in the soil (Photos 17, 19). We typically conducted drip tests at 5 cm depth, but at a few locations we tested repellency at 10 cm and 15 cm depths and found similar results. We found repellency when the soil was dry, but at sites where it had been wetted by rain, then repellency was absent. Water repellency makes it more likely that overland flow will be generated during high-intensity summer or early fall rains (generally following dry spells when water repellency is greatest). Note that we did not conduct water repellency tests in any unburnt areas.

Photo 17. TP19. After >40 seconds, 50% of drops not infiltrating. See 10 cm intervals.

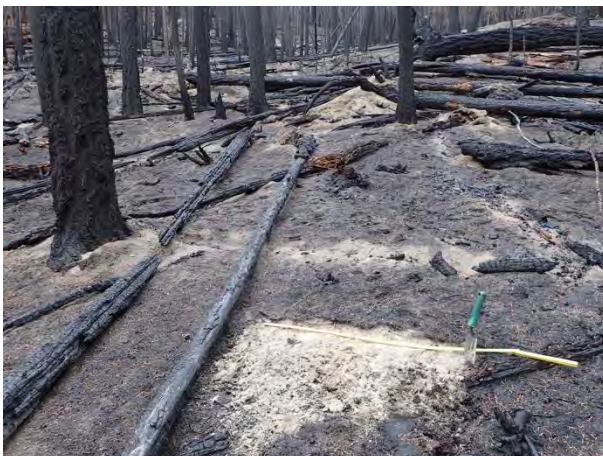
Photo 18. TP20. High soil and vegetation burn intensity. All blackened, no needle drop.

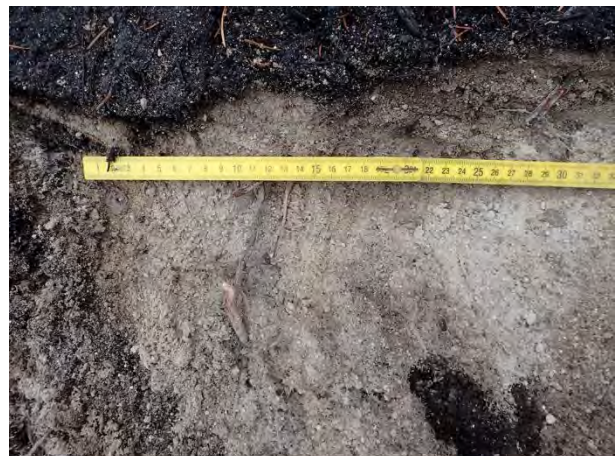
Photo 19. TP20. After >40 seconds, 100% of drops not infiltrating. See 10 cm intervals.

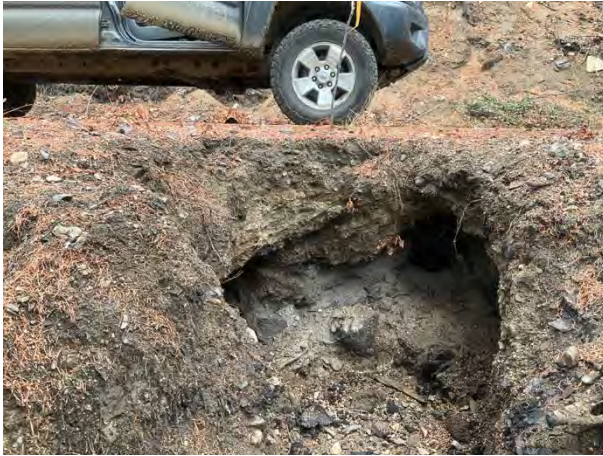
On Downton Face, Road ID R06128 1890 supports sections where burnt wood is causing a collapsing road shoulder, and presenting a risk to driving safety (WPs DK6, 7; Photos 20, 21). These areas should be identified and repaired.

Photo 20. WP DK6. Burnt wood creating driving hazard.

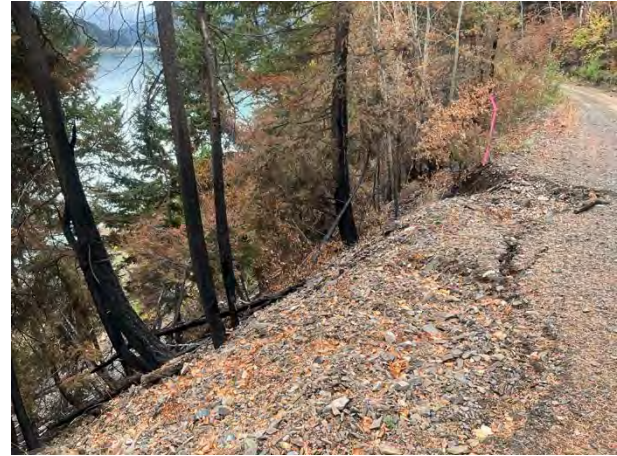
Photo 21. WP DK7. Burnt wood creating driving hazard.

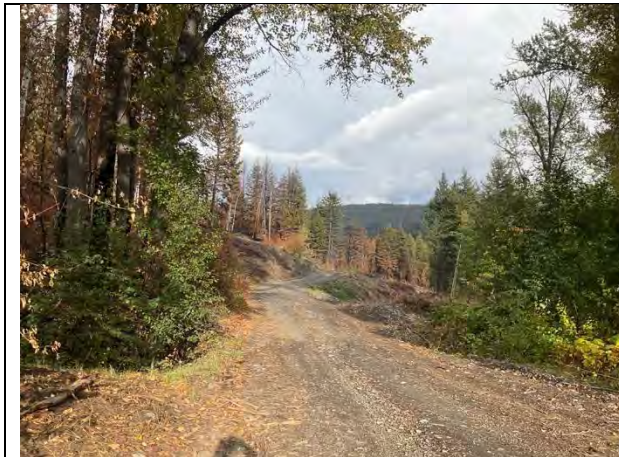
Crossing Penrose Creek, Road R06128 28-713-220 has a slight swale/dip in grade through the crossing (Photos 22, 23). The culvert should be monitored to ensure it does not plug, and the dip in grade needs to be maintained, a minimum sag and sag distance is 1 m over 20 m distance. If the culvert plugs or debris overwhelms the sag, then water and debris could be directed east down the road toward the junction with Gun Lake Road West.

Photo 22. WP DK103. View campside past Penrose Creek crossing on Road R06128 28-713-220. Ensure culvert is clear and sag is maintained.

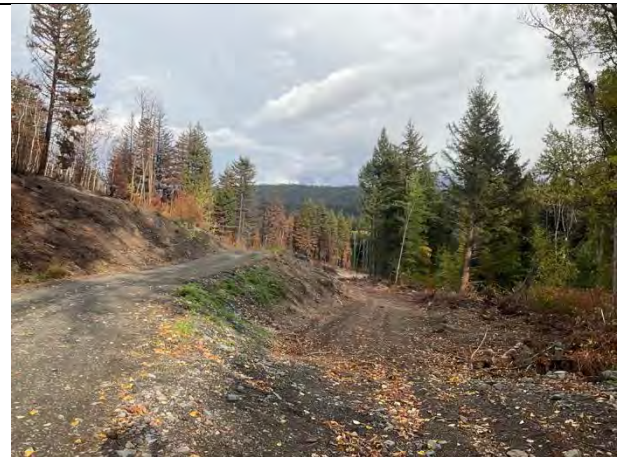
Photo 23. WP DK103. View campside past Penrose Creek crossing on Road R06128 28-713-220 to lower side of road where avulsion could impact.

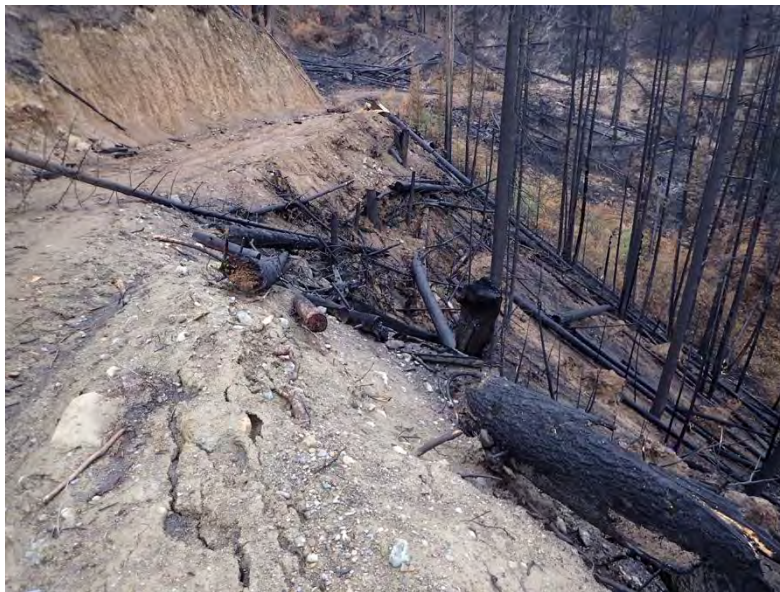
Photo 24. Firebreak road branching off Road R06128-191. Oversteeped fillslope with tension cracking presents landslide hazard above Slim Creek FSR. Permanent deactivation required.
