# BRITISH COLUMBIA MINISTRY OF FORESTS: POST-WILDFIRE NATURAL HAZARD RISK ANALYSIS

## LEVEL 2 RECONNAISSANCE REPORT – QUILPITUK CREEK (K51402) FIRE

| <b>FIRE NUMBER/STATUS:</b><br>K51402 Quilpituk Creek Wildfire -<br>classified as held on Aug. 19, 2026. | | <b>FIRE YEAR:</b> 2026 | <b>DATE OF FIELD REVIEW:</b><br>August 28, 2026<br><b>DATE OF REPORT:</b><br>September 22, 2026 |
| <b>AUTHOR:</b> J. Clarke, M.Sc., P.Geo., Geomorphologist, Clarke Geoscience Ltd. | | | |

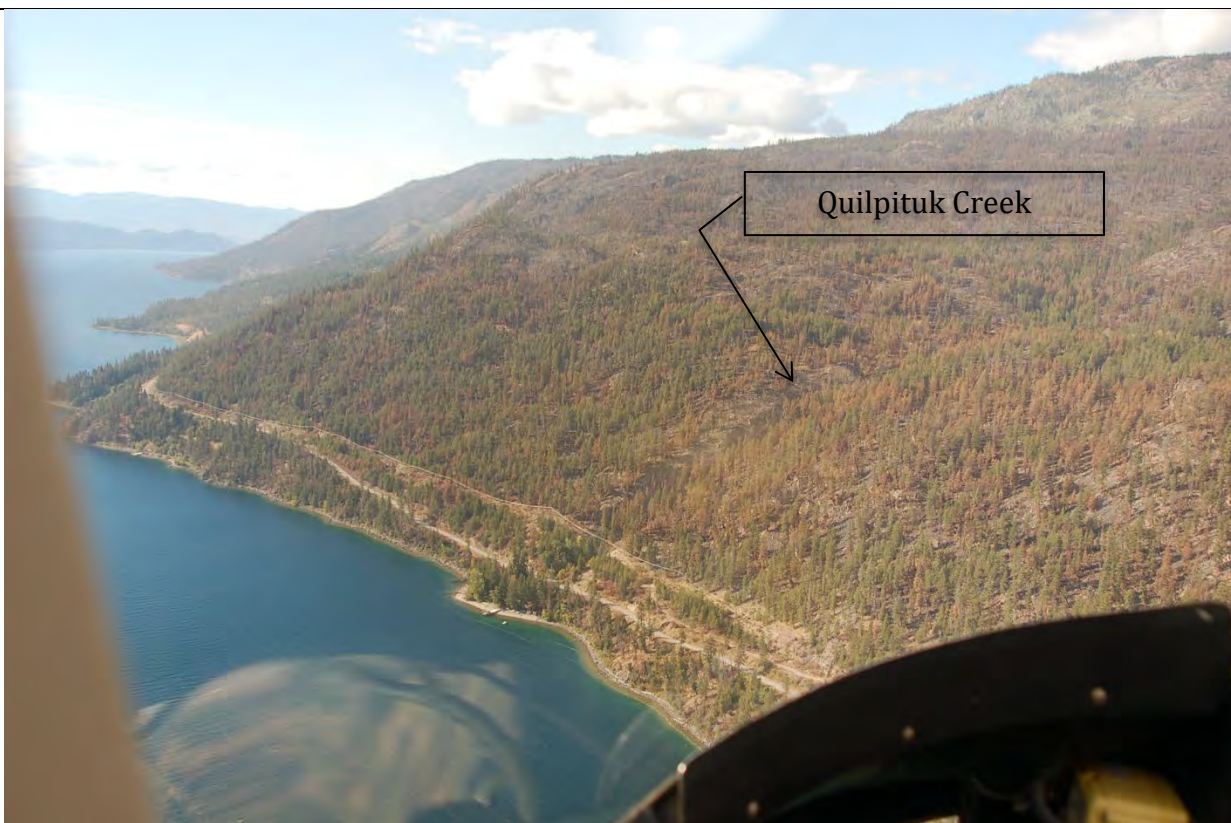
The creek becomes well-confined within a bedrock-controlled gully that extends downslope to Westside Road and beyond to a small fan area on Okanagan Lake. Because exact structure locations on the fan are unconfirmed, the spatial likelihood of impact to the private property located on the fan, downslope of Westside Road, is considered HIGH for small-scale sediment-laden flooding and for debris flood/debris flow. The spatial likelihood of impact to Westside Road is considered HIGH for both hazards. Thus, the partial risk of impact by post-wildfire natural hazards is rated VERY HIGH for all identified elements at risk based on the information gathered at this level of assessment.

Photo 1: View (south) of Quilpituk Creek gully extending down to Westside Road and the small fan area on Okanagan Lake. Linear feature upslope of Westside Road is the Fortis power transmission line.

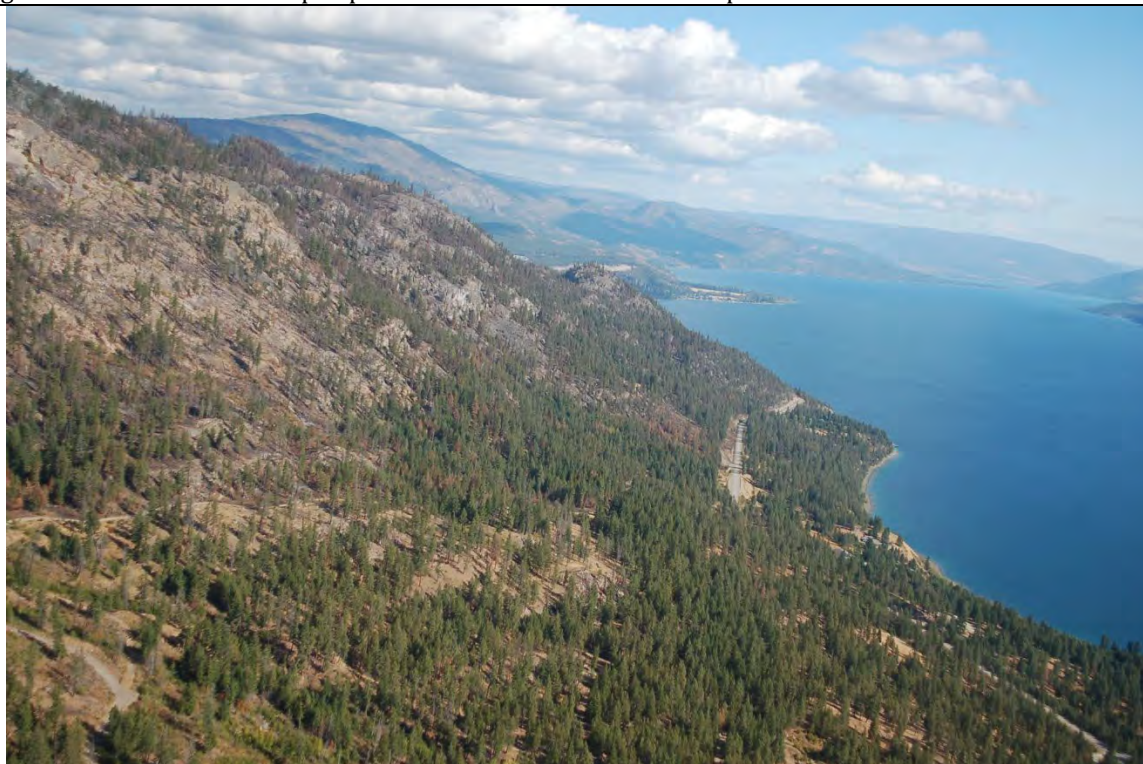
Photo 2: View north along face unit slopes between Ceasar's Landing and Nahun (incl. Tributary at Ceasar's Landing and Tributary Q4 showing unburned to low vegetation burn severity along lower slopes.

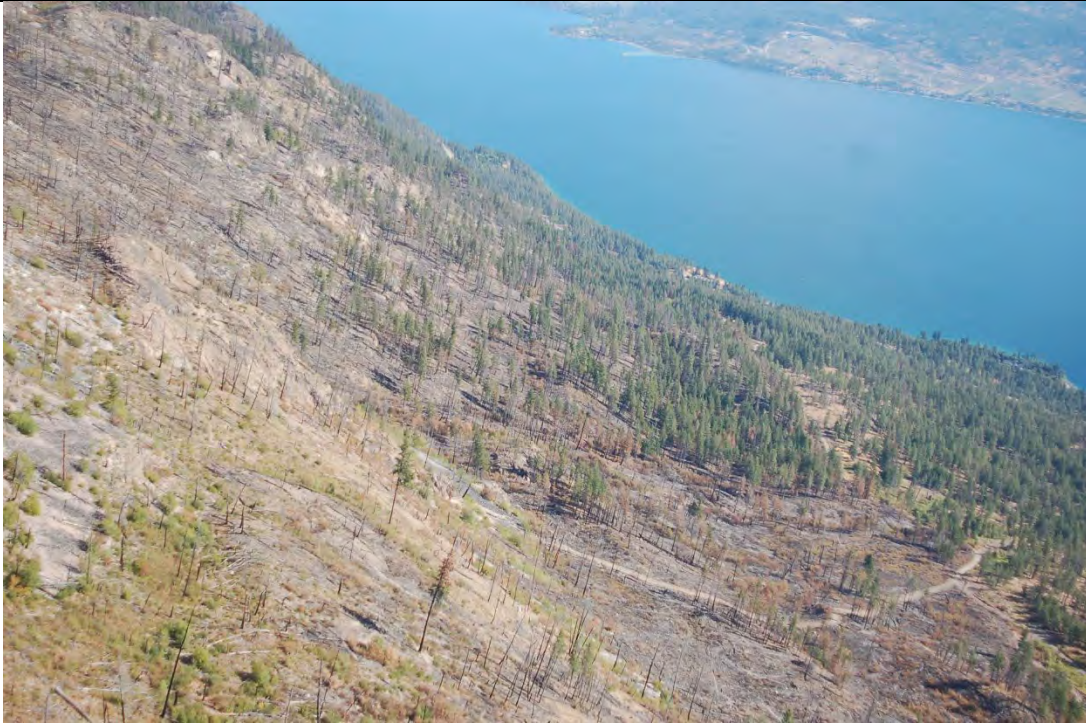
Photo 3: View north from the southern fire perimeter showing the southern Tributary Q4 and adjacent slopes that were previously burned in 2015 Shelter Cove Fire. Vegetation burn severity is none (unburned) to moderate. Fireguard along south perimeter is visible.

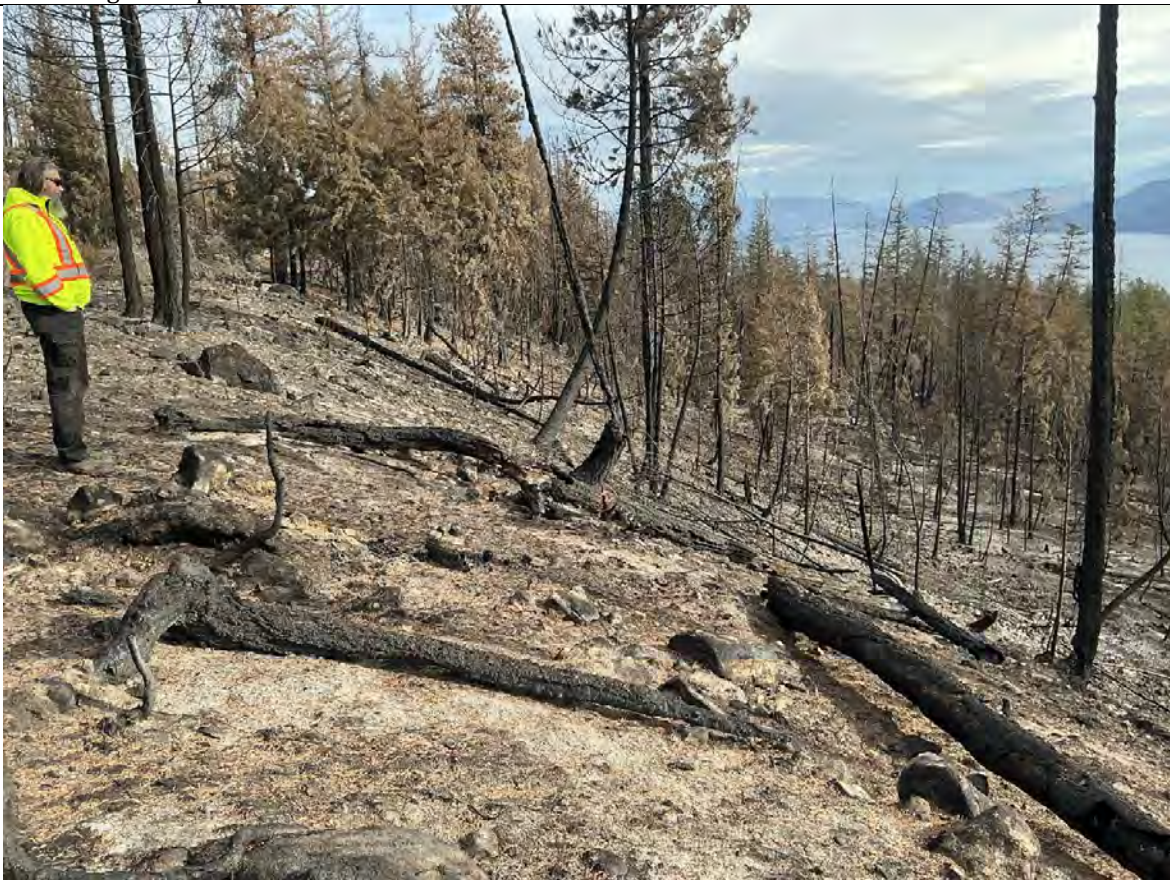
On the ground field checking was completed to correlate and validate VBS with a corresponding impact on soils known as Soil Burn Severity (SBS). This is an important determination for the likelihood of hydrologic effects such as water-repellent soils and the resultant impact of runoff. In general, areas mapped as moderate VBS were observed to have discontinuous pockets of high burn severity and indicators such as the consumption of surface

litter, duff, exposure of mineral soils, and a strong (but discontinuous) water repellency (see Photo 4). It is judged that VBS mapping slightly under-estimates the impact of the wildfire on soils within areas mapped moderate burn severity.

Photo 4: Moderate vegetation burn severity slopes in the Quilpituk Creek catchment. Soil burn severity is higher, with discontinuous water-repellent soils.

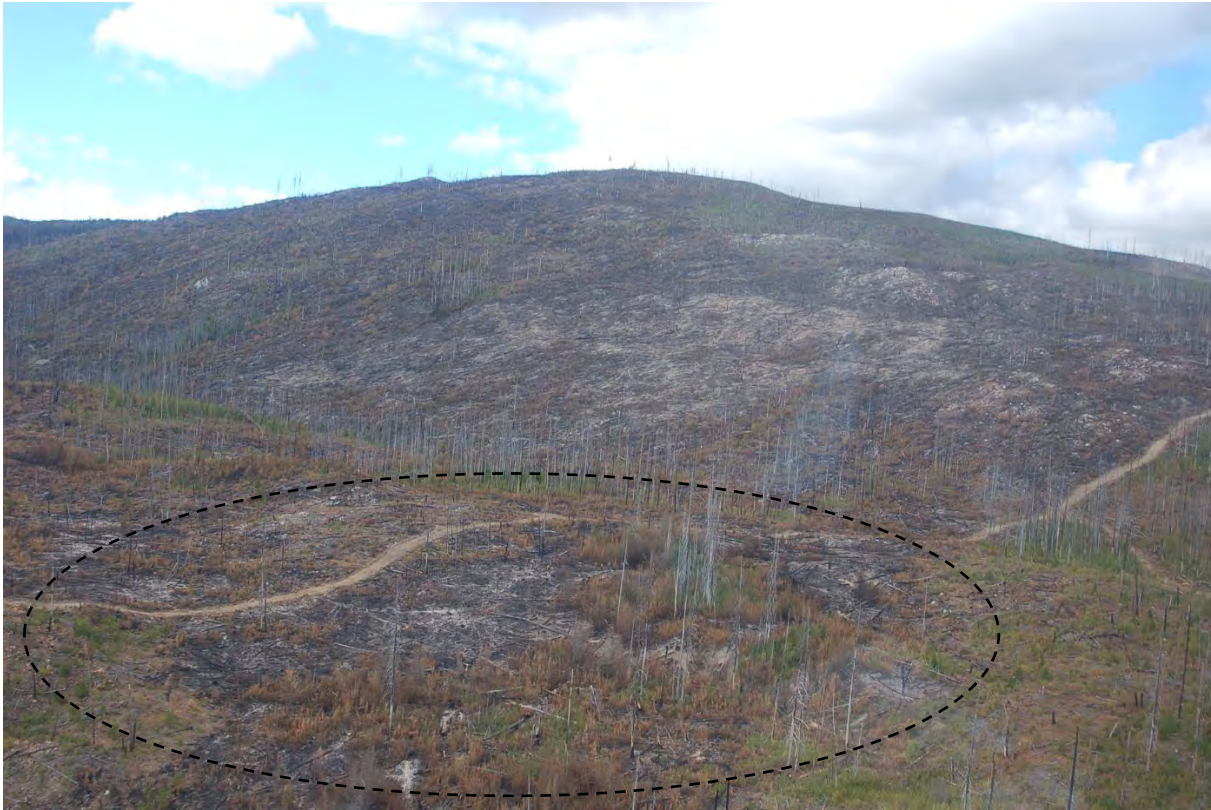
Almost the entire (97%) Quilpituk Creek catchment was burned, with 80% burned at moderate to high vegetation burn severity. Areas of high burn severity are found within the catchment below Bald Range Road (see Photo 5). The field review confirmed that in these areas, as well as much of the area mapped as moderate burn severity, fire consumed organic duff layers, exposing mineral soils on moderate to steep slopes. Discontinuously strong (high) soil-water repellency was also observed but decreases in areas where surficial materials are coarse colluvium. These conditions suggest a high likelihood for greater and faster surface runoff, shallow instability, and surface erosion over the next 5 years post-fire.

Photo 5: View (west) of the burned upper slopes of the Quilpituk Ck catchment. Bald Range Creek Road (and fireguard) traverses the catchment at ~920 m elevation. An area of high vegetation burn severity is outlined.

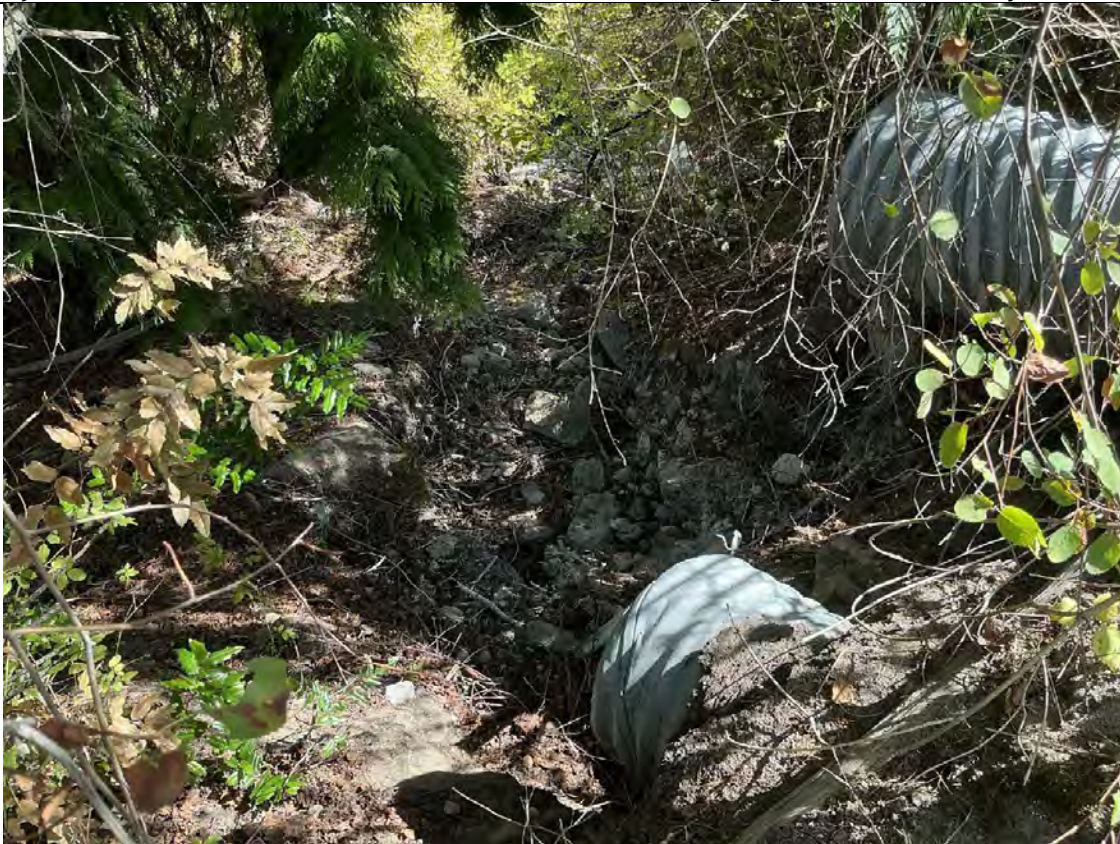
Photo 6: Quilpituk Creek culvert outlets (500 mm and 600 mm diameter) at Westside Road, view downstream. Note the deep channel scour indicative of high flow conditions. Only a small trickle (<0.5 litres/sec) of water was flowing at the time of the field assessment.

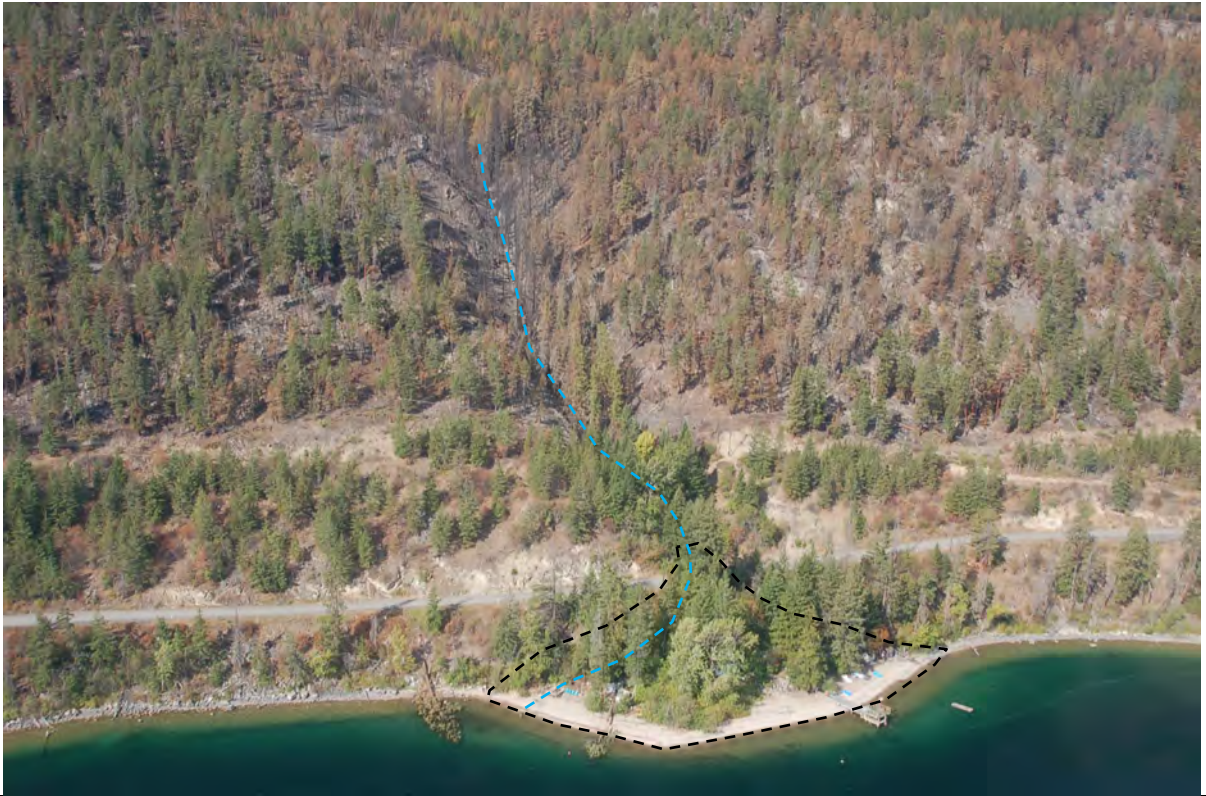
Photo 7: Lower Quilpituk Creek and fan area situated below Westside Road (outlined). Note the burned canyon slopes upslope of Westside Road. Note the private property on small fan below Westside Road.

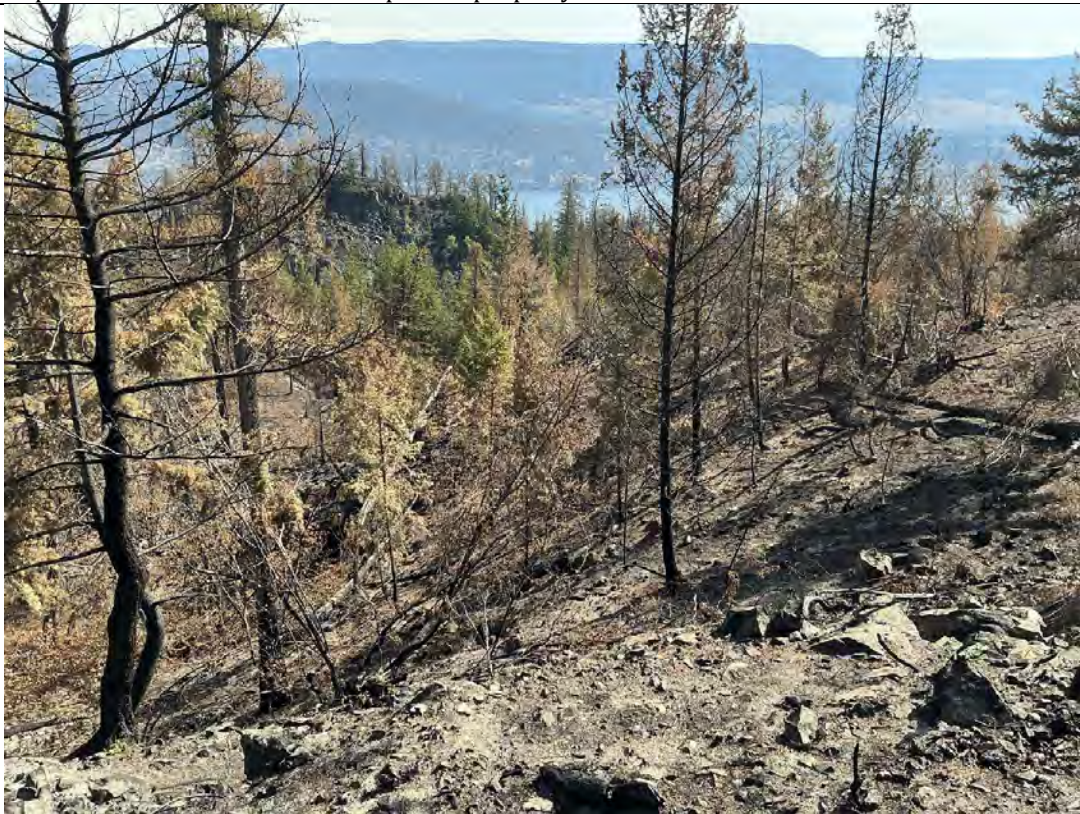
- **Tributary at Caesar’s Landing** – this tributary catchment has an area of 1.1 km<sup>2</sup> and 87% was burned in 2026, with 59% at moderate and high burn severity (see Photo 8). This level of burn is sufficient to impact catchment hydrology, including runoff rates and water yield (due to loss of vegetation cover that would normally intercept precipitation). The ephemeral stream originates at a small lake above Bald Range Creek Road and occupies a shallow swale before reaching hummocky bedrock topography. The channel is not well-defined and appears discontinuous before reaching a bedrock gully that extends a short distance (650 m) upslope of Westside Road. Along Westside Road, based on limited field review, there is no visible channel and no detected MOTT culverts (although the mapping does indicate the presence of culverts). There may either be a flow deflection upslope, or the tributary flows infiltrate and then flow subsurface. There is a transition from shallow bedrock to thick glaciofluvial and glaciolacustrine sediments at the south end of the study area. If flows go subsurface there is a likelihood that changes in groundwater flows will affect downslope stability. Downslope of the mapped tributary, along the shoreline and on private property, there is a large landslide feature (see Photo 9). The slide is a deep-seated slump measuring almost 100 m wide and 100 m long. According to historical google

Photo 8: View east from Bald Range Creek Road (~900 m elev.) near headwaters of Tributary at Caesar's Landing. Note bedrock slopes and irregular hummocky topography and thin soil cover. Low to moderate vegetation burn severity is observed.

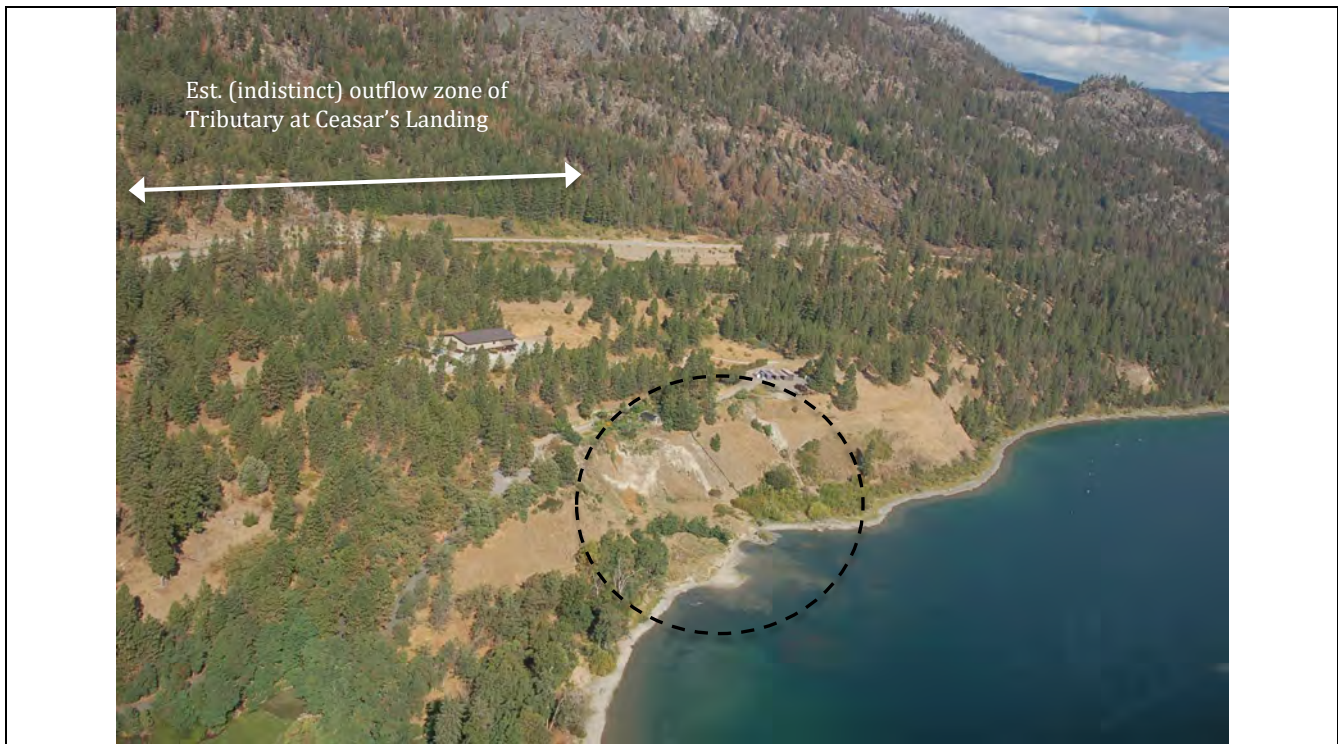
For the Tributary at Caesar's Landing, deep-seated landslide stability is an additional identified hazard. Due to a potential for post-fire incremental increase in water yield, the potential for changes to deep-seated landslide stability is rated MODERATE. Consultation with RDCO indicates that previous assessment work on the property has determined safe setback distances for structures. Therefore, the spatial likelihood of impact is rated LOW and the resultant partial risk is LOW.

Photo 9: Private property downslope of Westside Road near undefined outlet of Tributary at Ceasar's Landing. There were no observed culverts along Westside Road at the mapped channel path. However, there are nearby culverts that could be receiving runoff from the upslope catchment. Note the large landslide slump features along the shoreline (circled).
