Chemainus River Emergency Sediment Removal

# Construction Completion Report

**Final Report**  
**February 1, 2023**  
**KWL Project No. 3427.021**

**Prepared for:**  
**BC Ministry of Environment and Climate Change**

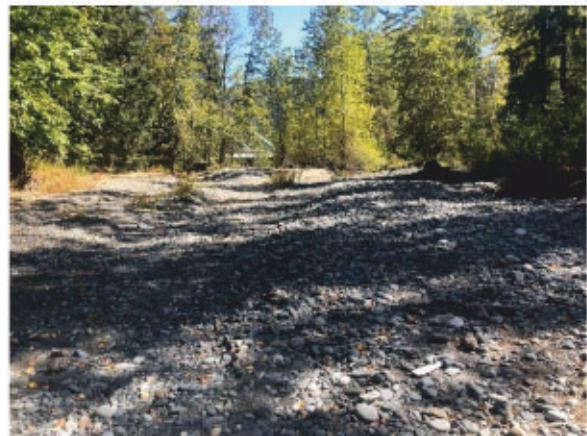
**Photo 2: Sediment Accumulated Inside Channel on Right Bank of Chemainus River**  
Note Highway 1 Bridge in background

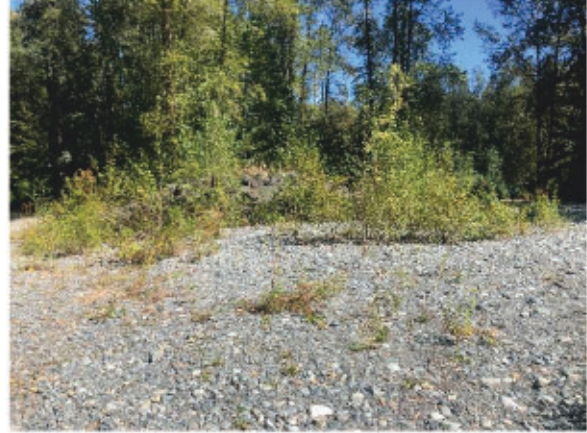
**Photo 4: DNC Water Supply Well Head Protected by Riprap Adjacent to Side Channel**

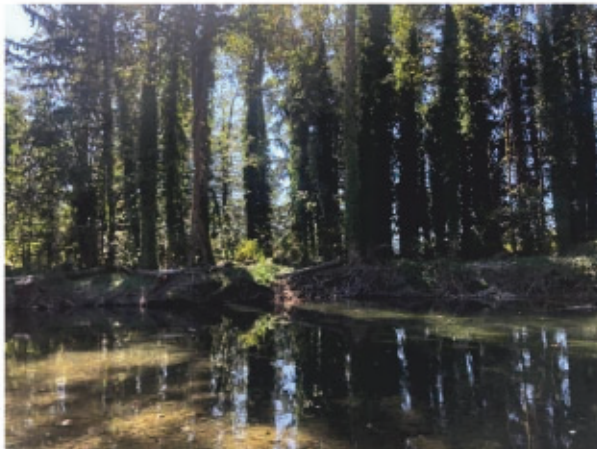
Air photo interpretation in the Geomorphic Atlas indicates that the bank has been eroding at an average rate of about 0.9 m/year but with variations on year-to-year basis with changes in peak flow magnitude since 1950. For instance, the November 2021 flood event resulted in between 2.5 m to 6.3 m in lateral bank erosion based on pre and post flood event survey carried out by NHC. Large woody debris and willow wattles installed along the bank in this location in late summer of 2021 failed during the November 2021 flood.

**Photo 6: Right Bank of Chemainus River  
Downstream of Highway 1 Bridge Showing  
Mature Riparian Trees and Exposed Roots**

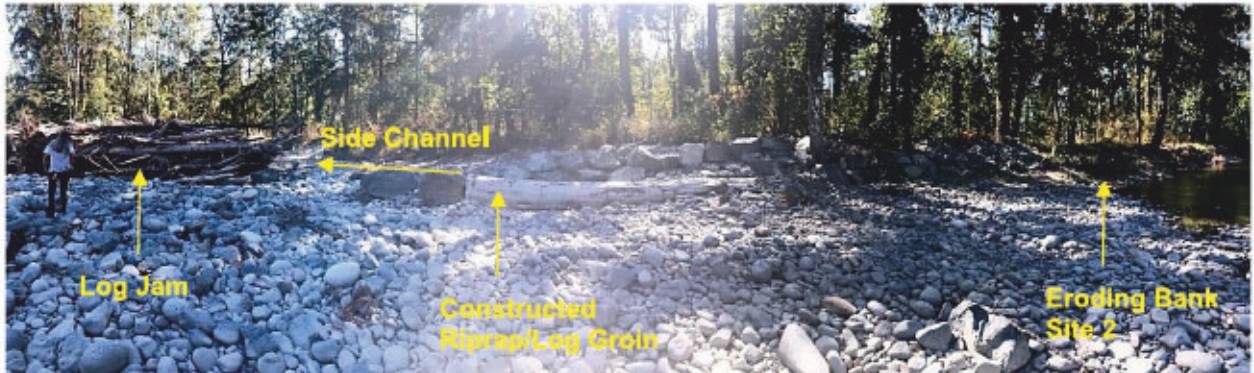
**Photo 7: Entrance to Right Bank Side Channel Showing Eroding Bank, Riprap/Log Groin, Log Jam**

Both the logjam and the groin limit the amount of water that flows into the side channel in this location. However, on-going erosion upstream (Site 2) could outflank the groin structure and result in additional water flowing into the side channel during large flood events.

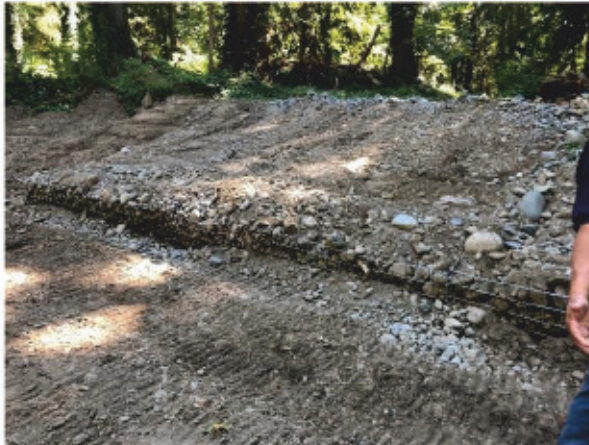
Two gravel berms have been constructed across the floodplain within Halalt FN reserve lands between the two side channels. A trapezoidal channel has been left in the berm at the location of the relic side channel (see Photo 8). These were constructed as emergency measures during the 2021 flood. They limit flow across the floodplain and concentrating flow in the two side channels.

**Photo 8: Opening Through the Berm for Smaller Right Bank Side Channel**

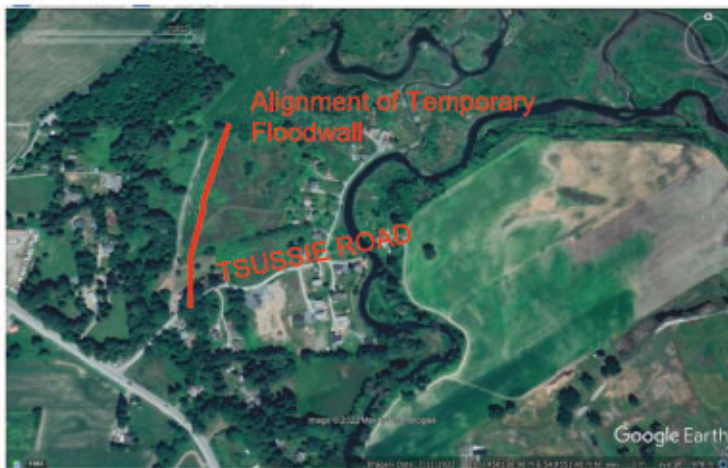
During the November 2021 flood, a temporary floodwall was installed at this location to direct flood water along Butcher Slough away from the Tsussie Road community (Photo 12). At the time of the site visit, the floodwall was removed, however, there are plans to re-install a temporary floodwall in the event of high flows in winter of 2022/23.

**Photo 12: Alignment of Temporary Flood Wall Partially Protecting Tsussie Road**

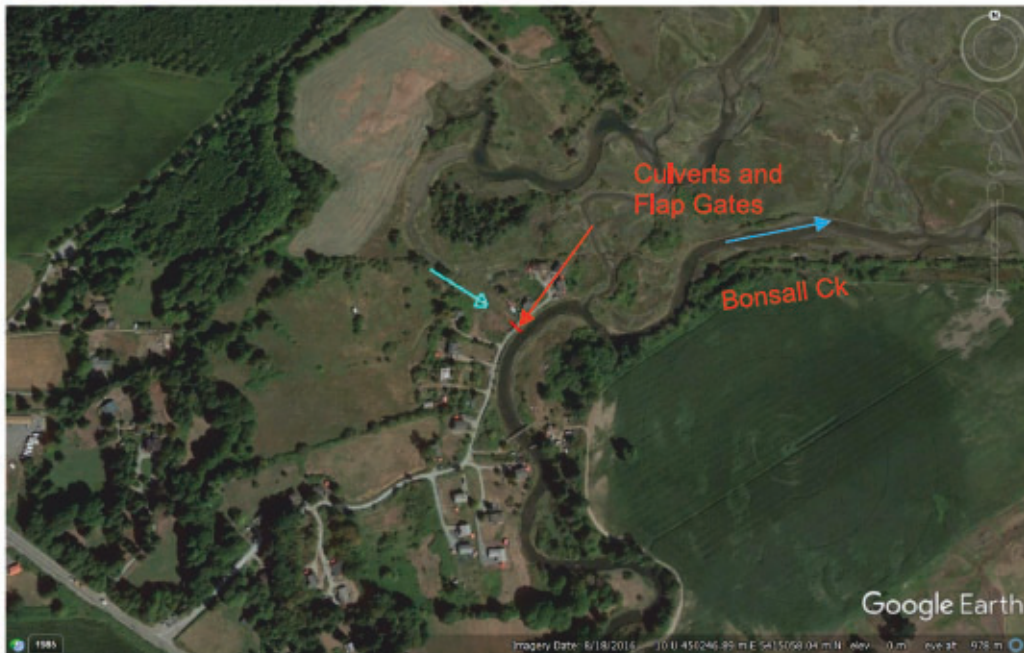
Two 600 mm culverts with flap gates were installed under Tsussie Road approximately 10 years ago. The intent of these culverts is to drain the fields to the west of Tsussie Road. However, the flap gates on the outlet into Bonsall Creek are corroded and no longer close/seal properly. This allows water from Bonsall Creek to flow into the fields during periods of high flow and high tide in Bonsall Creek. The drainage path and the culverts are shown in Photo 14.

**Photo 14: Location of Tsussie Road Culverts and Flap Gates**

The effectiveness of the flap gates should be assessed as part of on-going hydraulic modelling work and the flap gates should be replaced if the analysis indicates that the culverts/flap gates provide a drainage benefit.

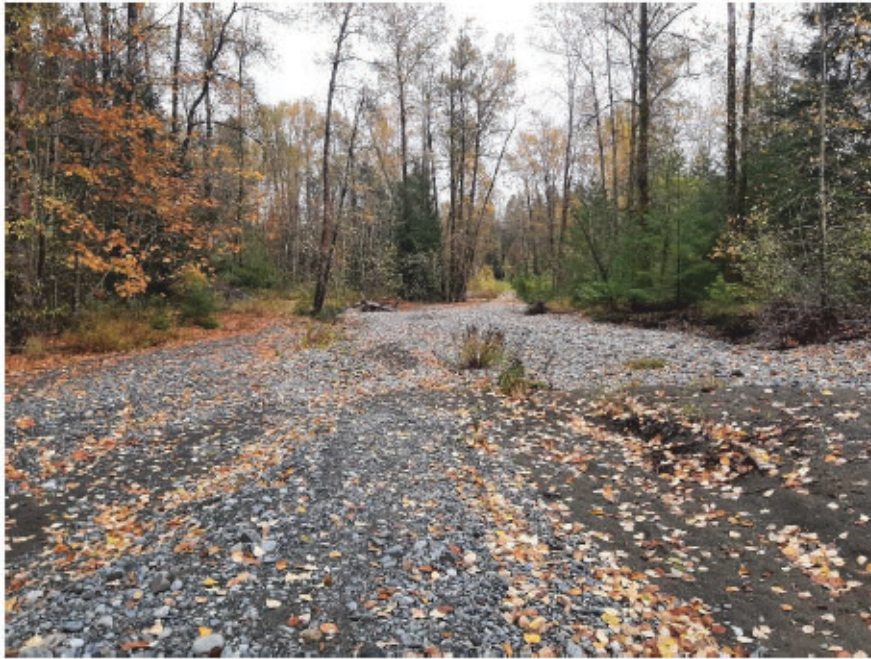
**Photo 1:** View downstream at the historic side channel at Site 1 that has been infilled with accreted sediment over time.

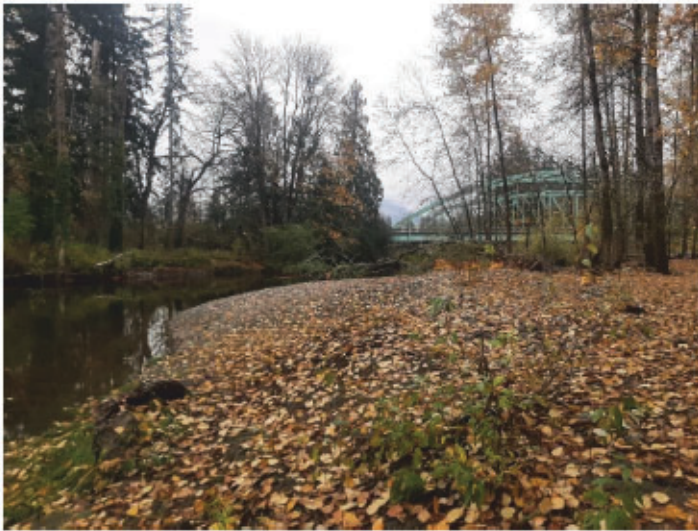
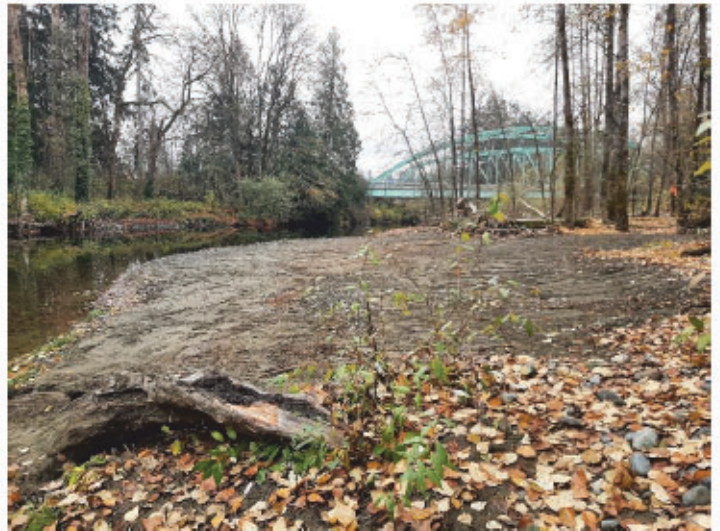
**Photos 2 and 3:** Looking upstream at the point bar of Site 1 before (left) and after (right) removal. The point bar lies at the inside of a sharp bend in the river and forces flow towards the opposite bank and causing erosion during high flows.

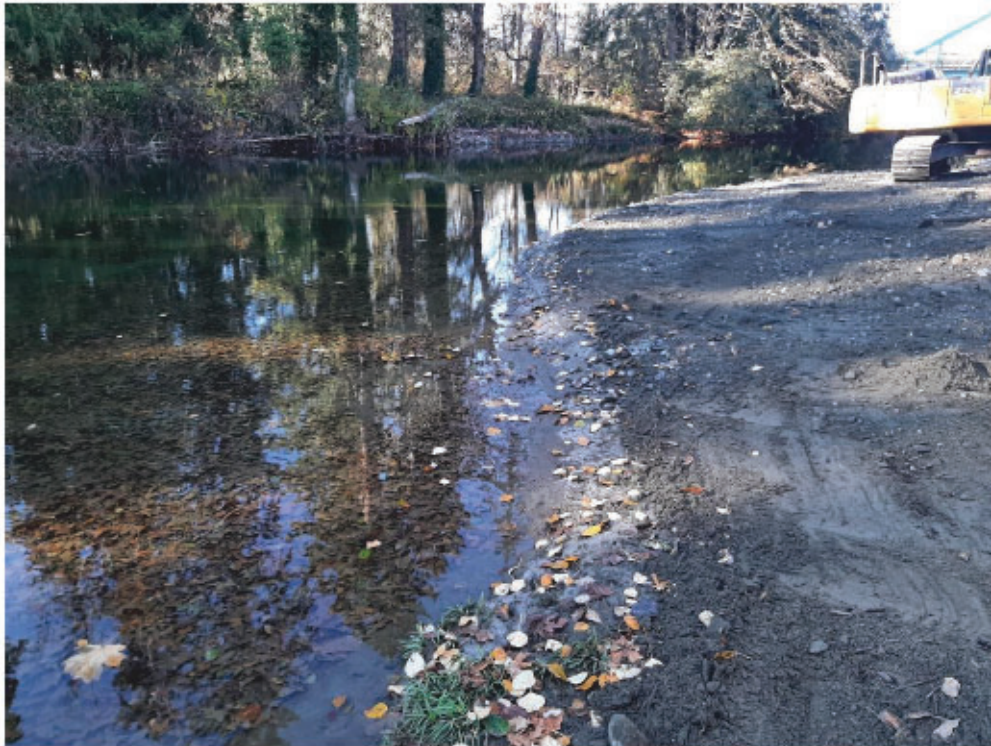
**Photo 11: Point bar after bulk excavation was complete, while shaping and compacting was ongoing. No sediments were introduced to the river, and turbidity levels remained well within acceptable ranges.**

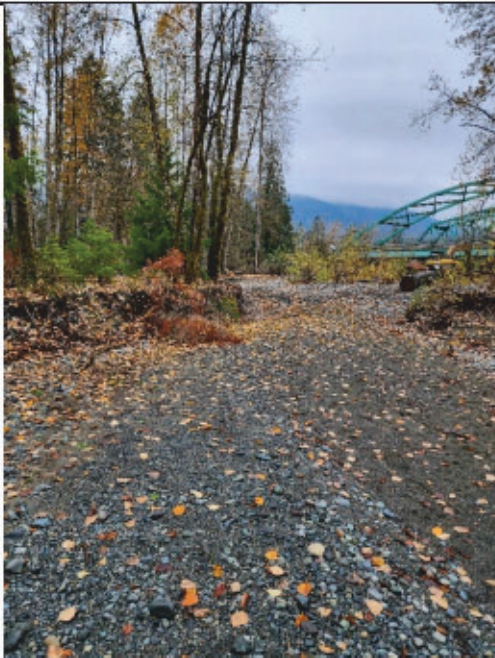
**Photo 1:** Area of concern, looking upstream, the left bank is lower in elevation than the new channel alignment. Possible over-topping point of new channel.

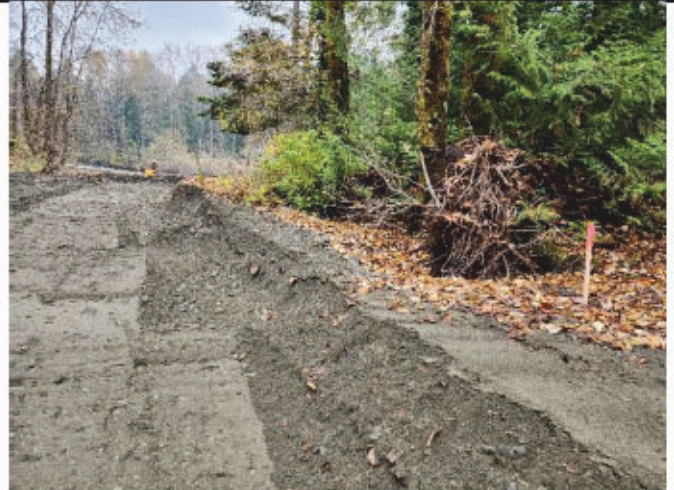
**Photo 4:** Looking downstream, right channel extents may impact tree nearest to top of bank.

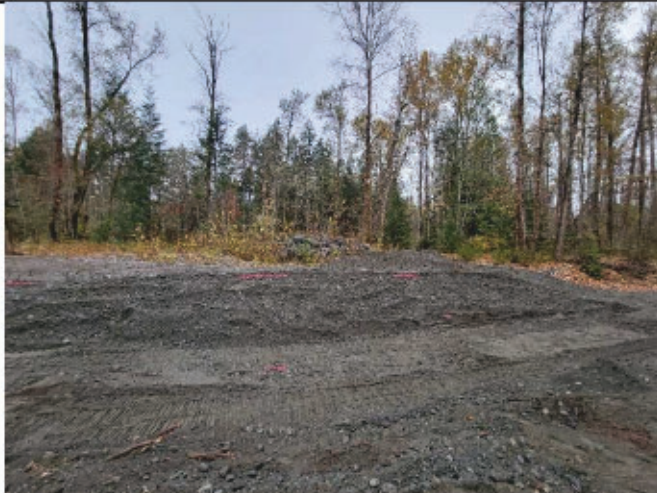
**Photo 1:** Area in front of downstream well head that will require riprap

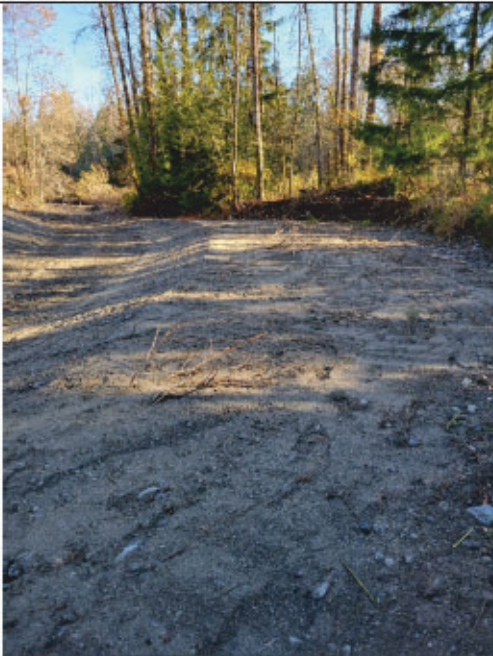
**Photo 1:** Overbank on right bank near downstream end filled to prevent fish stranding

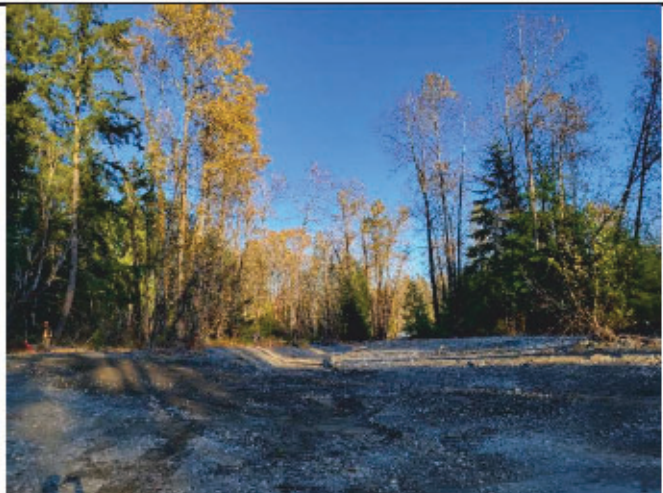
**Photo 4:** Some shaping and cleaning up still required

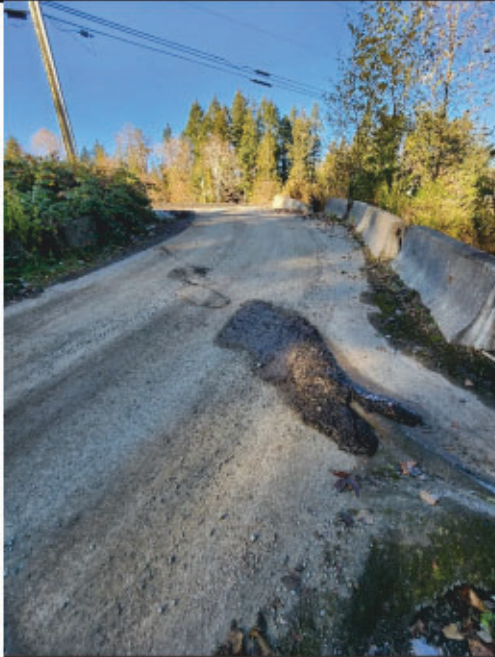
**Photo 1:** Drainage curb, destroyed by dump trucks, to be reinstated.

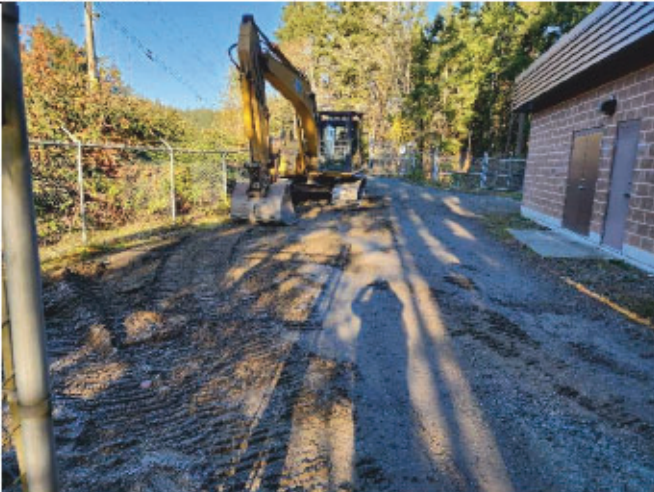
**Photo 3:** Stone Pacific to tidy pump house lot during demob.

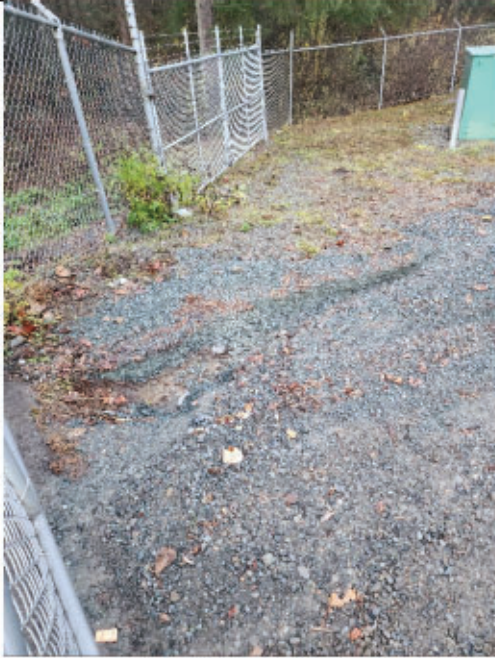
**Photo 1:** Deep scouring just below asphalt curb. Not sure if it is from a vehicle tire or water.

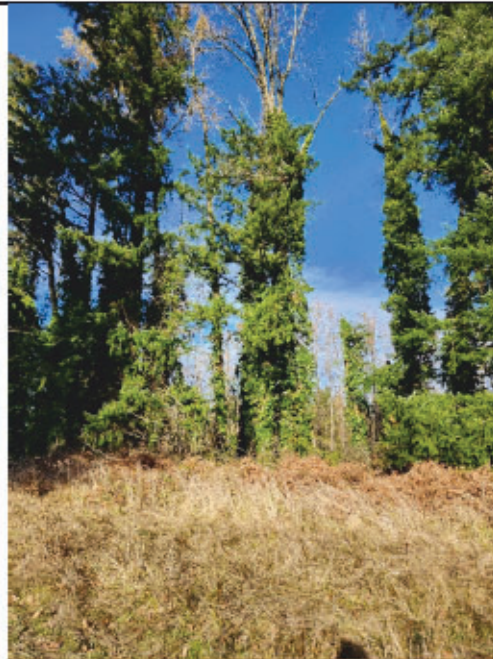
**Photo 4:** Broken tree caught in large group of cottonwoods.

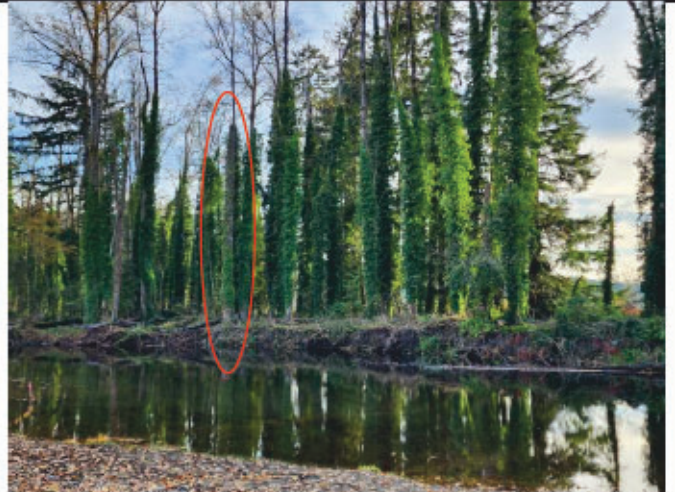
Photo 6: Previously topped marked tree that was left as is.
