# Ministry Of Environment and Climate Change Strategy

## Hatzic Emergency Work Program Pattison Creek

FEBRUARY 2024

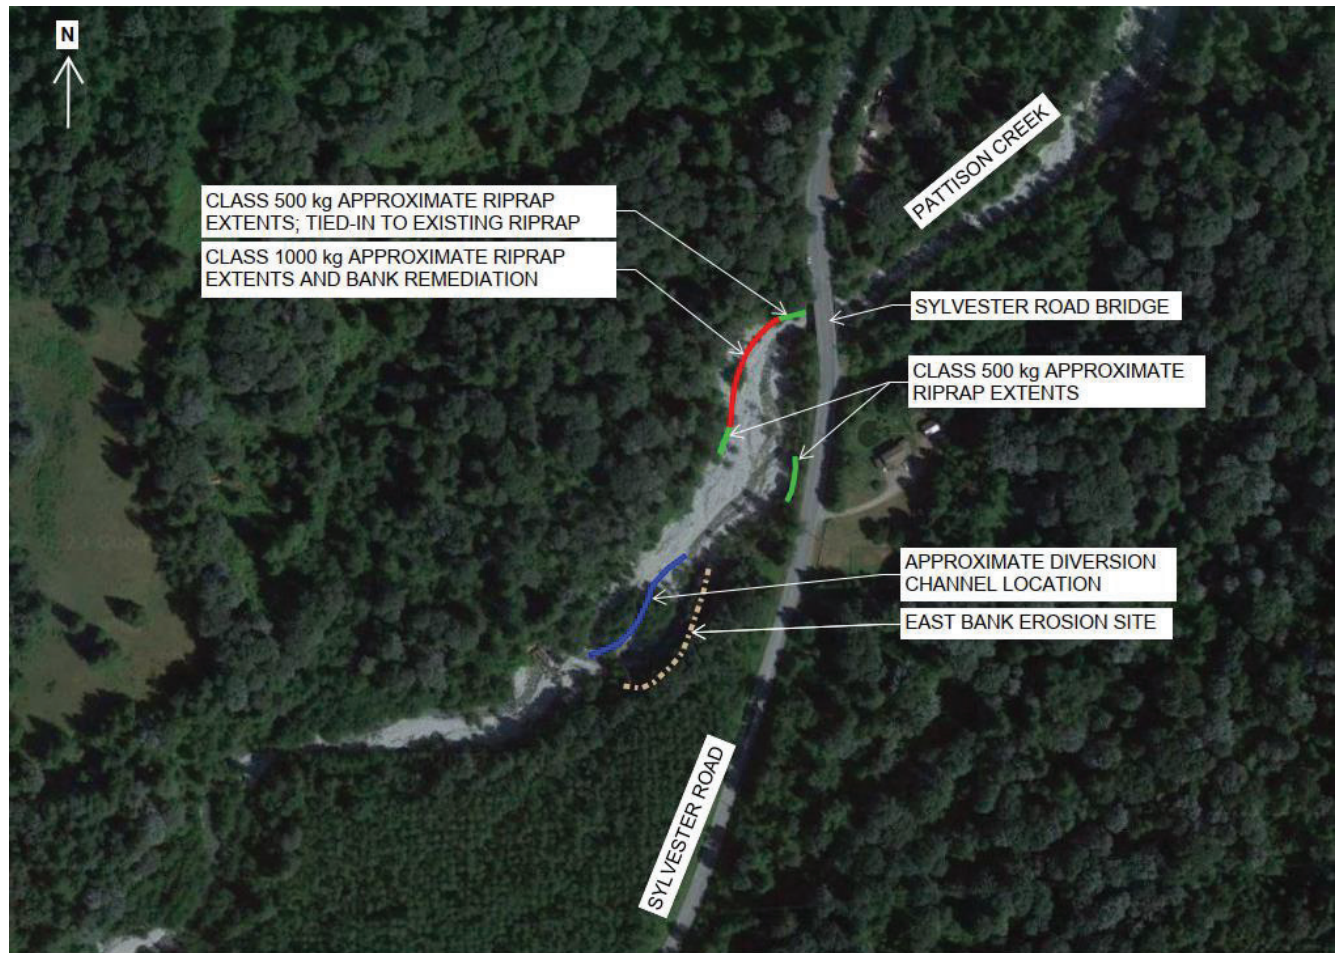
**Figure 1-1** Pattison Creek Overview

Sediment removal works were performed throughout nearly 200 metres of channel immediately downstream (south) of Pattison bridge on Sylvester Road. The upstream extent of sediment removal works terminated at the underside of the bridge; refer to **Figure 1-1** below for a site overview.

Additionally, the channel thalweg had established against the left channel bank toe, actively undermining and eroding the exposed slope face approximately 150 m. downstream of the Sylvester Road Bridge. As a result, the low-flow channel was realigned to follow the middle of the overall channel footprint (see diversion channel noted in **Figure 1-1**).

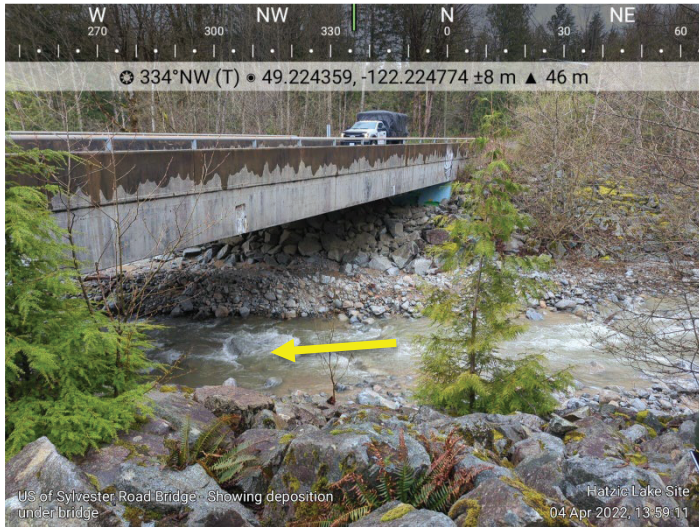
Deposition in Pattison Creek below Sylvester Road Bridge

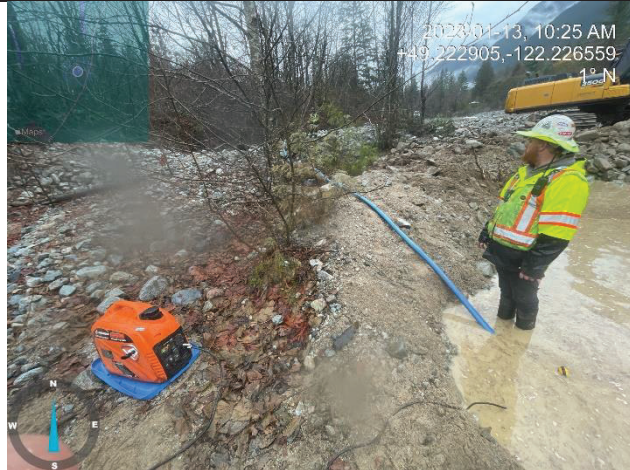
Photo 13. Turbid water was pumped to ground away from Pattison Creek for infiltration (Jan 13, 2023).

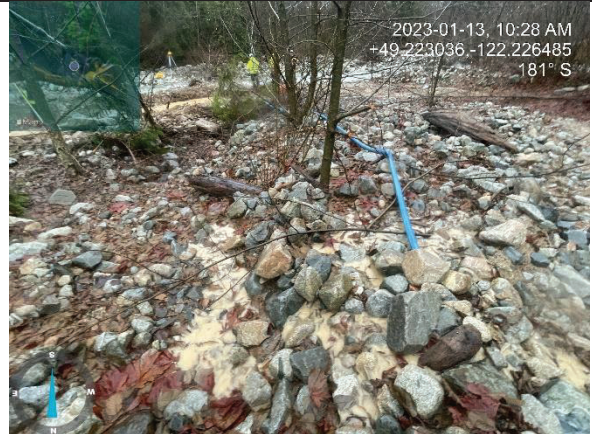
Photo 14. Outlet of the of the 2 inch hose; turbid water was pumped to ground away from Pattison Creek for infiltration (Jan. 13, 2023).

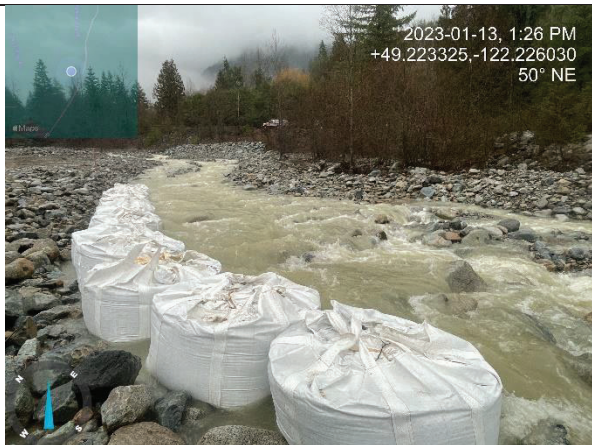
Photo 16. Elevated background turbidity at the upstream extent of the site. SEI notes that the origin of the observed turbidity was from outside of site (Jan 13, 2023).

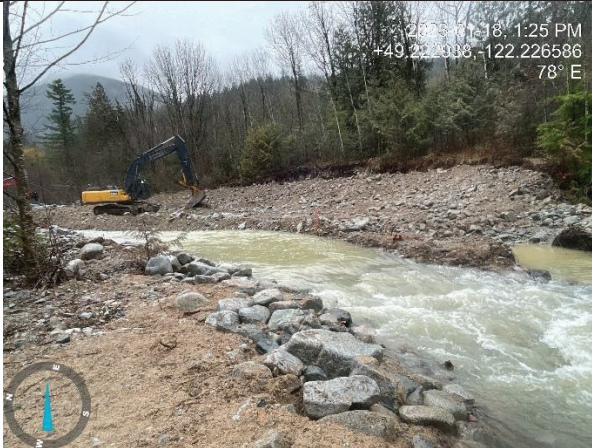
Photo 15. Grading of streambanks outside of the wetted stream perimeter and armoring with coarse material. Note that background flows were elevated, however, the EM observed the origin of the sediment to be upstream of the site (Jan. 18, 2023).

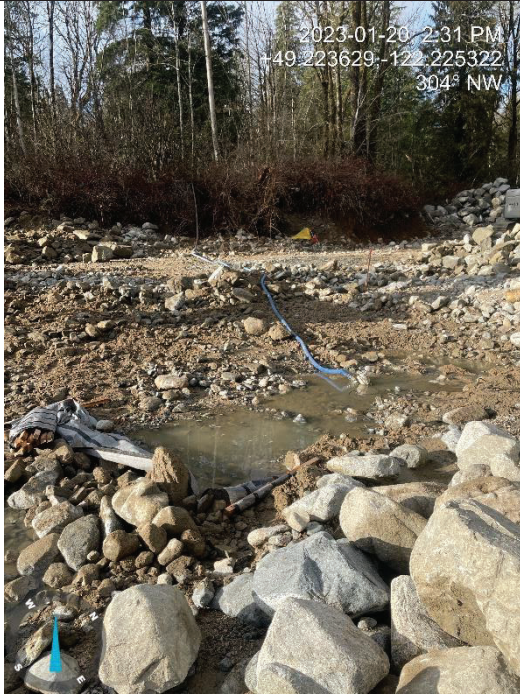
Photo 28. Set up sediment fencing to slow and settle the turbid flow (Jan 20, 2023).

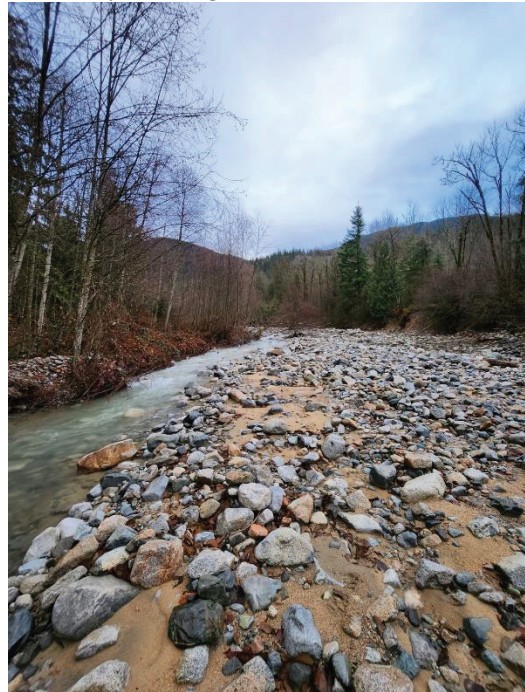
PHOTO #4 – Lower reach of Pattison Creek(North facing), noted erosion point along east bank

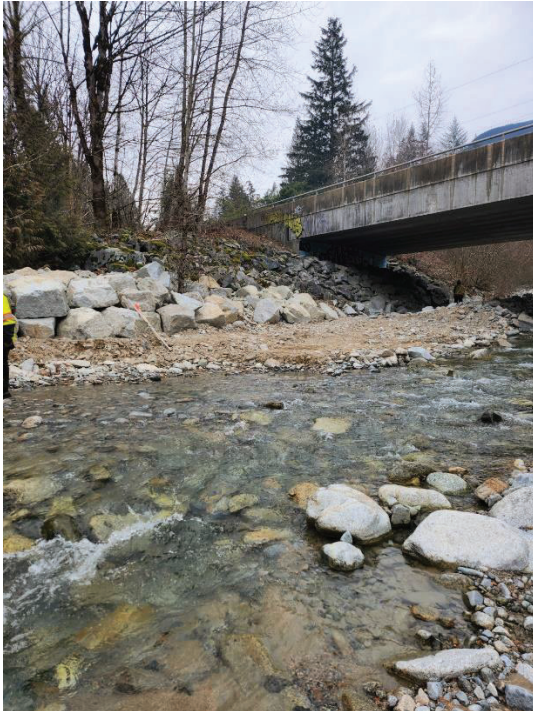
PHOTO #3 – Channel widened below bridge and rip rap armored

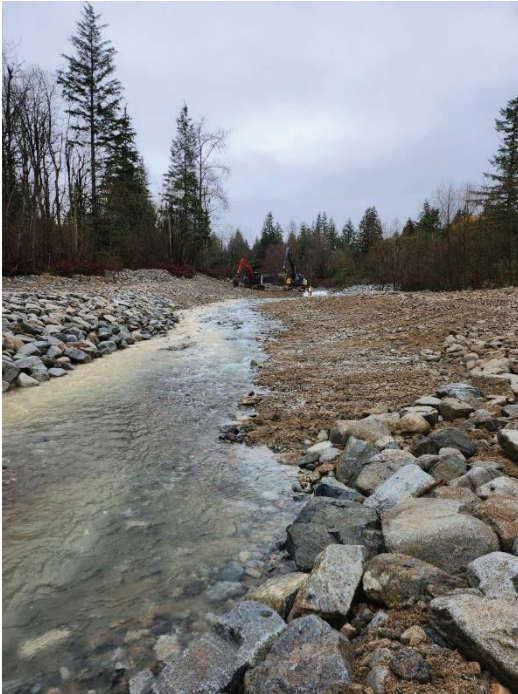
**PHOTO #3** – Pulse of turbid water during channel widening  
and sand bag removal

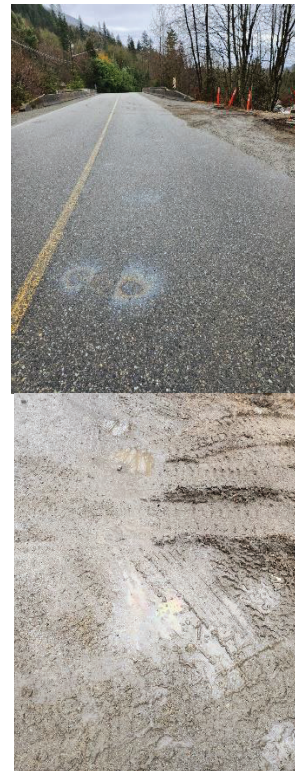
PHOTO #4 – Oil leak visible immediately after dump truck delivery
