# Ministry Of Environment and Climate Change Strategy

## Hatzic Emergency Works Program Carratt Creek

FEBRUARY 2024

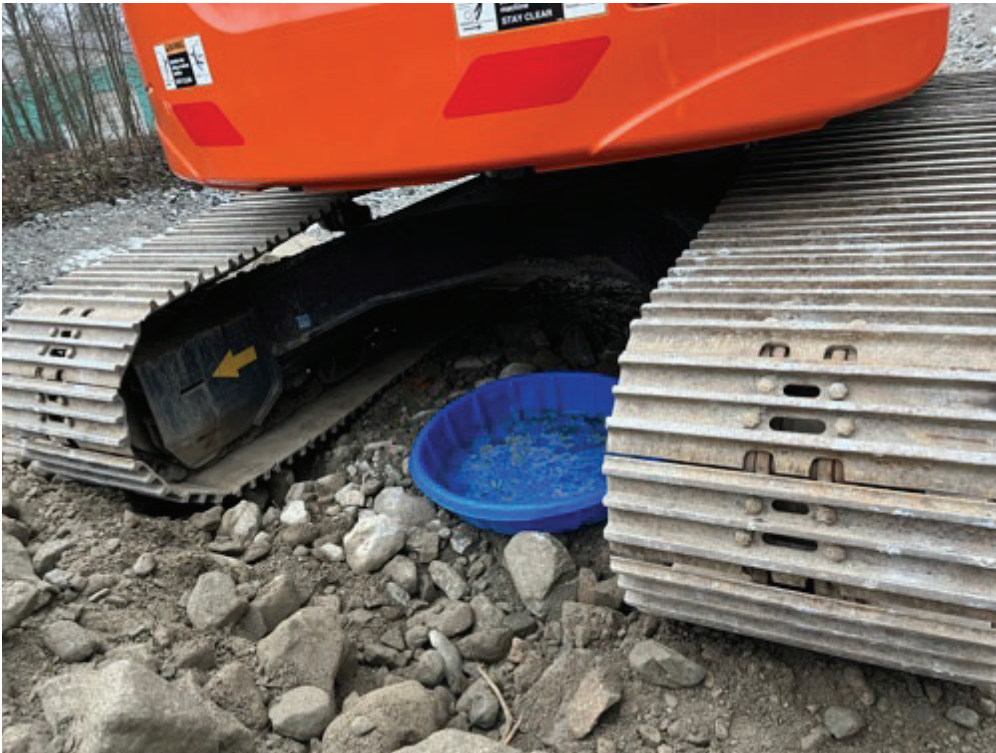
Photo 2. Drip trays underneath machinery.

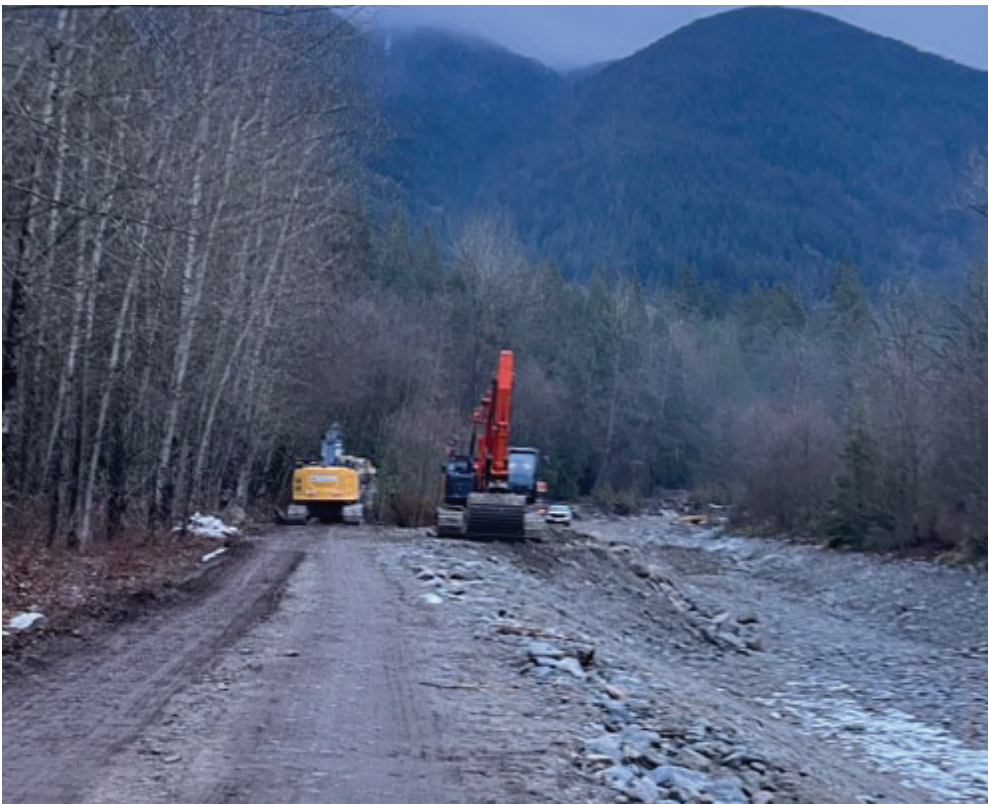
Photo 3. Machinery parked on top of bank along dike road overnight.

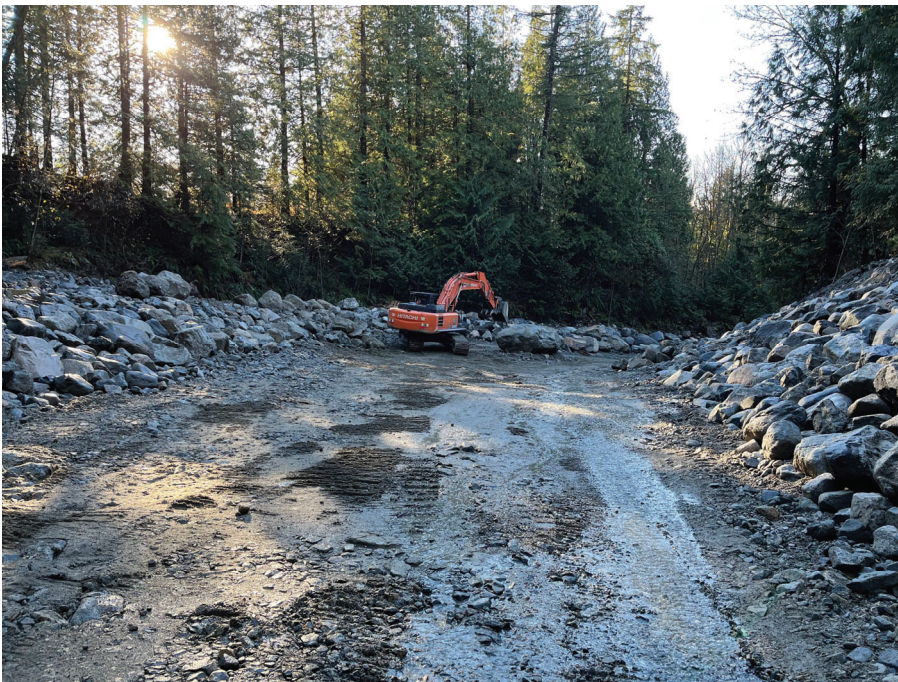
**Photo 3. Jakes armouring banks downstream of the debris jam.**

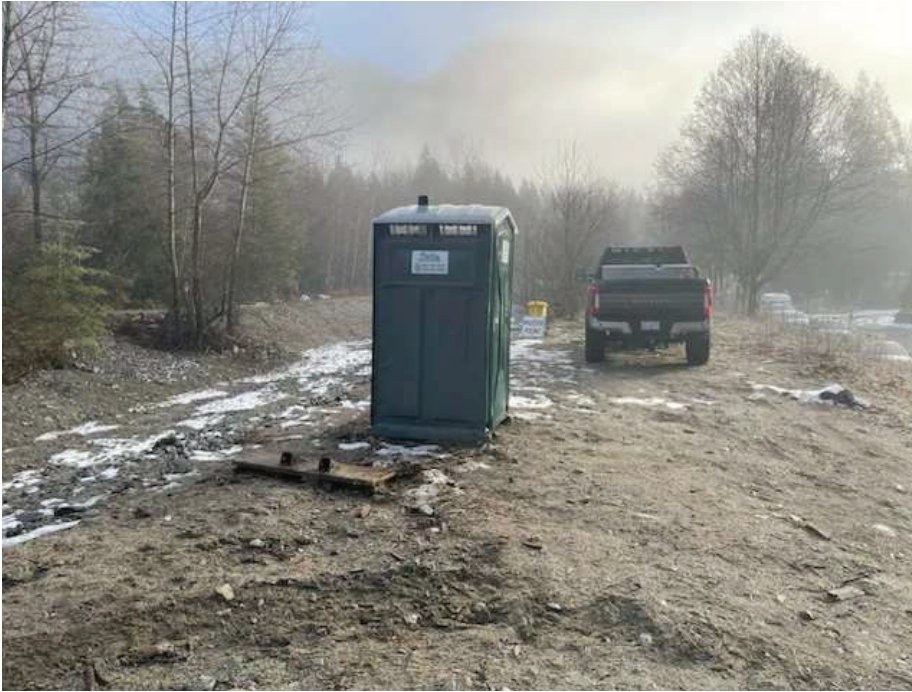
**Photo 4. Portable toilet on top of the bank.**

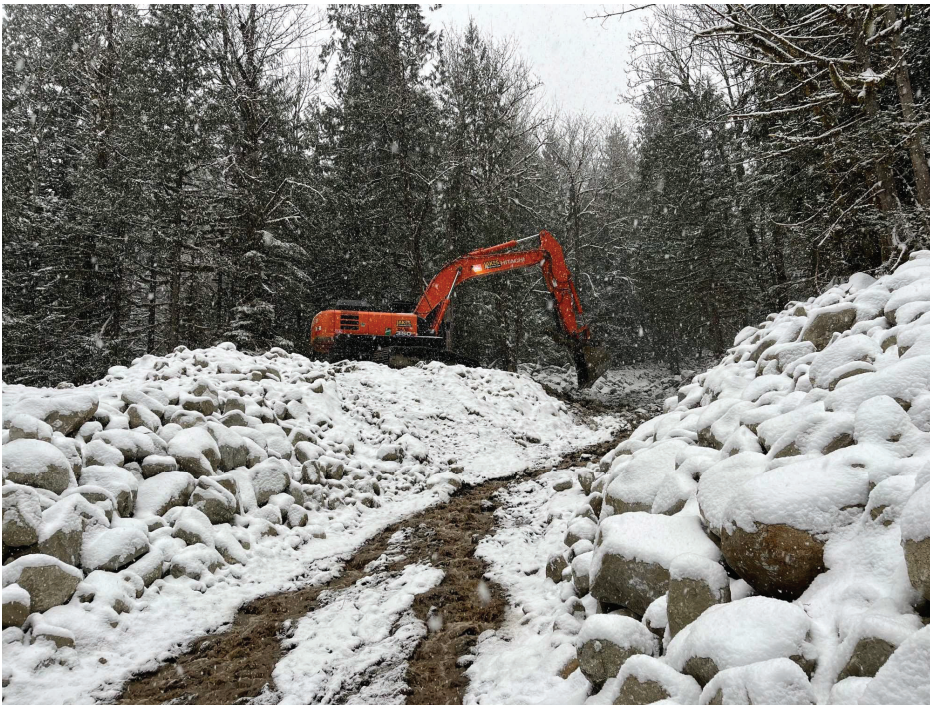
Photo 2. Jakes creating a berm across avulsion channel.

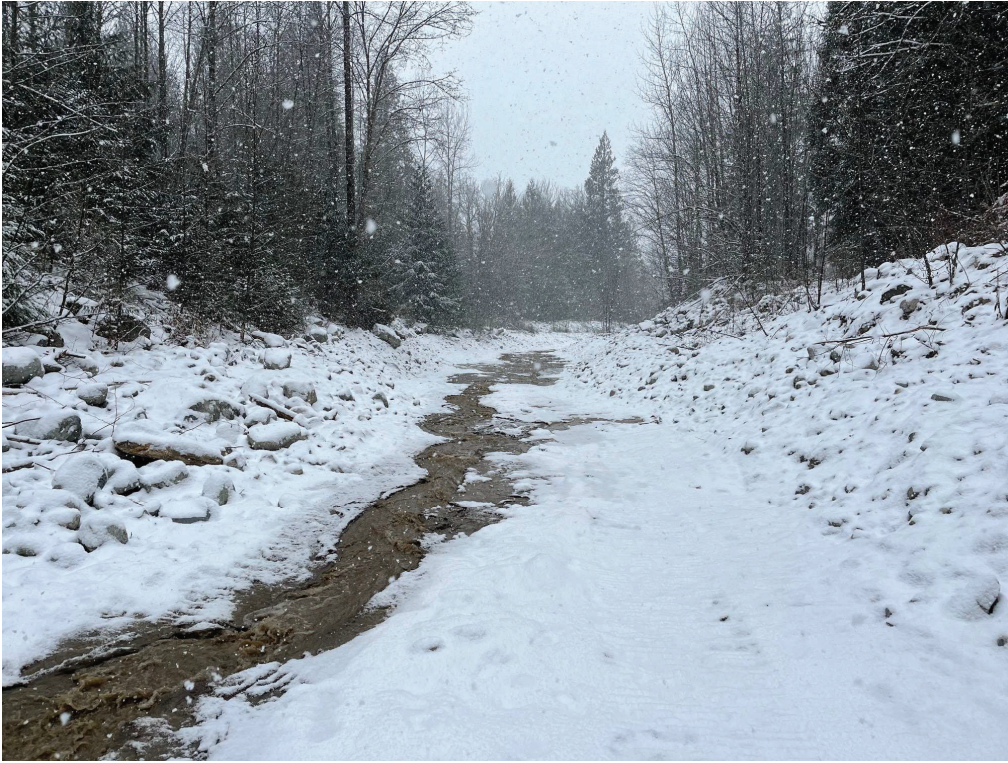
**Photo 3. Reintroduced flows within Carratt Creek.**

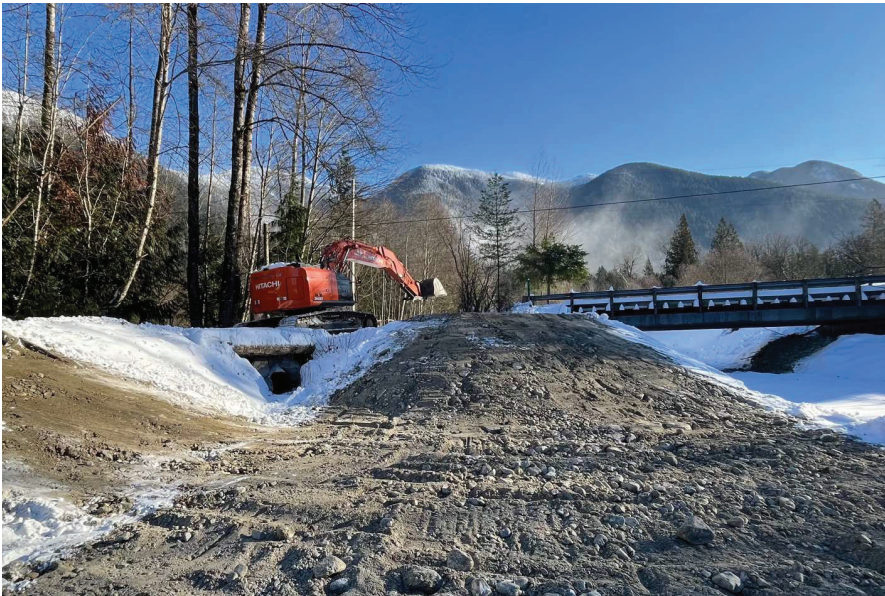
**Photo 2. Completed works downstream of bridge.**

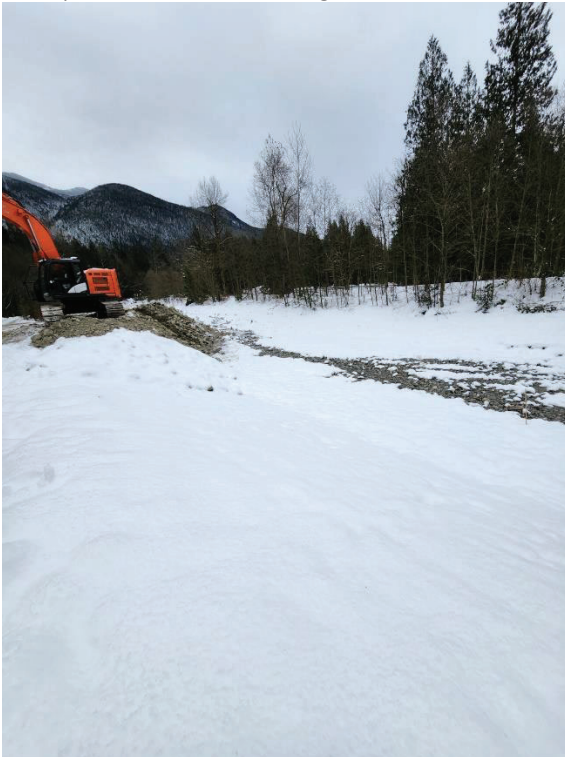
**PHOTO #3** – Creek frozen in lower reach, unwetted approx. 100m upstream of Carratt Rd Bridge

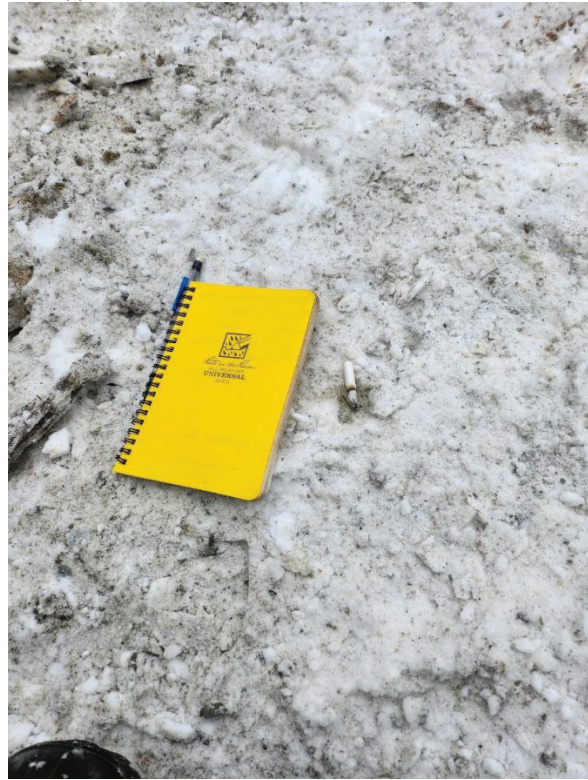
**PHOTO #4** – Cigarette butt discarded aside the access road into upper reach

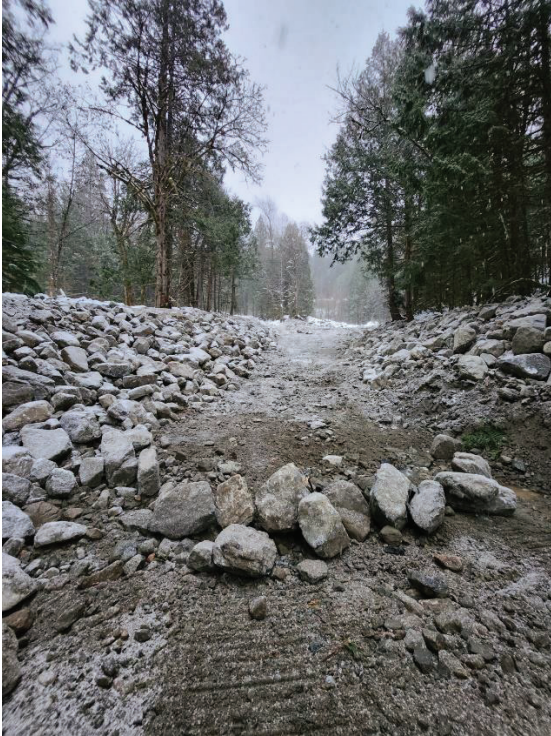
**PHOTO #1** – *Upstream facing* – loosely armored banks along upper reach & a line of small boulders

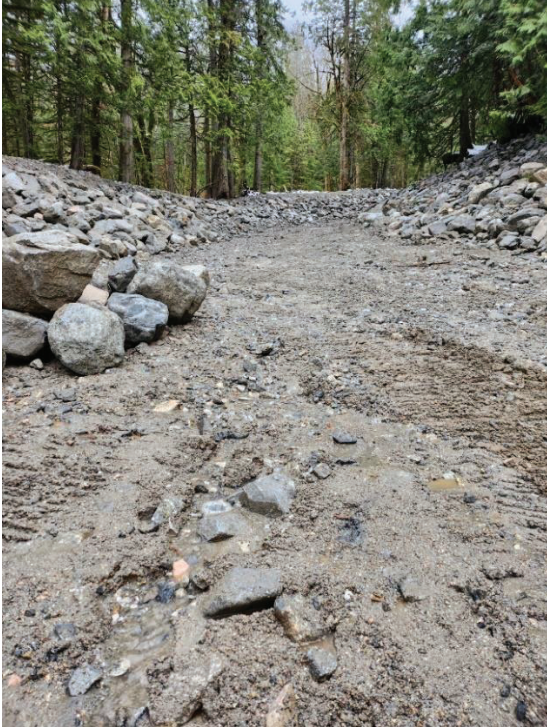
**PHOTO #1 – North facing –** loose boulder placement along upper reach; ground water exposed

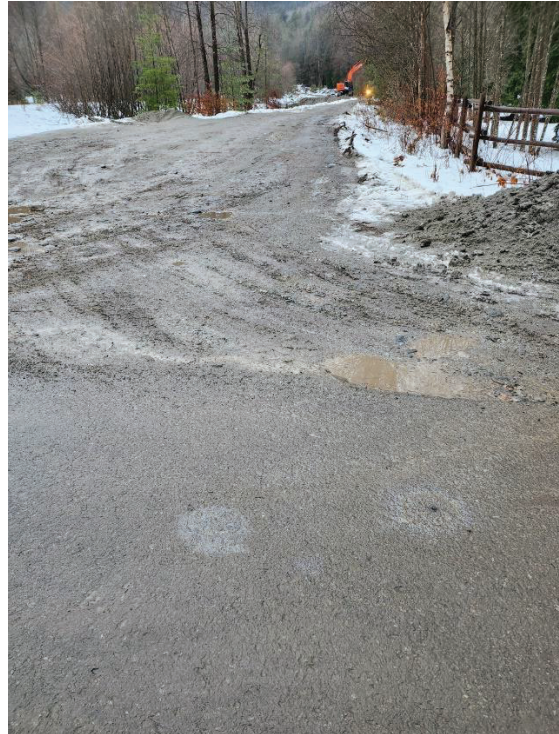
**PHOTO #4 –** Fuel sheen visible on Carratt Rd & dyke access road
