Associated  
Engineering

# Ministry of Environment and Climate Change Strategy Completion Report for Davies Creek

FEBRUARY 2024

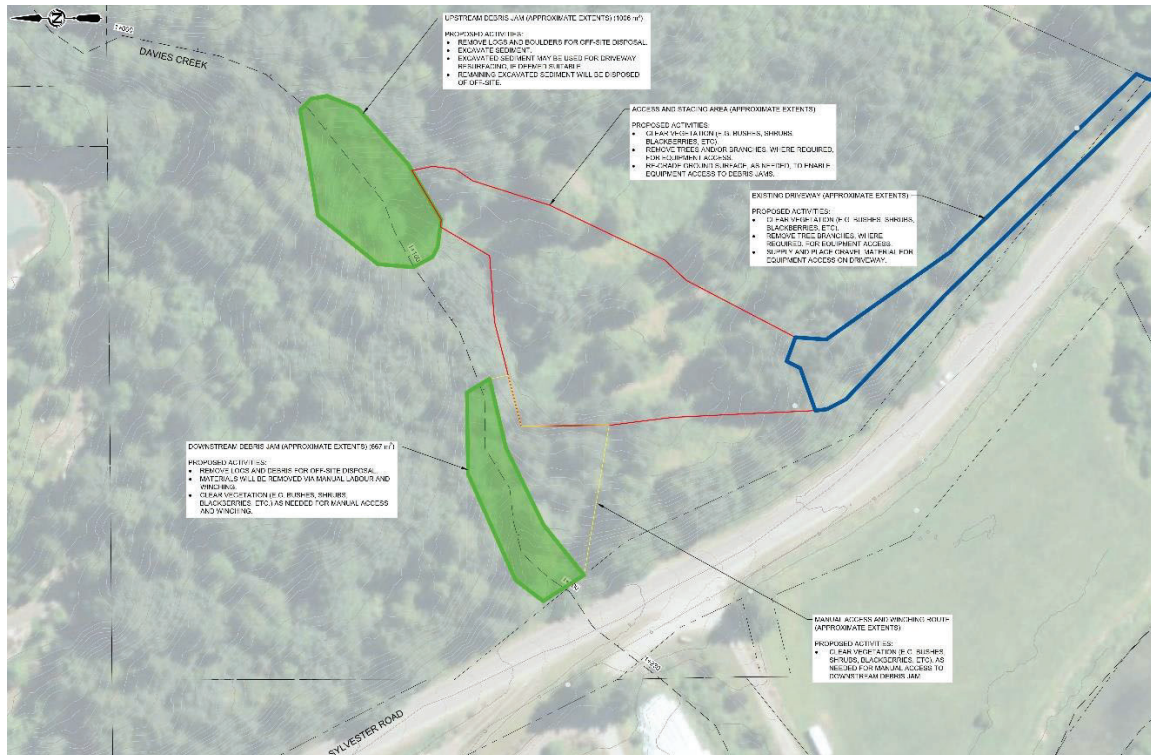
### Figure 1-1 Davies Creek Overview

Sediment removal works were performed throughout nearly 200 metres of channel immediately downstream (south) of Pattison bridge on Sylvester Road. The upstream extent of sediment removal works terminated at the underside of the bridge; refer to **Figure 1-1** below for a site overview.

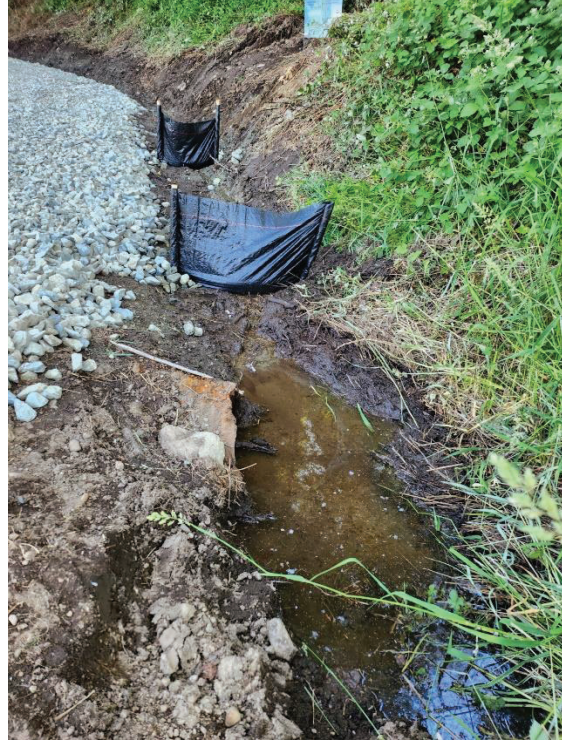
Silt fences functioning well, turbidity settling out

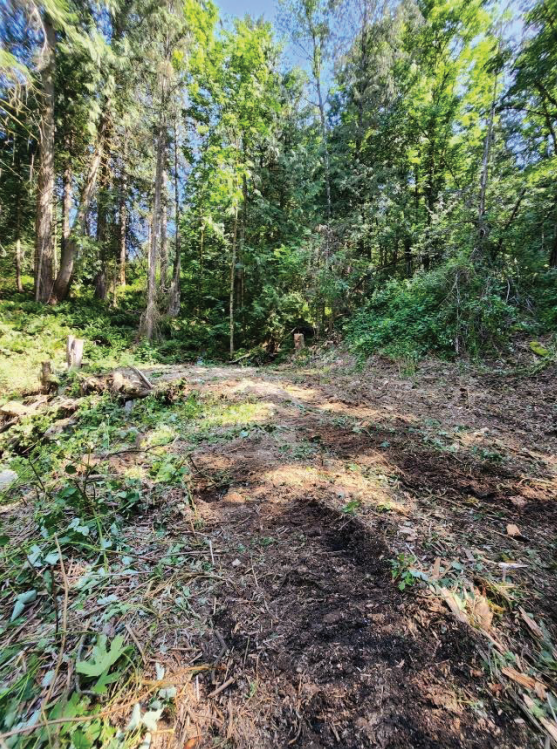
Access cleared to sediment deposit at creek

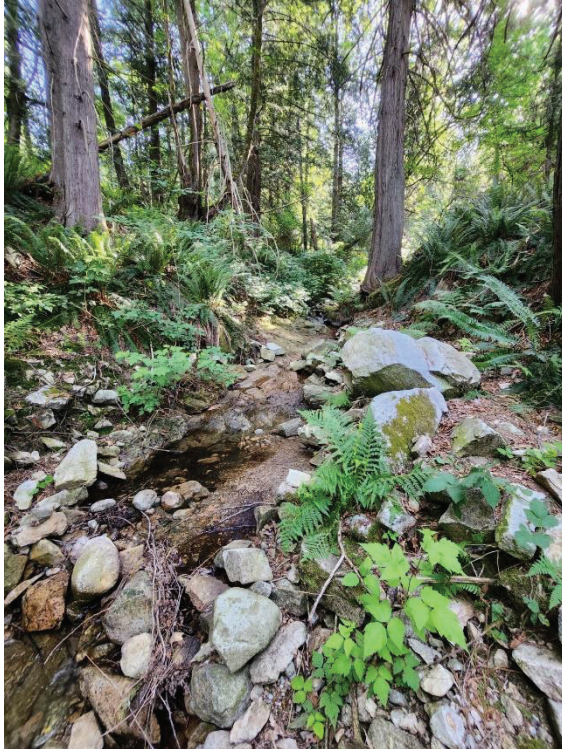
Creek below work activity, clear of turbidity

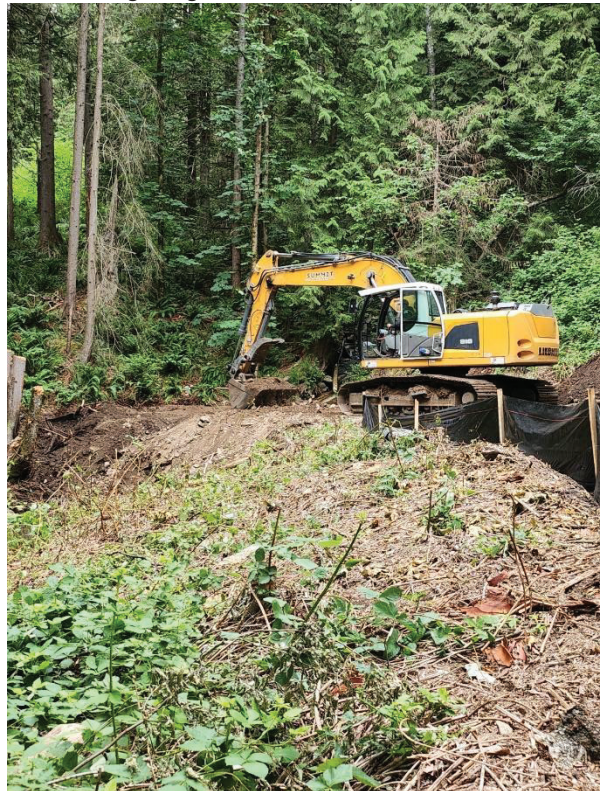
Beginning of sediment deposit excavation

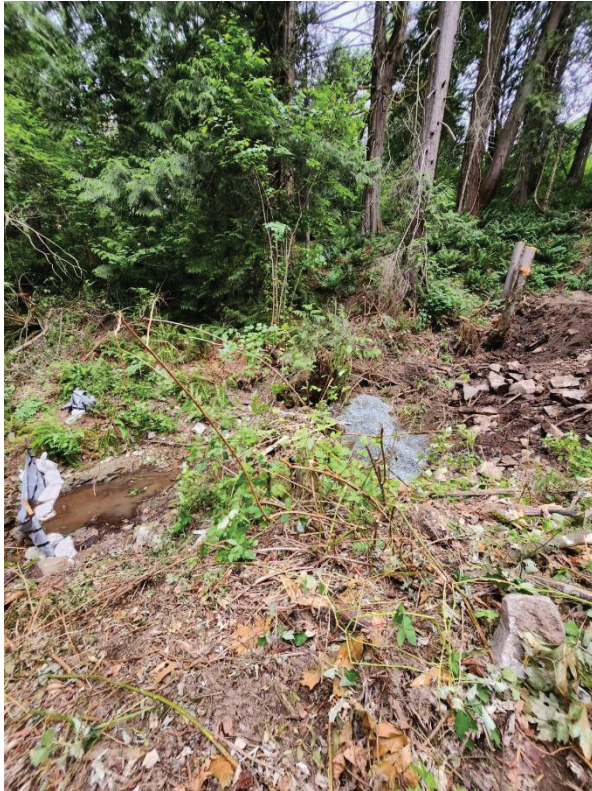
Visible pulse of turbid water downstream from excavation

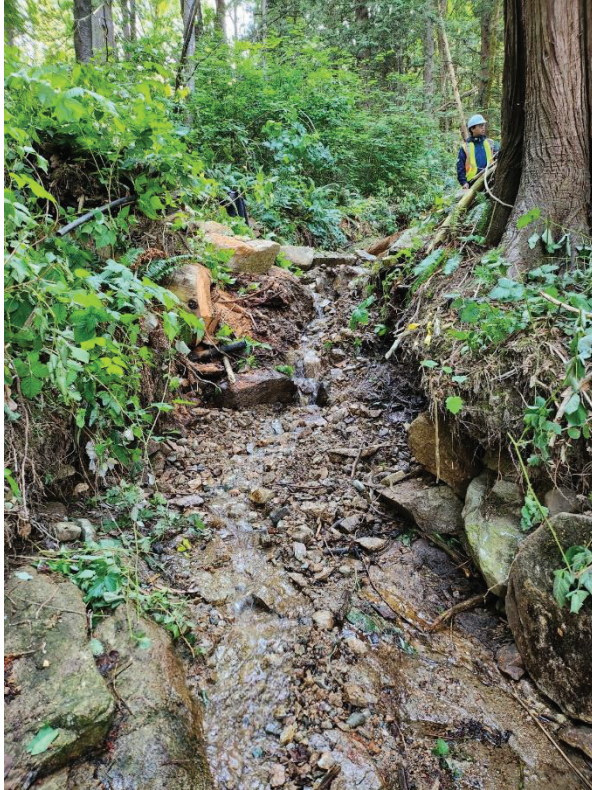
Small sediment deposit downstream(Facing upstream)

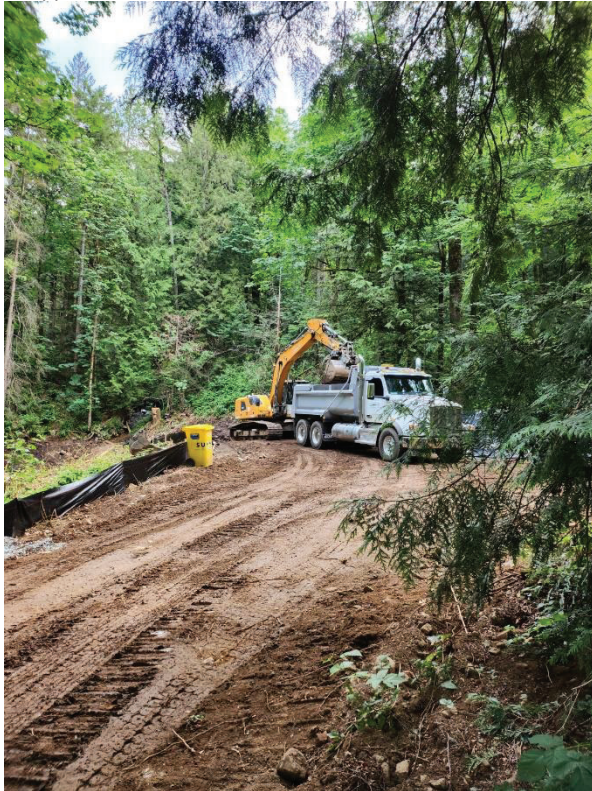
Upper reach stream sediment excavated and loaded out

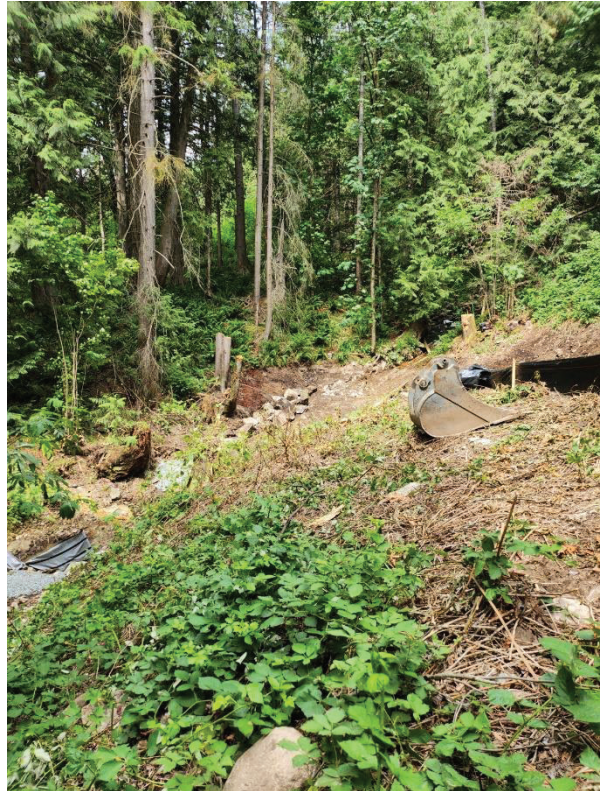
Boulder placement along North edge of bank

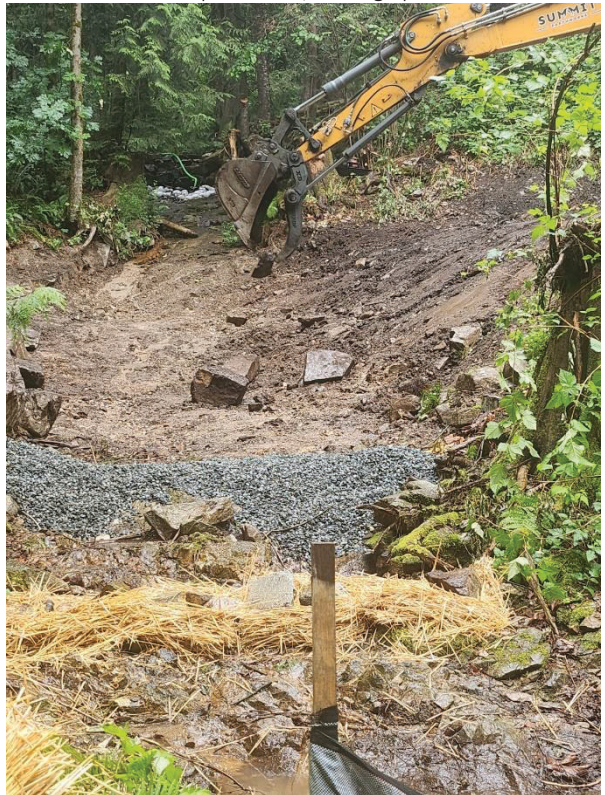
Boulder placement, looking up stream

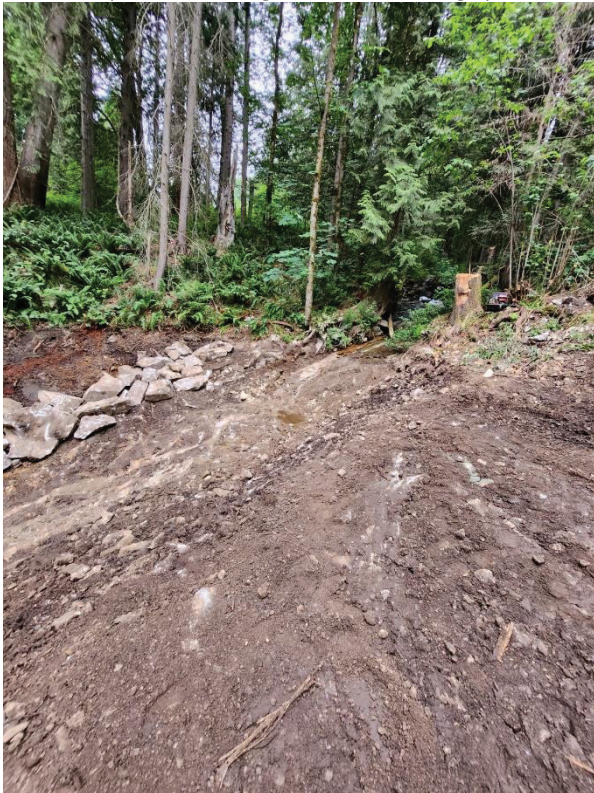
Boulder placement along north bank, looking up-stream

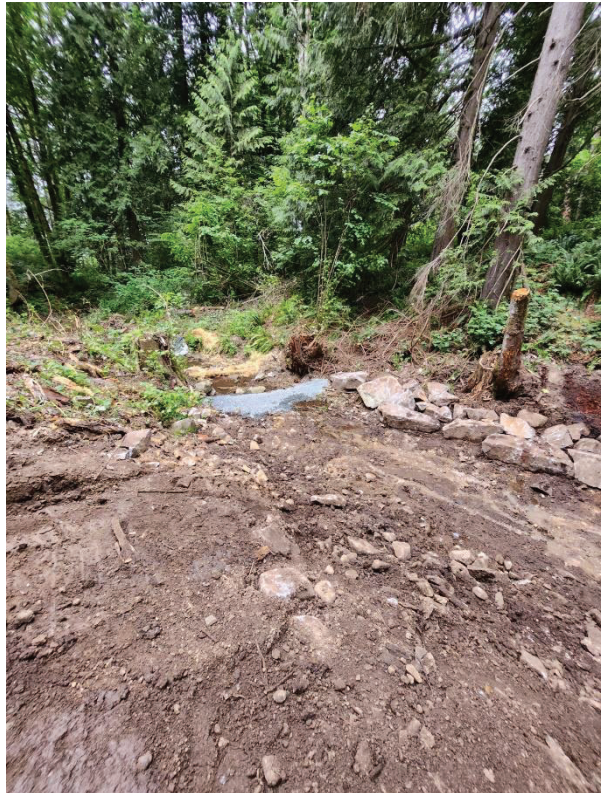
Boulder placement along north bank, downstream

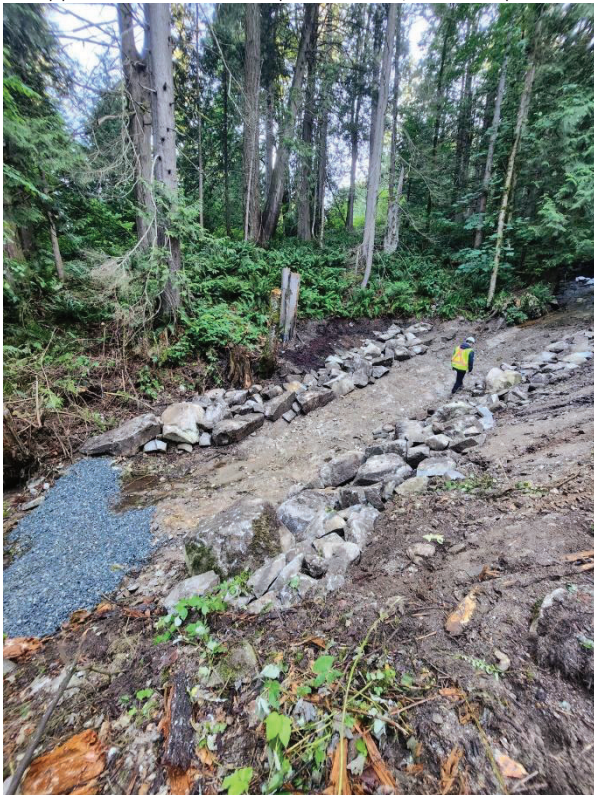
Upper reach sediment deposit cleared; boulders placed

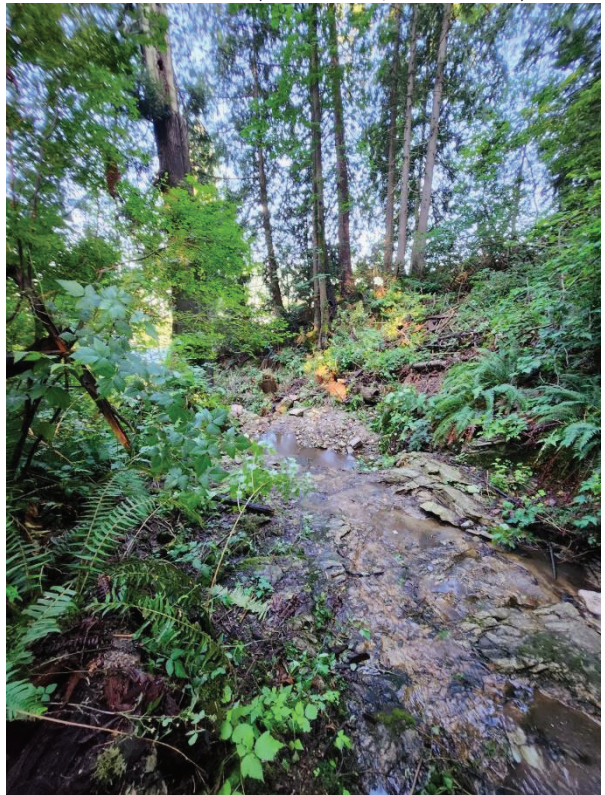
Lower reach sediment deposit cleared; free of woody debris

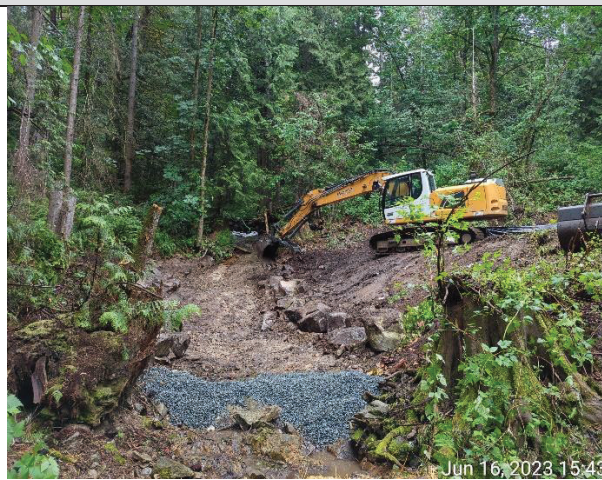
Photo 2. View of armoring of the southern bank of Davies Creek. (Jun. 16, 2023).

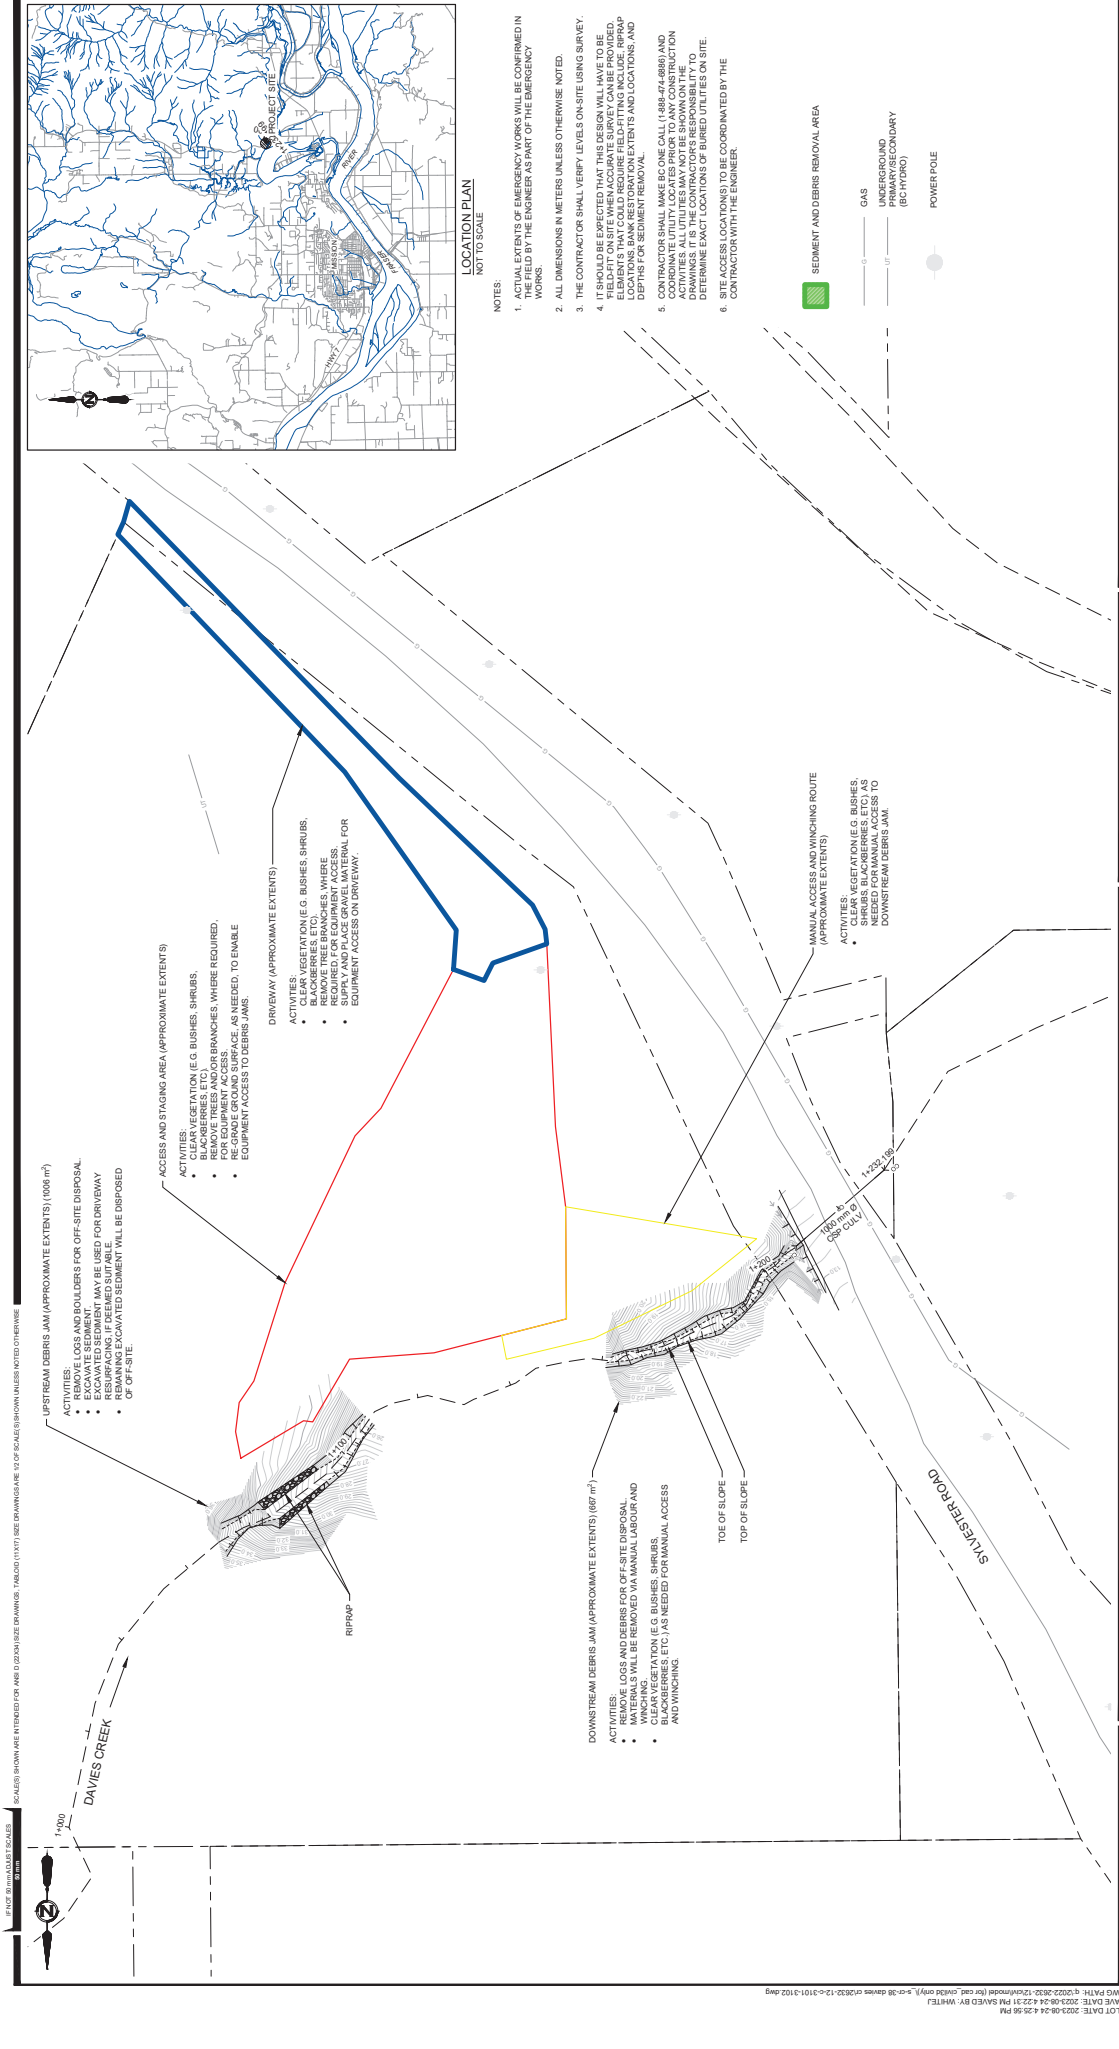
| DRAWING | REVISION | SHEET |
|---|---|---|
| PLAN<br>EMERGENCY WORKS | 2 | 3 |

IF NOT DIMENSIONAL SCALES  
0 1000  
1:1000  
DAVIES CREEK  
STAVERT ROAD  
PROJECT SITE  
UPSTREAM DEBRIS JAM (APPROXIMATE EXTENTS) (1000 m²)  
DOWNSTREAM DEBRIS JAM (APPROXIMATE EXTENTS) (600 m²)  
ACCESS AND STAGING AREA (APPROXIMATE EXTENTS)  
DAVIES CREEK  
STAVERT ROAD  
PROJECT SITE

- ACTIVITIES:
- LOGS AND BOLLERS FOR OFF-SITE DISPOSAL
  - EXCAVATE SEDIMENT
  - EXCAVATE SEDIMENT
  - REMAINING EXCAVATED SEDIMENT WILL BE DISPOSED OF OFF-SITE

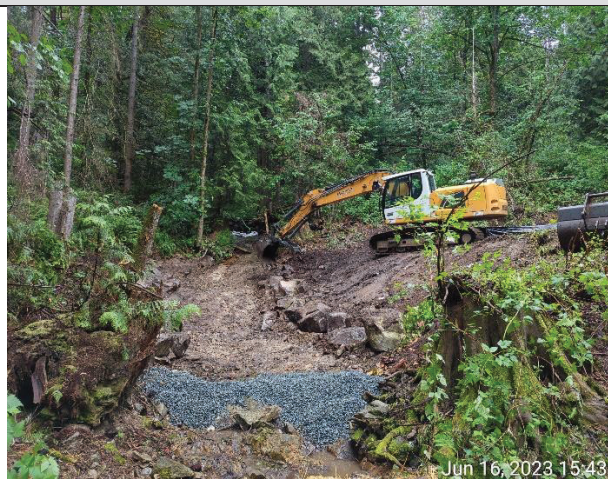
Photo 2. View of armoring of the southern bank of Davies Creek. (Jun. 16, 2023).
