# Ministry of Environment and Climate Change Strategy

## Hatzic Emergency Works Program Eng Creek and McNab Creek

## Post Construction Report

APRIL 2024

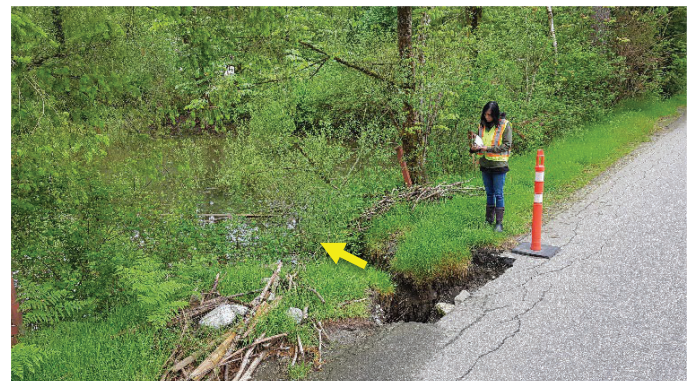
Erosion at Sylvester Road and Hartley Road intersection (west  
shoulder)  
Looking Northeast

1. Repair the shoulders of Hartley Road approximately 100 m west of the Hartley Road bridge. Determine presence of a culvert at this location. If culvert is found, restore the culvert; and
2. Repair the west shoulder of Sylvester Road at the intersection of Sylvester Road and Hartley Road.

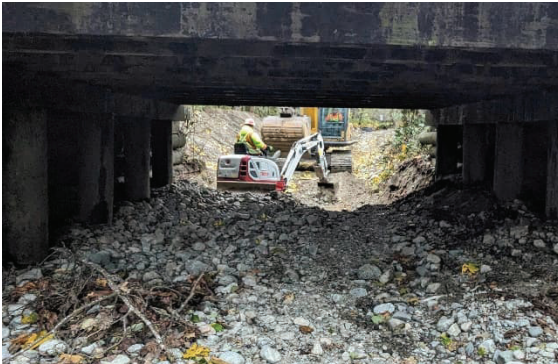
Figure - 1  
Facing E – Placing rip-rap underneath the  
Sylvester road bridge.

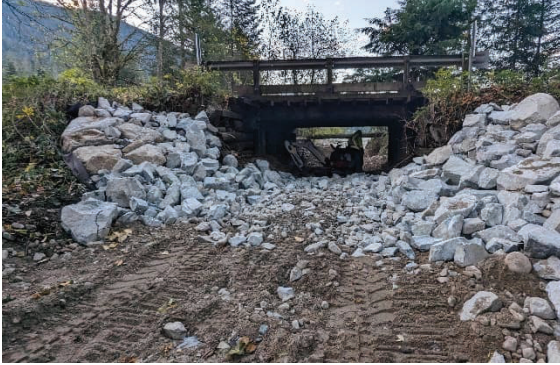
Figure - 1  
Facing S – Finished rip-rap at the Hartley Rd  
bridge.

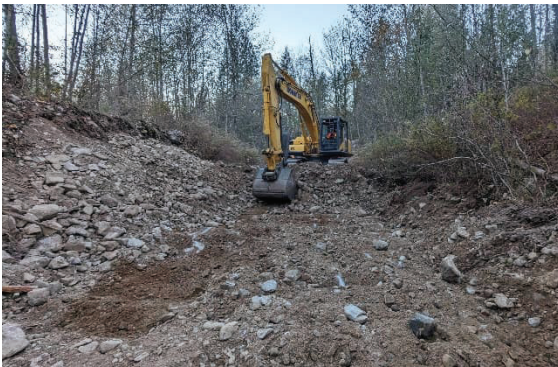
Figure - 1  
Facing N – Excavating sediment near station 210.

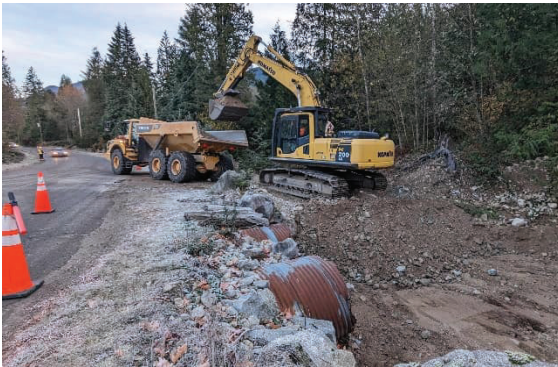
Figure - 1  
Facing N – Removing the last of the sediment  
from McNab creek.

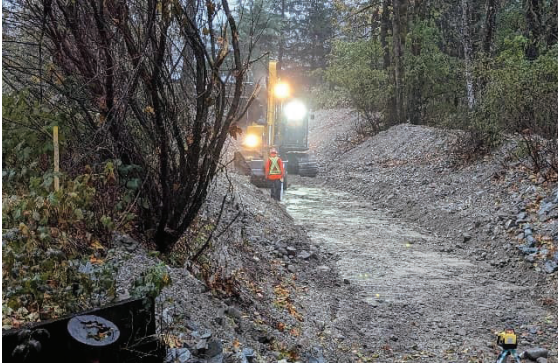
Figure - 1  
Facing S – Removing excess sediment from  
Eng creek.

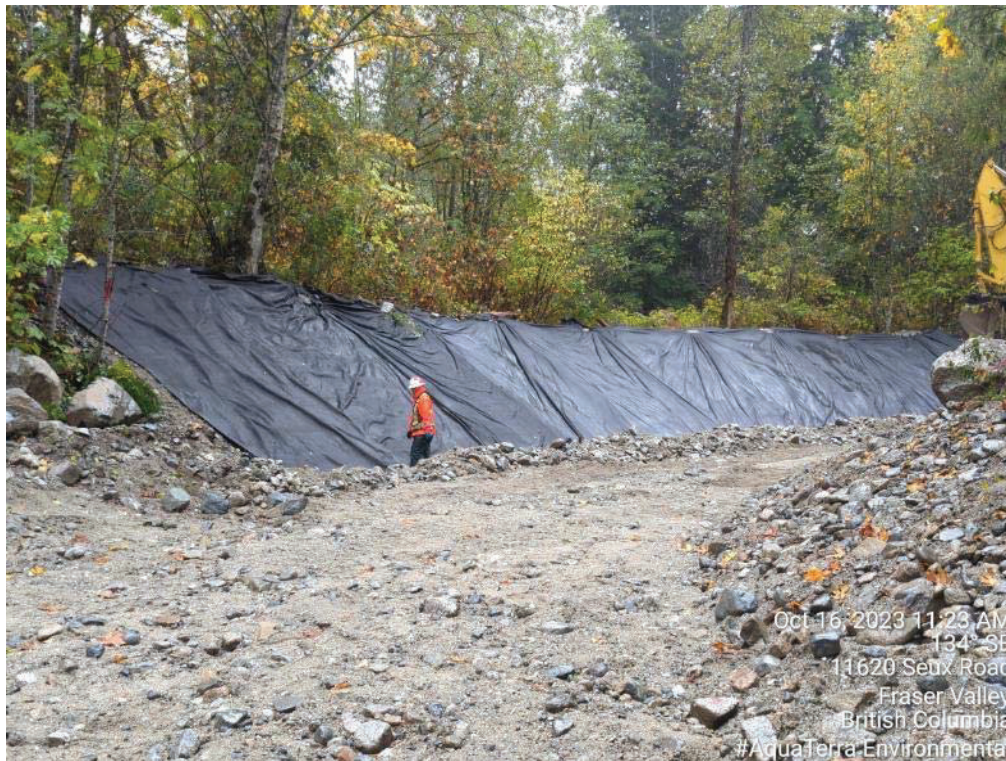
**Photo 3:** Textile fabric covering exposed bank slope.

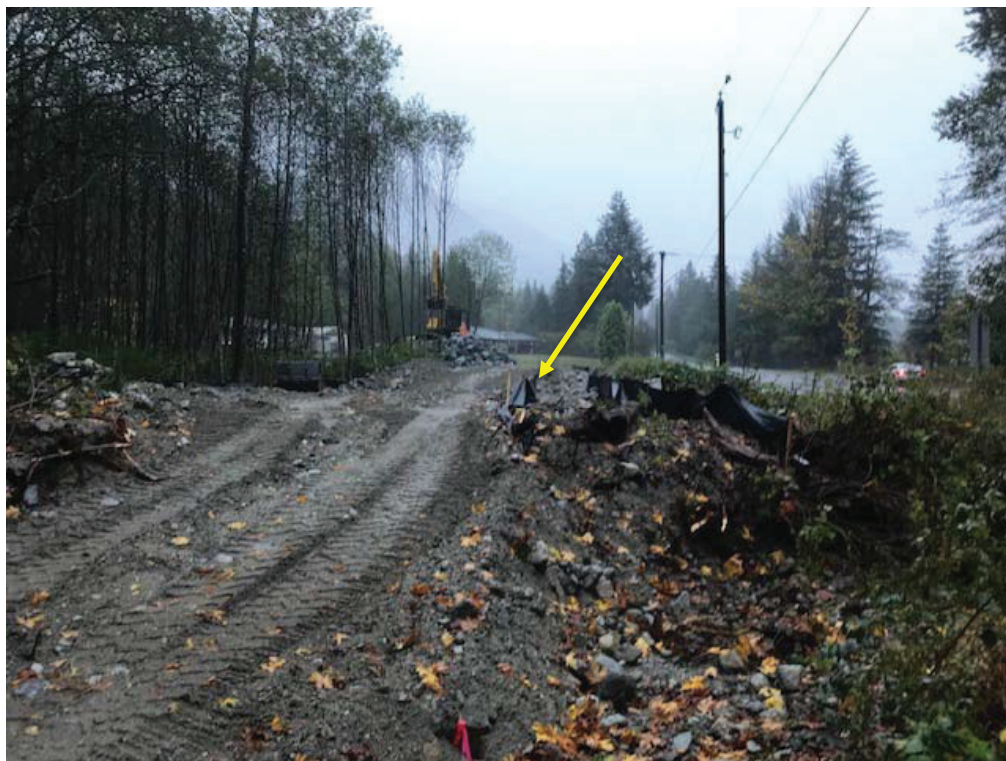
**Photo 3:** Silt fencing requiring repair.

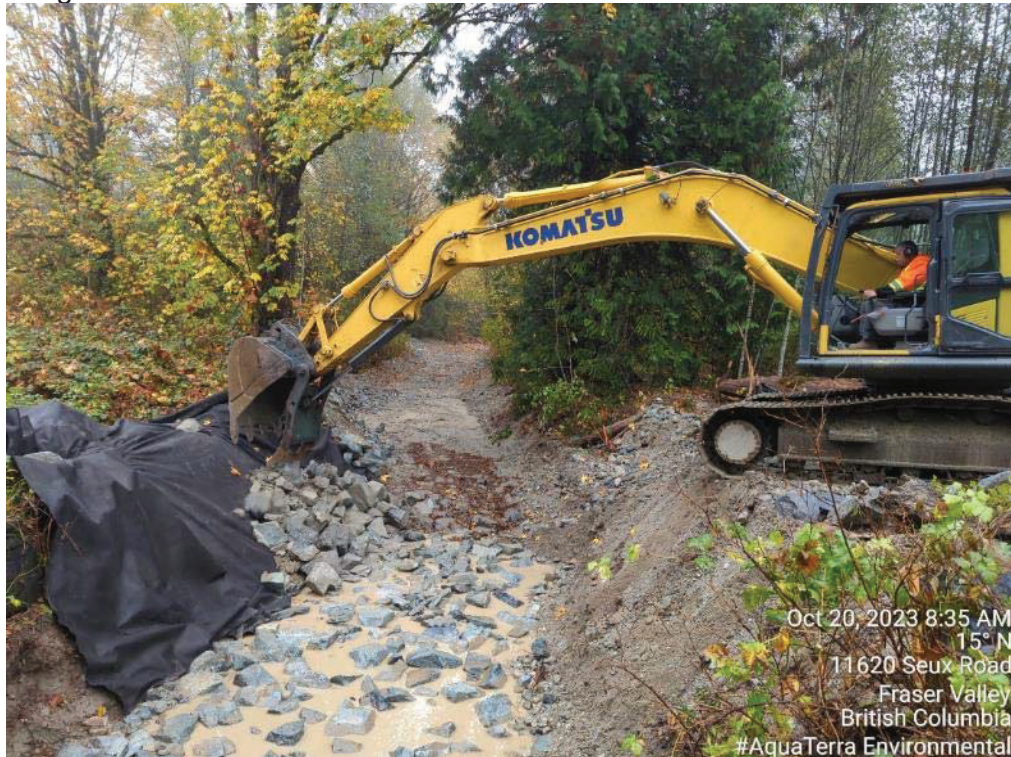
**Photo 5:** Riprap covering geotextile material with large pool of standing water observed in the foreground.

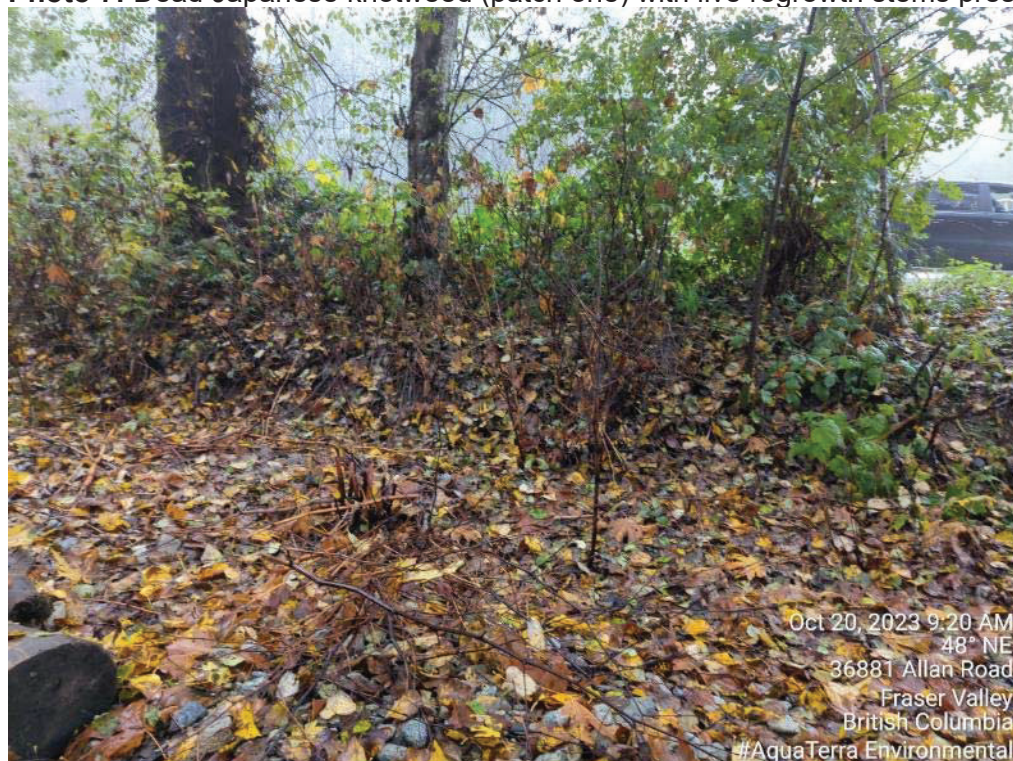
**Photo 7:** Dead Japanese knotweed (patch one) with live regrowth stems present.

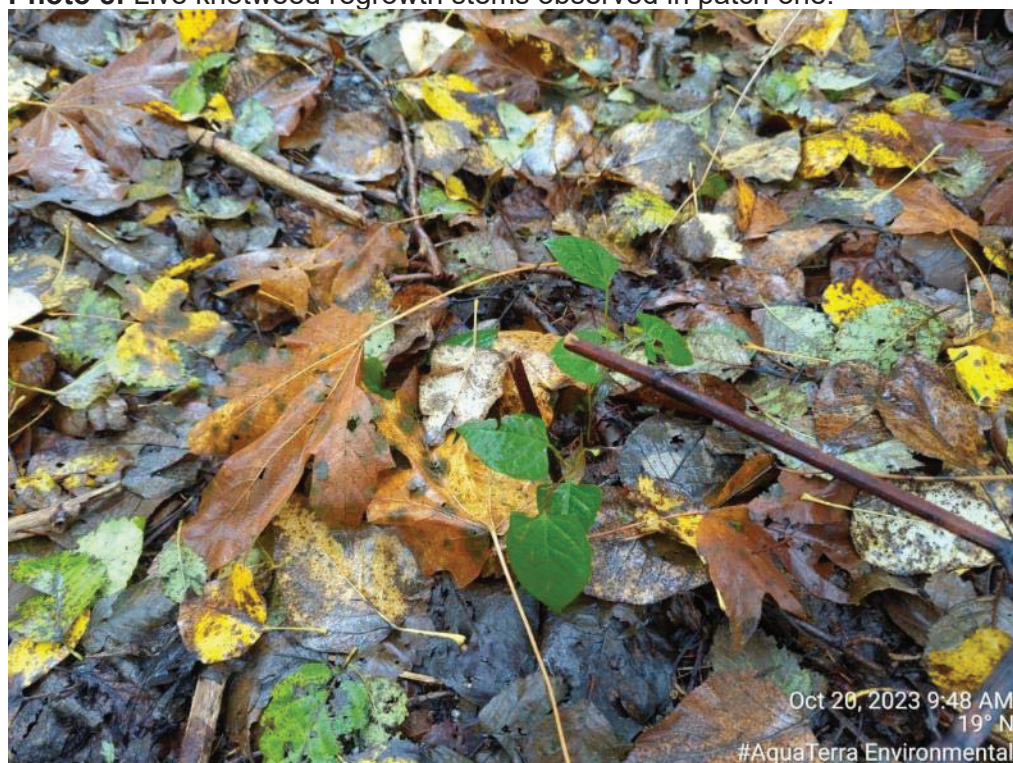
**Photo 8:** Live knotweed regrowth stems observed in patch one.

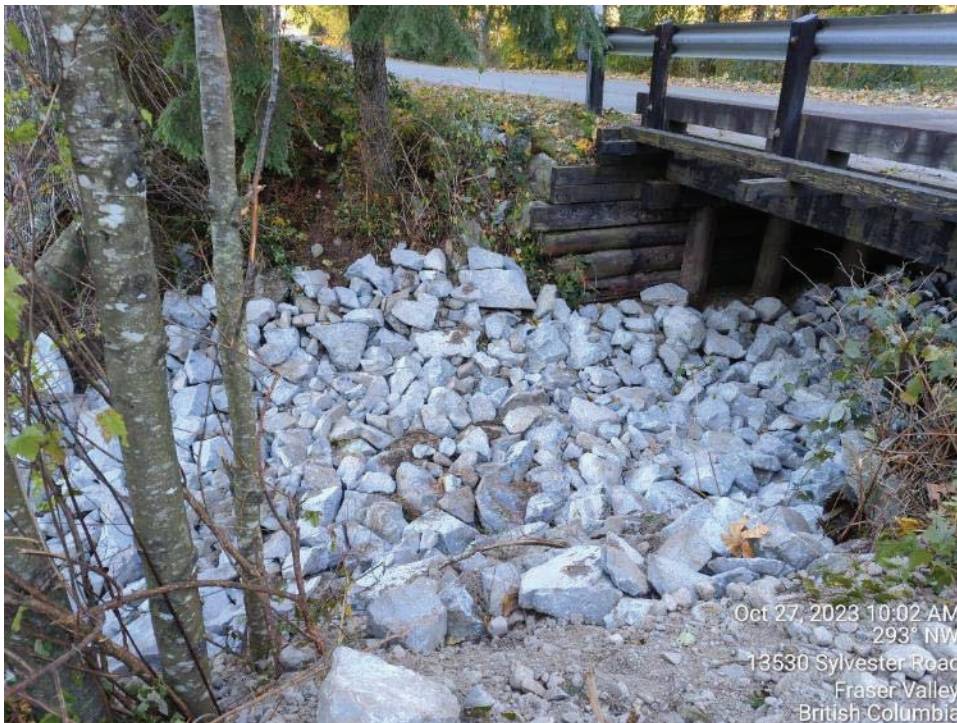
**Photo 18:** Riprap installed at the outflow of Eng Creek on the southside of Hartley.

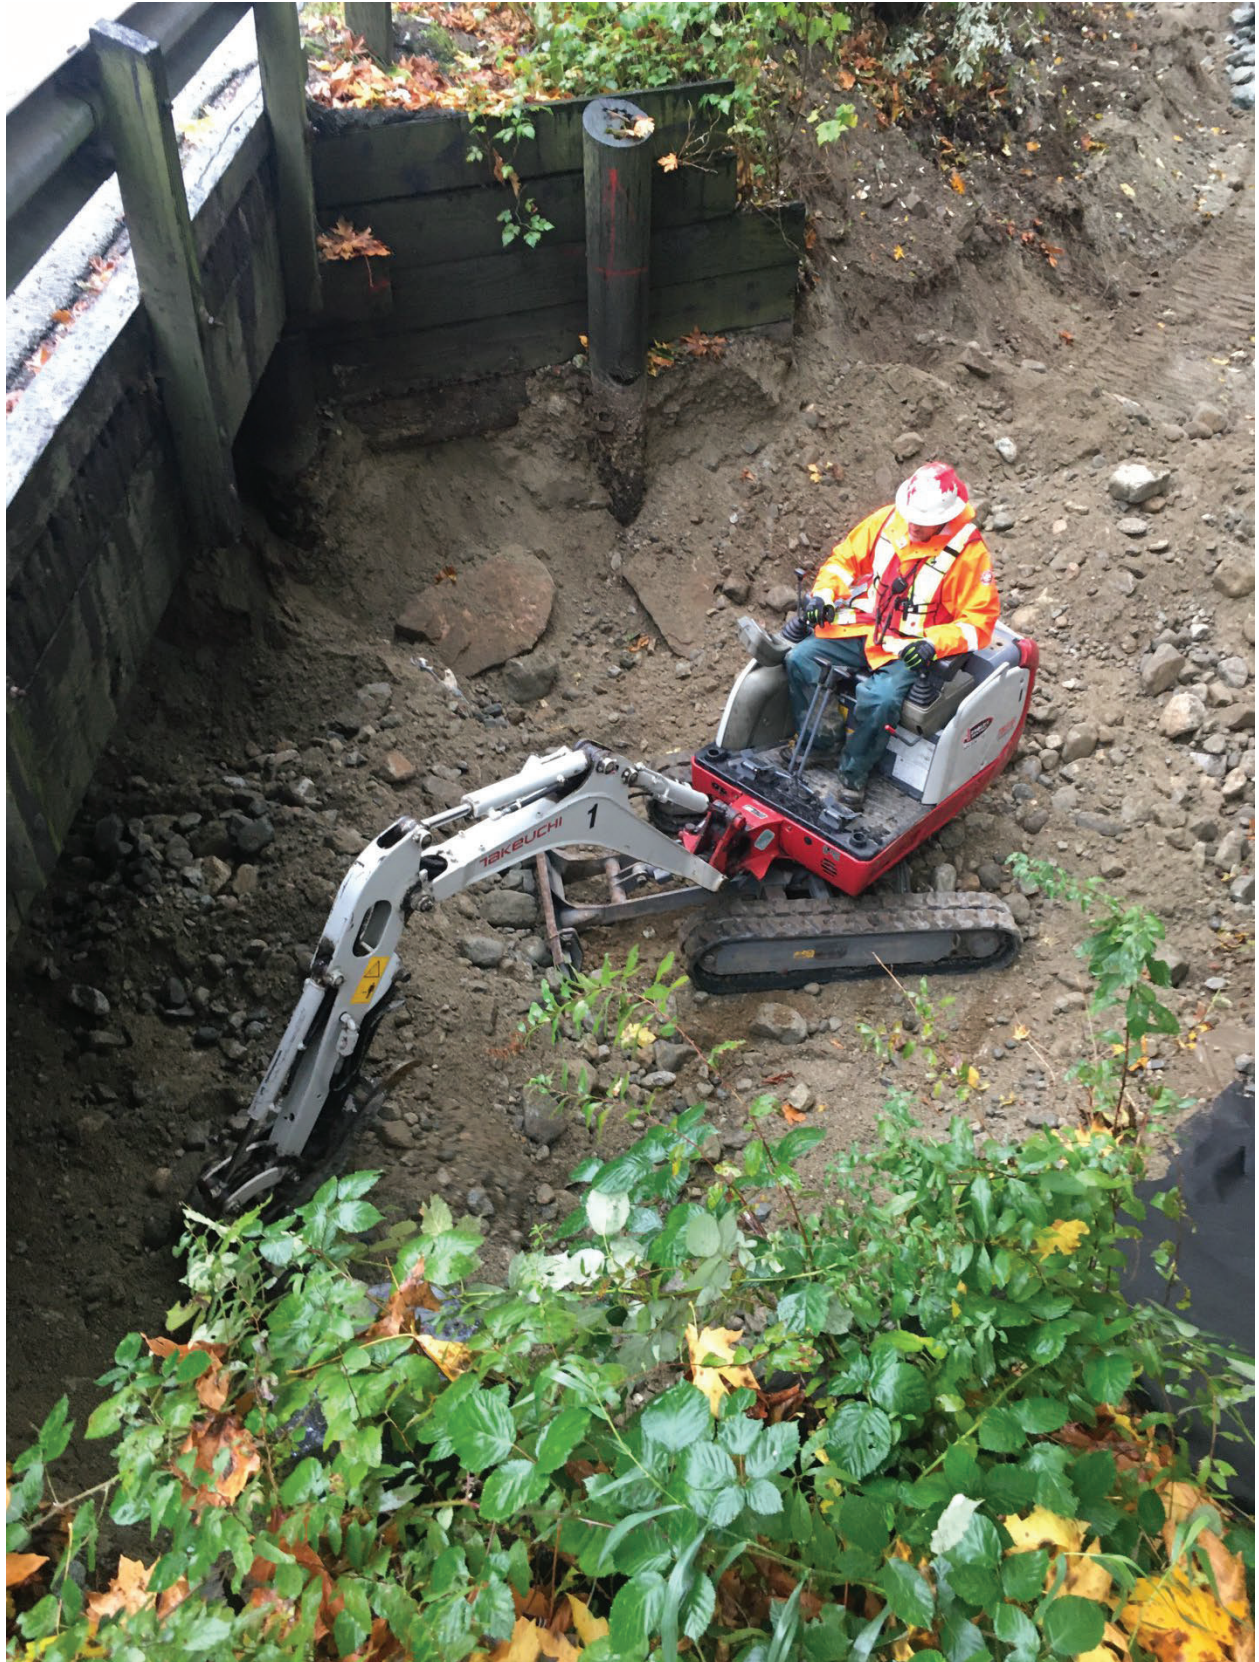
Bed-load removal under bridge

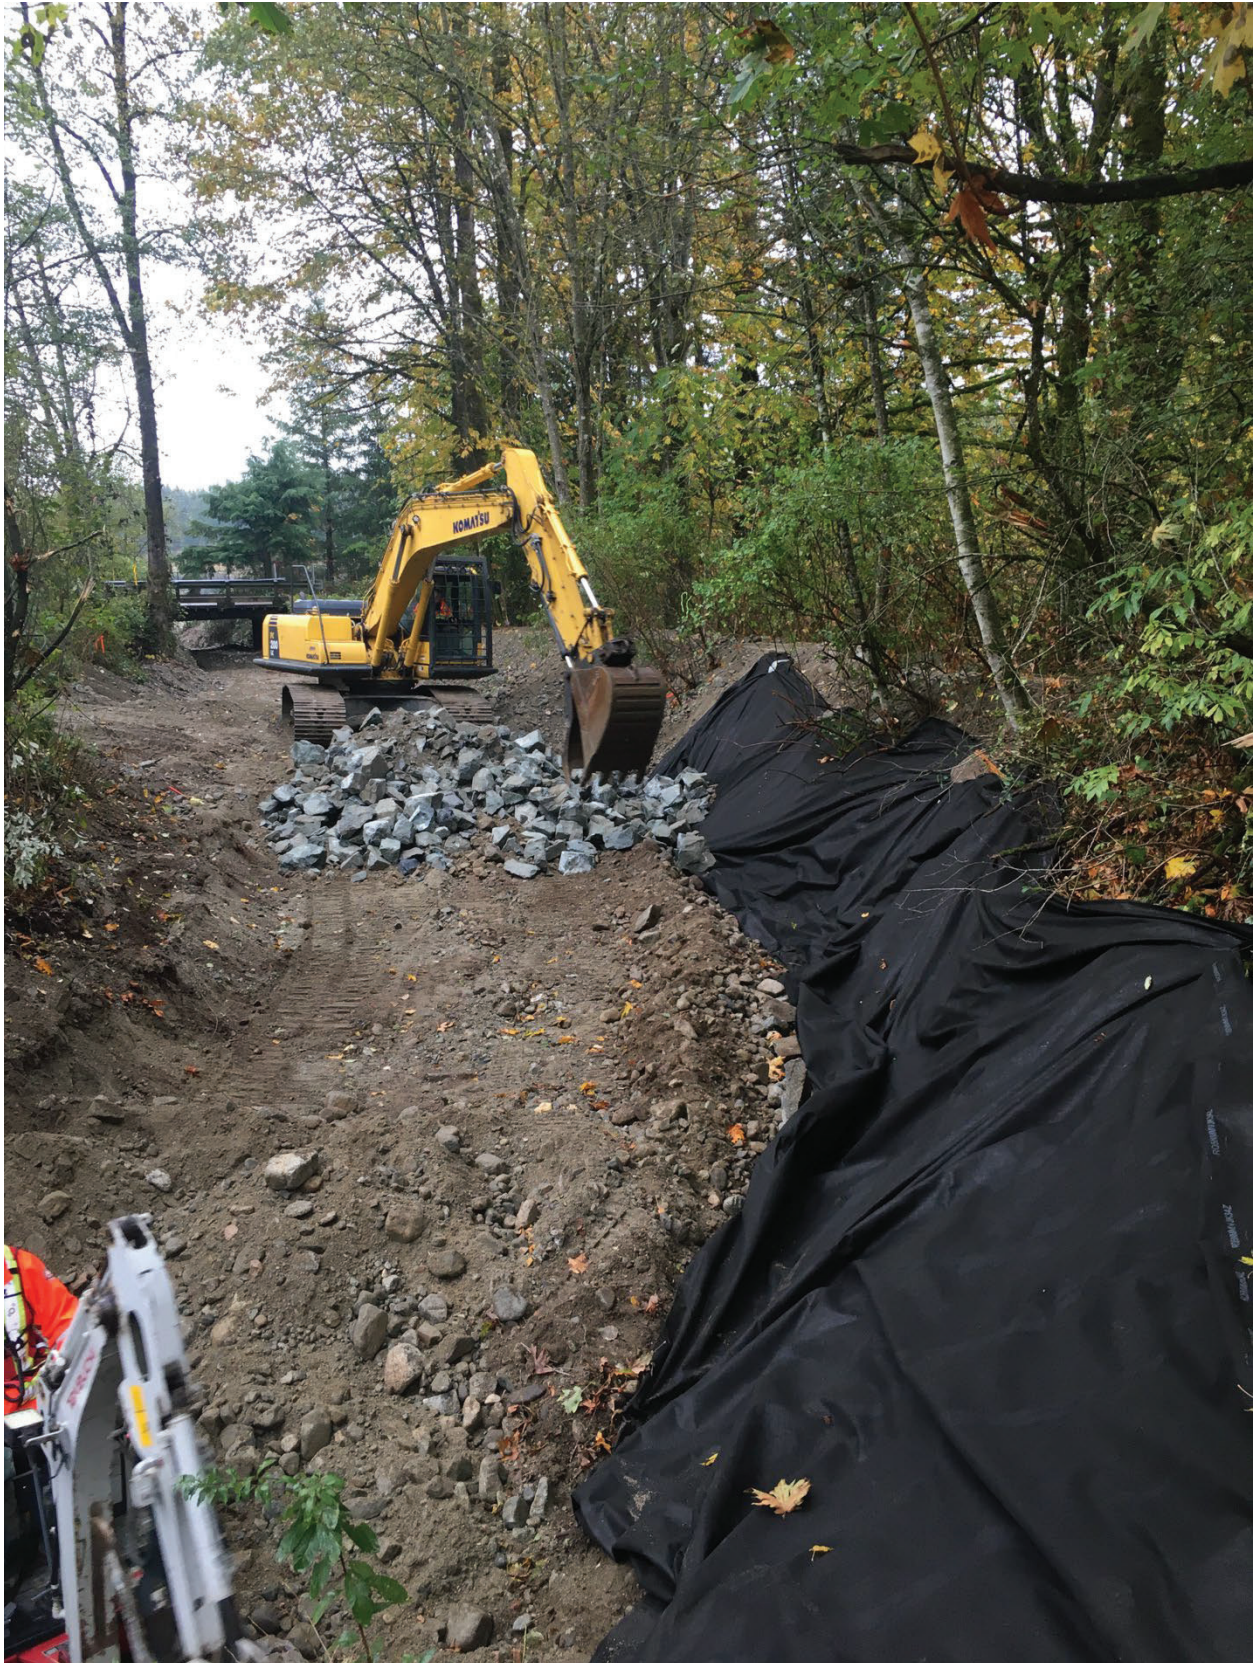
Rip-rap along bank of creek
