# Chemainus River Right Bank Recovery below Highway #1 Bridge

## 2024 Construction Completion

**Final Report**  
**December 30, 2025**  
**KWL Project No. 3427.025**

**Prepared for:**  
**BC Ministry of Environment and Climate Change**

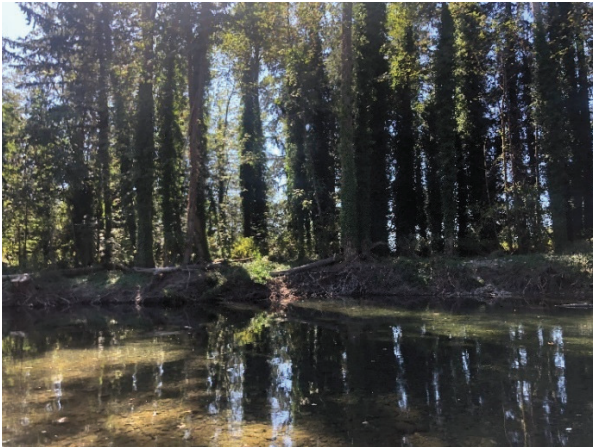
Air photo interpretation in the Geomorphic Atlas indicates that the bank has been eroding at an average rate of about 0.9 m/year but with variations on year-to-year basis with changes in peak flow magnitude since 1950. For instance, the November 2021 flood event resulted in between 2.5 m to 6.3 m in lateral bank erosion based on pre and post-flood event survey carried out by NHC. Large woody debris and willow wattles installed along the bank in this location in late summer of 2021 failed during the November 2021 flood.

**Photo 6: Right Bank of Chemainus River  
Downstream of Highway 1 Bridge Showing Mature  
Riparian Trees and Exposed Roots**

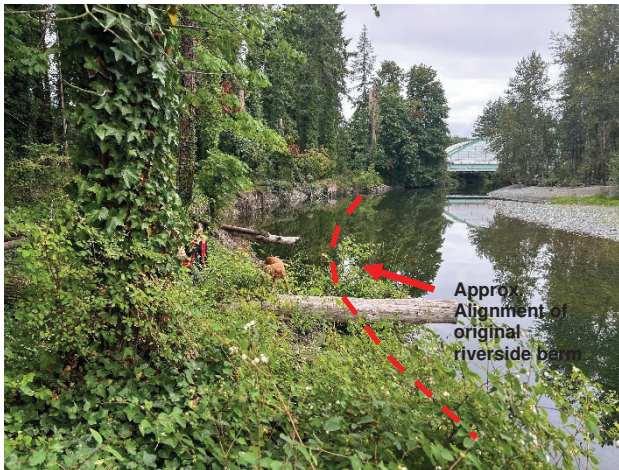
Based on conversations on site with the owner of the property on which the erosion is occurring and Chief Thomas of Halalt FN, we understand that erosion of the right bank of the Chemainus River has result in loss of approximately 200 m of a berm which ran parallel to the river channel. This riverside berm connected from the end of the access road/berm from Halalt Land to the Highway 1 road embankment downstream of the highway bridge crossing (see Photo 7).

**Photo 7: Right Bank of Chemainus River  
Downstream of Highway 1 Bridge Showing  
Approximate Alignment of Original Berm**

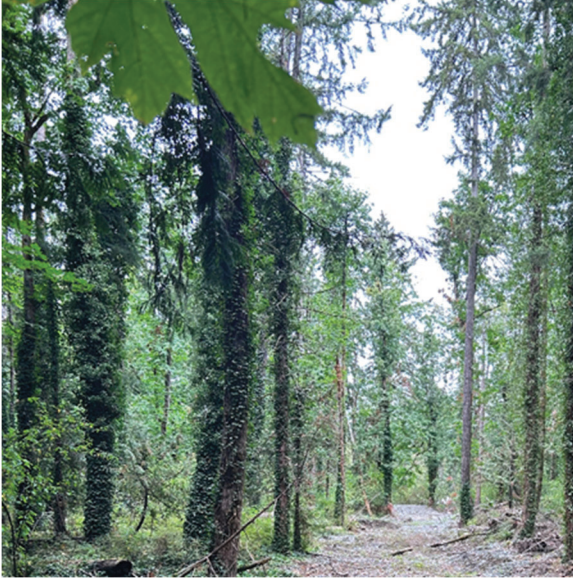
**Photo 12: Temporary berm across floodplain within Halalt FN now removed.**

As a precaution, these temporary berms have now been removed on recommendation from KWL (see Photo 12). It should be noted that wood debris was observed along the alignment of the temporary berms. It is not clear if this wood debris was placed as part of construction of the berms or was in place before construction (see Photo 13). It is recommended that this material be removed and incorporated into future rehabilitation work.

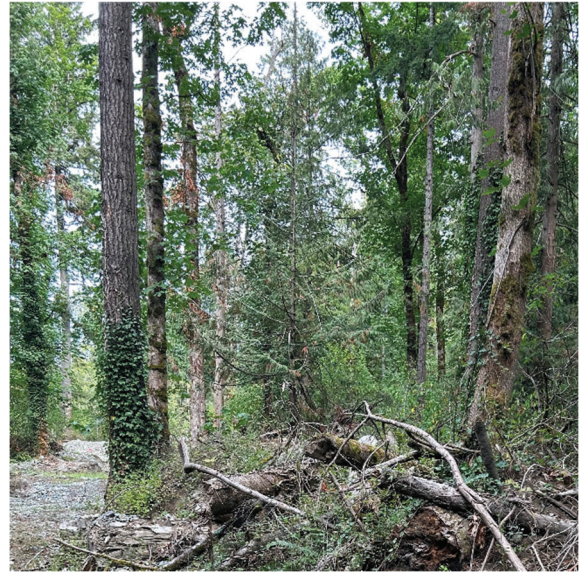
**Photo 13: Wood debris observed adjacent to alignment of temporary berm.**

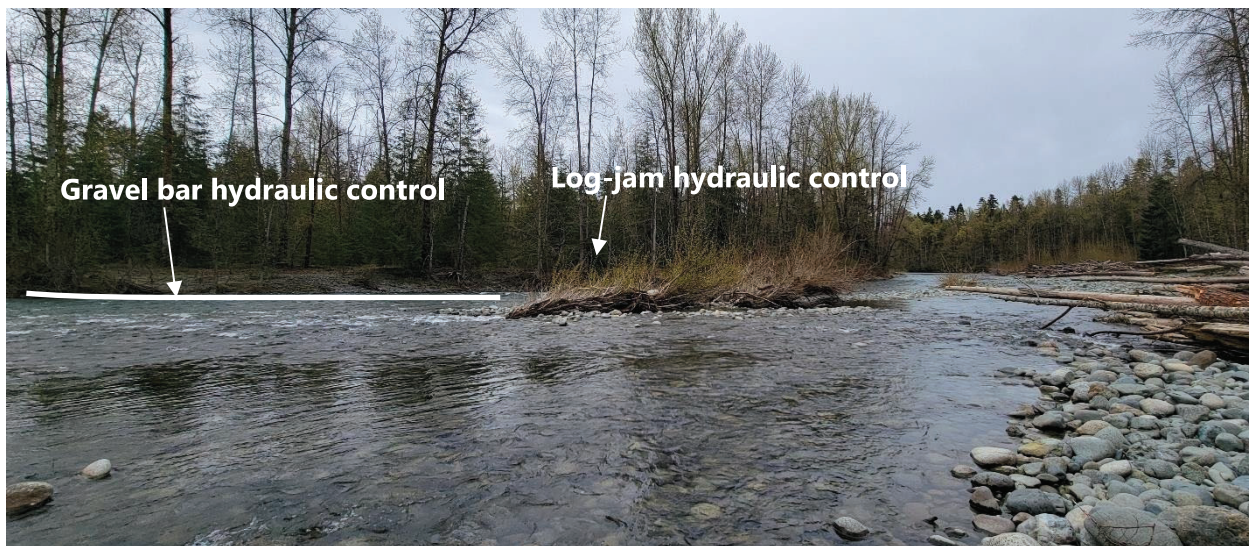
**Photo 1** Gravel bar and log jam downstream of the project area.

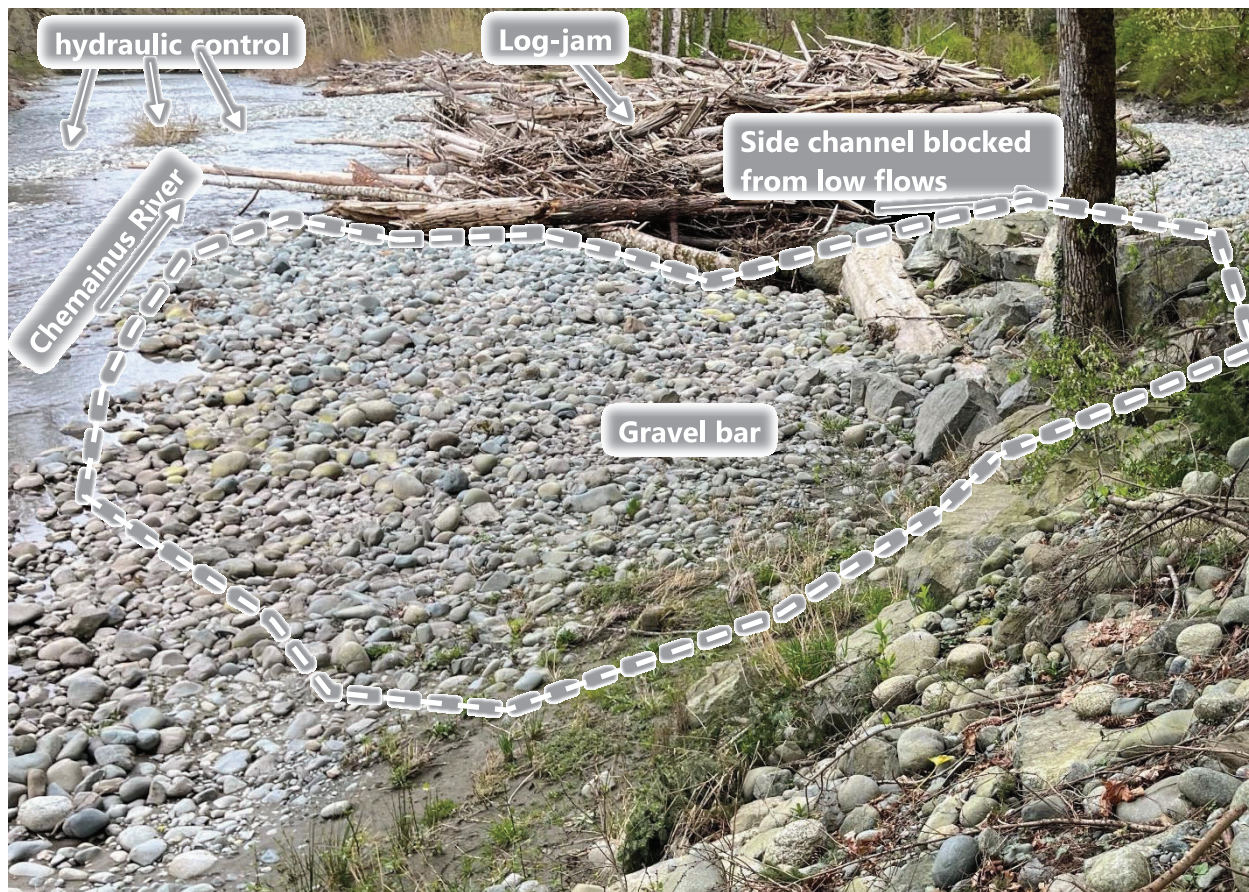
**Photo 2** Gravel bar preventing low-flow from entering right bank side channel.

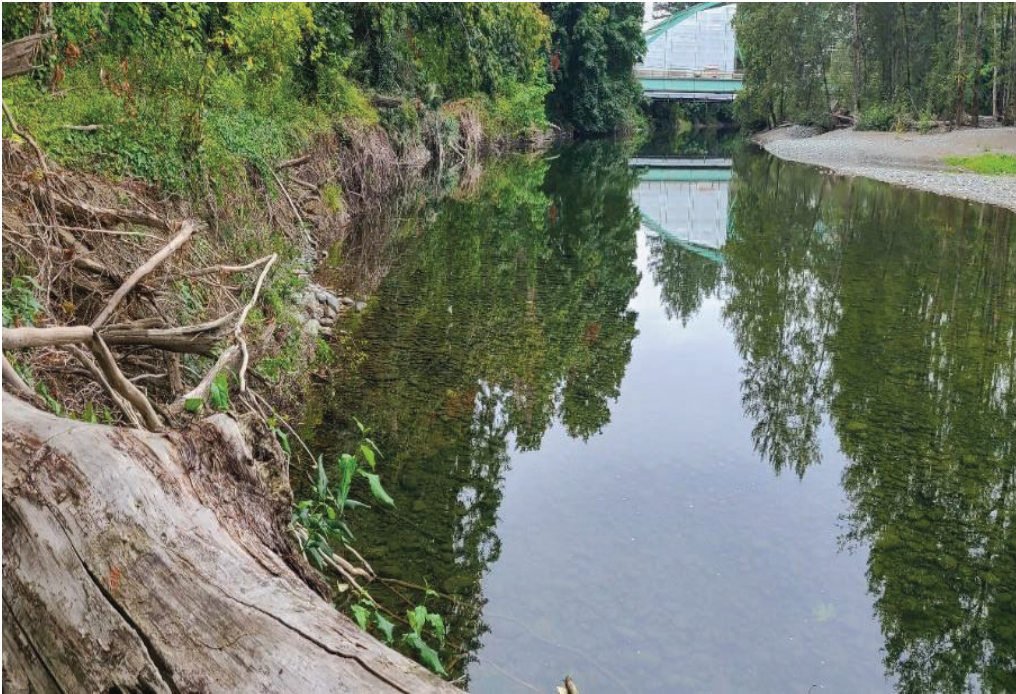
**Photo 1: Chemainus River looking upstream towards Highway 1 Bridge. Undercut banks visible to the left (river right when looking downstream).**

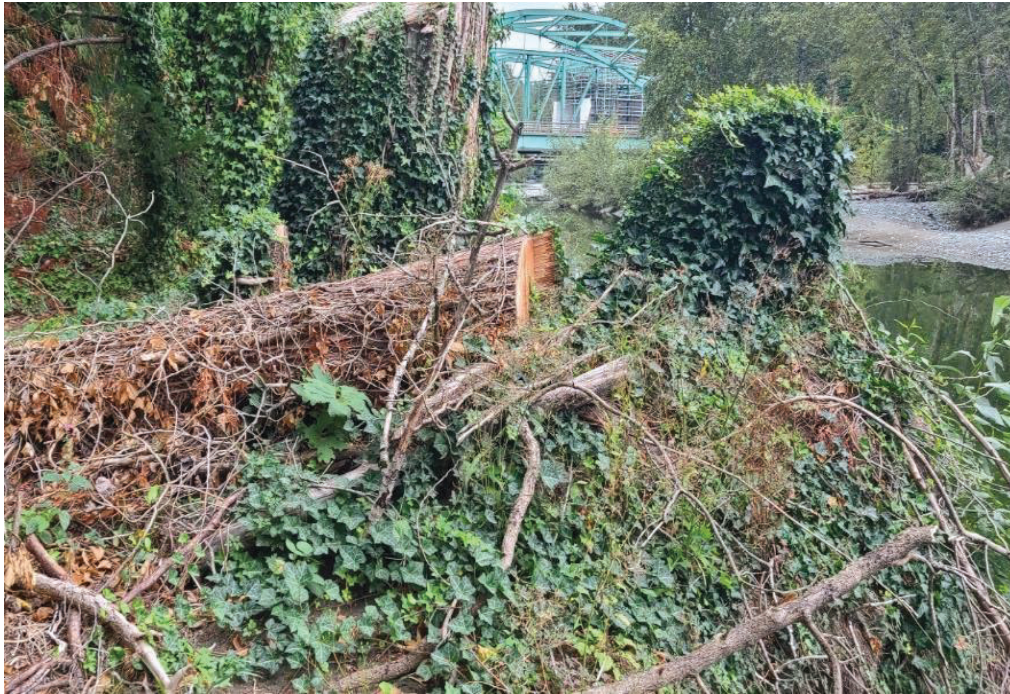
Photo 4: Extensive invasive English Ivy herbaceous cover.

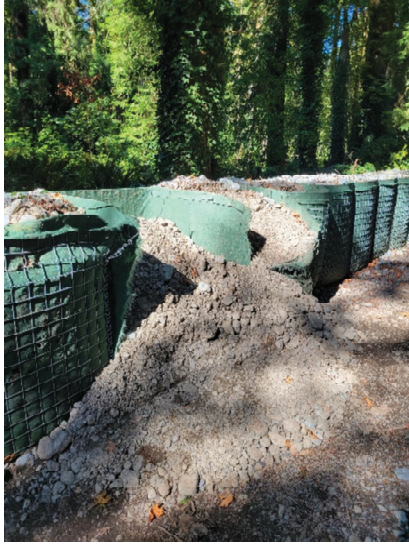
| Photo 3:<br>Access road reclamation underway | | Photo 4:<br>Damaged Hesco baskets | |

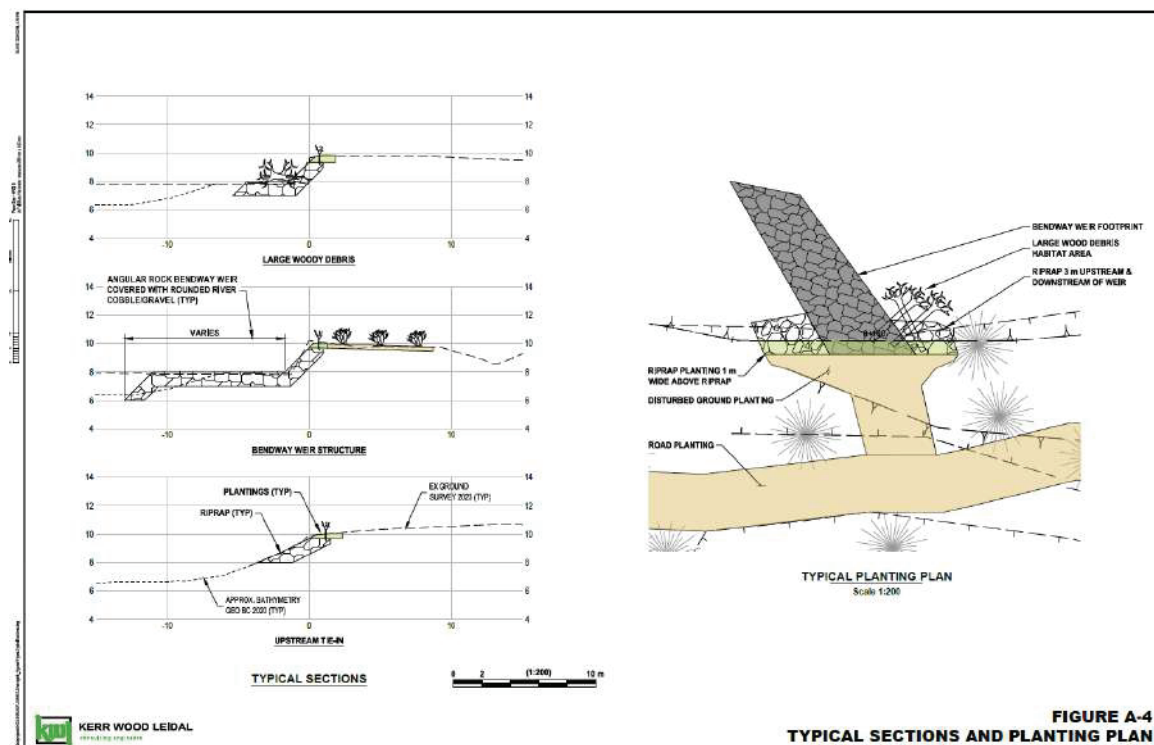
It should be noted that KWL design drawings appear to indicate 3 pieces of LWD for each weir - see **Figure 3** (excerpt from KWL's EA and Offsetting Plan). Having 2 pieces of LWD instead of 3 is not expected to significantly reduce instream cover for fish or aquatic habitat complexity. Post-project instream cover and aquatic habitat complexity values are still expected to be higher compared to pre-existing conditions, when also considering benefits of cover and provision of velocity shadows created by the weirs.

Figure 3. Excerpt from KWL's EA and Offsetting Plan showing LWD specifications.

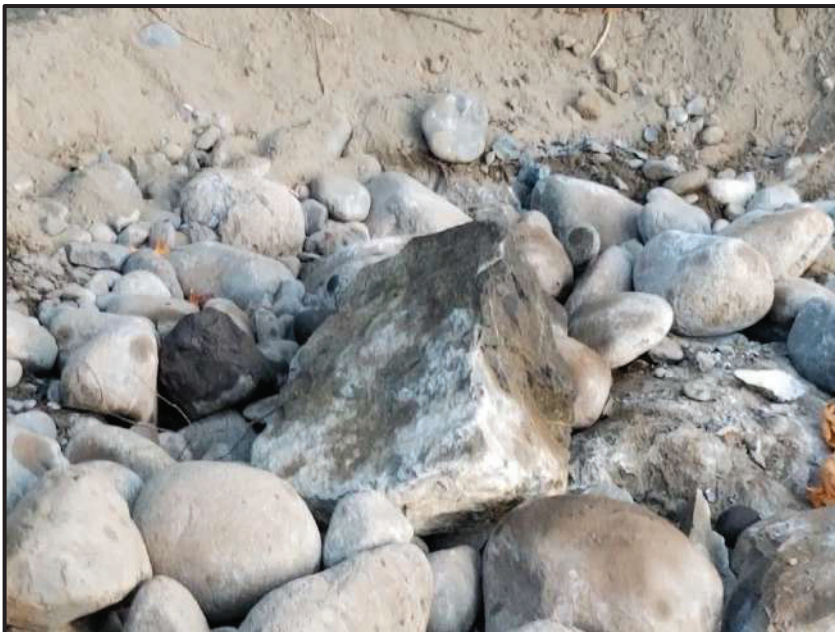
**A SMALL LEAK WAS DETECTED IN THE EXCAVATOR'S FUEL SYSTEM AND RESULTED IN SEVERAL BOULDERS BEING COATED IN DIESEL FUEL. ALL THESE ROCKS (EXAMPLE SHOWN) WERE REMOVED AND PROPERLY DISPOSED OF.**

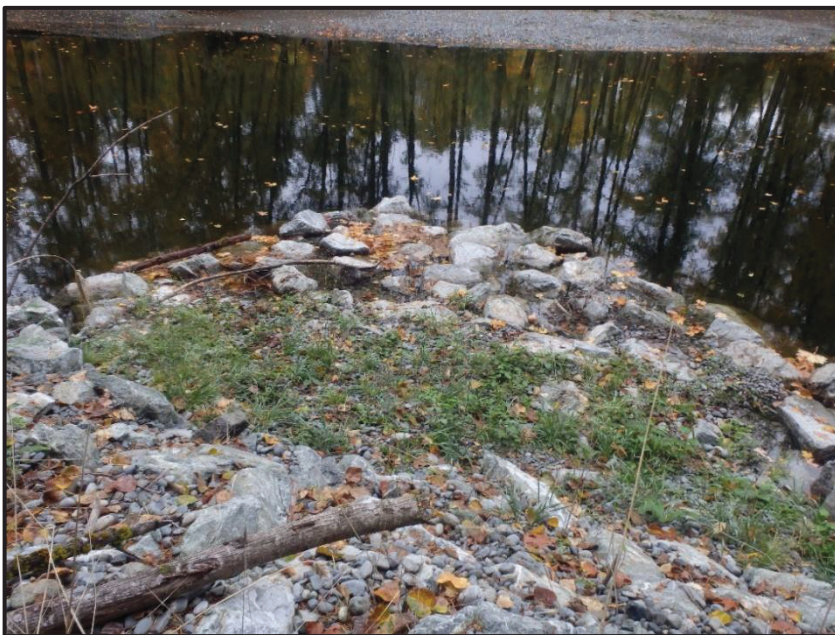
Looking downstream along the top of bendway weir #6. Note that live stakes were inserted into the riprap and successful growth is limited.

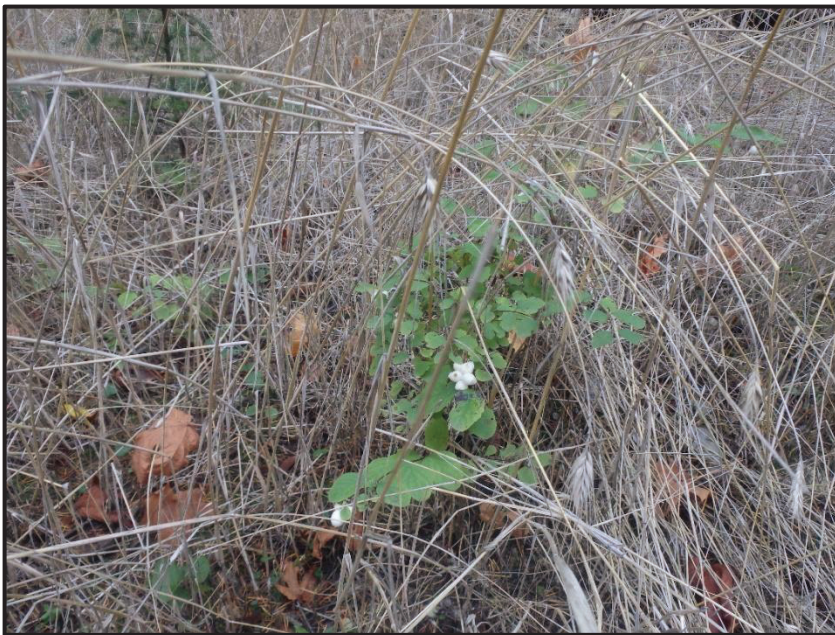
Most of the live stakes placed in the riprap did not survive; however, this is an example of a surviving live stake, with new growth.

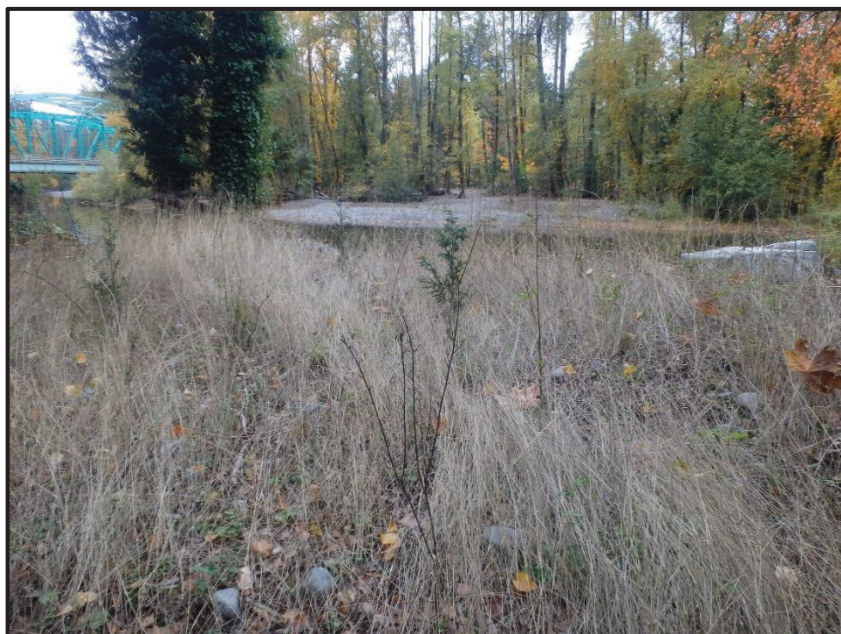
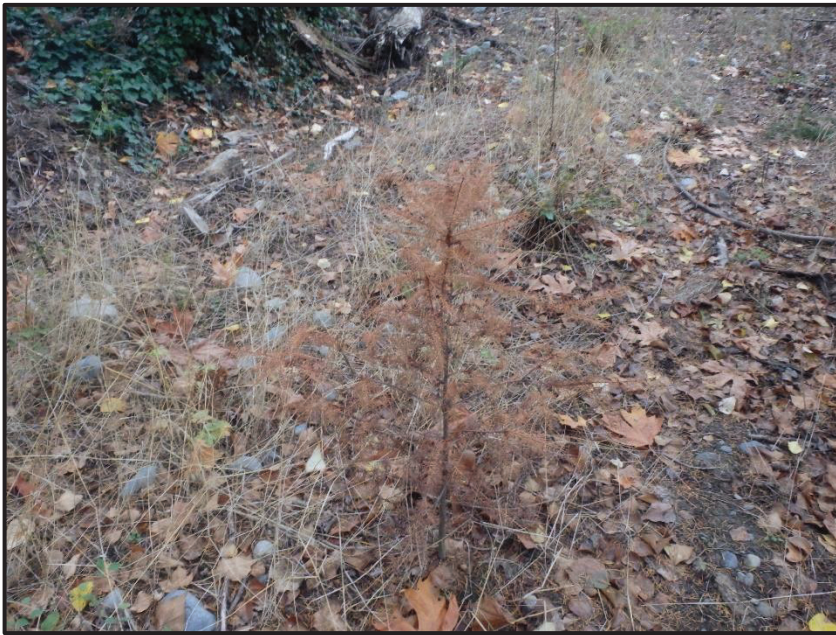
Above and below: a disturbed planting zone, showing Coarse Woody Debris placement and success of grass establishment. Several deciduous trees have been subjected to browsing pressure, but at the time of the assessment it was noted that the level of browse does not warrant additional planting measures.
