Chemainus River Sediment Removal and Temporary Flood Barrier

# 2023 Construction Completion Report

**Final Report**  
**December 11, 2025**  
**KWL Project No. 3427.025**

**Prepared for:**  
**BC Ministry of Environment and Climate Change**

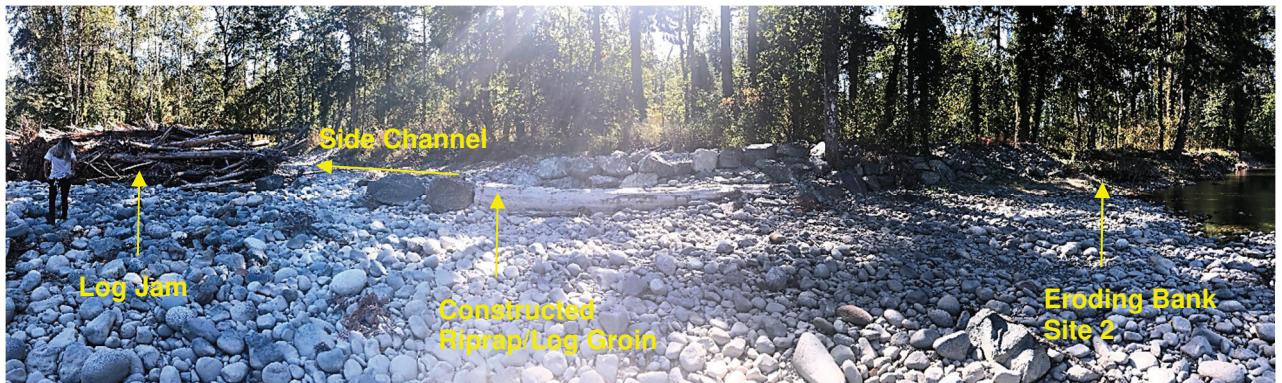
Two side channels are located on the right bank floodplain of the Chemainus River. The first side channel, which is an active side channel that is about 10 m wide and runs from the downstream end of the long eroding bend on the right bank (Site 2) to approximately 100 m downstream (into Reach 4). The upstream end of the active right bank side channel is partially blocked by a significant log jam located on the right bank as well as a constructed riprap/log groin which crosses the open portion of the side channel (Photo 8).

**Photo 8: Entrance to Right Bank Side Channel Showing Eroding Bank, Riprap/Log Groin, and Log Jam**

Both the logjam and the groin limit the amount of water that flows into the active side channel in this location. However, ongoing erosion upstream (Site 2) could outflank the groin structure and result in additional water flowing into the active right bank side channel during large flood events.

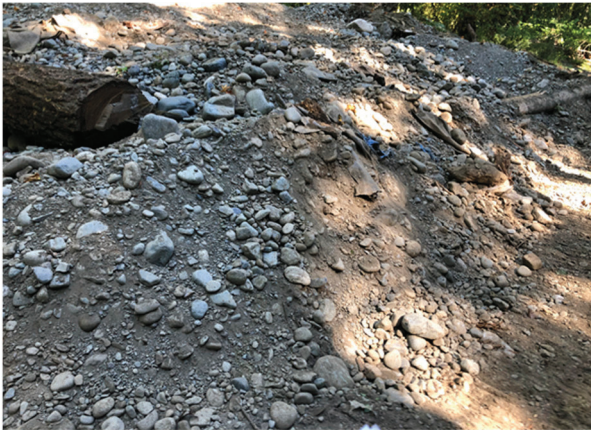
Two temporary gravel berms were constructed across the relic side channels in the floodplain within Halat FN reserve lands (see Photo 9). A trapezoidal channel has been left in the berm at the location of the relic side channel (see Photo 10). These were constructed as emergency measures during the 2021 flood. They limited flow across the floodplain and concentrated flow in the two side channels.

**Photo 9: Berm constructed within Halat FN across the relic floodplain side channels on right bank of Chemainus River**

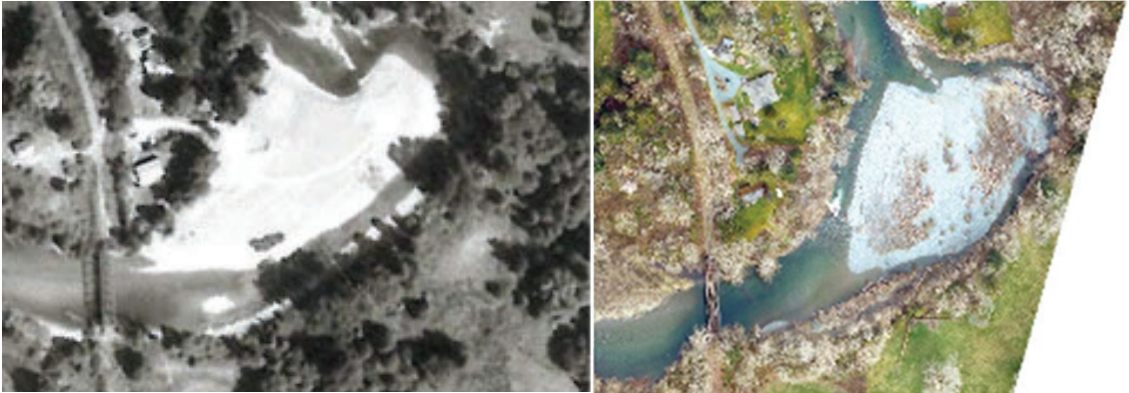
Site 4 is located between the E&N Railway Bridge and the Chemainus River Bridge (Reach 2 in the NHC Geomorphic Atlas). This area is a depositional zone with a 10,000 m<sup>3</sup> (approximate) gravel bar. The right bank of the channel is protected by riprap between the E&N bridge and a bedrock outcrop upstream of the Chemainus Road bridge. Since 1992, the channel has migrated from the right bank to the left bank (Photo 14).

**Photo 14– Air photos from 1992 (left) and 2021 (right) showing how channel morphology has changed in the depositional area over time (Source: NHC 2022)**

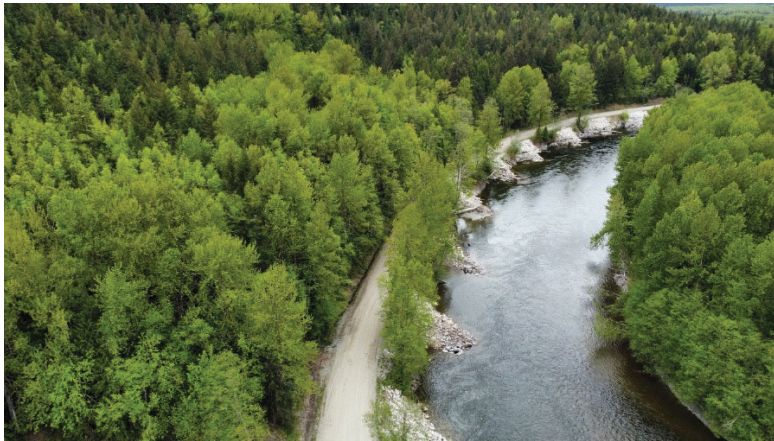
To protect the natural berm from erosion, the proposed bank reinstatement works would also include hard points (spurs or bendway weirs) in the river channel to direct flow away from the erodible bank to allow the bank to restabilize over time as well as riparian and aquatic habitat features to protect and promote healthy fish habitat in the reach. An example of a site combining hard points with riparian habitat is shown in Photo 16).

**Photo 16: Example of Combination of Riparian Habitat with Rock Hard Points for Erosion**

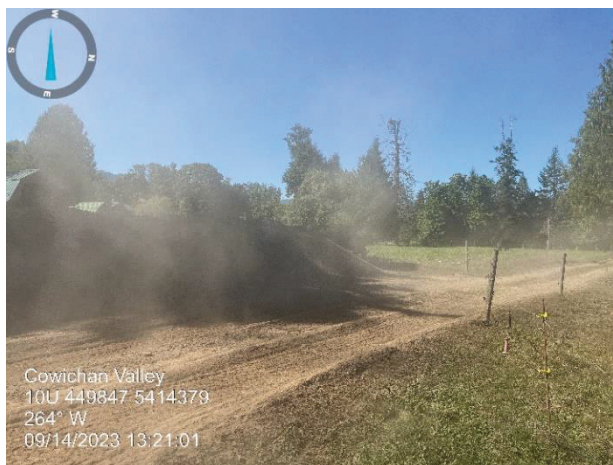
- **Outstanding deficiencies in erosion and sediment control measures**, including excessive dust production from trucks driving on the agricultural field and subsequently a lack of consistent visits by water trucks to control dust. Non-compliance was first observed on Wednesday, September 13 and brought to the contractor's attention. The issue was resolved on Monday, September 18 when Stone Pacific provided a water truck to be on-site full time for dust control.

**Photo 1:** Dust generated from trucks driving on access road

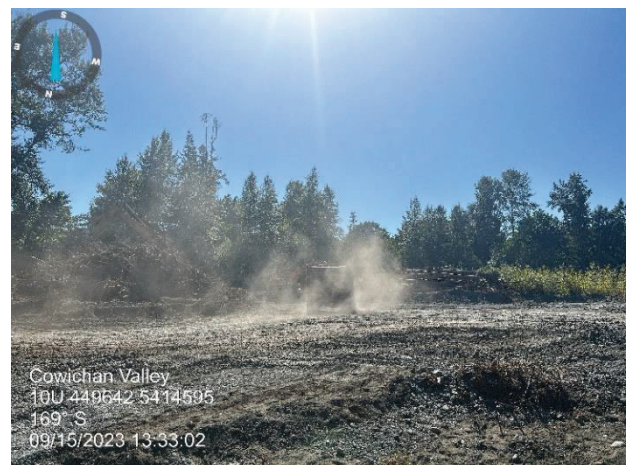
**Photo 2:** Dust on gravel bar

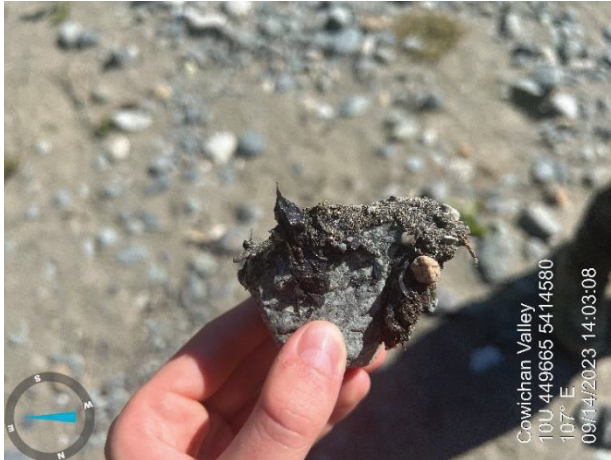
- **Equipment condition and leaks**, including leaking of oil and grease onto gravel by excavators and/or dump trucks. The exact source was not determined. EM requested all contaminated gravel be removed off-site.

**Photo 3:** Rock with grease found adjacent Chemainus River

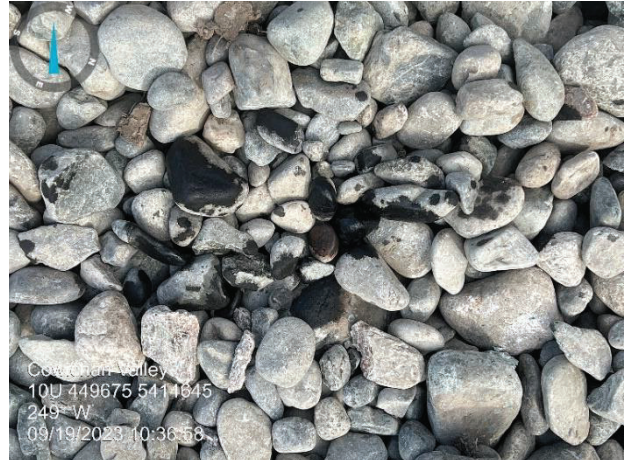
**Photo 4:** Rocks with oil or grease

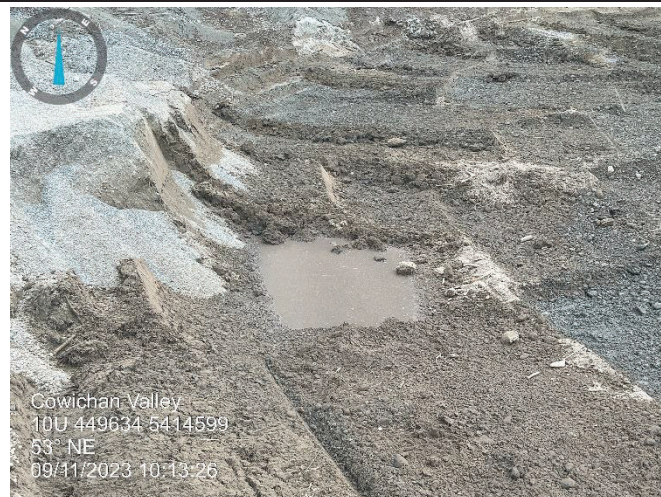
**Photo 3:** Small groundwater infiltration

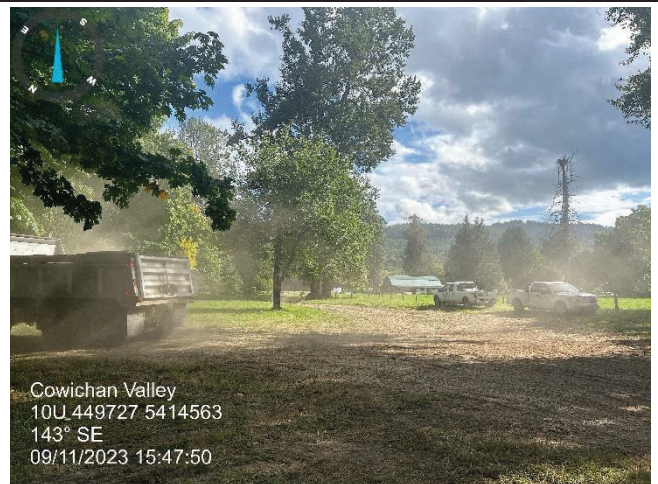
**Photo 4:** Dust within field from access road

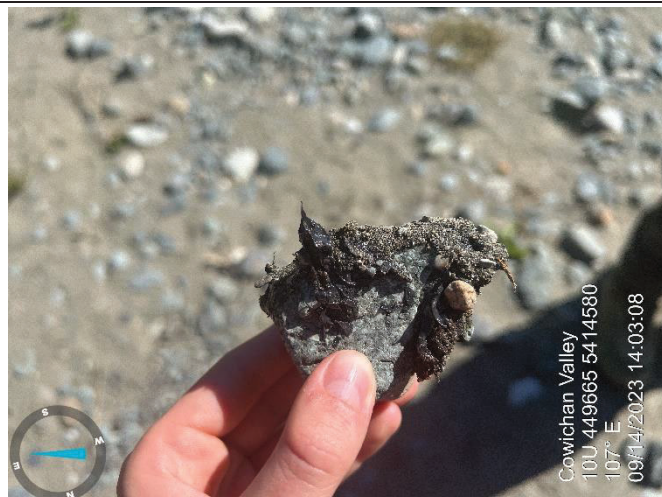
**Photo 3:** Rock with grease found adjacent Chemainus River. Removed off-site.

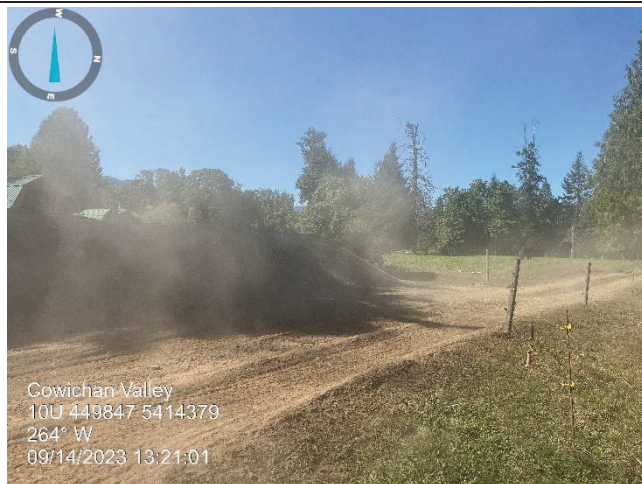
**Photo 4:** Dust generated from trucks driving on access road

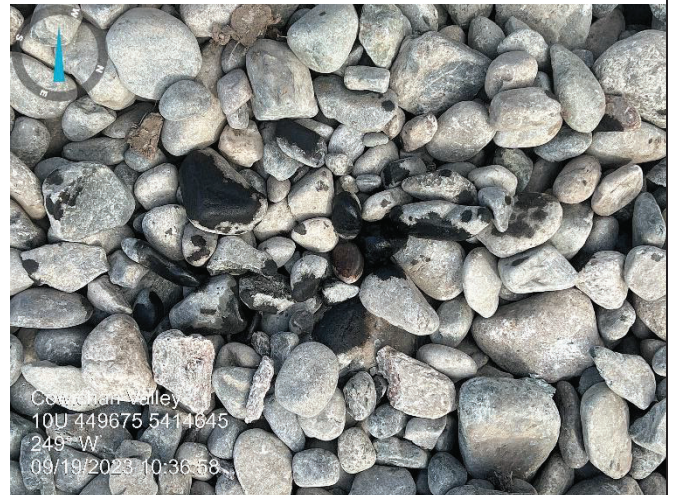
**Photo 2:** Rocks with oil or grease

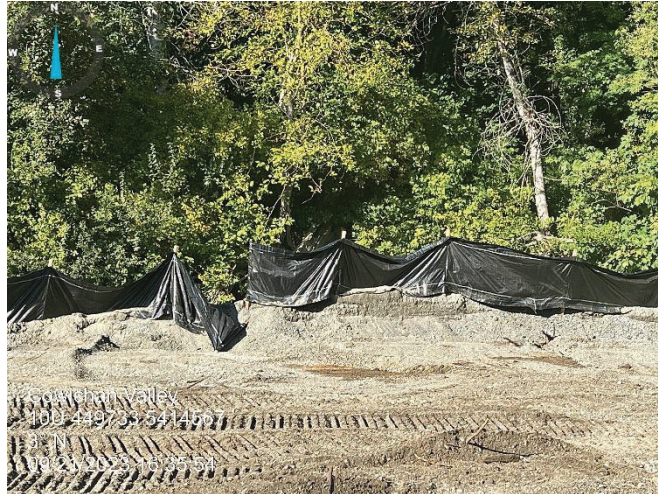
**Photo 1:** Damaged section of amphibian exclusion fencing

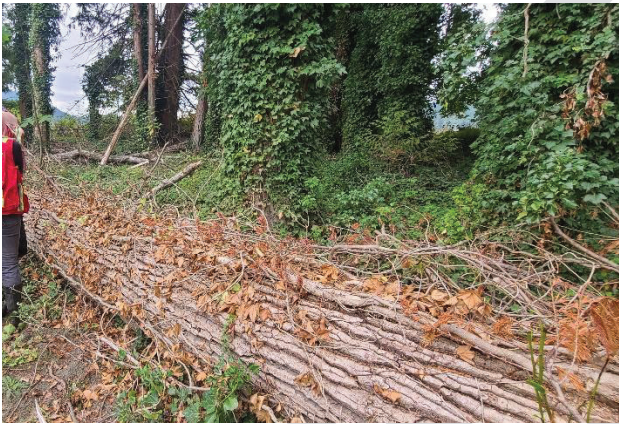
**Photo 5: Large woody debris to be re-oriented**

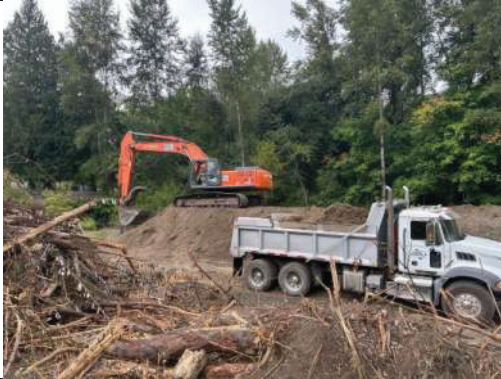
Photo 4  
Groundwater  
infiltration from  
overexcavation  
of silt.  
2023-09-11

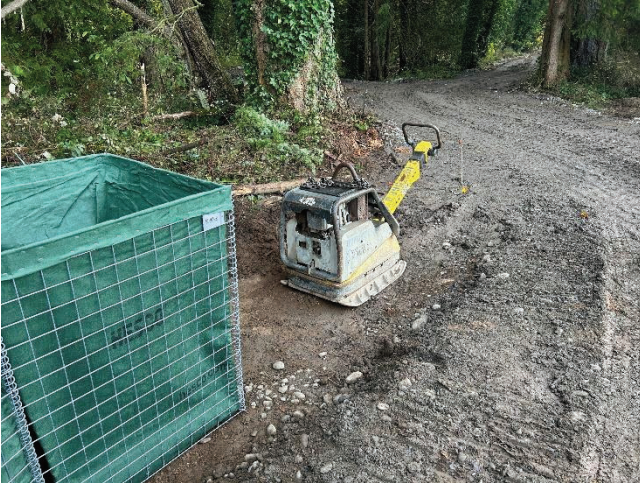
**Photo 1: End of constructed HECO baskets at chainage 0+220. Note excavation into original ground.**
