Province of British Columbia  
MINISTRY OF ENERGY AND MINES  
Report of Inspector of Mines  
Reclamation and Permitting  
(Issued pursuant to Section 15 of the *Mines Act*)

Inspection No.: 65419  
File: 18040-02-09  
Mine No.: 0100079  
Permit No.: M-241  
Emp/Cont: 0 / 0  
Orders H&S: 0 RECL 19  
Stop Work: 0

**Mine Name:** Yellow Giant Gold Project  
**Location:** Banks Island, Skeena MD / 53.370, -130.148  
**Owner, Manager:** Dirk Meckert

### Inspection Report

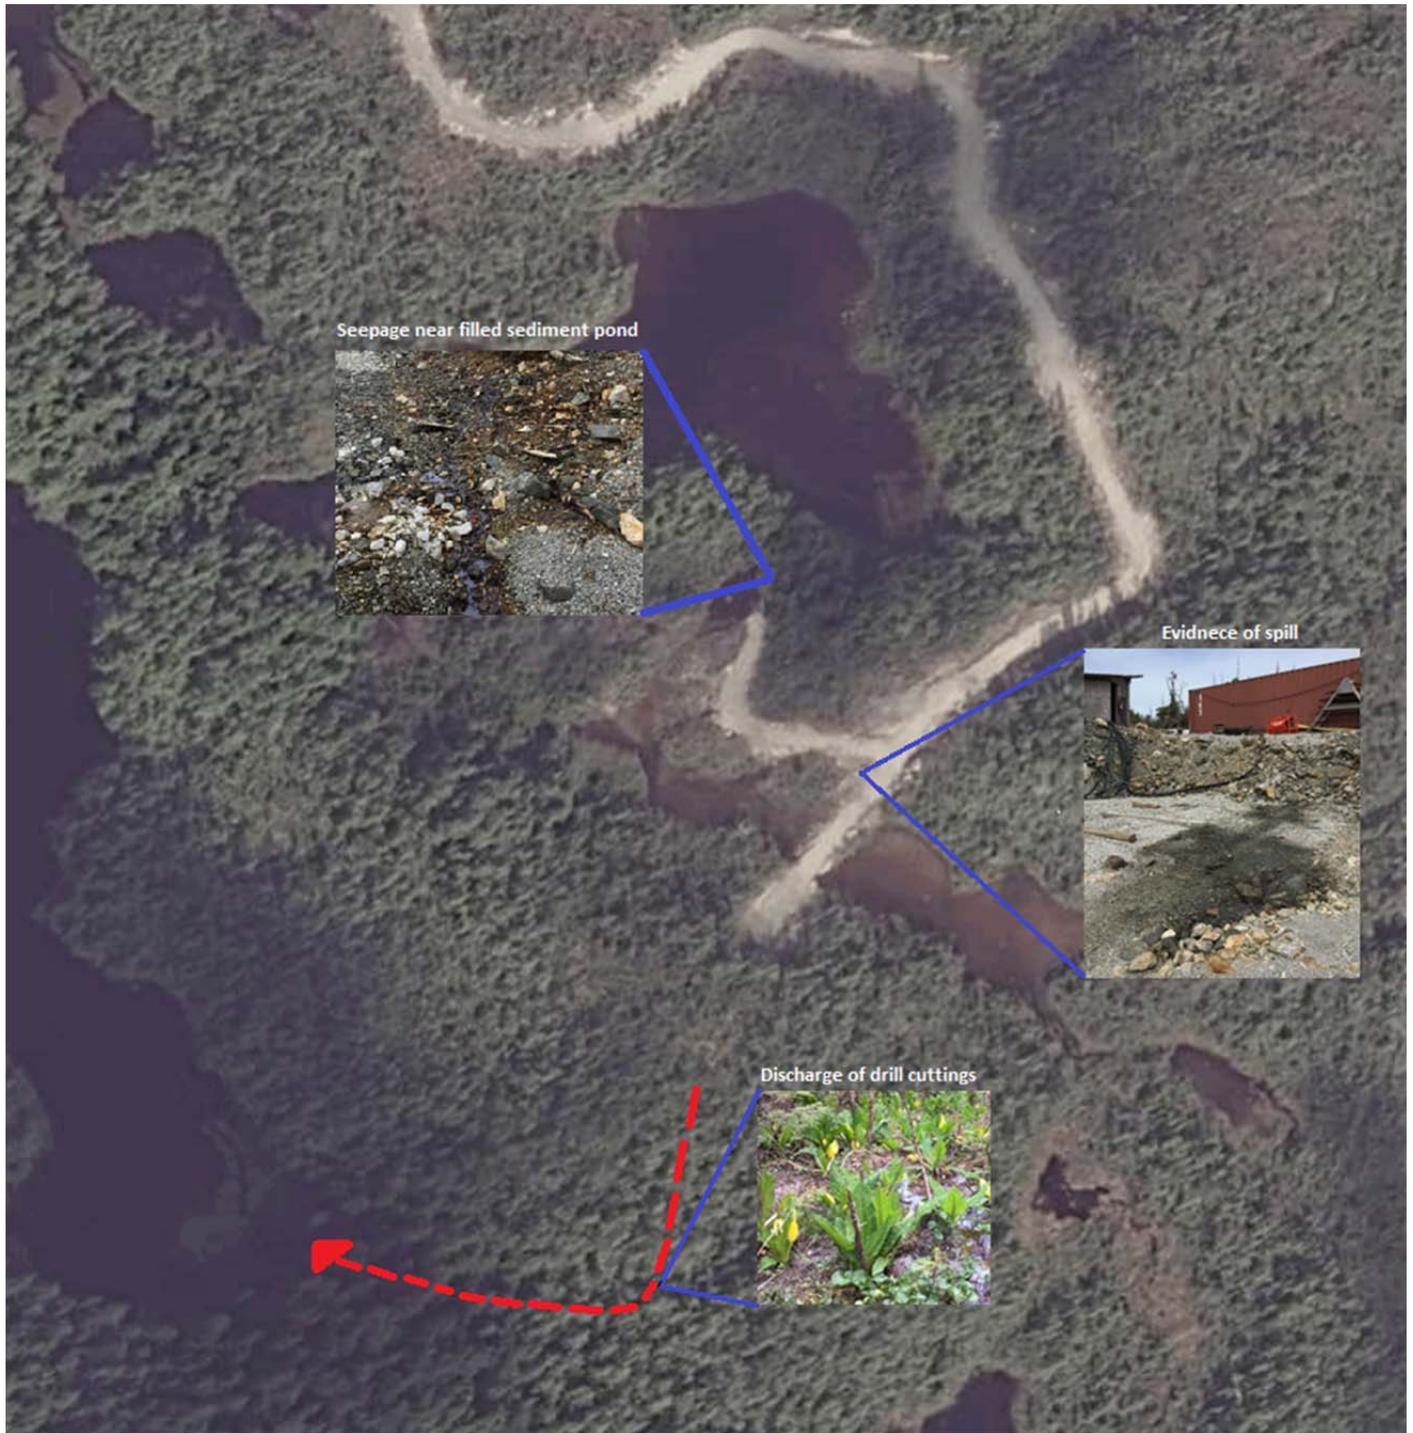
Figure 2: Discovery site

Drill cuttings released to the environment at the Discovery site remain in place. Sediment was observed to have deposited on the forest floor and flowed into an unnamed creek, extending toward Hepler Lake.

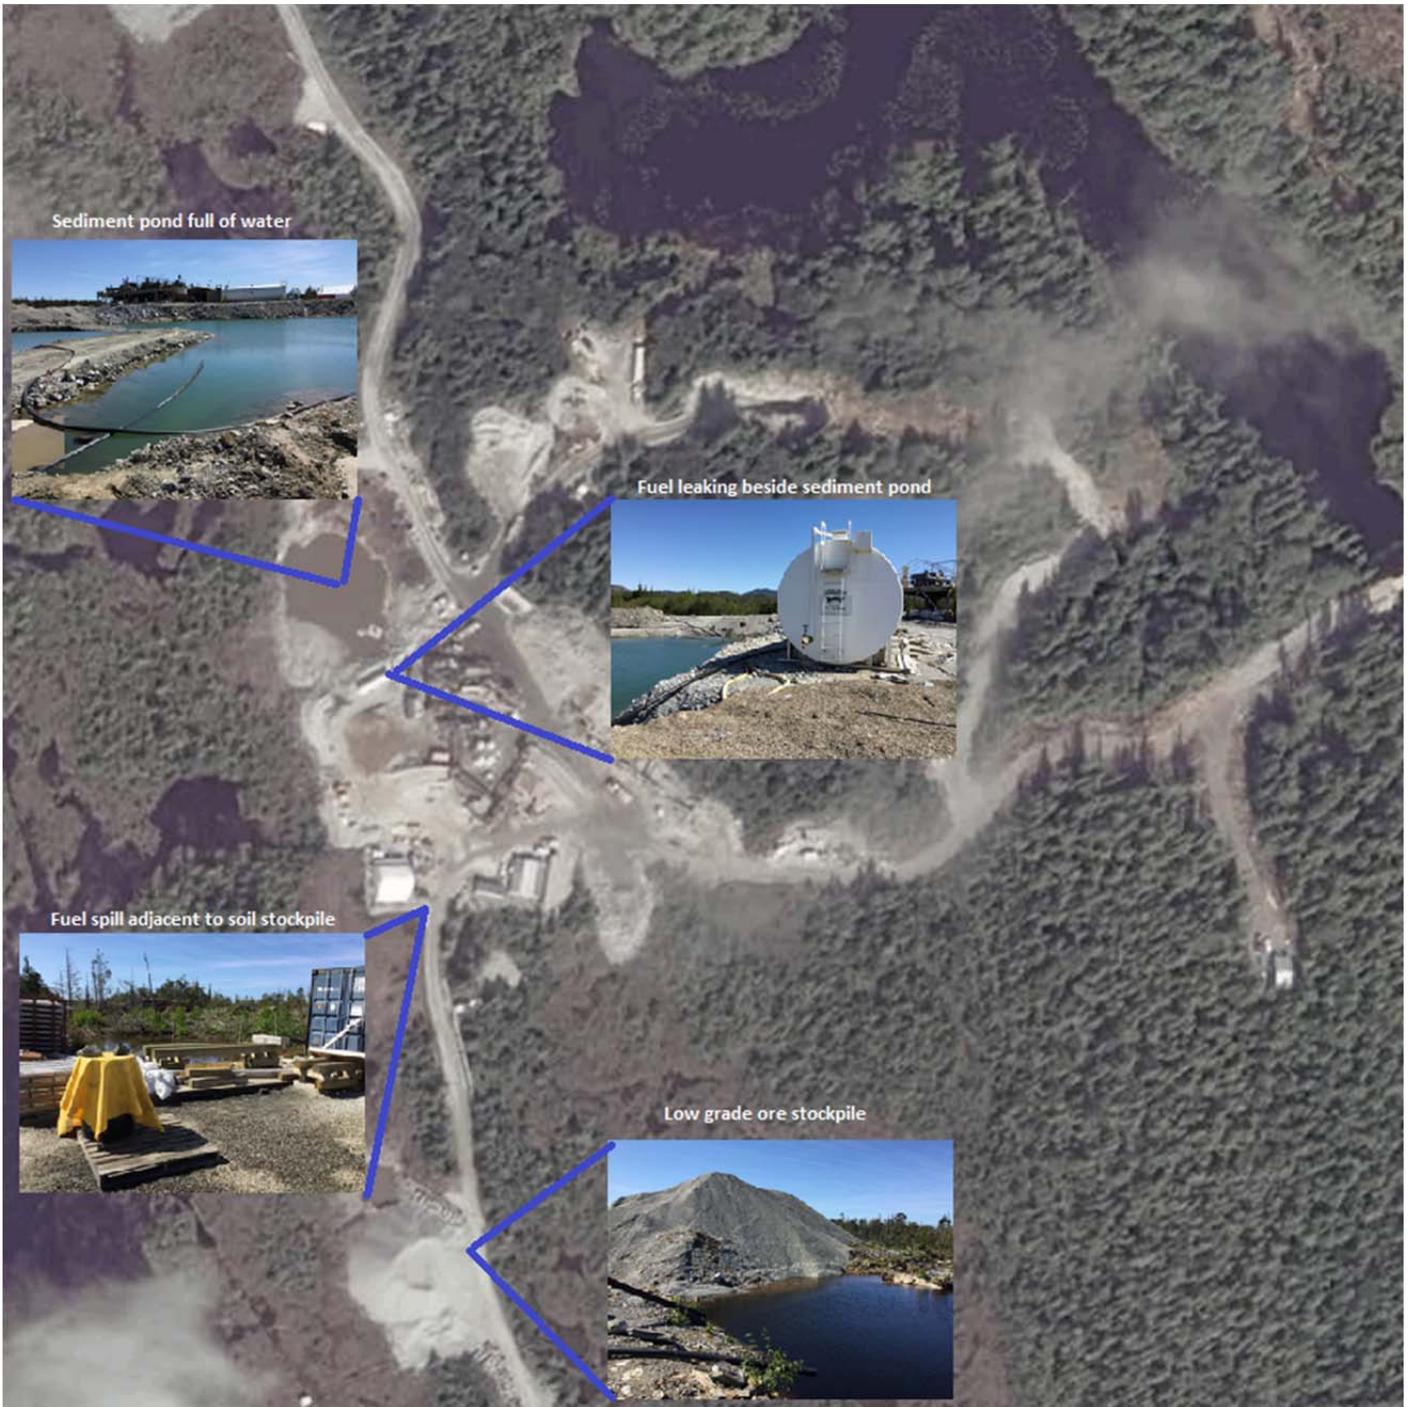
Tel site:

5. The sediment control pond at the Tel site was full, with less than 1m freeboard. **Permit M-241 condition C.3.(b)** requires that a minimum of 1.0 m freeboard below the spillway be maintained to prevent accidental release of sediment laden water. The September 3, 2015 inspection report closed this part of the mine to prevent its unauthorized use. The operational requirements to maintain the freeboard of the pond continues to be a requirement for the sediment control pond facility. Similarly, the seepage from the Bob stope is currently uncontrolled and appropriate actions are required to contain this water on-site. **The Mine Manager shall consider options to remedy these issues (i.e., maintenance of adequate freeboard of the sediment control pond and control of Bob seepage water through the site water management works) and provide the options analysis and preferred option in the Mine Manager's response to this report. The chosen option must meet the objective of ensuring best practices in environmental protection are implemented and maintained.**

8. Fines excavated from the sediment control pond were being stored in a 1.5 m high bermed facility at the north end of the Tel mine site. **Permit M-241 condition D.3.(d)(vii)** requires that all sediments removed from the sediment control pond be processed in the ore processing plant and waste from the processing of the sediments is to be backfilled in underground workings. At this time, this inspector is aware that milling and underground activities are not authorized. **The Mine Manager shall ensure that sediment excavated from the sediment control pond located on surface is contained and protected to ensure the materials do not erode. The materials shall be sampled and characterized to assess potential risks to the environment. This issue shall be remedied immediately.**
