Post-Wildfire Natural Hazard Risk Assessment for the Downton Lake Fire (K71649)

Report by

Cordilleran Geoscience
PO Box 612,
Squamish, BC
V8B 0A5

Draft: November 22, 2023
Final: December 14, 2023

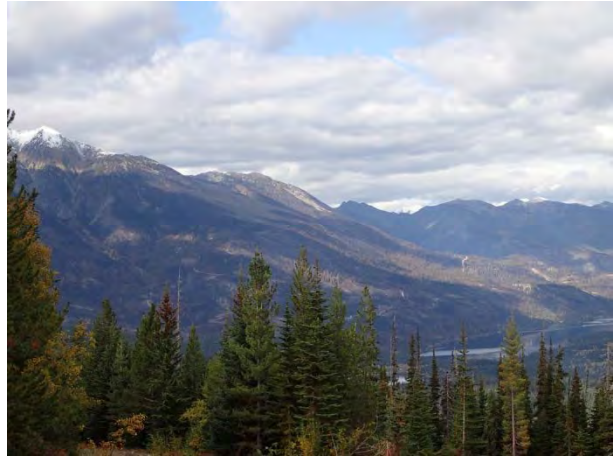
Photo 2. View north across the east slope of Mount Penrose above Gun Lake, and the distant south facing slopes above Gun Creek.

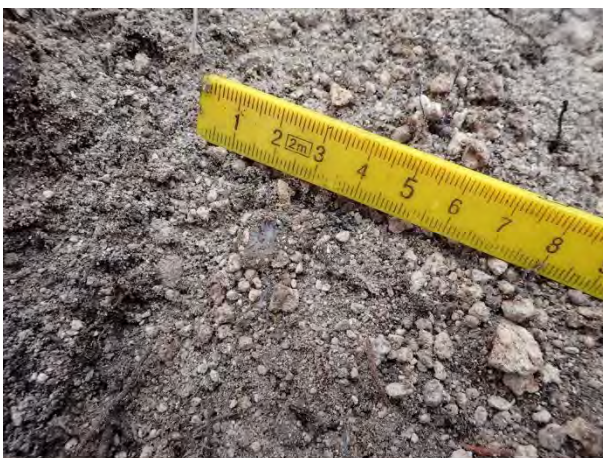
Photo 3. Bridge River tephra grain size, 1-10 mm diameter, sand to granule gravel.

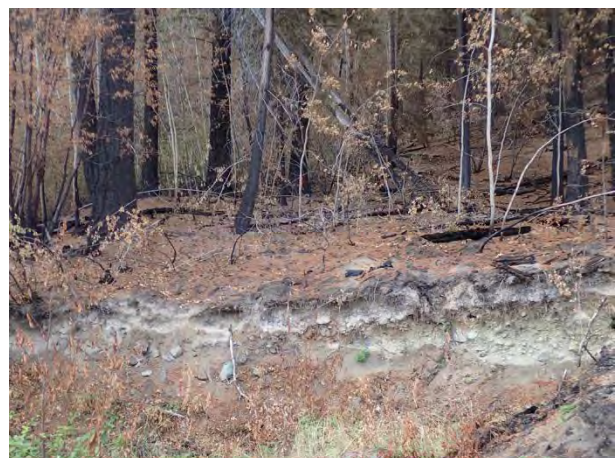
Photo 4. Bridge River tephra in road cut. Forms veneer 0.5 m thick.

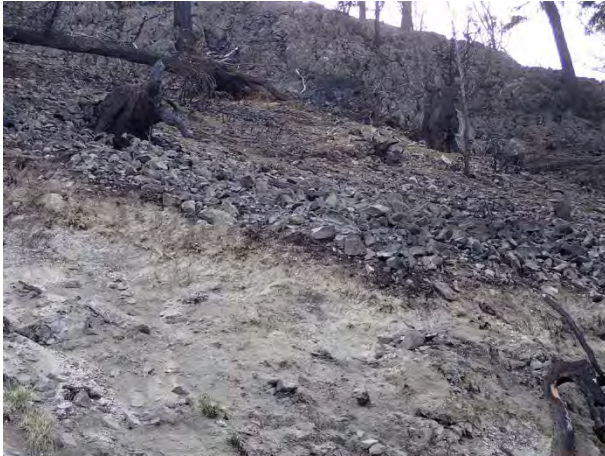
Photo 5. Rockfall fragments below rock outcrop form veneer covering tephra visible in road cut along Slim FSR.

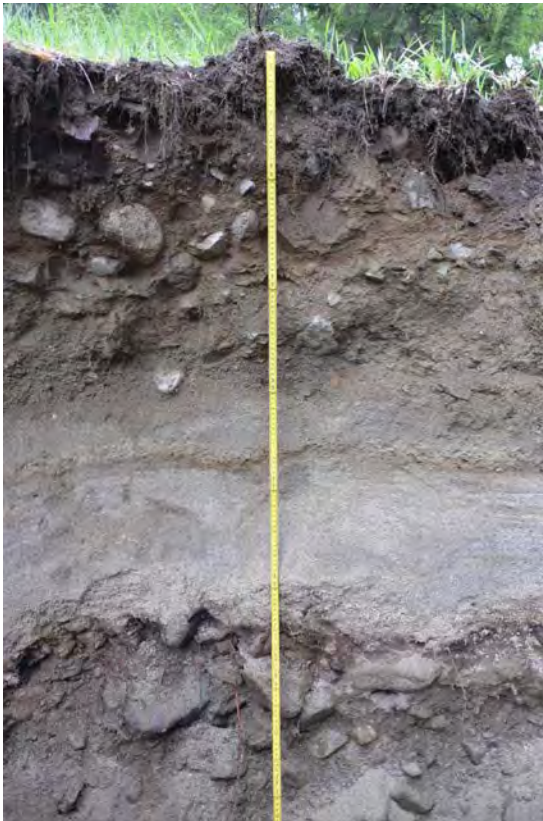
Photo 7. Bridge River tephra, 60-110 cm depth; 60-75 cm depth is reworked. Buried by surface debris flow deposit, Walker Creek fan (Cordilleran 2015).

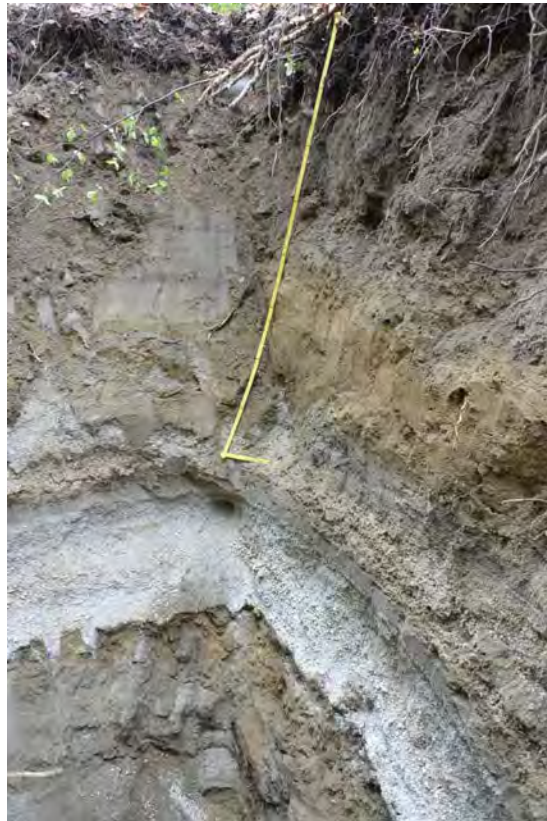
Photo 8. Bridge River tephra, 200-250 cm depth, buried by reworked tephra, and two debris flood units (sand/fine gravel), Walker Creek fan. (Cordilleran 2015).

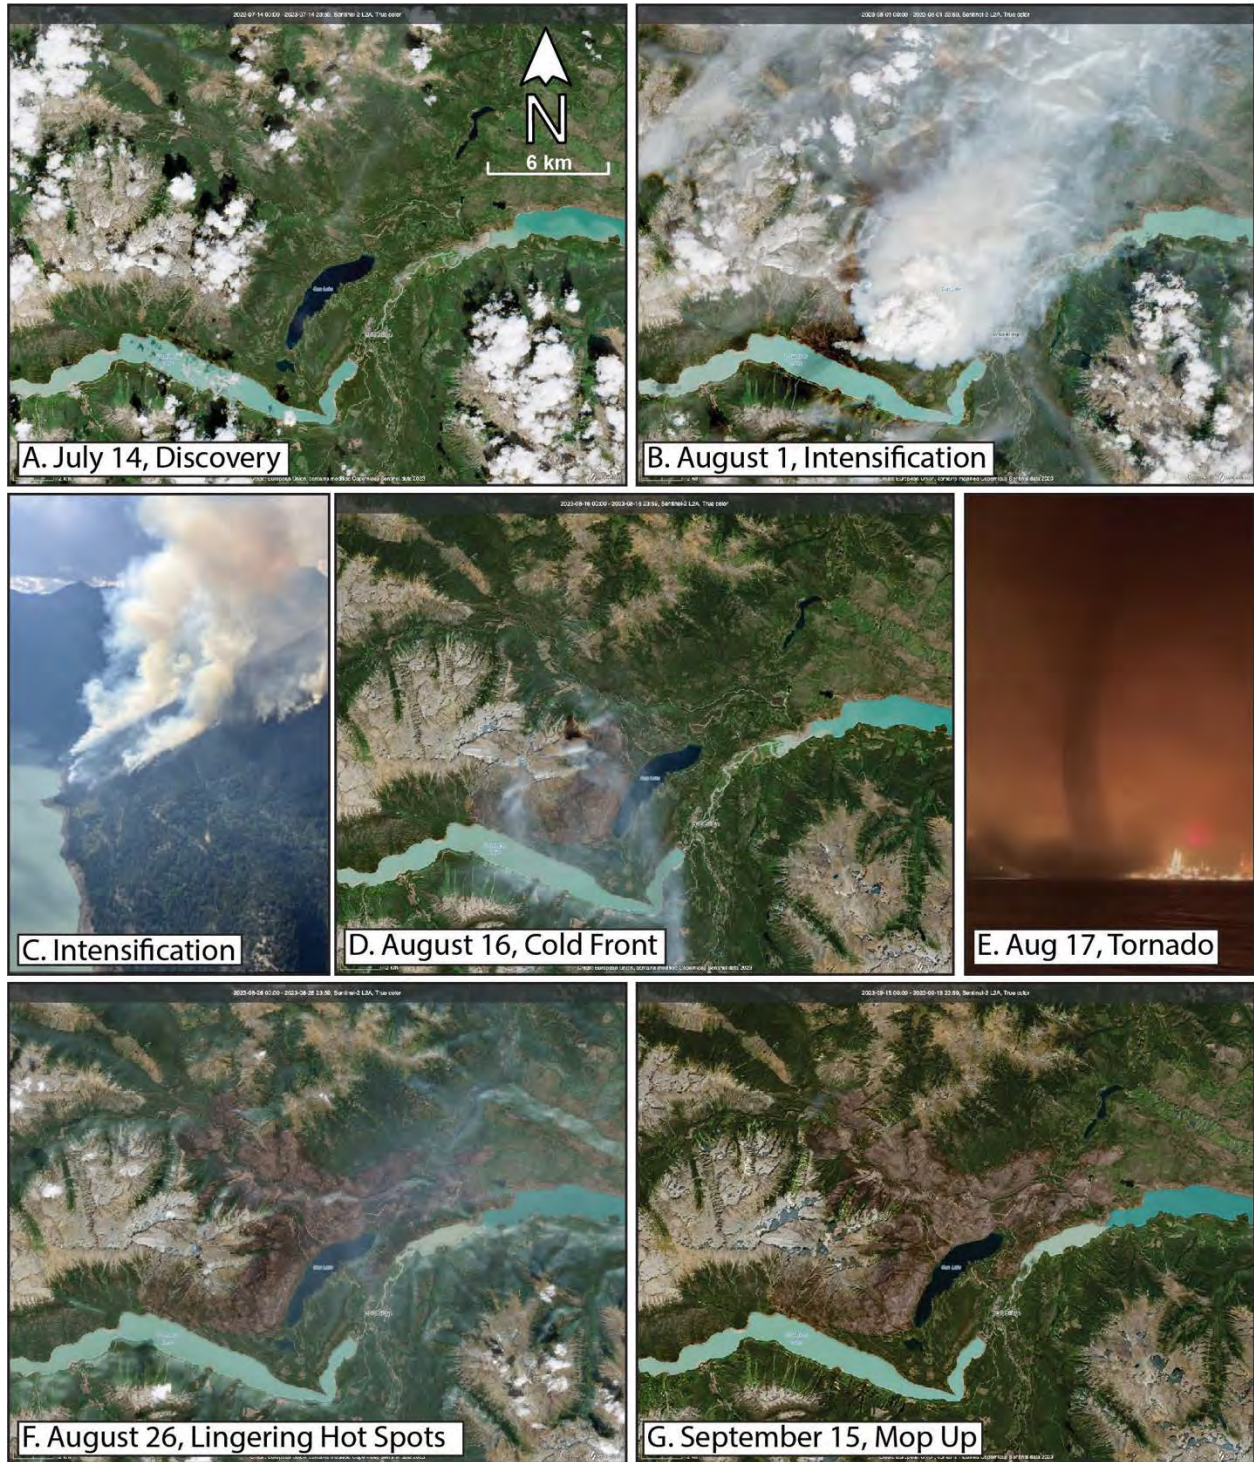
A fire tornado (Figure 6E) is a rare phenomenon, requiring a combination of high ambient heat, very low relative humidity and dew point temperatures, and fanning winds (Figure 5). On the evening of August 17th, originating off Gun Lake, the fire tornado touched down at 13770 Gun Lake Road West (509974 m E, 5637022 m N) creating a damage corridor 300 m in diameter with the vortex throwing trees from the perimeter in to the center, with a few large diameter trees snapped indicating Storm Force (Force 10; 89-102 km/hr) or greater wind speeds (Photos 9, 10).²

Figure 6. Progression of the Downton Lake Fire, July 14 to September 15, 2023. Satellite imagery (A, B, D, F, G) from <https://dataspace.copernicus.eu/>. Photos C, E from the BC Wildfire Service.

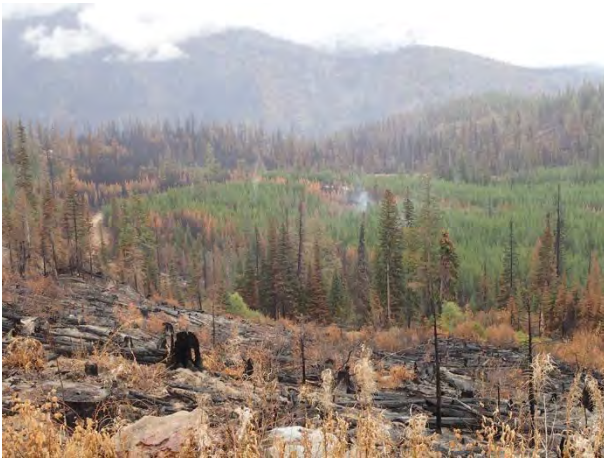
Vegetation burn severity describes the degree of fire impact on the forest canopy and understory (Photo 12). The following classification is used (after Curran et al, 2006):

Photo 12. A mosaic of vegetation burn severities which was well reflected by the BARC mapping.

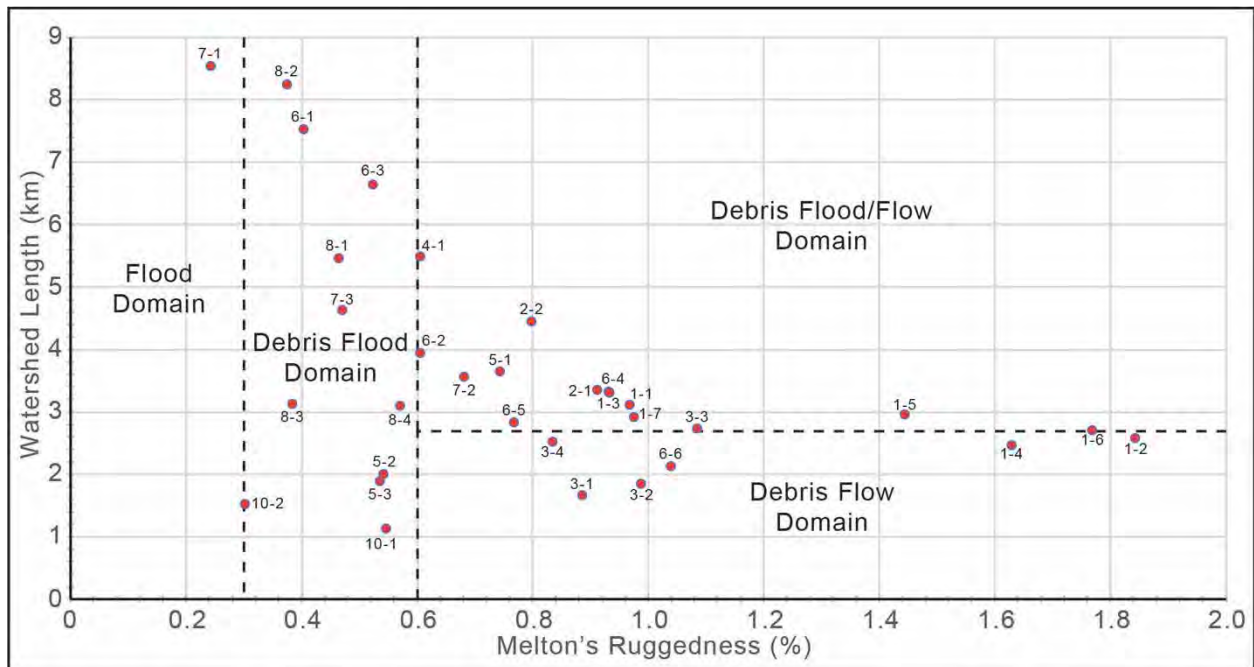
- 1) Flood (Fw, ruggedness <30%),
- 2) Debris flood (Fd, ruggedness $\geq 30\%$ & <60%),
- 3) Debris flood/flow (Fd/Df, ruggedness $\geq 60\%$, watershed length >2.7 km), and
- 4) Debris flow (Df $\geq 60\%$ ruggedness, watershed length ≤ 2.7 km).

Figure 7. Geomorphic domains for sub-basins overlapped by the Downton Lake fire boundary.

Table 6 presents the results of the analysis for 31 sub-basins divided amongst nine landscape units. 66% of creeks have >60% ruggedness and are either debris flood/flow or debris flow Creeks. 33% of creeks are debris flood creeks. There are no steep sub-basins in landscape Unit 9, Lajoie-Plateau Ponds, so that area is not shown.
