Chemainus River Emergency Sediment Removal

# Construction Completion Report

**Final Report**  
**February 1, 2023**  
**KWL Project No. 3427.021**

**Prepared for:**  
**BC Ministry of Environment and Climate Change**

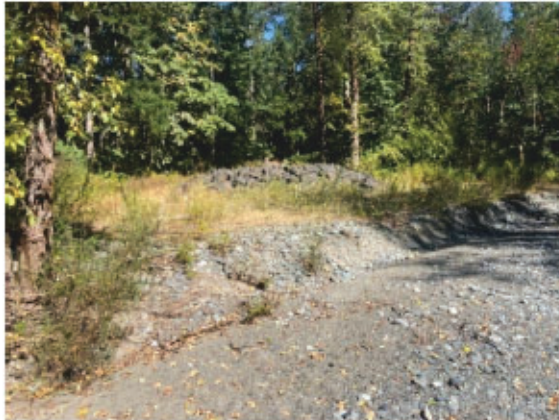
Well heads for the District of North Cowichan (DNC) water supply system are located adjacent to the side channel and are protected by riprap (Photos 1 and 2). The elevation of the riprap beneath the newly constructed channel is roughly 7.2m (above CGVD28 Datum), and the elevation of the bottom of the channel at this location is roughly 7.9m. A test pit was dug at the downstream well head to confirm the location of the riprap. Additional riprap armouring was determined as unnecessary based on the test pit and the record drawings for the well head protection provided by DNC.

**Photo 1: DNC Water Supply Well Head Protected by Riprap Adjacent to Side Channel**

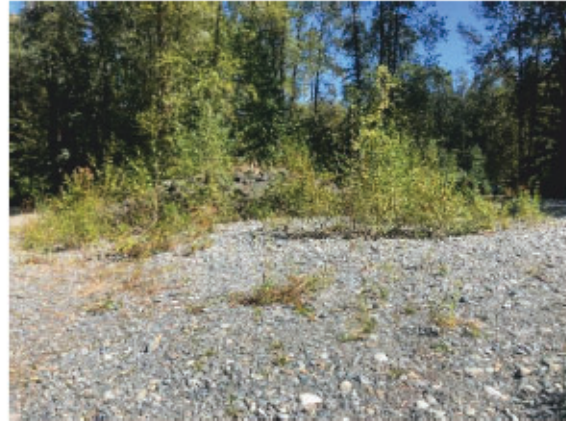
**Photo 2: DNC Water Supply Well Head Protected by Riprap Adjacent to Side Channel**

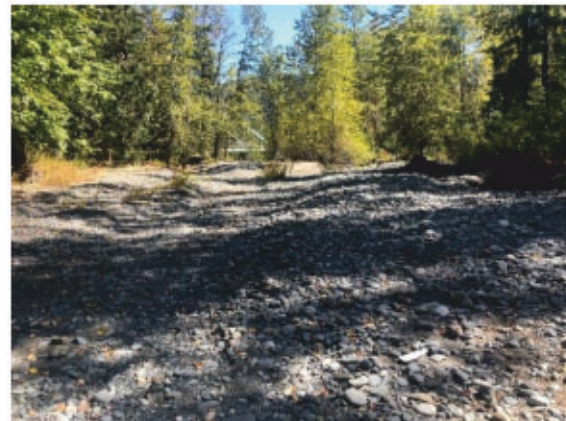
Site 1 consists of a gravel/cobble point bar on the mainstem and a relic side channel consisting of finer gravel and sand. Over time, sediment has built up in the side channel such that the elevation is about 1 to 2 m higher than the mainstem channel elevation and is only activated during high flow events. Photos 3 and 4 below show the point bar and side channel.

**Photo 4: Sediment Accumulated Inside Channel on Right Bank of Chemainus River**  
Note TCH Bridge in background

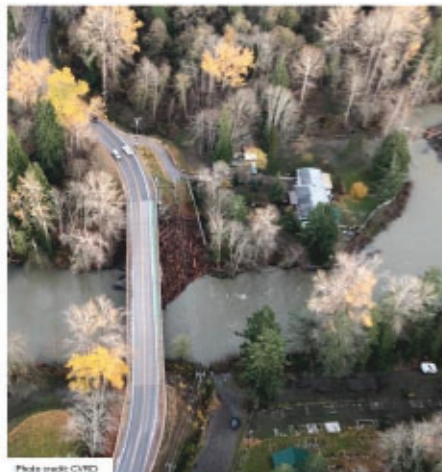
In November 2021, a large amount of wood debris accumulated on the right abutment of the Chemainus Road Bridge (Photo 11). This debris has since been removed. However, it remains a location where debris accumulates and may require removal at this location again in future.

The combination of debris and sediment accumulation in this location along with the relatively low right bank of the river in this location, can result in increased overbank flow. However, the potential for channel avulsion is limited as the entire reach between the two bridges is protected from erosion by either riprap or bedrock outcrops.

**Photo 11: Large woody debris on right abutment of Chemainus Road Bridge after November 2021 flood which has since been removed**

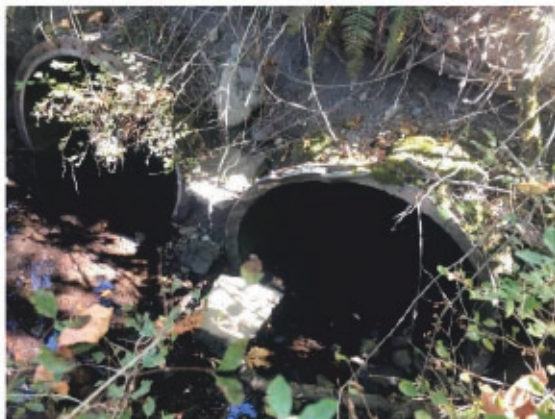
There are two 1,200 diameter steel culverts at the Swallowfield Access Road where it crosses the Swallowfield Access Road (Photo 13). These may be undersized for the flow in Butcher Slough and could be contributing to higher peak flood water levels upstream, near Tsussie Road.

**Photo 13: Swallowfield Access Road Culverts**

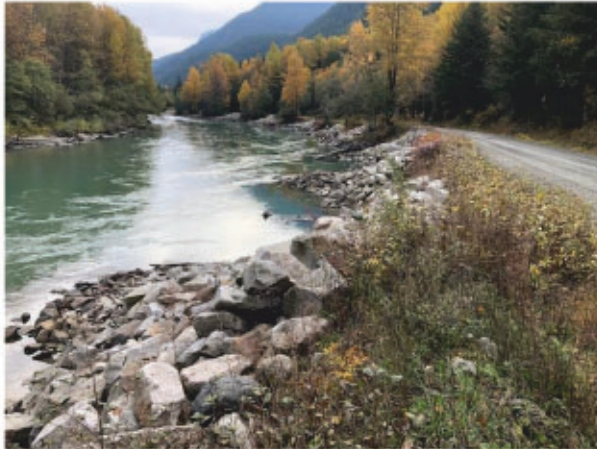
**Photo 15: Example of Combination of Riparian Habitat with Rock Hard Points for Erosion**

Given the risks associated with ongoing erosion of the right bank downstream of Highway 1 Bridge (Site 2), permanent protection of this highly erodible bank from further erosion is top priority. Permanent protection could include both hard points (riprap spurs or bendway weirs) to direct flow away from the bank as well as riparian and aquatic habitat features to protect and promote healthy fish habitat in the reach. An example of a site combining hard points with riparian habitat is shown in Photo 15.

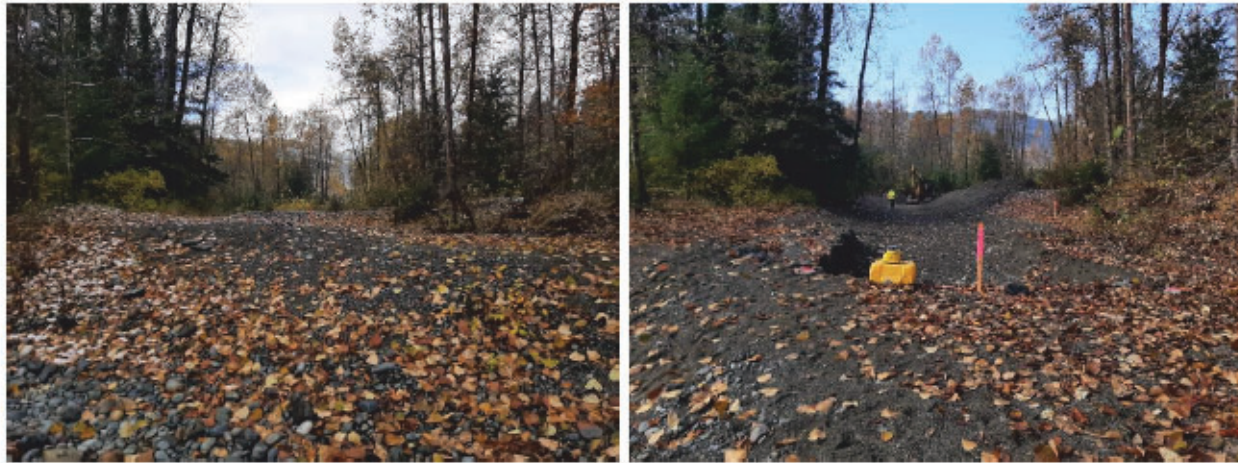
Before and during photos of the downstream end of the left bank side channel excavation.

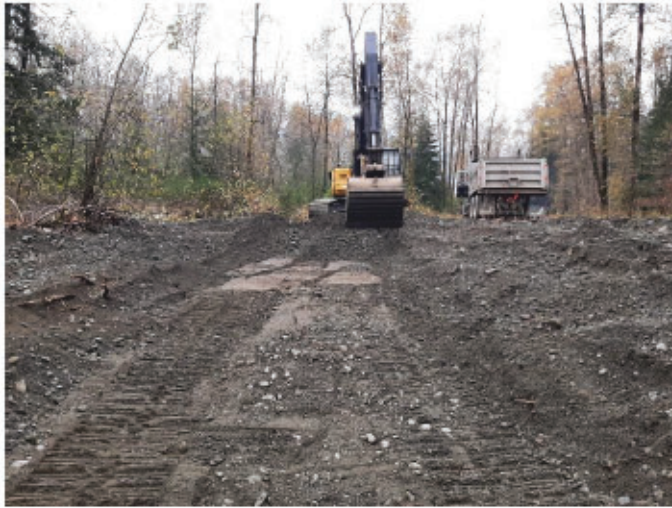
Onsite works were conducted from November 7 – 18, 2022 inclusive of pre-work meetings and demobilization from site. Works consisted primarily of removal of sediments with excavators and hauling off site with dump trucks (Photo 4). Additionally, one downed tree was removed from the mainstem channel immediately upstream of the point bar (Photo 5, Figure 1).

**Photo 4: A dump truck being loaded by an excavator on accreted sediments of the historic side channel on Nov. 9, 2022.**

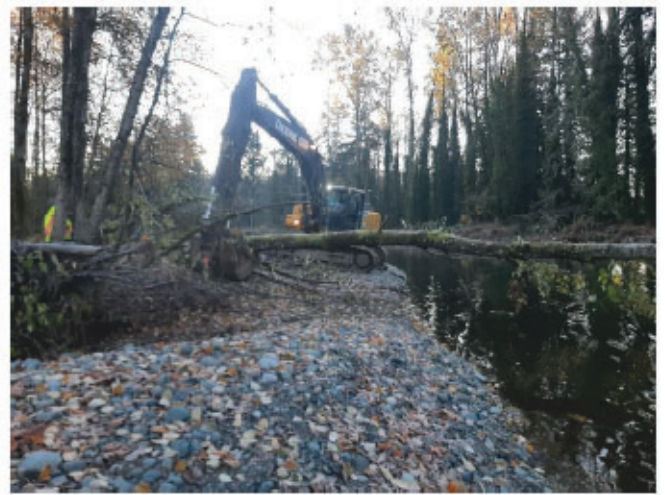
**Photo 5: Excavator removing downed cottonwood from the mainstem channel immediately upstream of the point bar.**

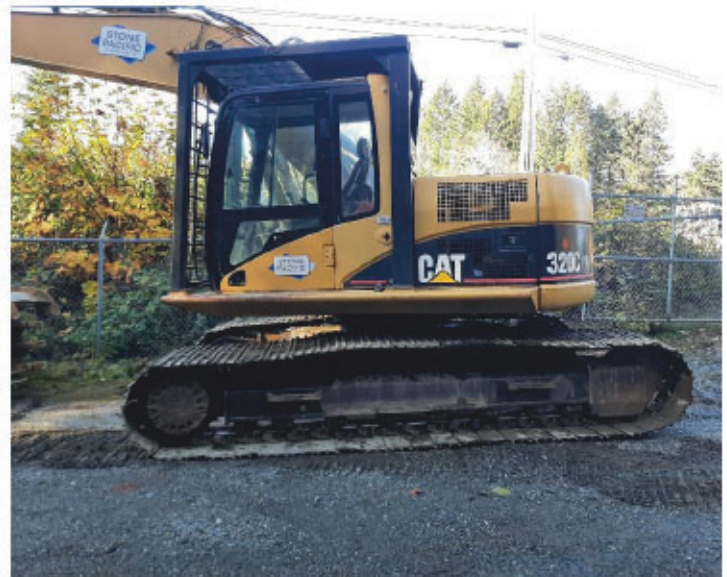
**Photo 7: Excavator arriving on site pressure washed clean to avoid introduction of invasive species.**

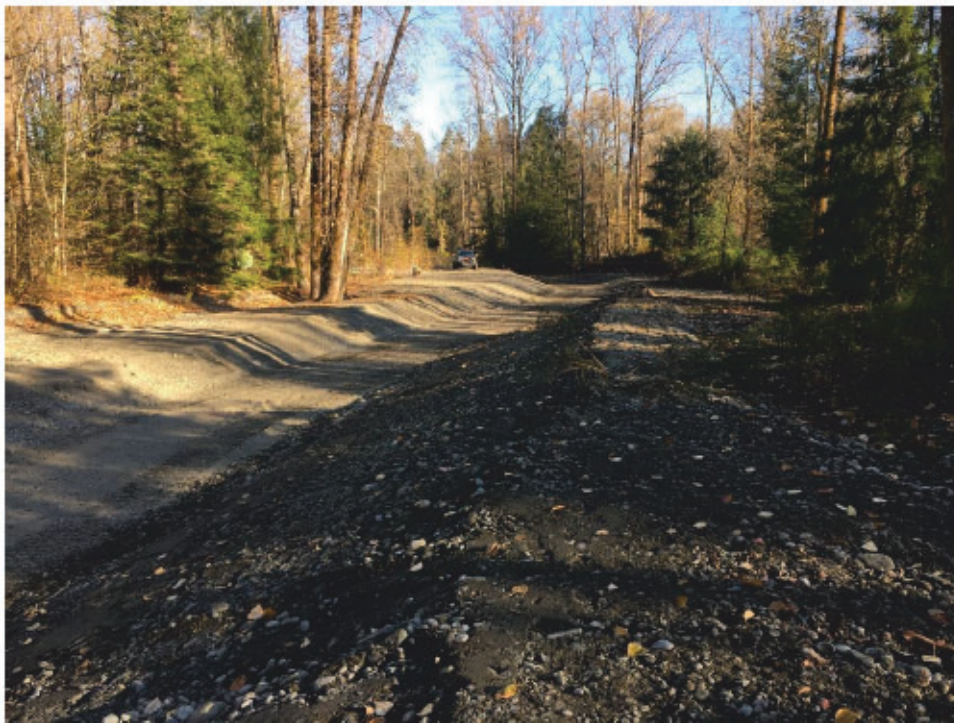
**Photo 10: Walls of newly excavated left bank side channel after compaction with excavators.**

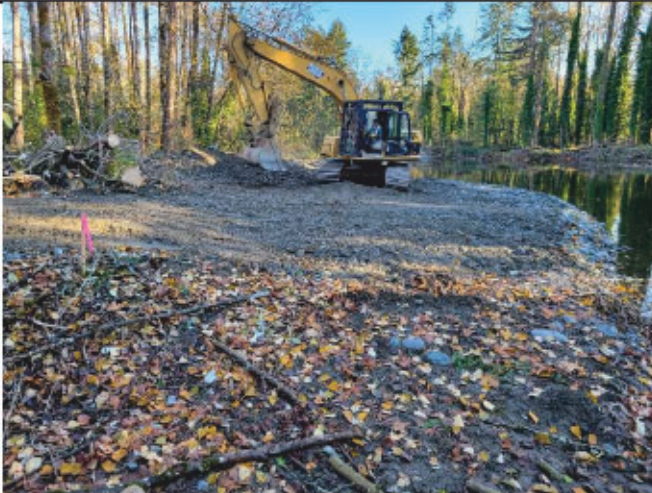
**Photo 1:** Bar topping nearing completion with removed tree

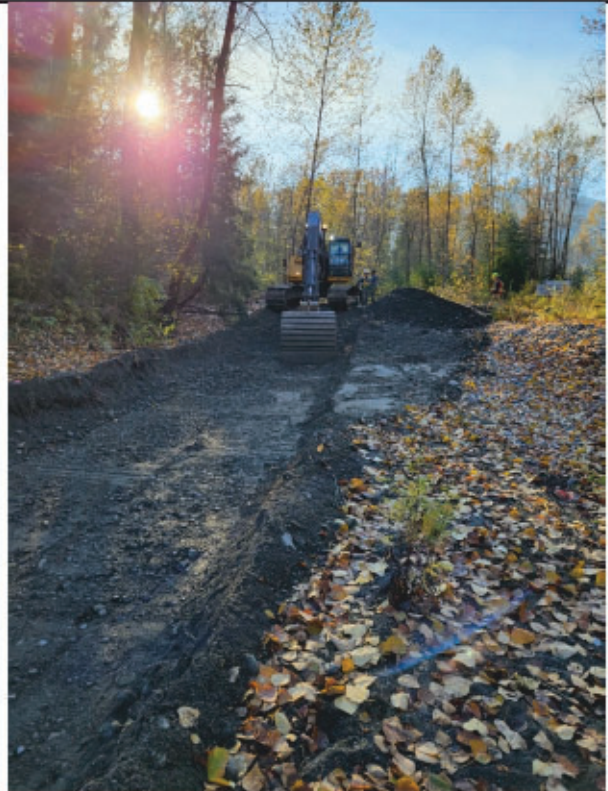
**Photo 2:** Overflow channel excavation beginning

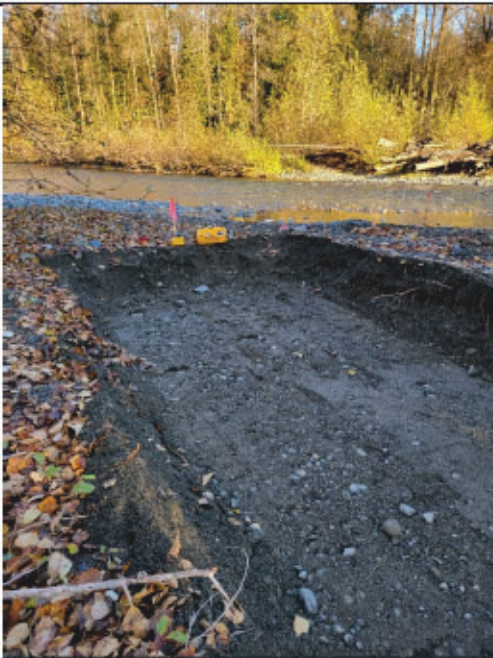
**Photo 3:** Unexcavated "berm" at downstream end of channel.

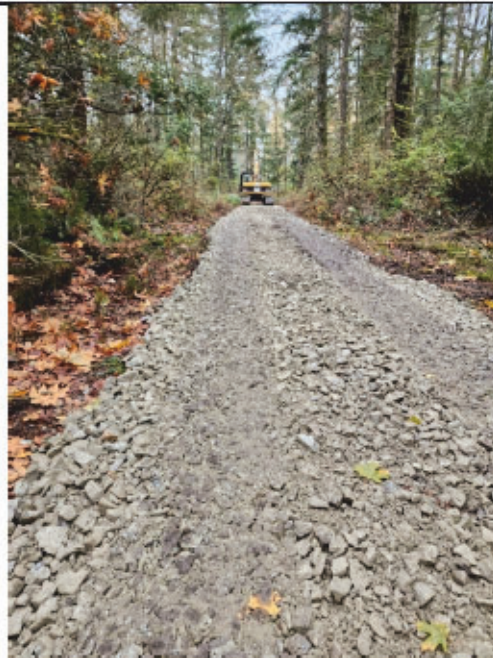
**Photo 2:** Material trucked in for access road.

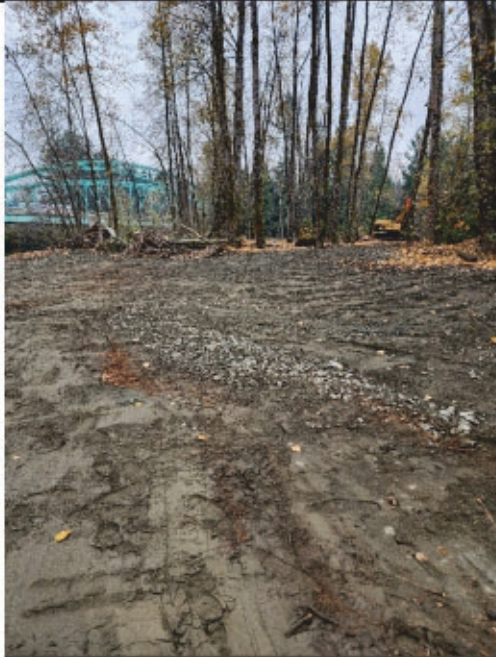
**Photo 3:** Point bar at completion mid-day.

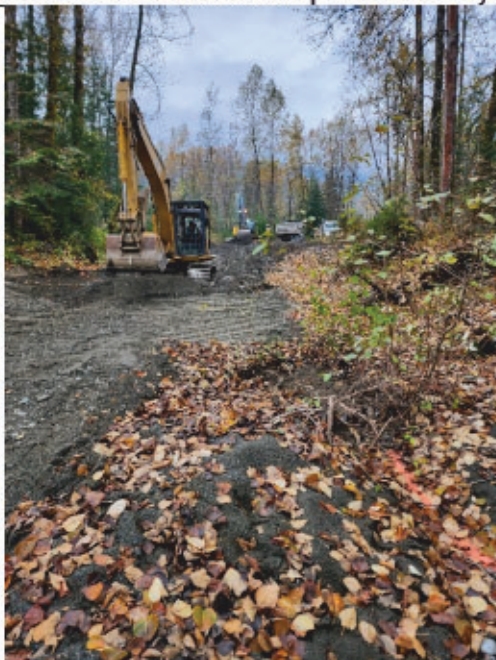
**Photo 5:** Looking upstream, one operator performing bulk material removal while grading commences at the downstream wedge.

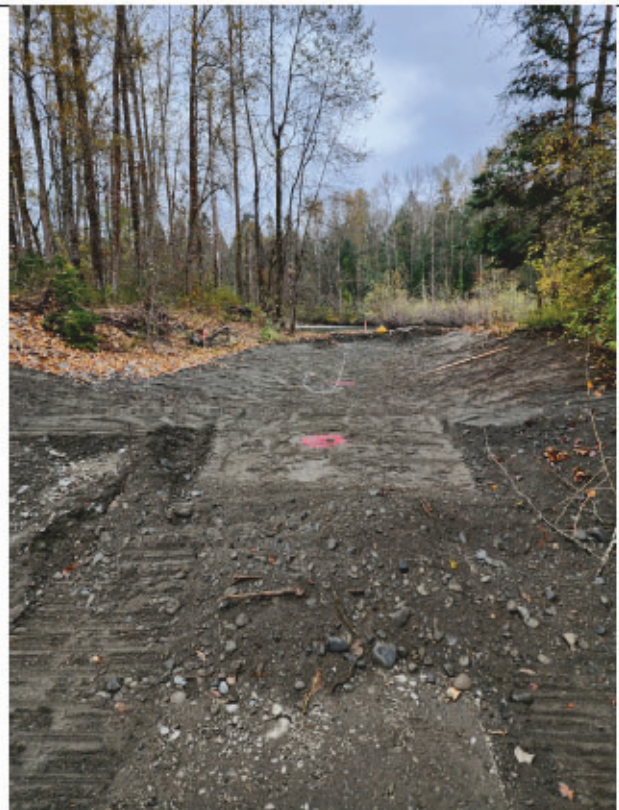
**Photo 6:** End of day progress downstream.

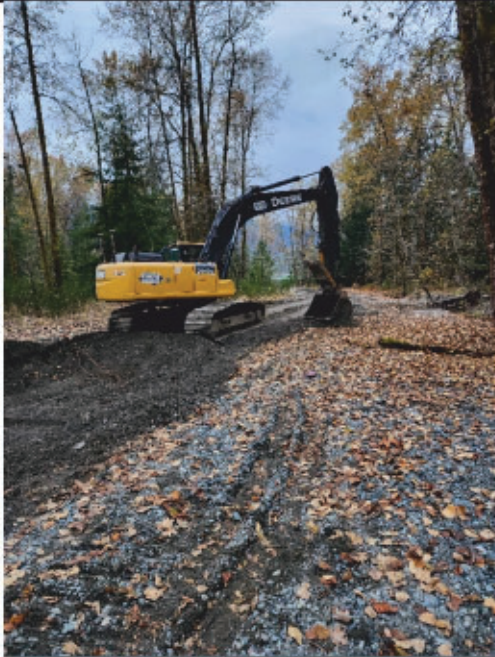
Photo 7: Looking upstream, end of day progress.

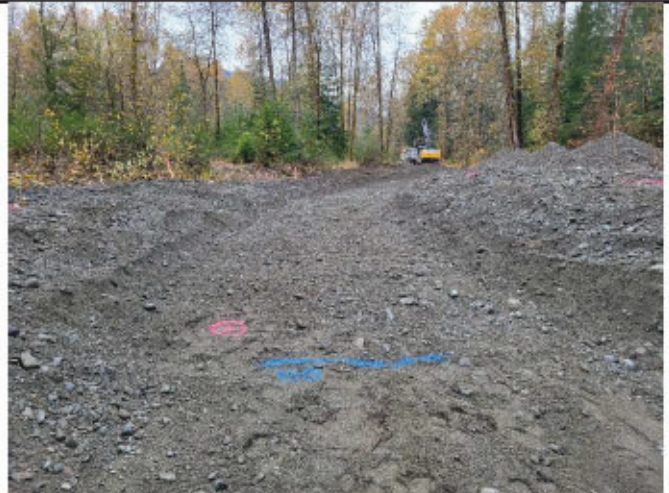
**Photo 2:** Current channel geometry, looking upstream

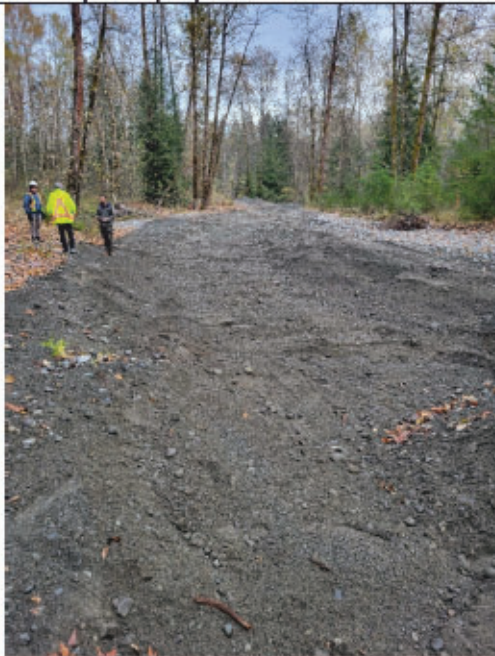
**Photo 3:** End of day channel extents, looking downstream

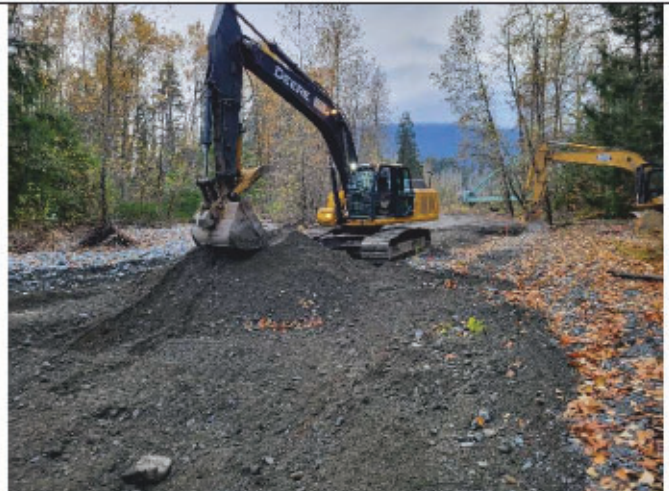
**Photo 4:** End of day progress – excavation has nearly reach the access road

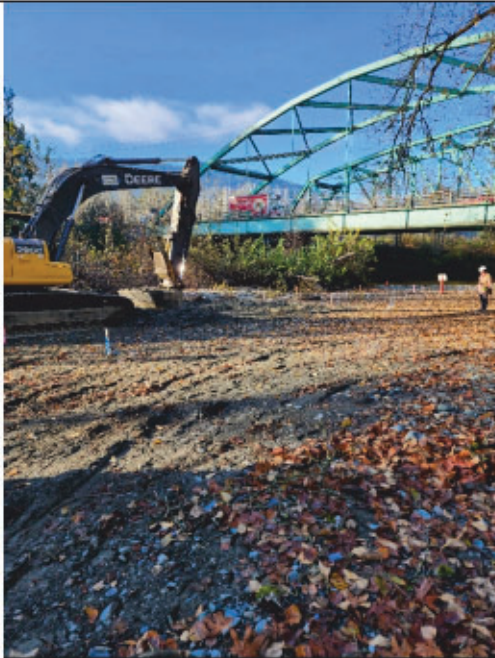
**Photo 1:** Excavation starting at upstream end.

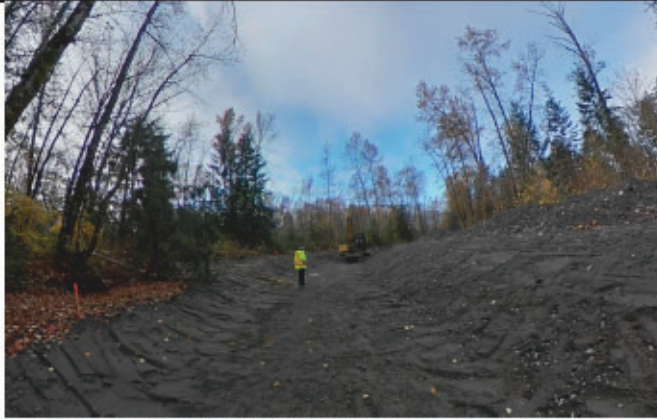
Photo 3: Grading continued towards upstream end.

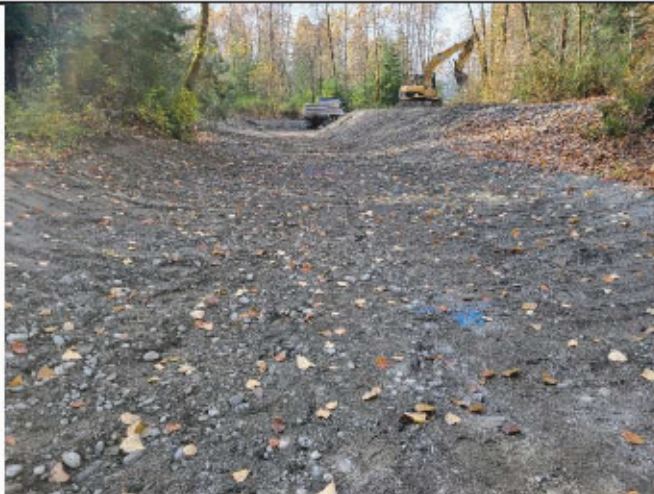
**Photo 1:** Initial shaping of 3:1 side slopes at the downstream end

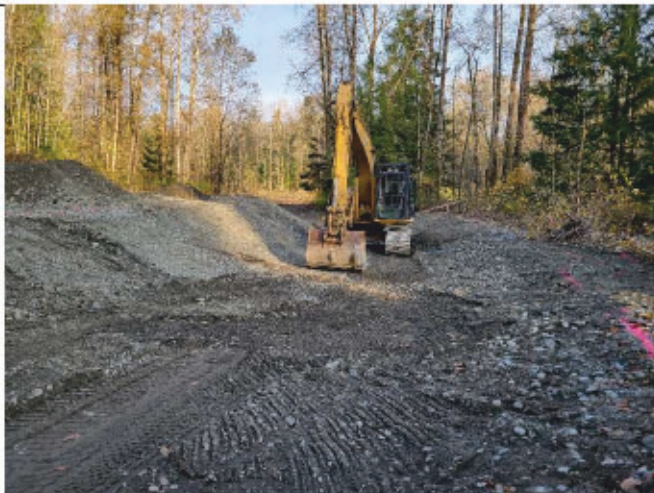
**Photo 3:** End of day progress at downstream end, looking downstream

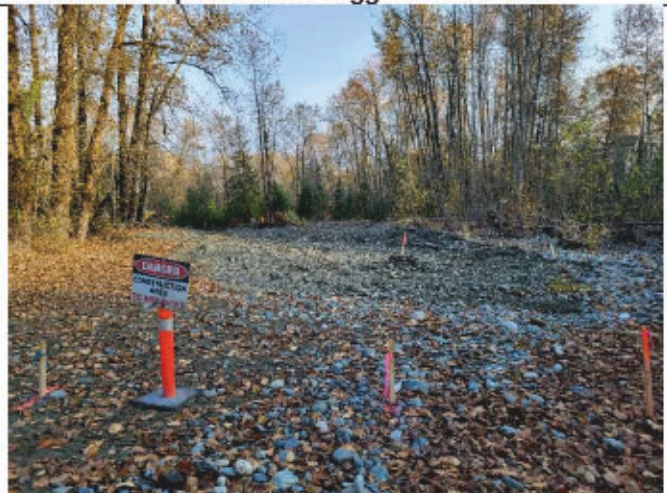
**Photo 4:** End of day progress at upstream end, some excavation remains at the access road

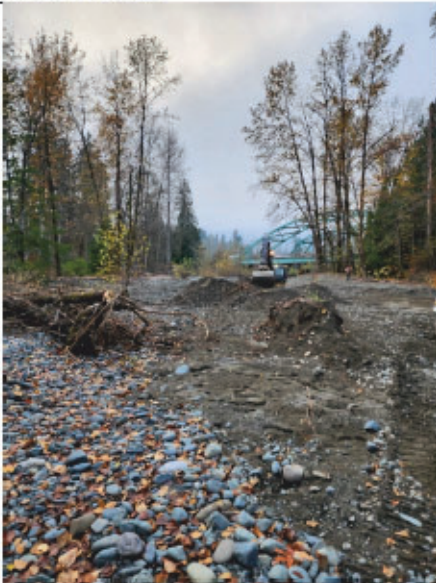
**Photo 1:** End of day, excavation remaining

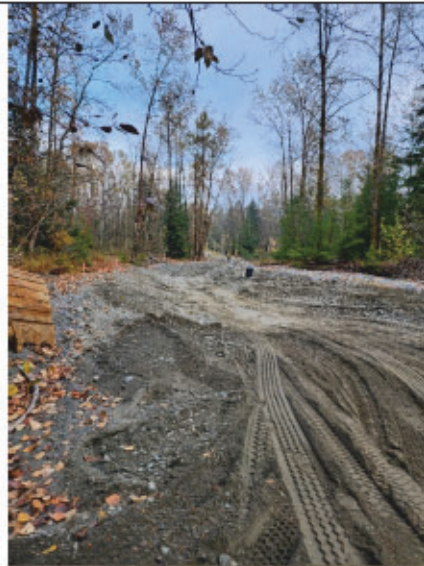
**Photo 2:** End of day progress looking downstream.

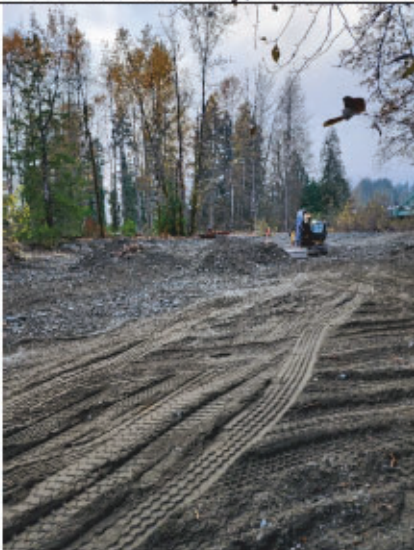
**Photo 3:** Remainder of bulk removal at end of day.

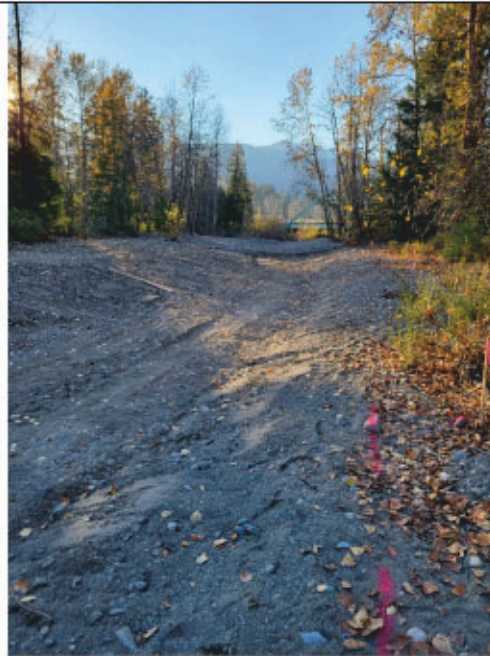
**Photo 2:** Channel excavation complete

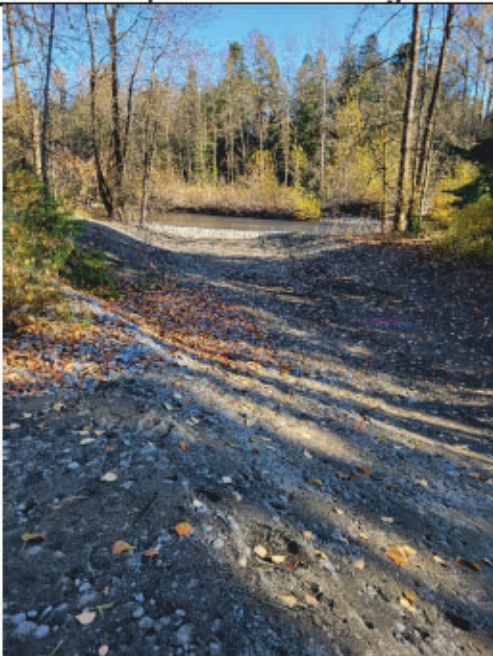
**Photo 3:** Downstream fill berm removed

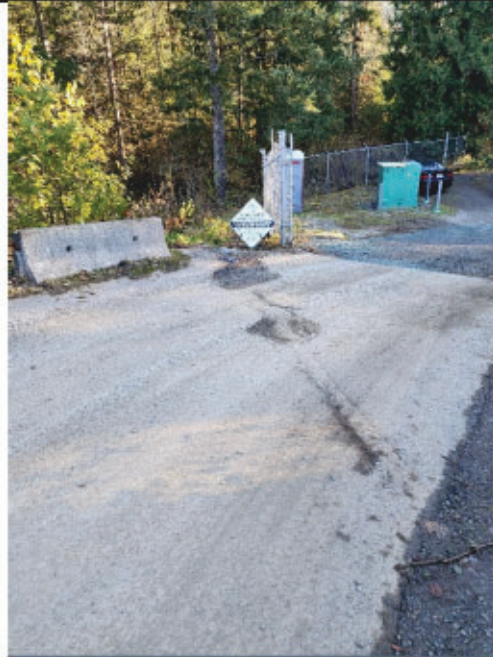
**Photo 2:** Drainage curb from another angle.

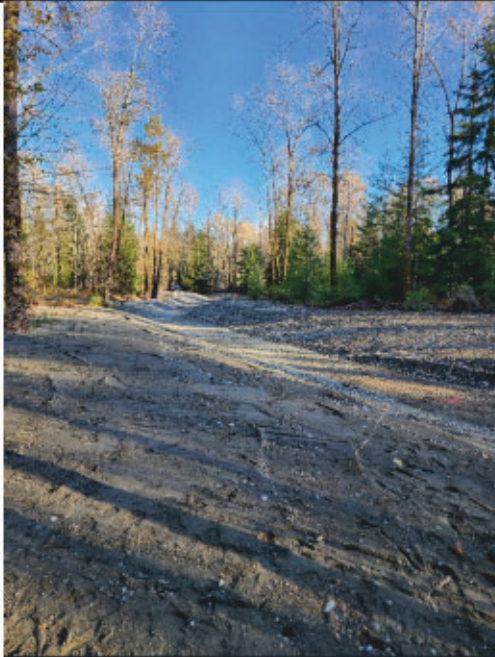
**Photo 5:** End of day, construction wrapped up.

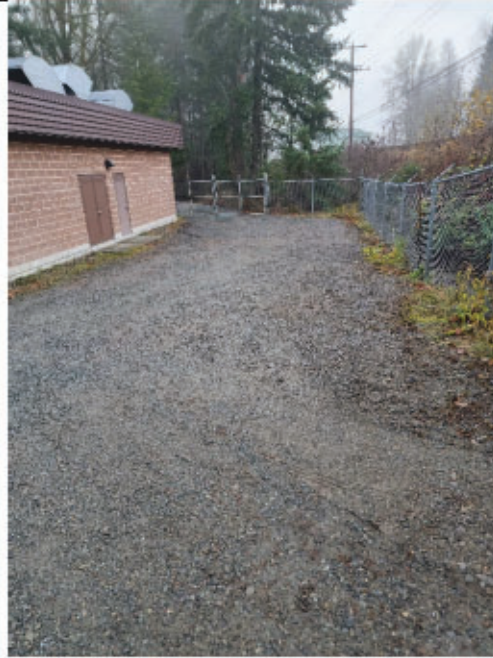
**Photo 2:** Pump house lot after demob.

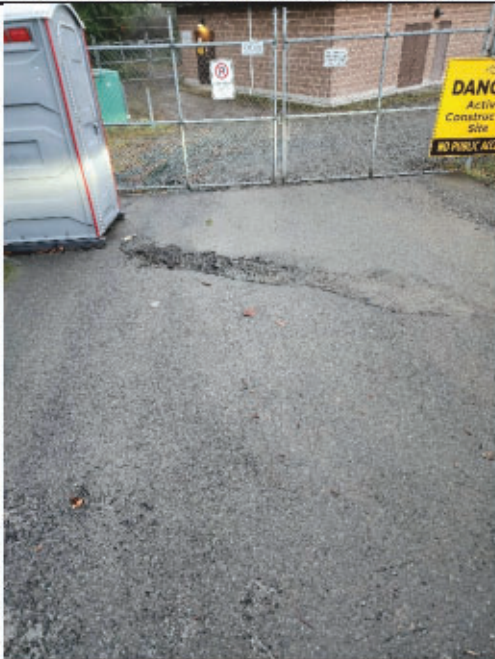
**Photo 3:** Asphalt drainage curb after demob.
