# Ministry Of Environment and Climate Change Strategy

## Hatzic Emergency Work Program Pattison Creek

FEBRUARY 2024

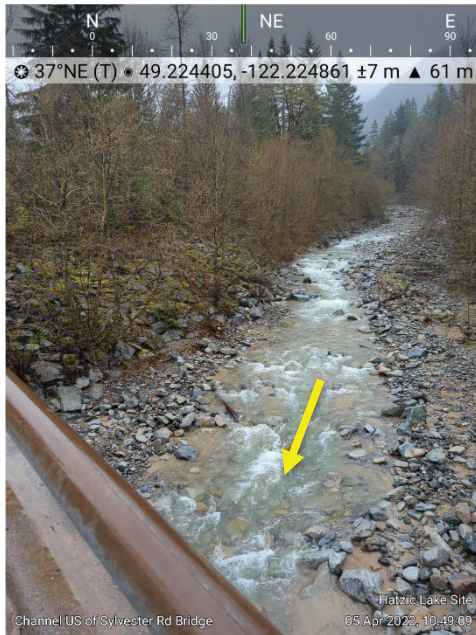
Pattison Creek:  
Viewing Upstream from Sylvester Road Bridge

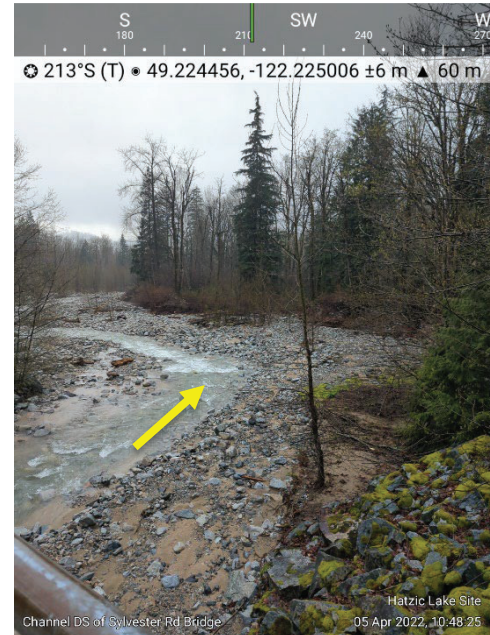
Pattison Creek:  
Viewing Downstream from Sylvester Road Bridge

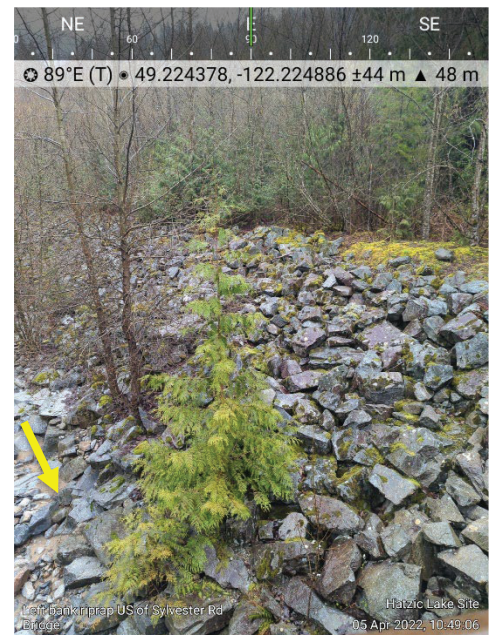
Riprap on Left Bank upstream of Sylvester Road Bridge

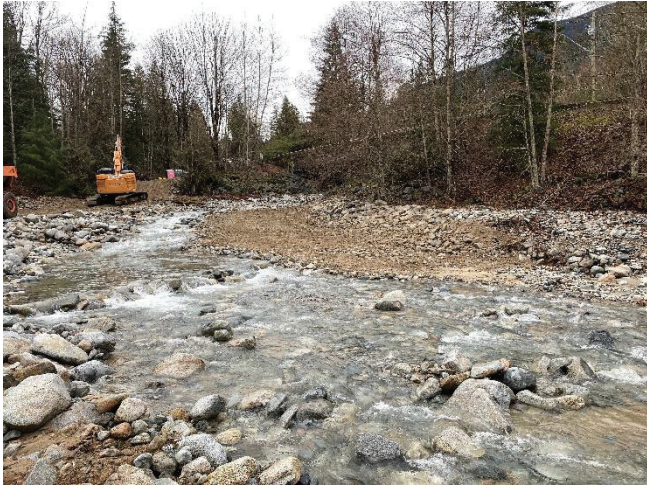
Figure -3  
Looking northerly at the cleaned east bank at 0 020  
to 0 040

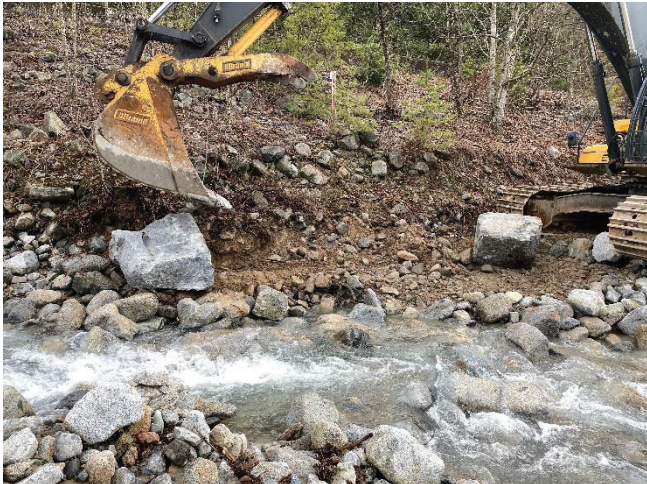
Figure -  
Looking easterly at start of rip rap placement- keying  
in

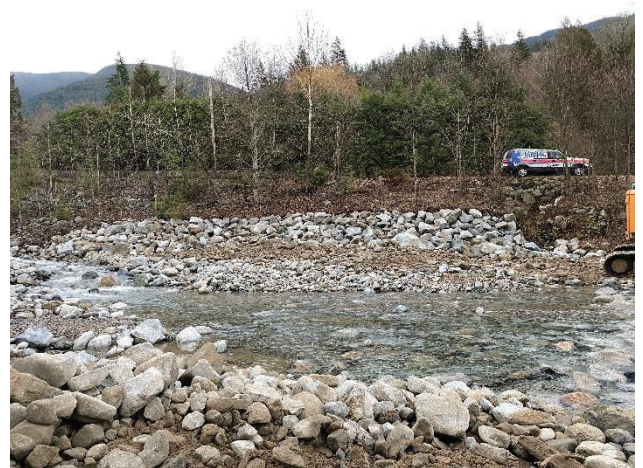
Figure -  
Looking easterly at the completed placement of rip  
rap on east bank -erosion protection

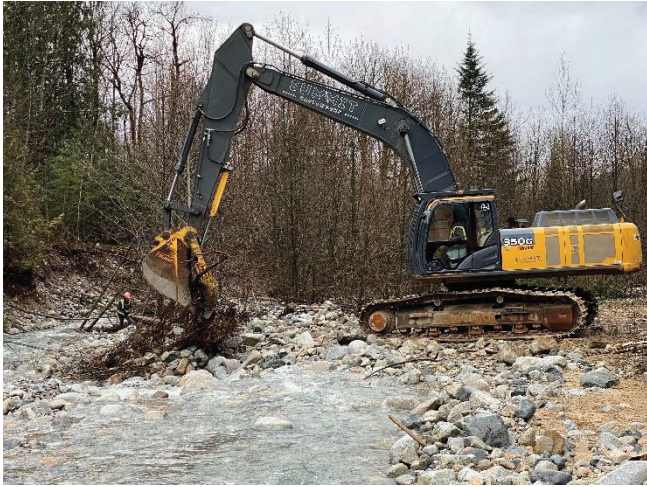
Figure -  
Looking southerly at debris removal at 0 100

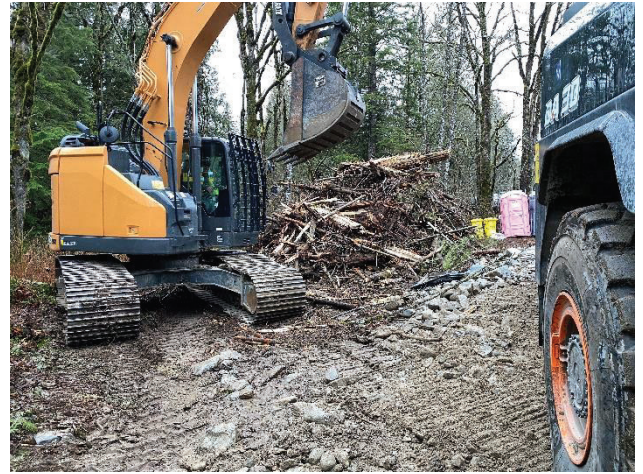
Figure -  
Looking at wood stockpile

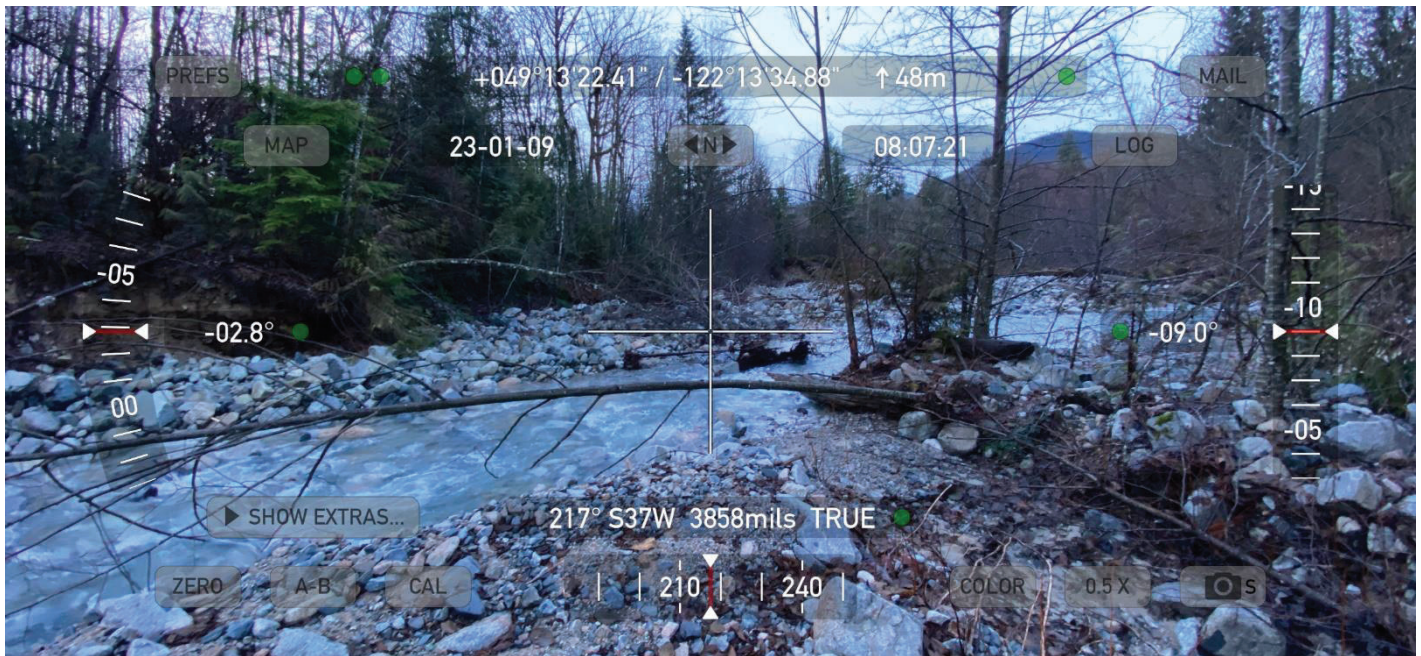
Figure -  
Looking at 0 200 before tree removal at creek edge

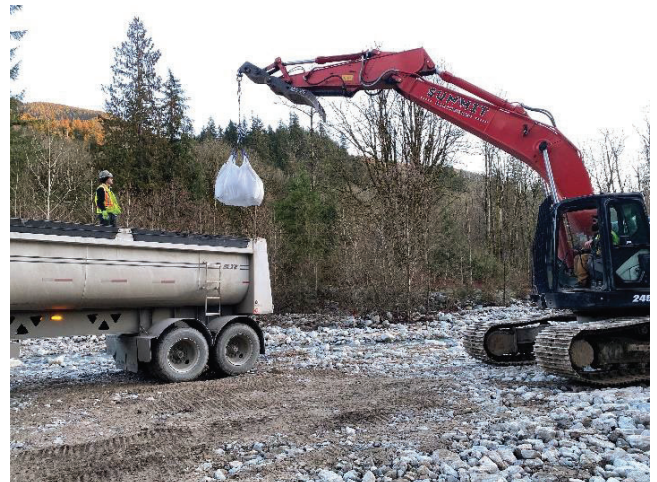
Figure -2  
Looking southerly at meg bags being off loaded

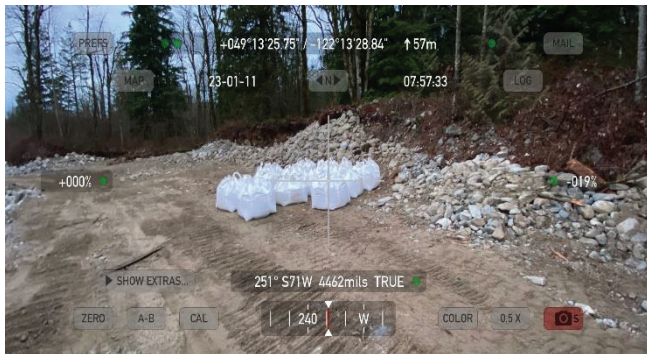
Figure -1  
Looking southerly at the meg bags on site

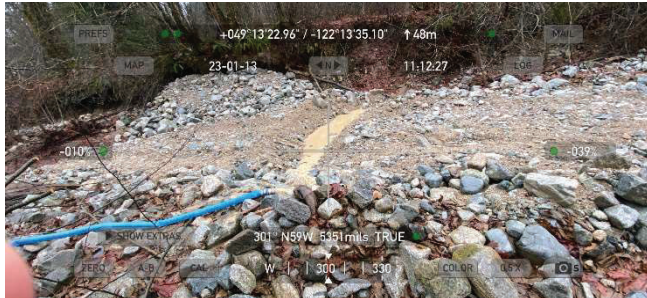
**Figure -9**  
Looking westerly at pumped out excess water settlement

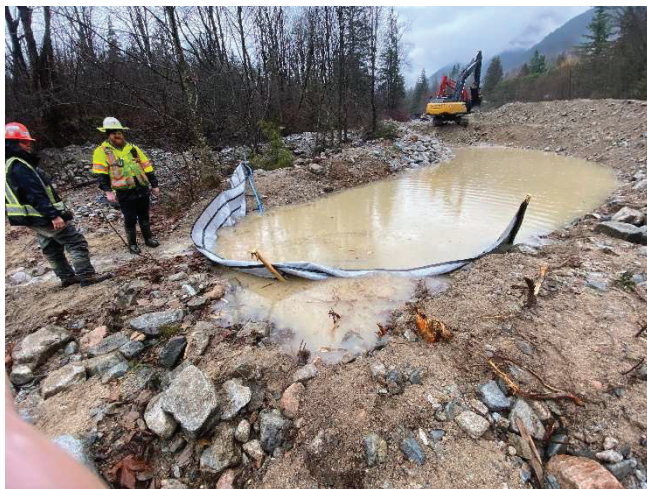
**Figure -11**  
Looking northerly at installed settlement fencing

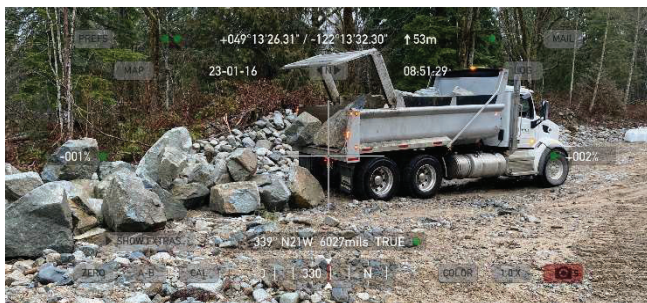
**Figure -1**  
Looking at delivery of 1000kg rip rap to site

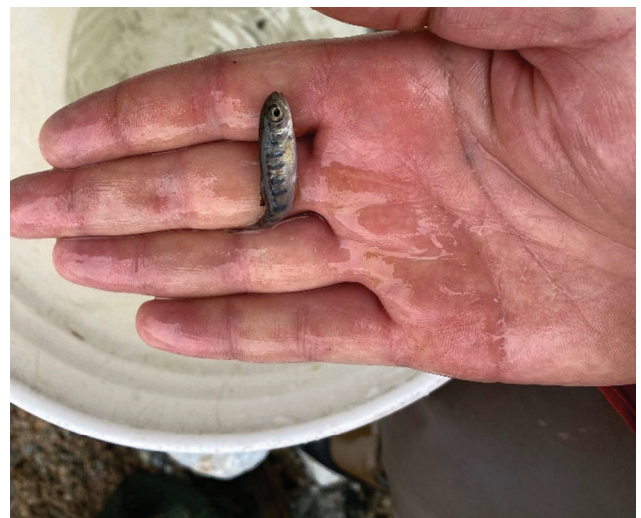
**Figure -4**  
Looking at recovered coho from infill stream

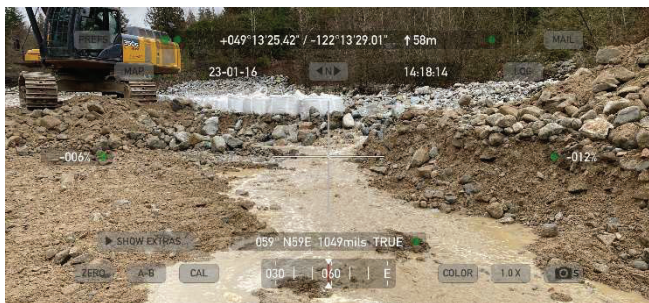
**Figure -7**  
Looking northerly at the opening to water on the new channel

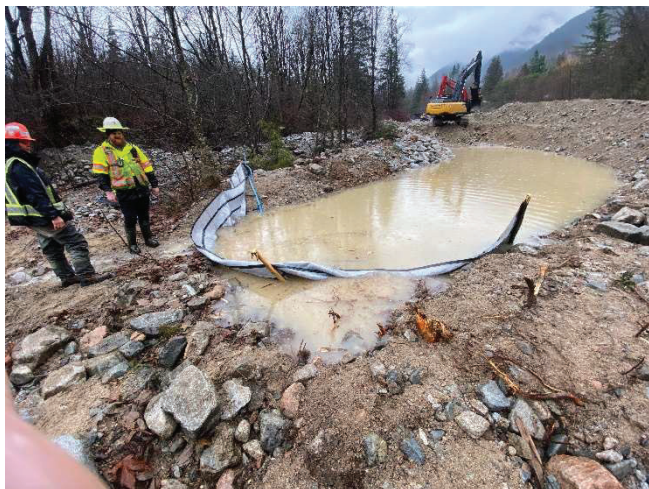
**Figure -11**  
Looking northerly at installed settlement fencing

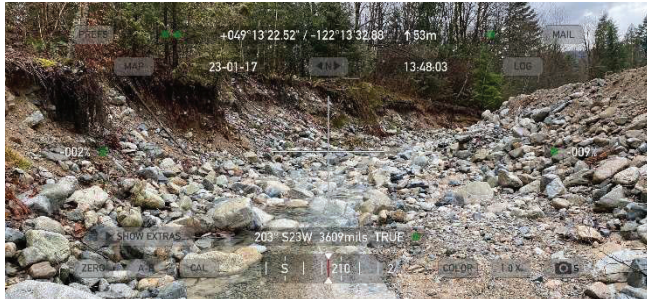
**Figure -3**  
Looking southerly at infill section

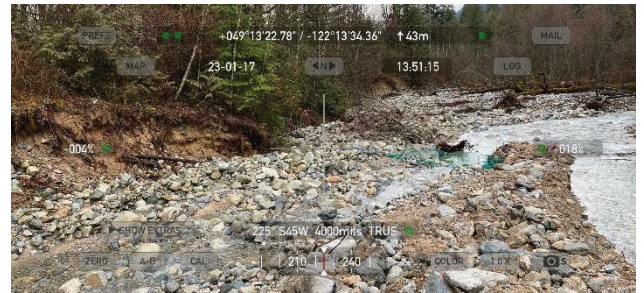
**Figure -4**  
Looking southerly at downstream section creek -  
infill section -east bank

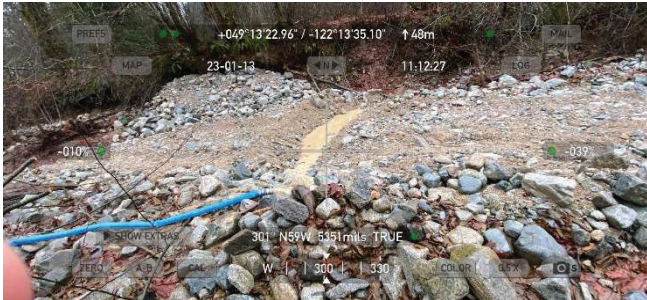
**Figure -9**  
Looking westerly at pumped out excess water settlement

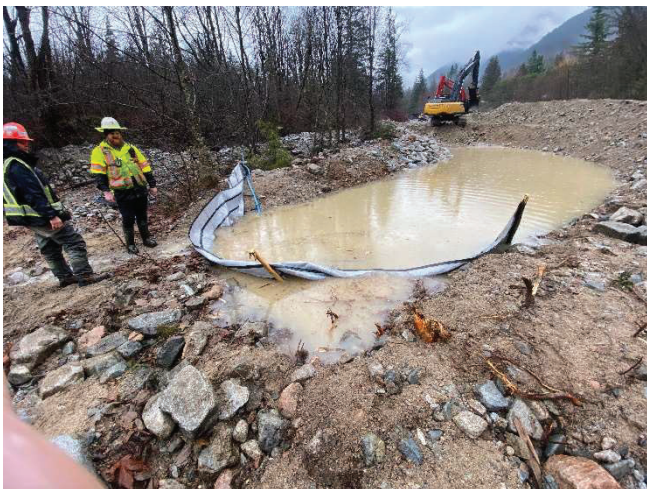
**Figure -11**  
Looking northerly at installed settlement fencing

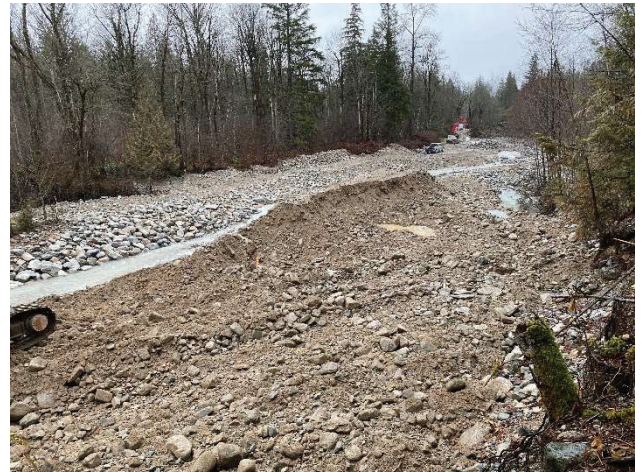
**Figure -4**  
Looking northerly at infill at 50% complete

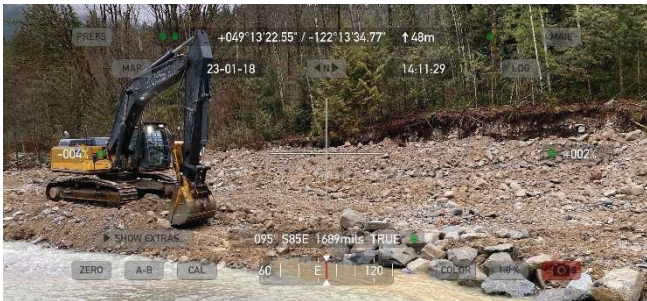
**Figure -5**  
Looking at mid section of the infill works

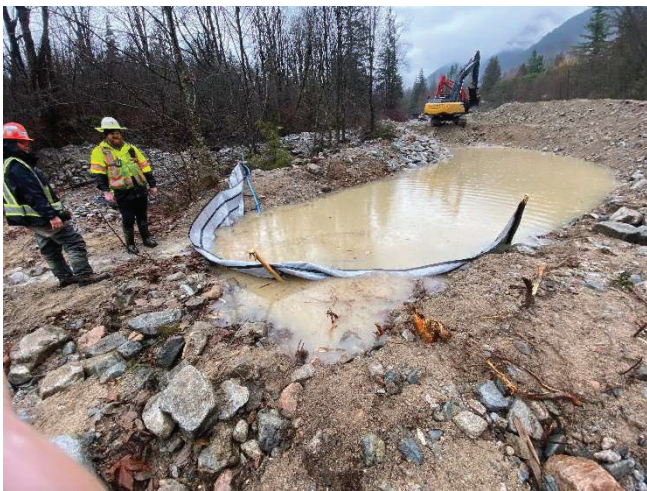
**Figure -11**  
Looking northerly at installed settlement fencing

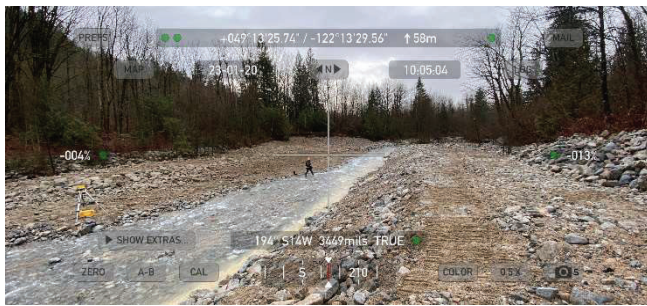
**Figure -1**  
Looking southerly at new diverted creek

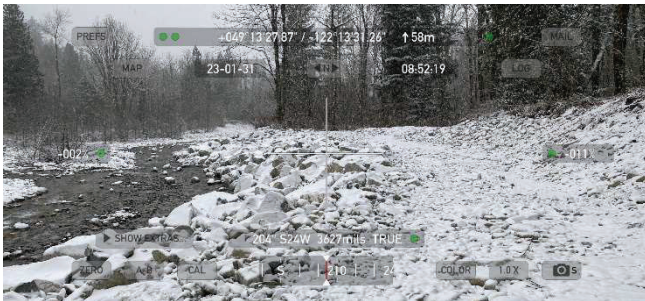
**Figure -5**  
Looking southwesterly at creek rip rap covered in snow

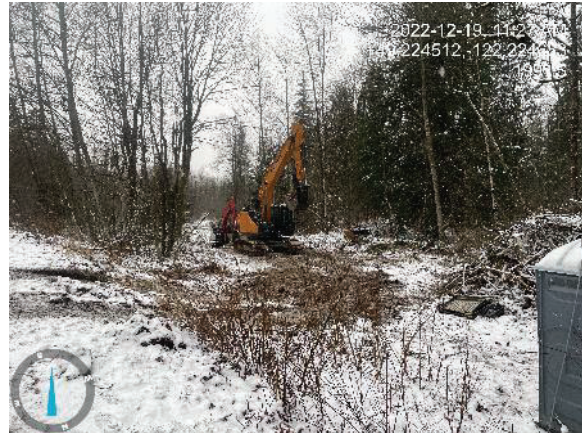
Photo 2. South-facing view of grading of the access road, above the wetted perimeter of Pattison Creek (Dec. 19, 2022).

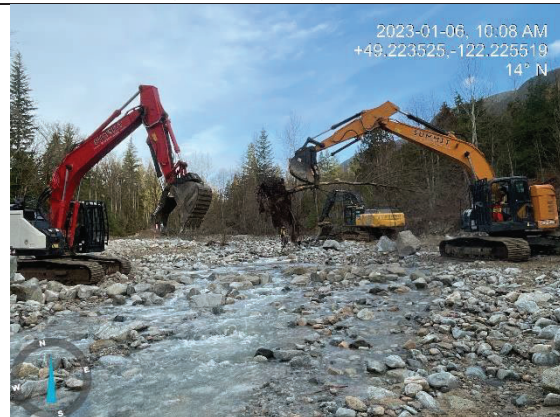
Photo 6. rock placement to minimize sediment upheaval for stream crossing (Jan 06, 2023).

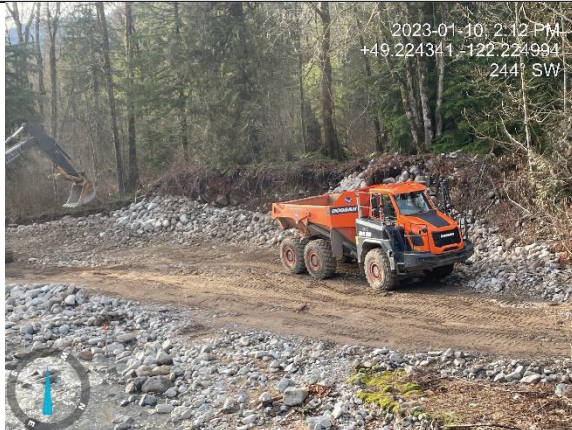
Photo 5. West bank stabilization (Jan 10, 2023).

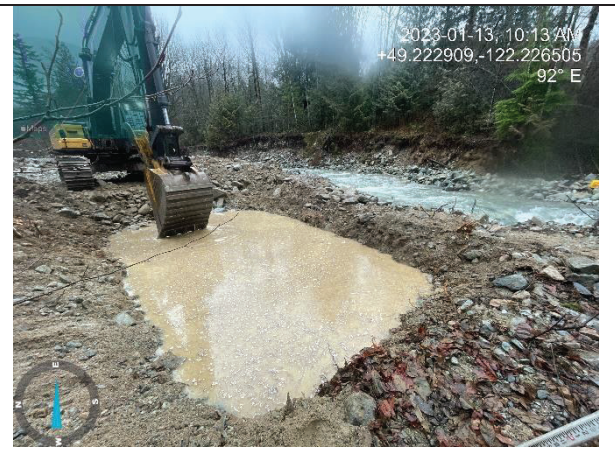
Photo 12. Pic of the excavation for the creek diversion channel. Turbid water was allowed to settle and has not yet been released from containment (Jan 13, 2023).

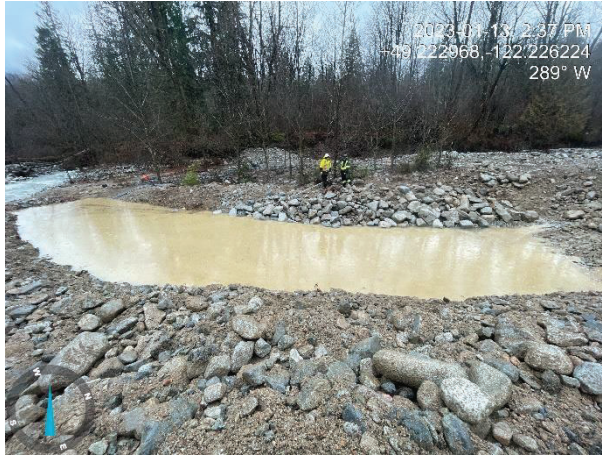
Photo 17. Turbid water within the excavated diversion channel was contained and left to settle over the weekend. (Jan 13, 2023).

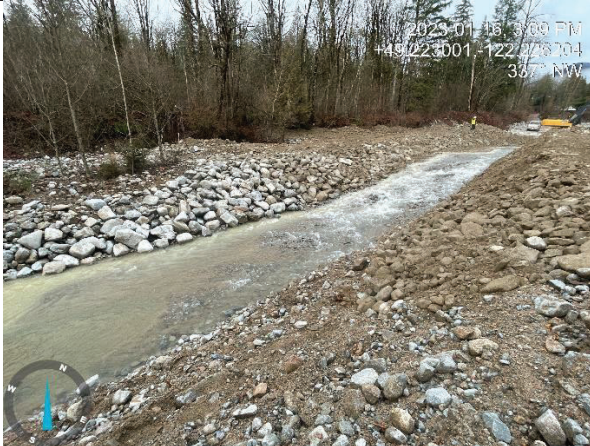
Photo 7. Flow within the diversion channel, slowly removing deflection berm gravel bags by end of the day (Jan 16, 2023).

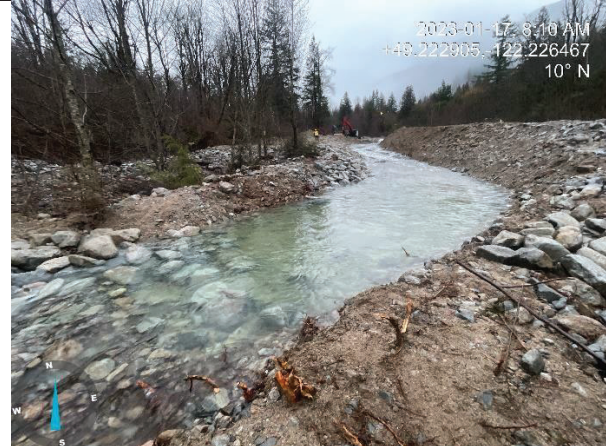
Photo 8. 75% of available flow diverted to the diversion channel (Jan 17, 2023)

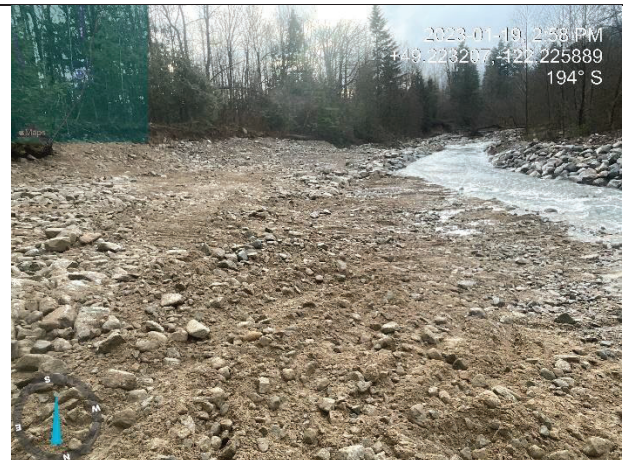
Photo 20. East embankment stabilized (Jan 19, 2023)

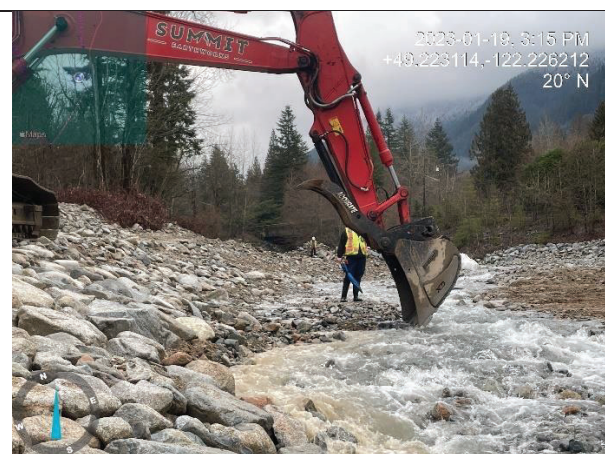
Photo 22. Sediment deposit removal from creek causing high turbidity monitoring (Jan 19, 2023).

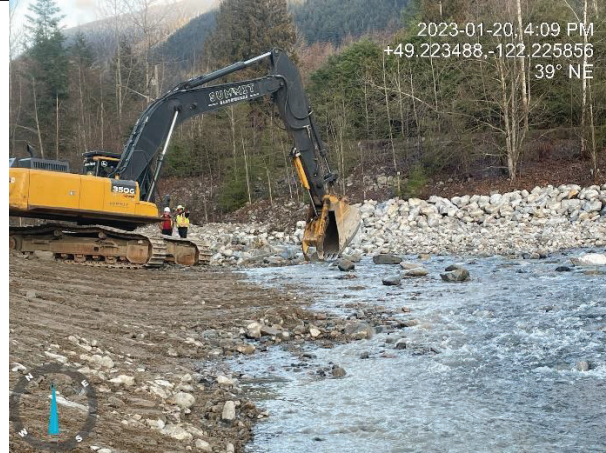
Photo 29. Excavate turbid material on inside of berm bags, and remove bags for the weekend, placing large boulders back in creek (Jan 20, 2023).

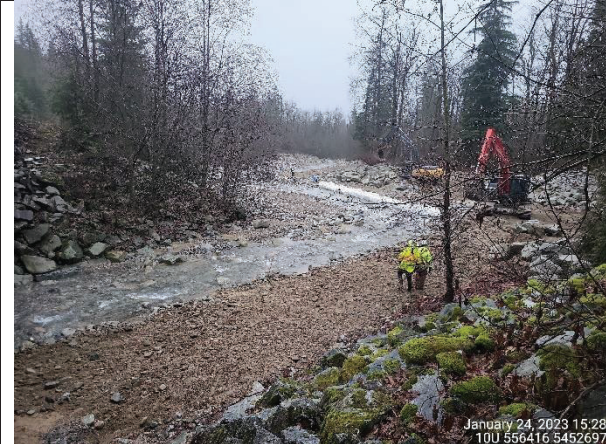
Photo 5. South-facing view of excavation downstream of the bridge to widen the creek channel (Jan 24, 2023)

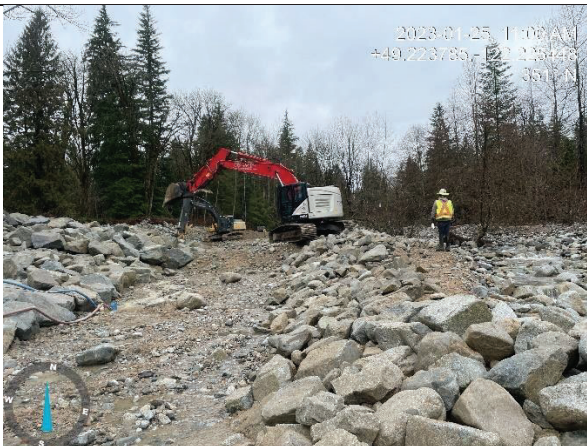
Photo 6. North-facing view of excavation of the river right diversion channel looking up. Riprap placement on right bank, as well armoring opposite bank with boulders (Jan 25, 2023).

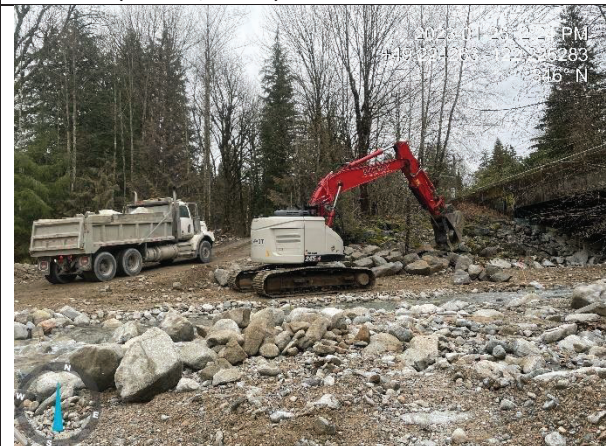
Photo 7. North-facing view downstream of the bridge of riprap placement along right bank (Jan. 25, 2023).

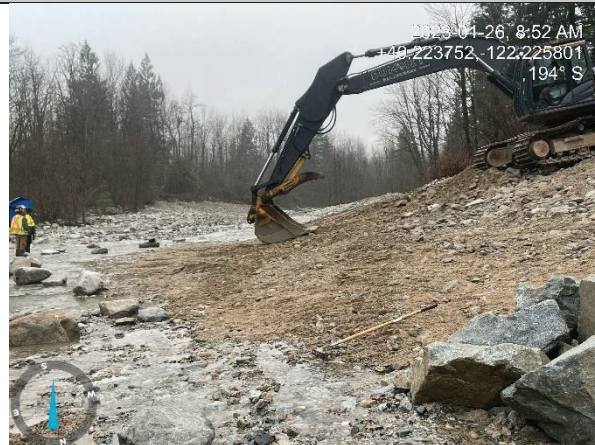
Photo 8. South-facing view of bank contouring along the right bank (Jan 26, 2023).

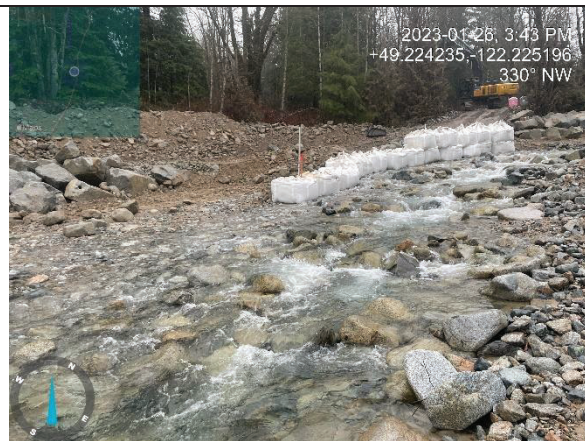
Photo 10. Northwest-facing view of ~25% flow in river right diversion channel. Deflection berm gravel bags being removed upstream. Salvage started in the afternoon. (Jan 26, 2023).

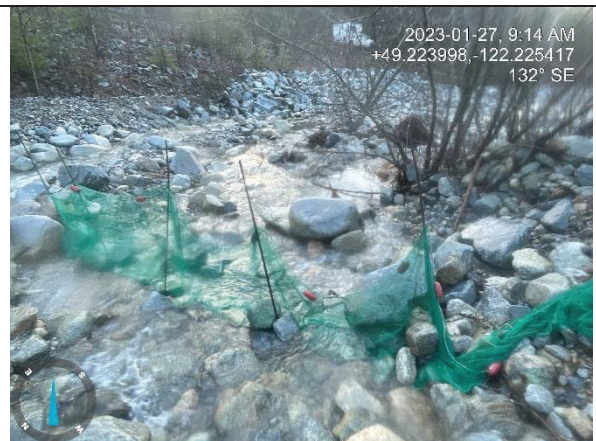
Photo 11. Southeast-facing view of fish exclusion fencing installed in the middle creek flow, removed after salvage was complete and deflection gravel berm bags removed (Jan 27, 2023).

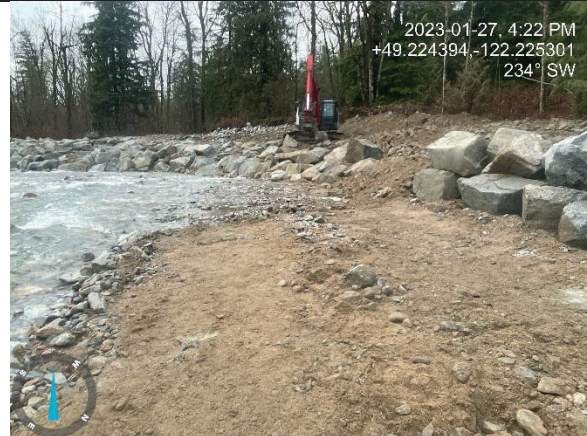
Photo 13. Southwest-facing view of deflection gravel berm bags removed. Right creek flow 50%, left creek flow 35%, middle creek flow 15%. (Jan. 27, 2023).

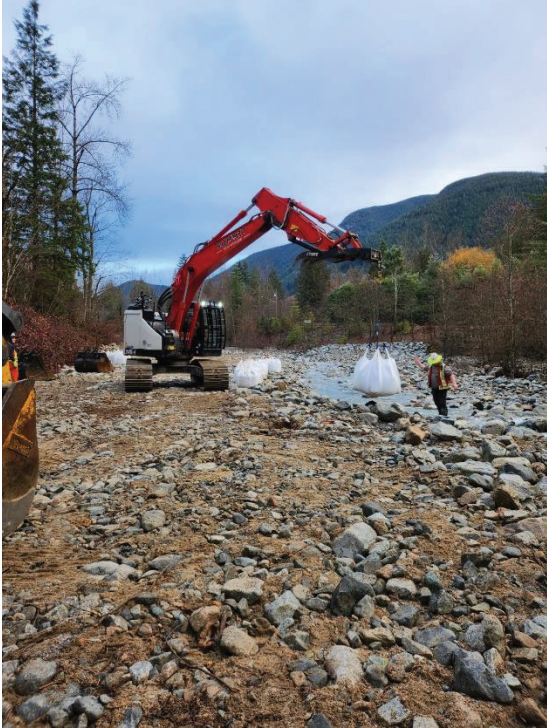
PHOTO #1 – Sang bag placement at top of diversion channel

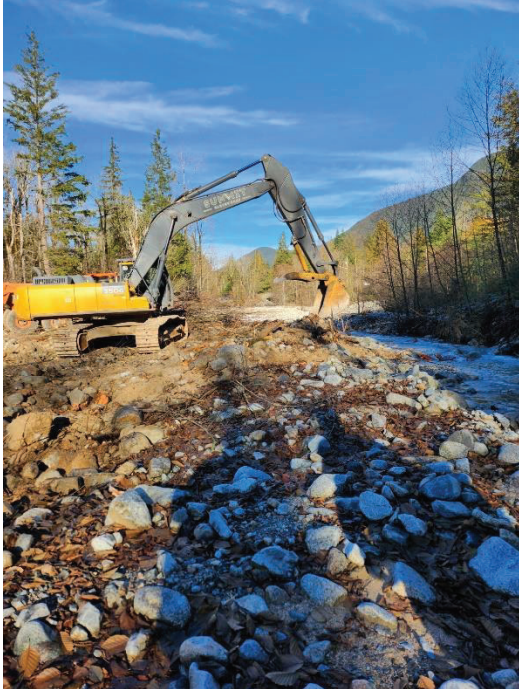
PHOTO #3 – East side of diversion channel after tree removal

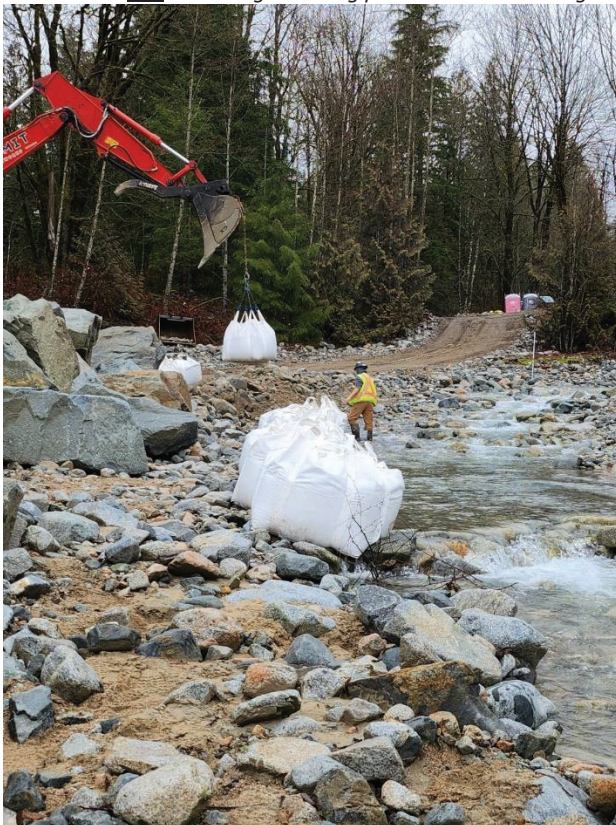
PHOTO #3 – 245 extending sand bag placement below bridge

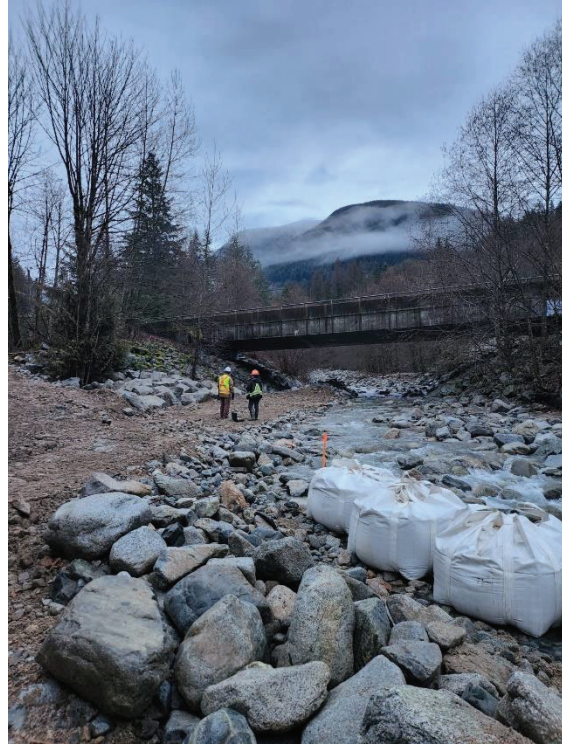
**PHOTO #2** - Channel peeled back by 245 Excavator below bridge

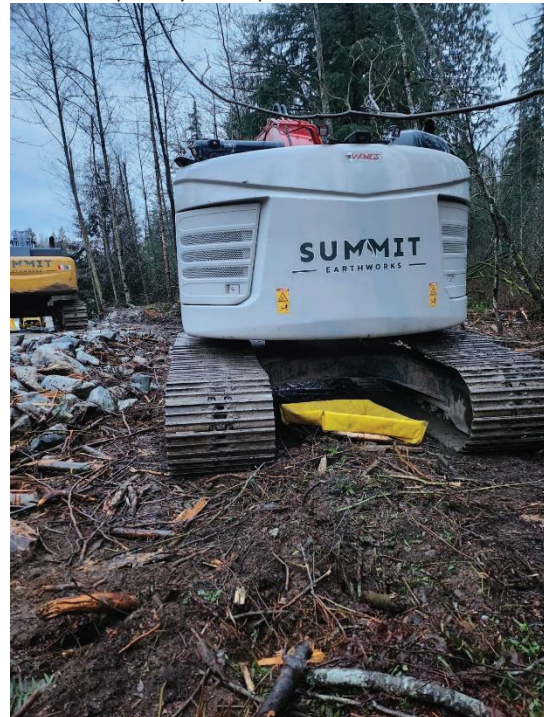
**PHOTO #4** – Spill tray under parked 245 Excavator
