# Ministry Of Environment and Climate Change Strategy

## Hatzic Emergency Works Program Carratt Creek

FEBRUARY 2024

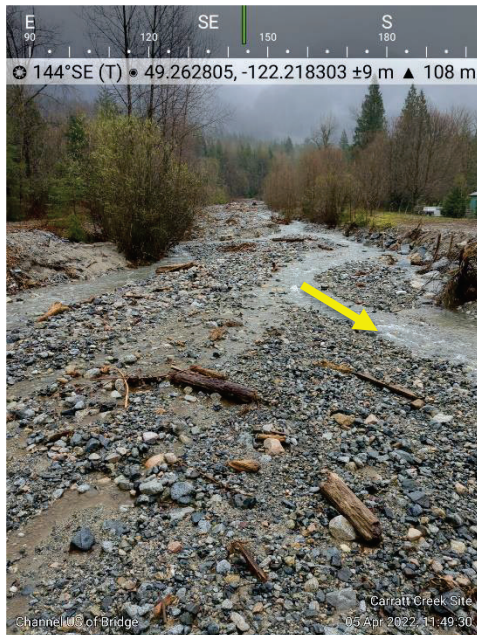
Carratt Creek:  
Viewing Upstream from Carratt Rd Bridge

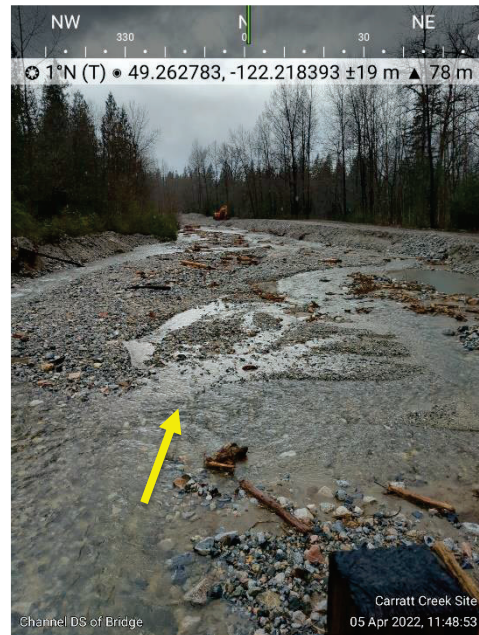
Carratt Creek:  
Viewing Downstream from Carratt Rd Bridge

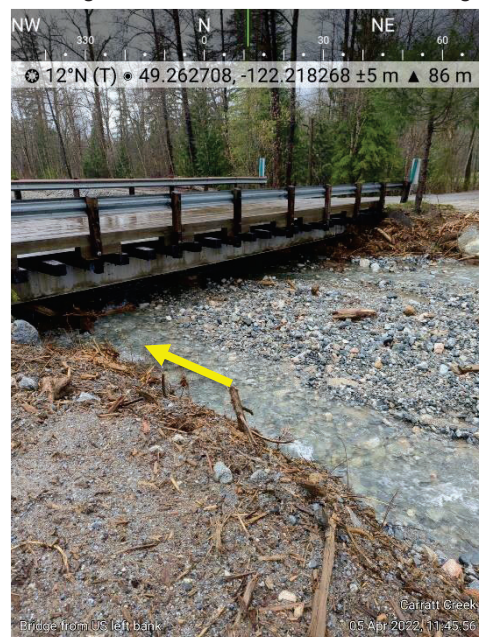
Carratt Rd Bridge:  
Viewing Downstream from Upstream Left Bank

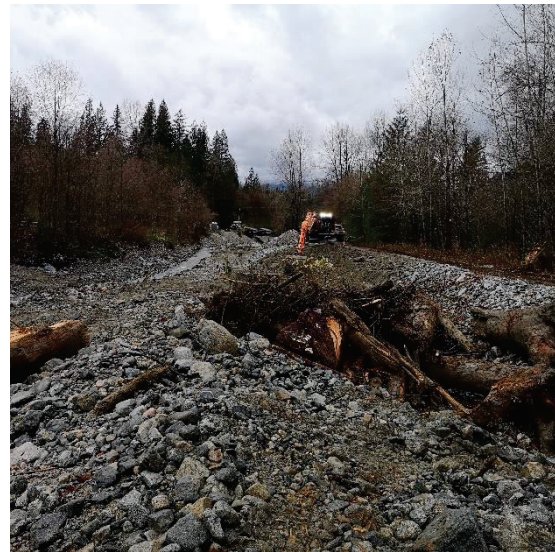
Figure 2-4  
Richco – Woody Debris Removal

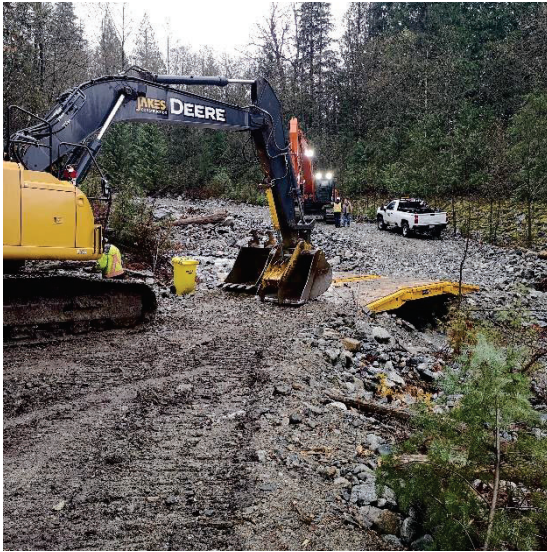
Figure 2-5  
Jakes - Temporary Bridge Installation

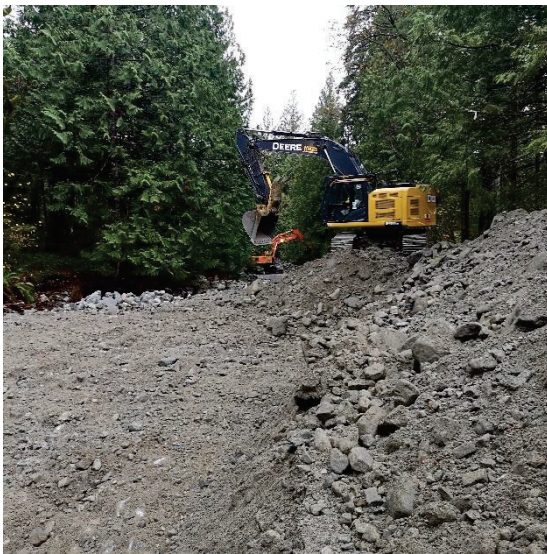
Figure 2-7  
Jakes - Upstream Truck Turn-Around  
Construction

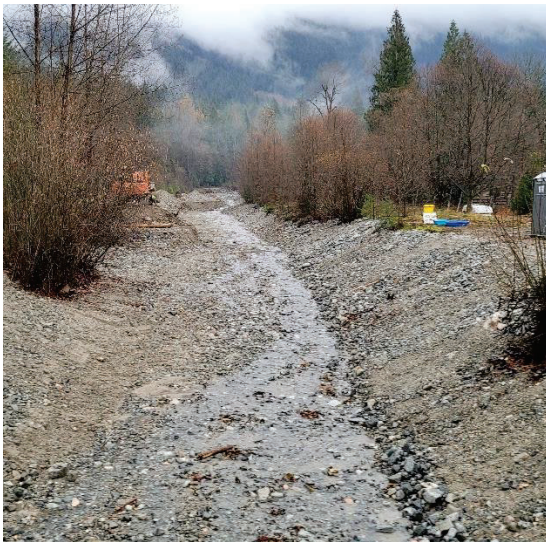
**Figure 2-3**  
**Richco – Sediment Removal Progress**

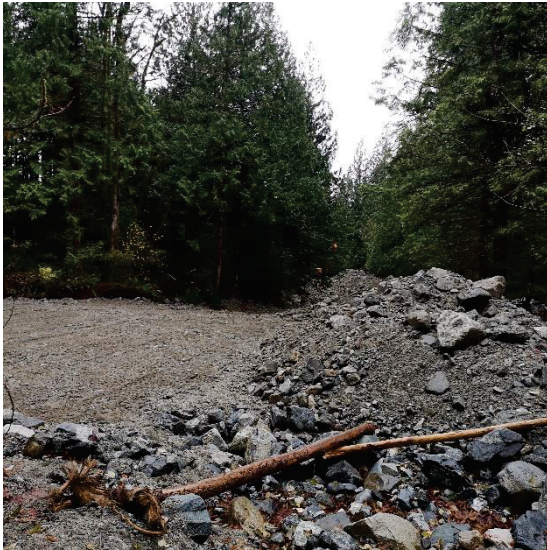
Figure 2-5  
Jakes – Turn-Around Area Completion

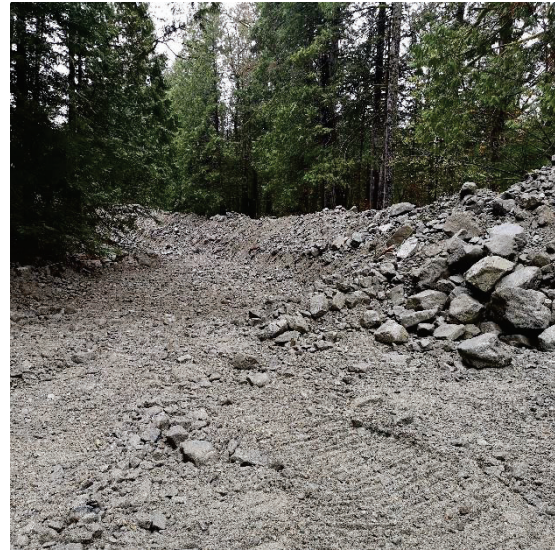
Figure 2-6  
Jakes – Stockpiling of Channel Sediment

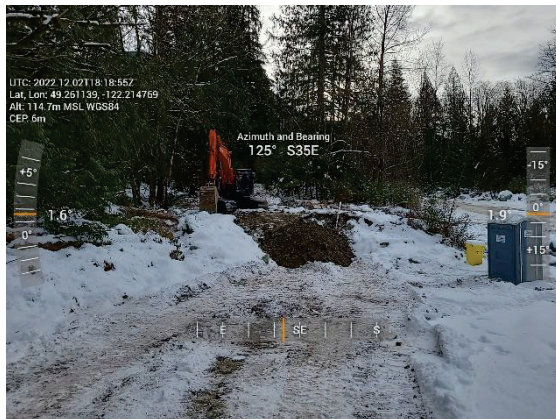
Figure 2-1  
Richco - Access ramp creation (HESCO  
Baskets)

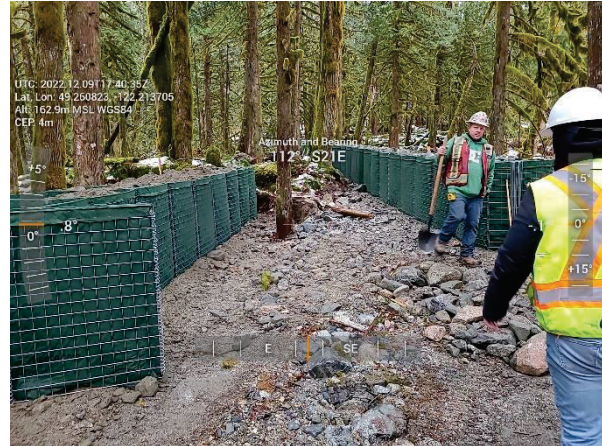
Figure 2-2  
Richco - HESCO Basket Progress &  
Alignment Extension (Right)

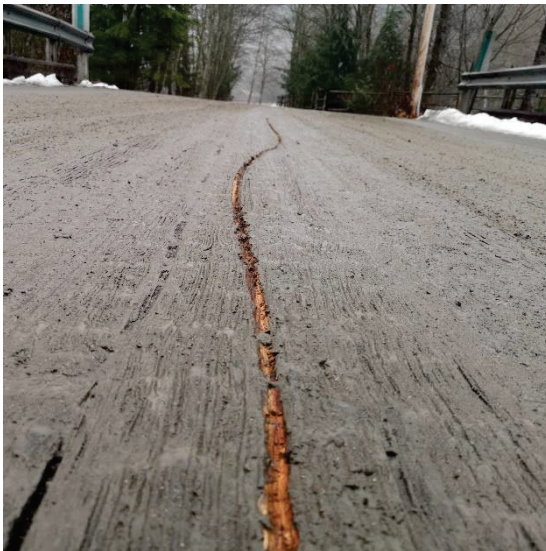
- Excavation of in-stream sediment deposition underway, loading tandem axle dump trucks (x3). No Jakes rock trucks operating. Richco intends to complete sediment removal by noon on Monday, Dec. 19<sup>th</sup> to allow for Jake's streamflow diversion upstream.
- Washing station is present at Eng Road.
- Gouge noted in Carratt Road bridge wooden surface. Cause of gouge unknown, to be further monitored.

Figure 2-3  
Gouge in Bridge Surface

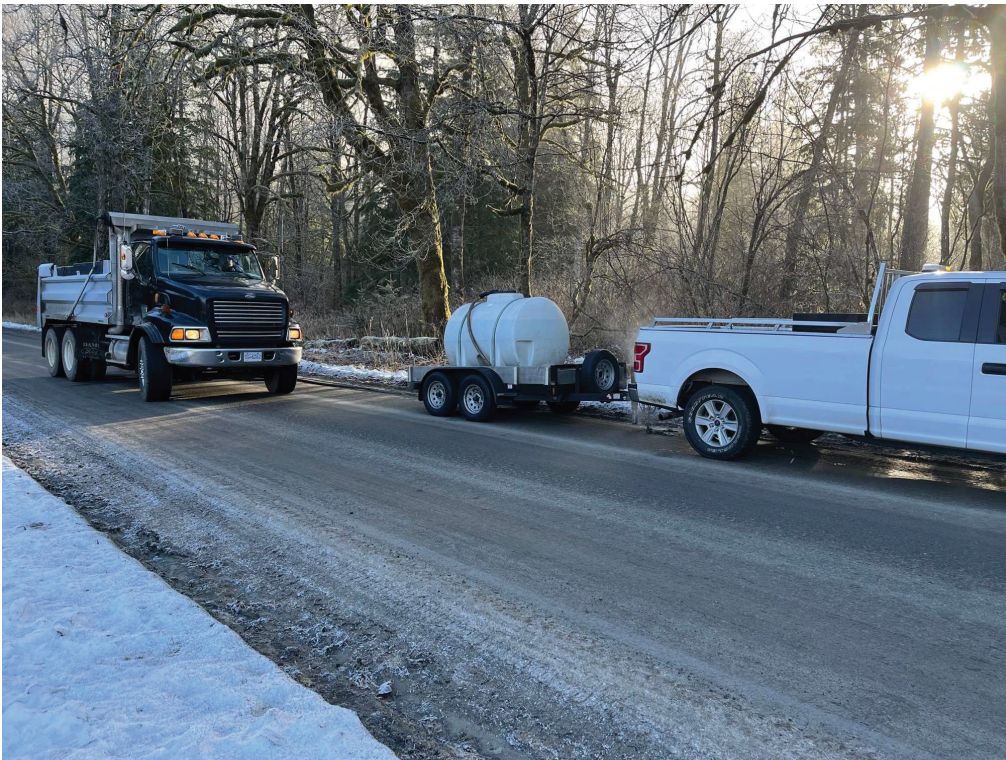
Photo 3. New wash station location on Eng Road to clean off haul trucks after exiting Eng Pit.

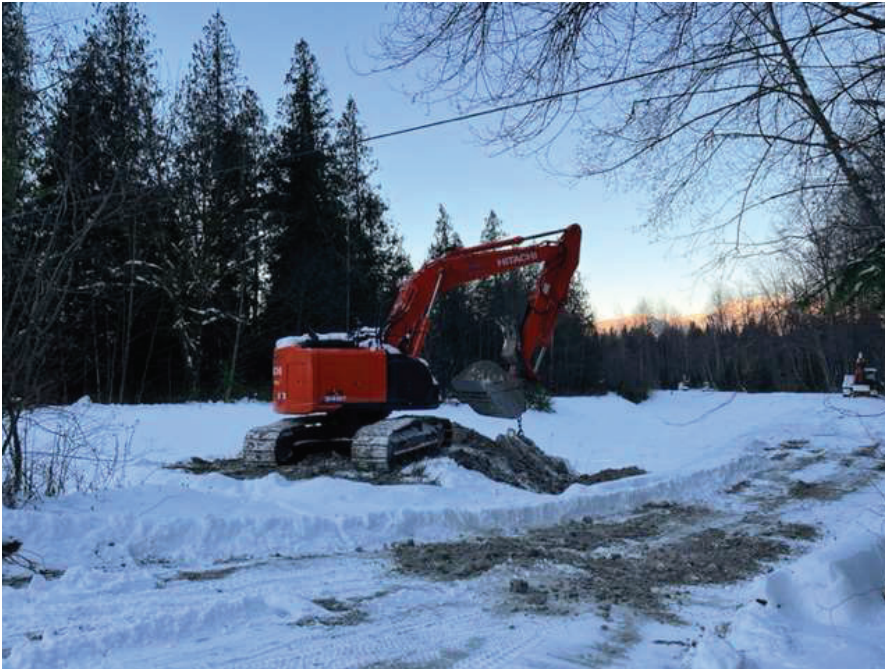
**Photo 1. Richco removing material from downstream of Carratt Road bridge.**

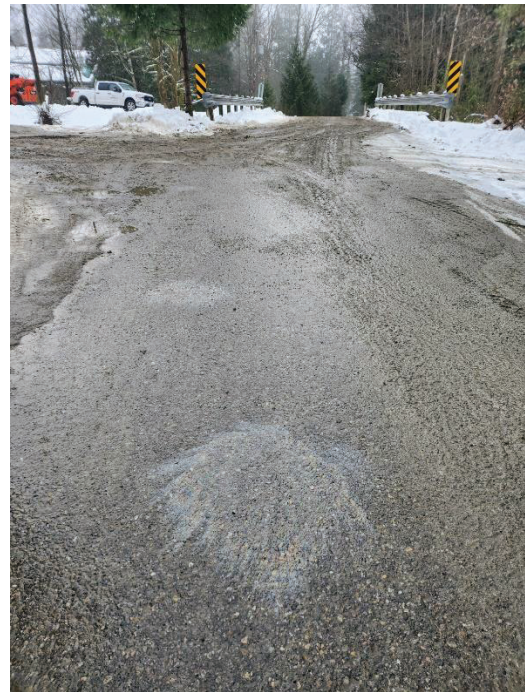
**PHOTO #4** – Fuel sheen visible on Carratt Rd & dyke access road

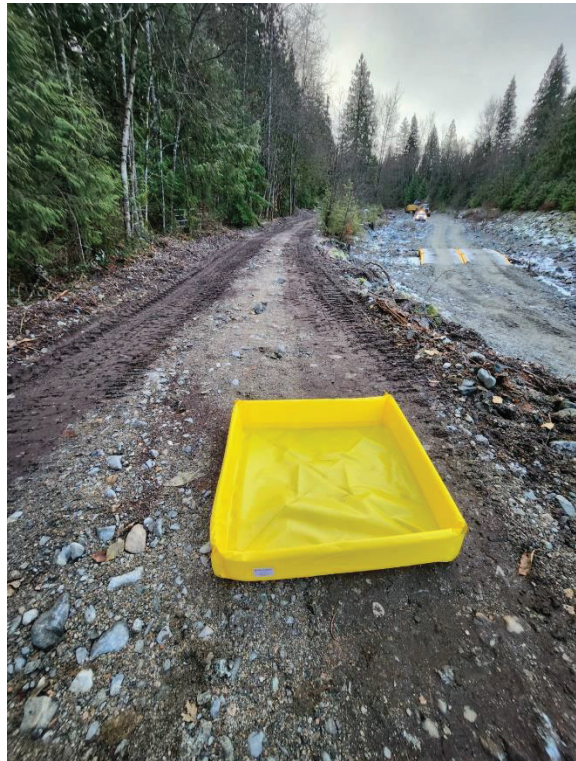
PHOTO #4 – Clean spill tray along access road into Hesco Basket area
