Associated  
Engineering

# Ministry of Environment and Climate Change Strategy Completion Report for Davies Creek

FEBRUARY 2024

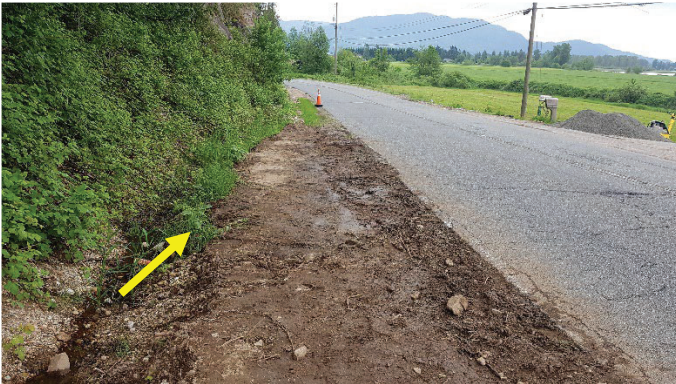
Sylvester Road – East Roadside Ditch (Not Davies Creek)

1. Remove sediment and debris in the east ditch of Sylvester Road from Davies Creek to the downstream culvert at the sag in Sylvester Road;
2. Repair the western side slope of Sylvester Road where overtopping flows scoured the embankment;
3. Complete a hydraulic capacity assessment of the existing culvert and evaluate replacement options;
4. Restore the channel's capacity by:
  - a. Coordinating with MoTI, FVRD, and environmental regulators;
  - b. Sediment and vegetation removal upstream of Sylvester Road. Extents to be determined as part of the hydraulic assessment; and
  - c. Replacement and expansion (based on current Codes and Standards) of the existing culvert on Davies Creek.

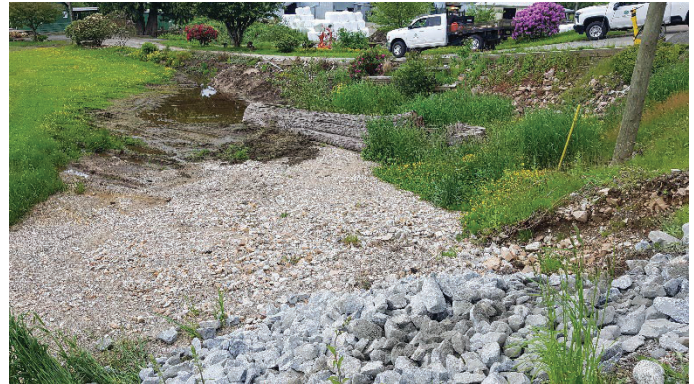
Sylvester Road – West Side Slope (Not Davies Creek)

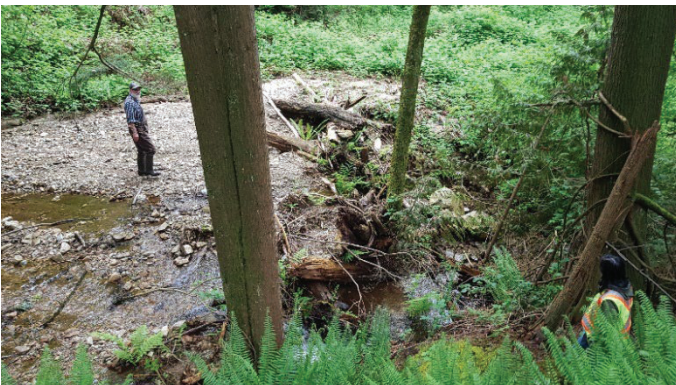
4. Large debris were observed approximately 20 m upstream of the culvert;
5. A large log/sediment jam, located approximately 100 m upstream of the culvert, poses a significant risk to private property. A visual inspection suggests that the debris jam is not stable and that it could mobilize during a major rainfall event. If carried downstream to the culvert it would likely be blocked again, repeating the problems that occurred in November 2021; and

We anticipate significant damage to Sylvester Road, private property, and risk to residents and motorists if the log jam were to mobilize during a major rainfall event.

Davies Creek – Upstream Log Jam (Side Profile)

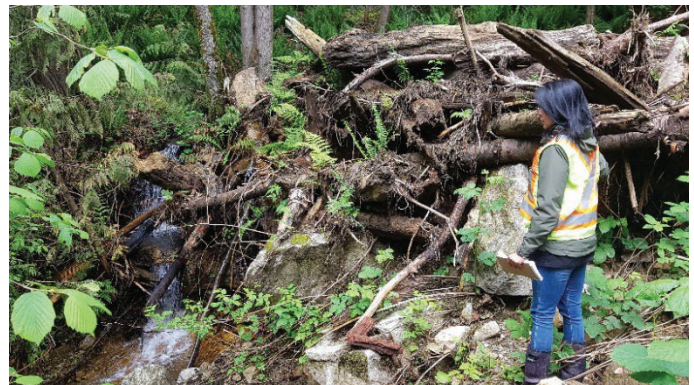
Davies Creek – Upstream Log Jam (Looking Upstream)

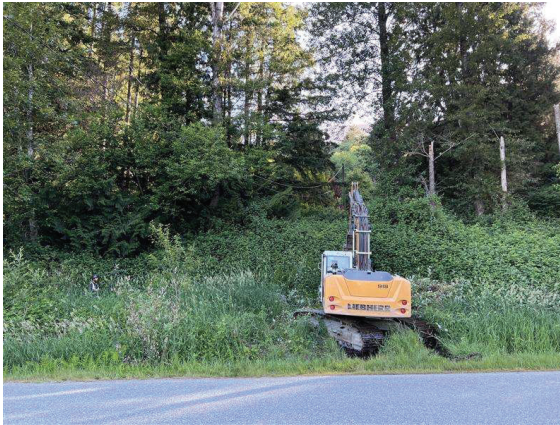
Figure 1  
Excavator at the Entrance of Access Road

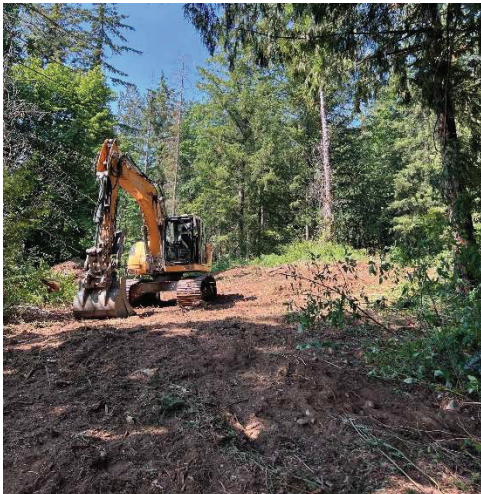
Figure 3  
Excavator Clearing at the Open Area

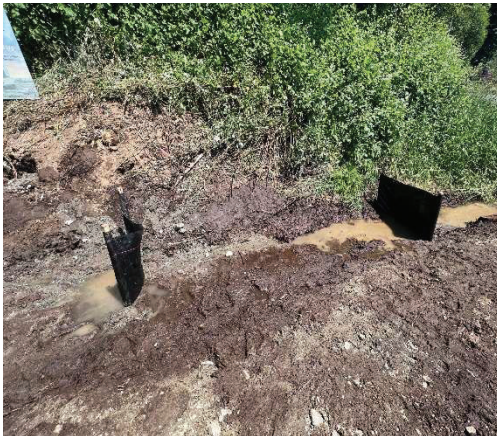
Figure 3  
Silt Fences on the Ditch

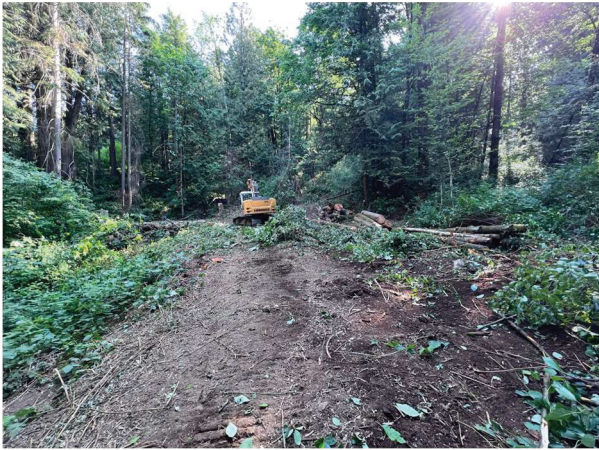
Figure 1  
Stockpiling Logs and Stripping Topsoils

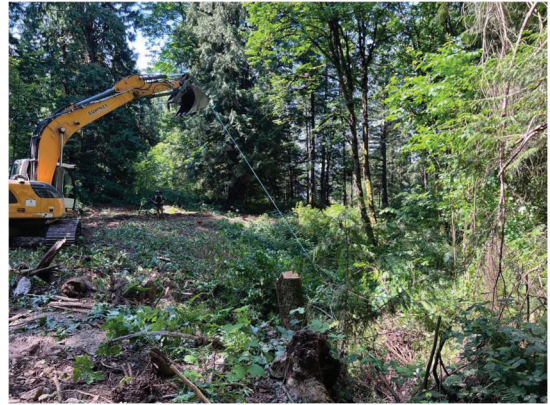
Figure 2  
Excavator Pulling Organics Out of the Creek

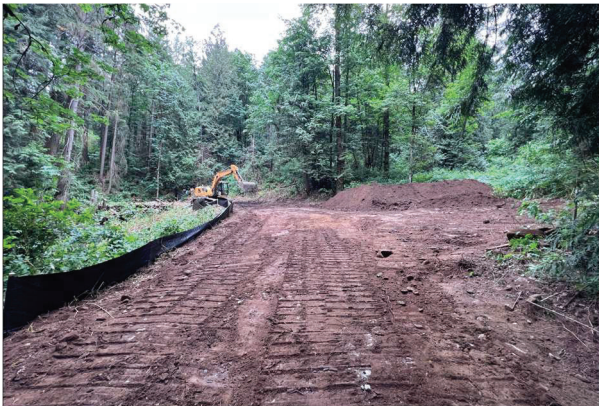
Figure 3  
Upper Access Road with Silt Fences

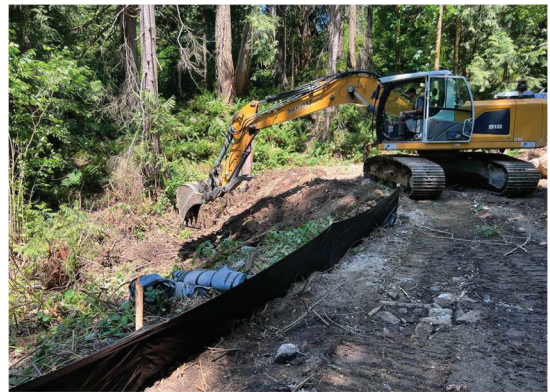
Figure 4  
Clearing on the Creek

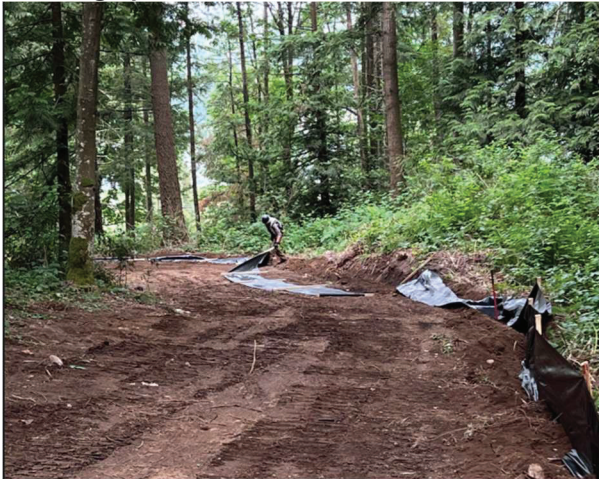
**Figure 1**  
**Installing Silt Fences Along Upper Access Road**

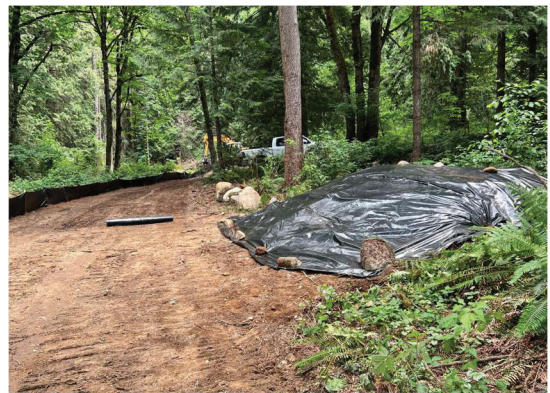
**Figure 2**  
**Stockpile Covered with Poly Sheeting**

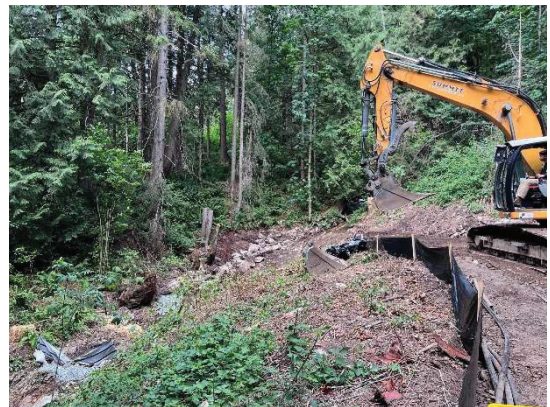
**Figure 4**  
**Excavator Placing Boulders to Creek's Bank**

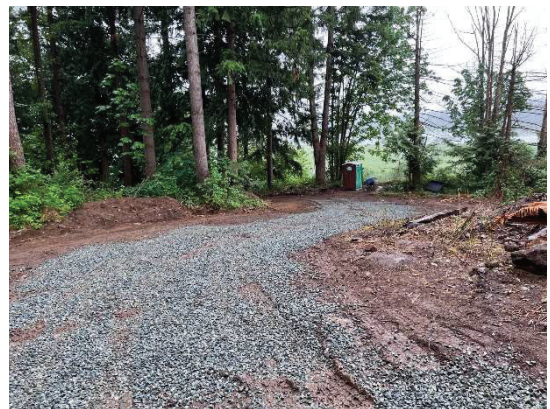
**Figure 4**  
Gravel Spread on Steep Slope

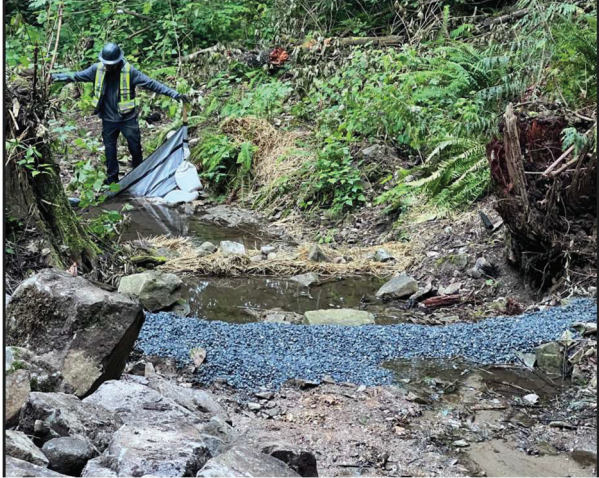
Figure 1  
Removing Check Dam and Sediment Control Structure

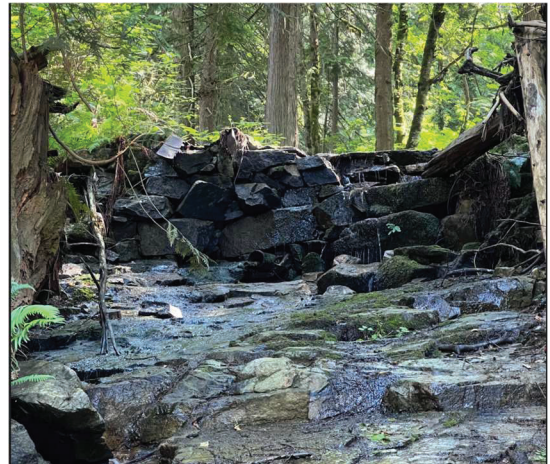
Figure 2  
Temporarily Pool Removed

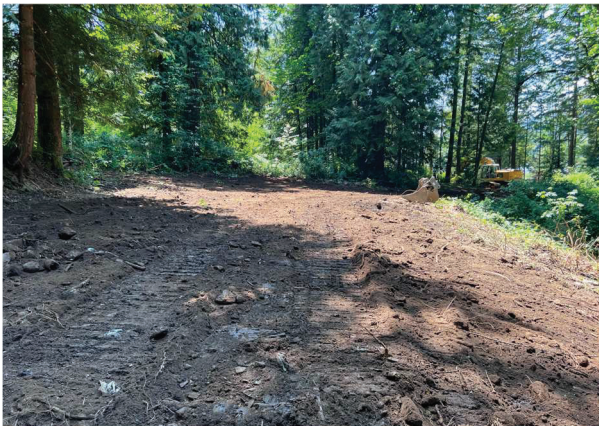
Figure 3  
Spreading Soil Stockpile to Ground and Removal of Silt Fences

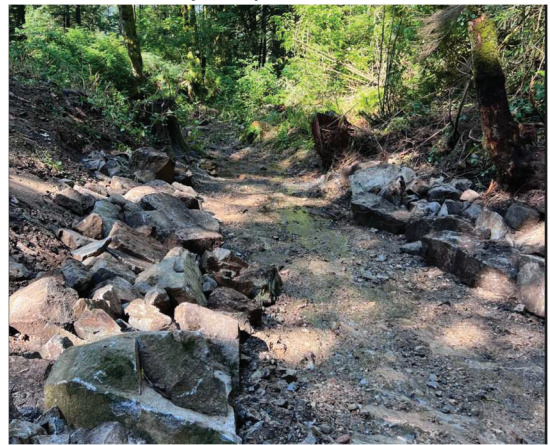
Figure 4  
Looking Downstream After Removal of Check Dam

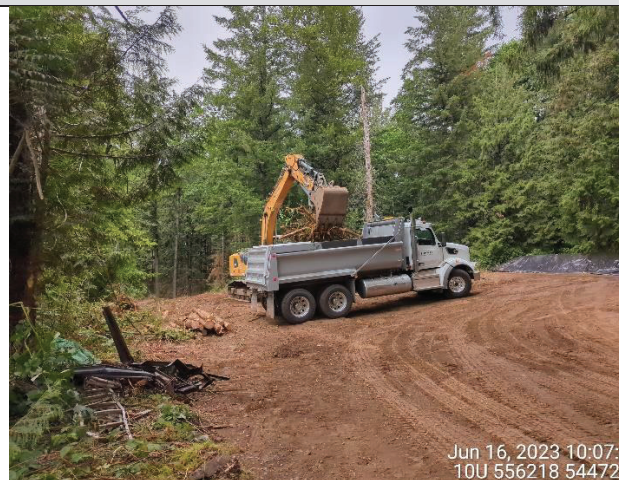
Photo 1. View of woody debris from road clearing being removed and sent to Summit's dump site. (Jun. 16, 2023).

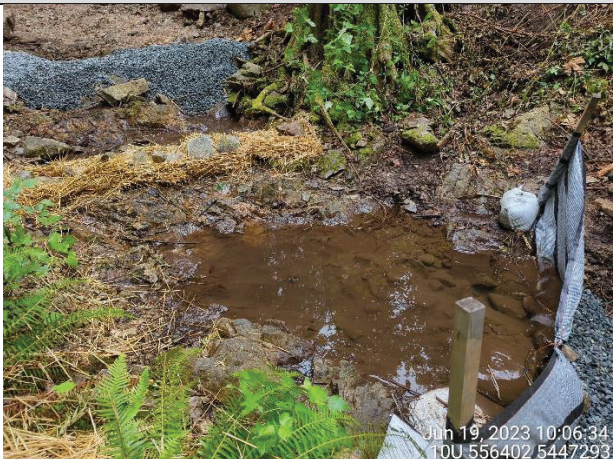
Photo 1. View of gravel, straw , and silt fence check dams set up at the top of Davies Creek. (Jun. 19, 2023).

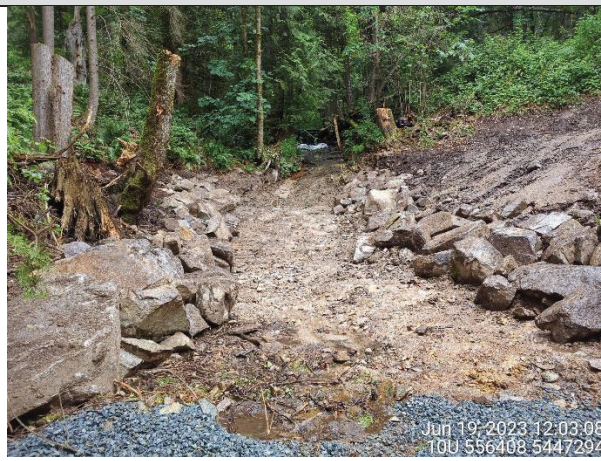
Photo 2. View of Davies Creek after armouring works have completed. (Jun. 19, 2023).
