# Ministry of Environment and Climate Change Strategy

## Hatzic Emergency Works Program Eng Creek and McNab Creek

## Post Construction Report

APRIL 2024

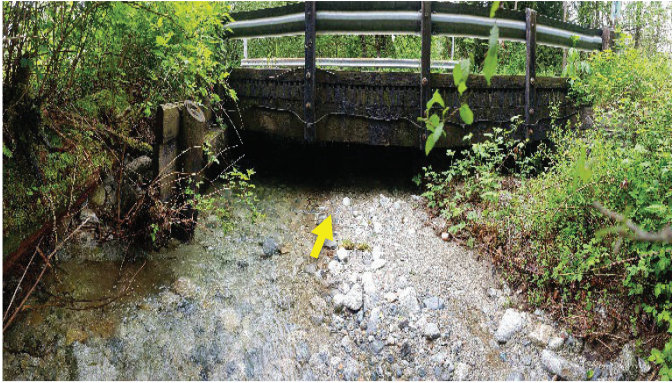
Eng Creek  
Upstream of Sylvester Road Bridge – Looking Downstream

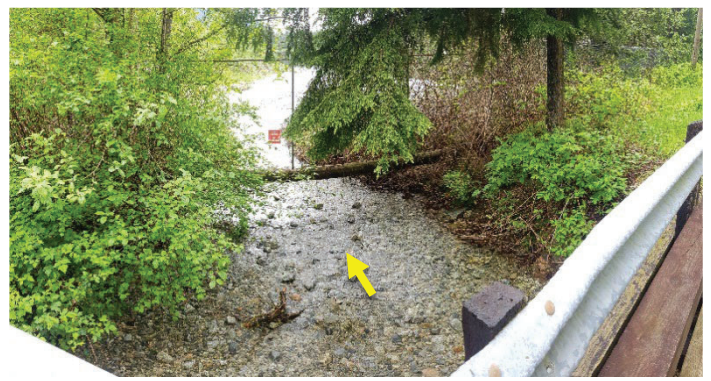
2. Sediment deposition has been observed within the Hartley Road bridge; however, it is unclear if the hydraulic capacity of the bridge has been compromised;

Eng Creek  
On Hartley Road Bridge – Looking Downstream

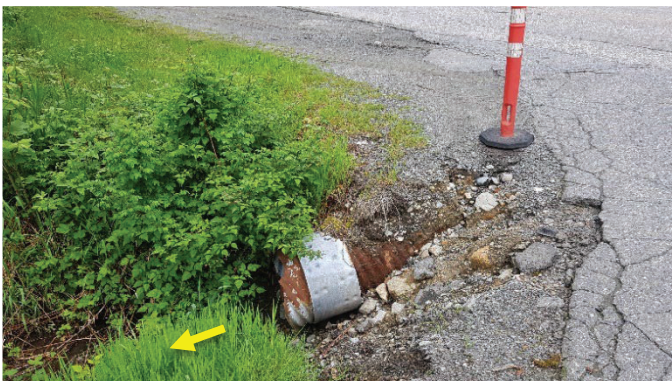
5. Roadway shoulder erosion/scour was observed at the intersection of Hartley Road and Sylvester Road (west shoulder), and at Hartley Road north shoulder, approximately 100 m west of the Hartley Road bridge; and

Erosion at Sylvester Road and Hartley Road intersection (west  
shoulder)  
Looking Northeast

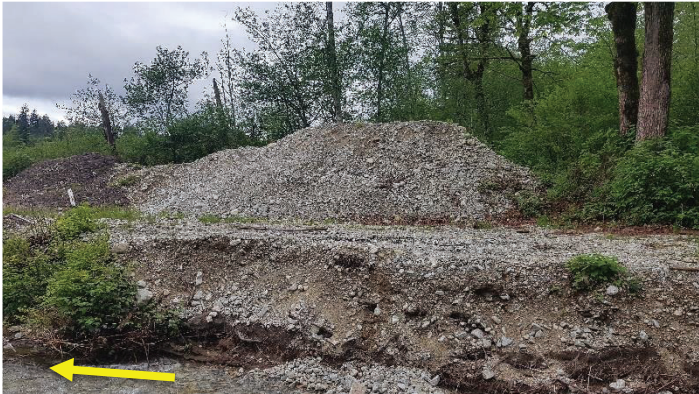
Excavated Materials downstream of Sylvester Road culverts

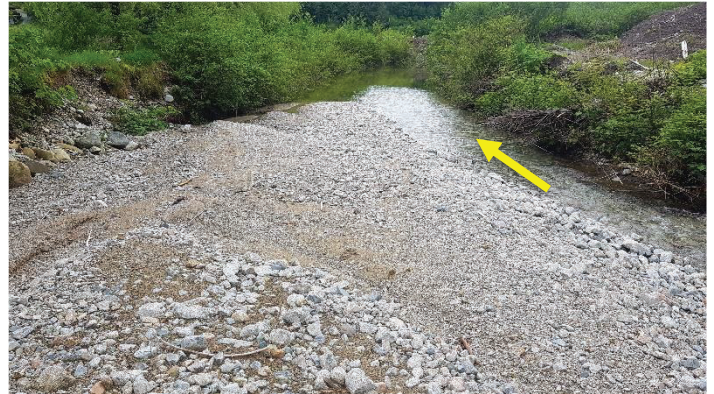
Deposition in MacNab Creek downstream of Sylvester Road culverts

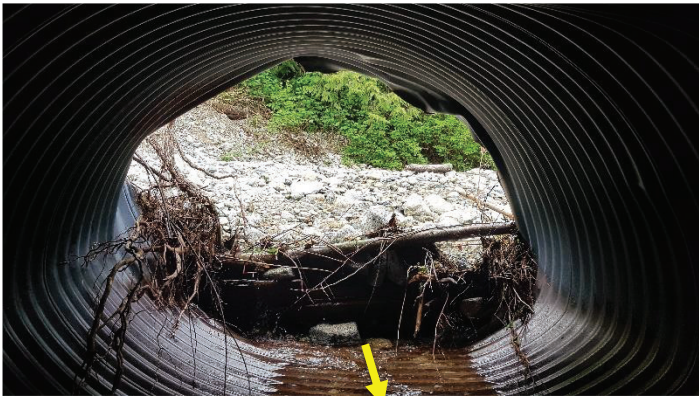
- **McNab Creek:**
  - Sediment removal was necessary to restore the one in ten-year hydraulic capacity of the channel.
  - The hydraulic capacity of the two 1650 mm x 1150 mm elliptical CSP culverts across Sylvester Road is not adequate to convey the one in ten-year design flows, even after additional sediment removal. The tailwater for the one in ten-year condition from Allan Lake is equivalent to the Sylvester Road elevation. This reduces the available capacity in the culverts and results in upstream flow overtopping the road.

Upstream blockage of northern MacNab Creek culvert at Sylvester Road

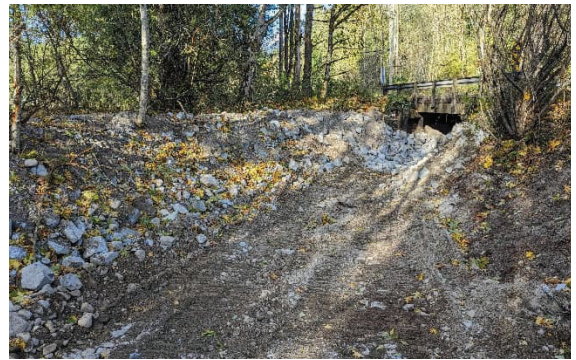
Figure - 2  
Facing N – Finished rip-rap on the west side of  
the Sylvester road bridge.

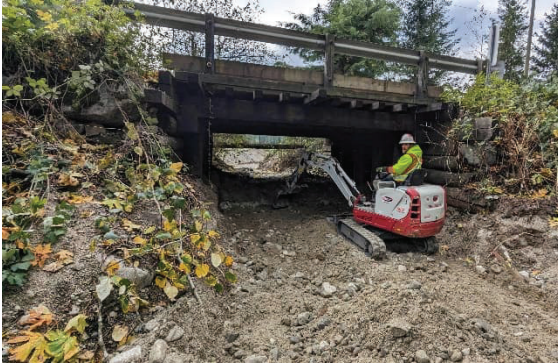
Figure - 3  
Facing S – Removing sediment from under the  
Hartley road bridge.

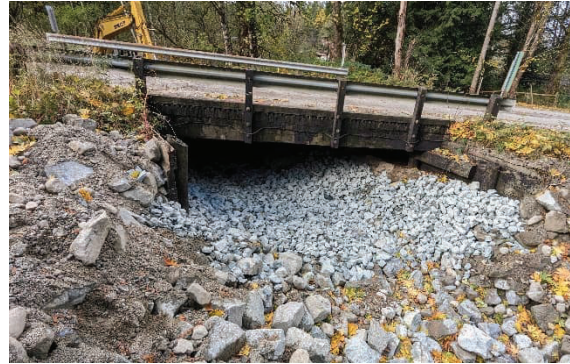
Figure - 4  
Facing W – Finished rip-rap on the east side of  
the Sylvester road bridge.

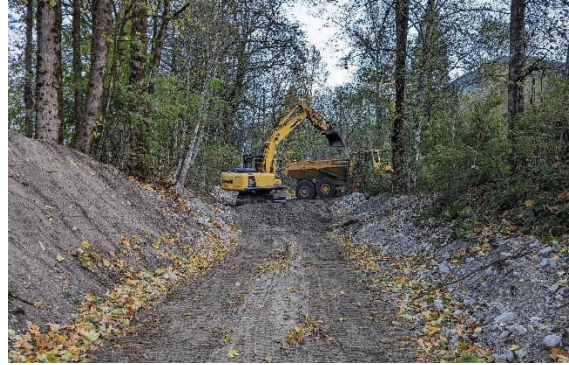
Figure - 2  
Facing N – Removing remaining sediment  
from between the 2 bridges.

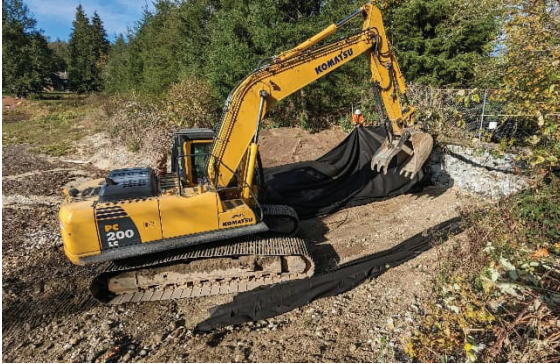
Figure - 3  
Facing NW – Installing filter fabric at the Allen  
Lake inlet.

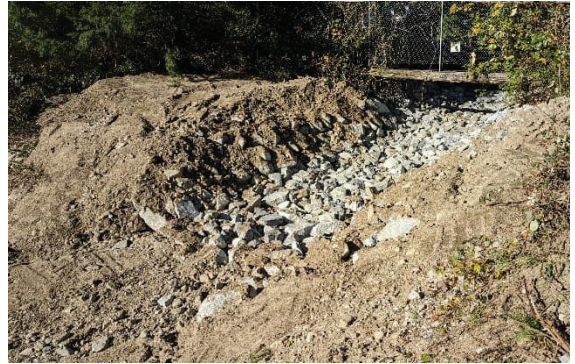
Figure - 4  
Facing NW – Finished rip-rap at the Allen  
Lake inlet.

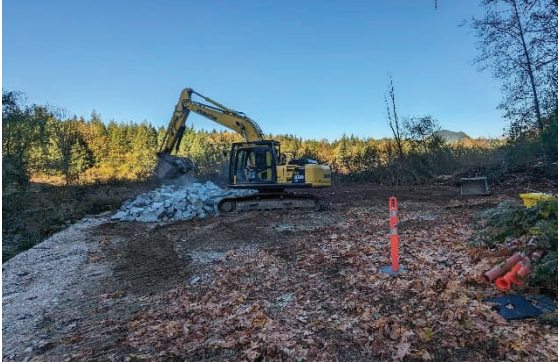
Figure - 1  
Facing W – Establishing the laydown area.

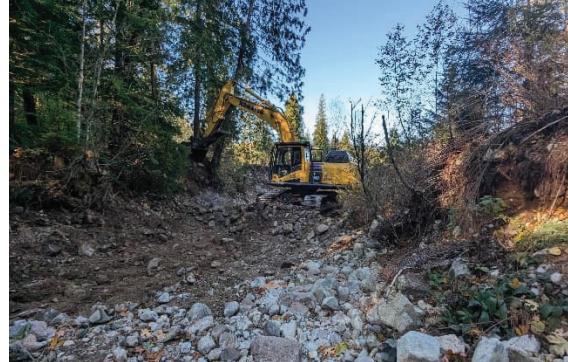
Figure - 2  
Facing W – Sediment removal at station  
0 350

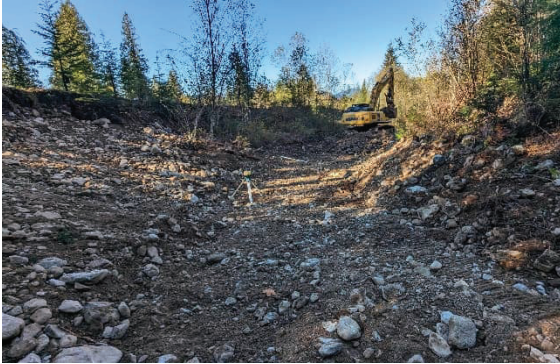
Figure - 3  
Facing NW – Sediment removal near station  
0+340

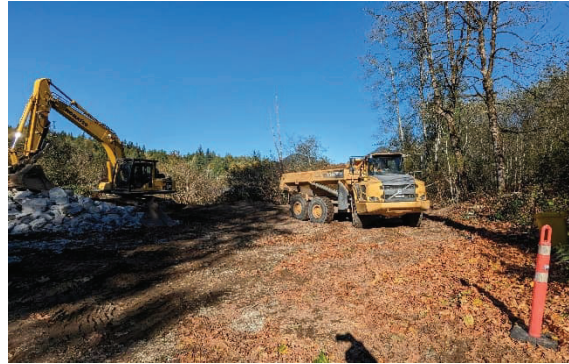
Figure - 4  
Facing NW – Offloading creek sediment at the  
laydown.

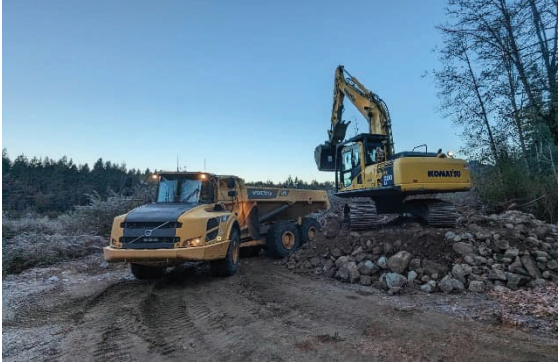
Figure - 1  
Facing W – Hauling sediment to the laydown  
area next to Allan lake.

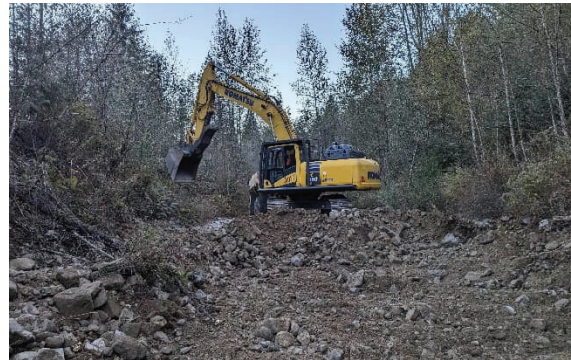
Figure - 2  
Facing N – Sediment removal near station 310

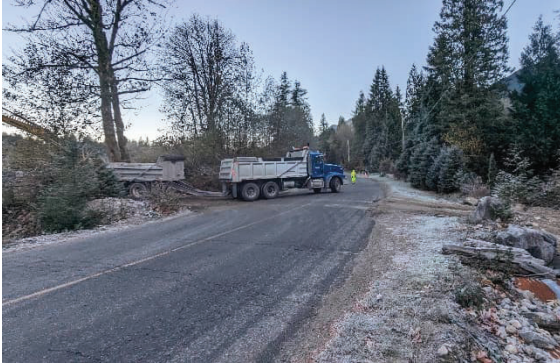
Figure - 3  
Facing NW – Hauling sediment from site.  
Flaggers controlling traffic.

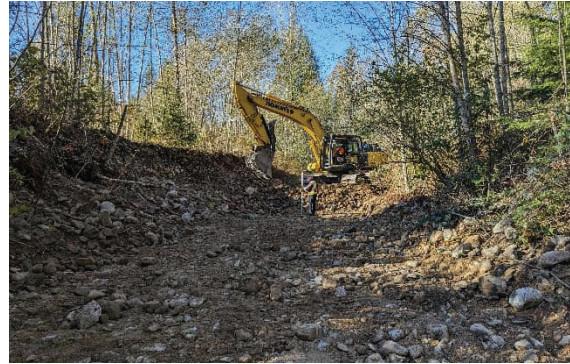
Figure - 4  
Facing NW – Sediment removal near station  
210.

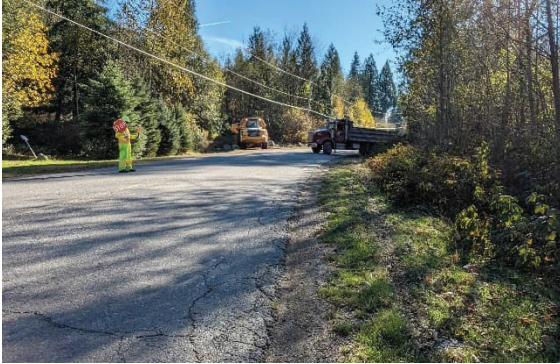
Figure - 3  
Facing S – Hauling sediment from site.  
Flaggers controlling traffic.

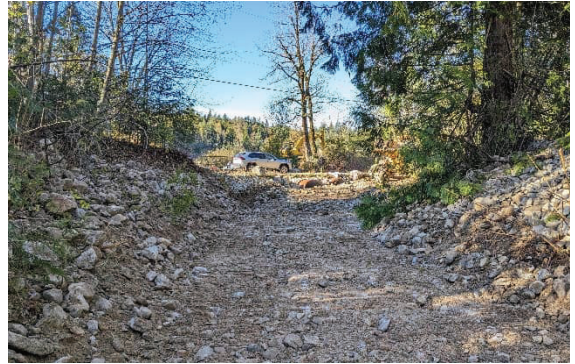
Figure - 4  
Facing W – Sediment removed up to the  
Sylveser Rd culverts.

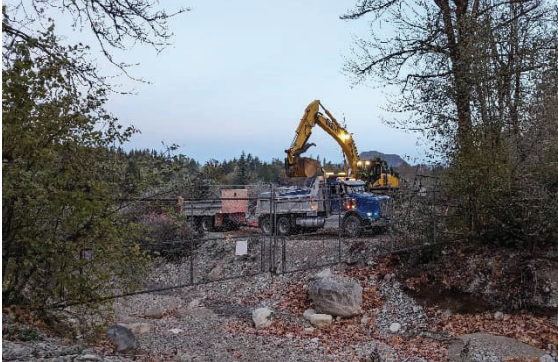
Figure - 1  
Facing NW – Loading sediment from the  
laydown area.

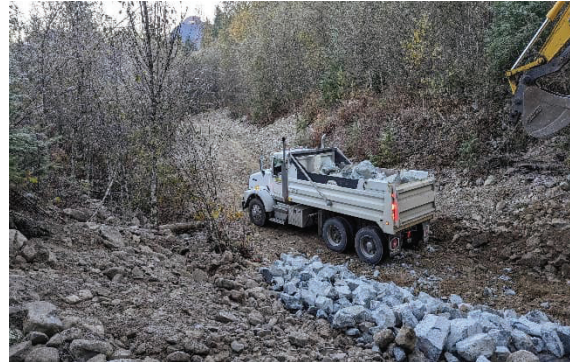
Figure - 2  
Facing NE – Hauling rip-rap upstream to  
station 350.

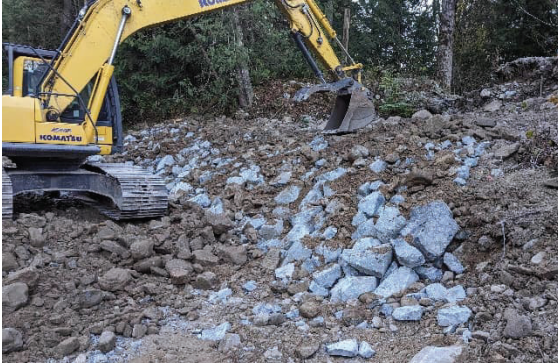
Figure - 3  
Facing SE – Installing rip-rap at station 350.

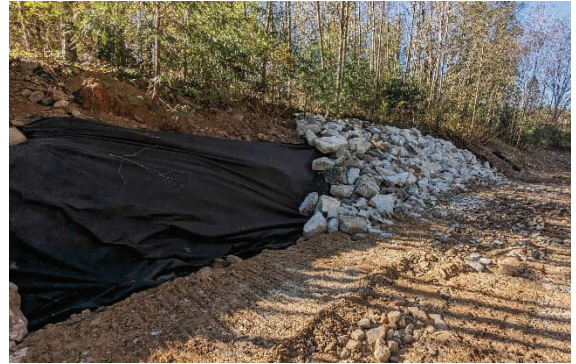
Figure - 4  
Facing SW – Installing rip-rap at station 150.

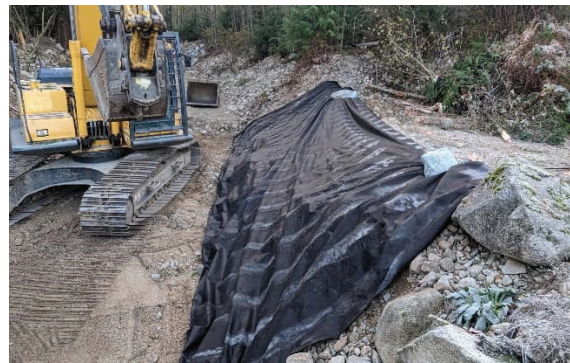
Figure - 3  
Facing S – Installing rip-rap at the culvert inlet.

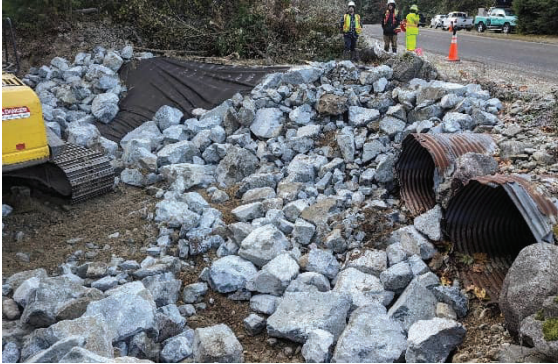
Figure - 4  
Facing W – Finished rip-rap at culvert inlet.

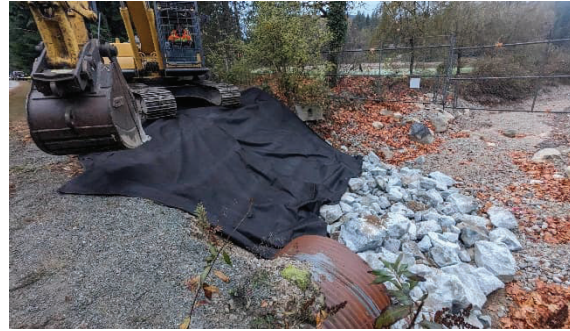
Figure - 2  
Facing SW – Installing filter fabric along the  
banks near the culvert outlet.

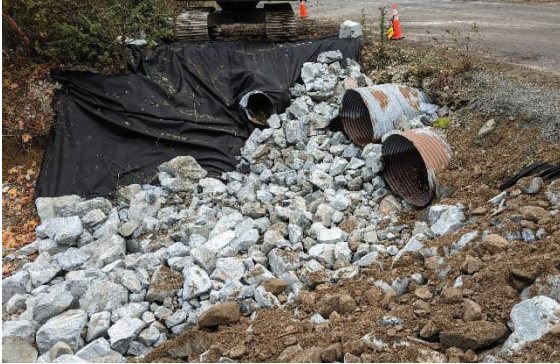
Figure - 3  
Facing N – Installing rip-rap and filter fabric at  
the culvert outlet.

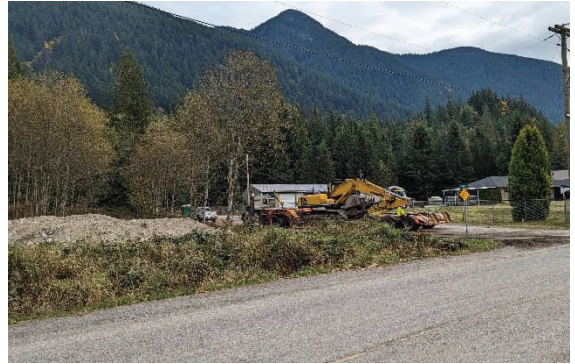
Figure - 4  
Facing E – Mobilized equipment back to Eng  
Creek laydown.

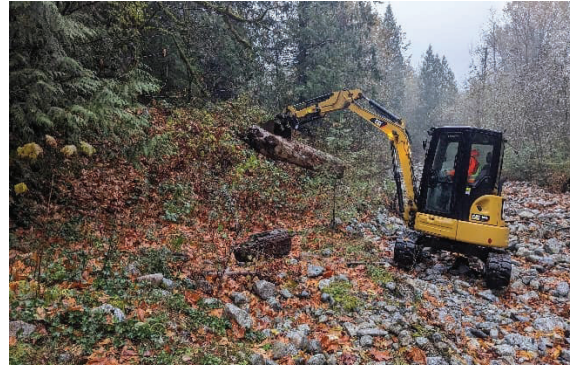
Figure - 3  
Facing E – Loading contaminated soil offsite.

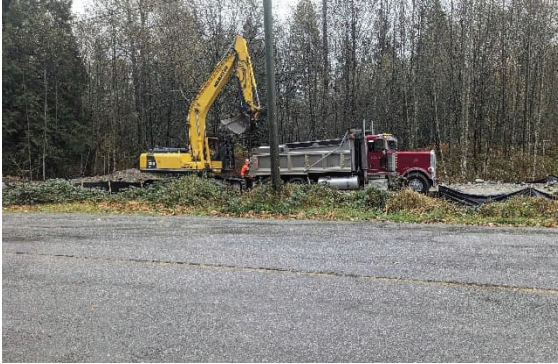
Figure - 4  
Facing N – Removing excess material at  
McNab culvert outlets.

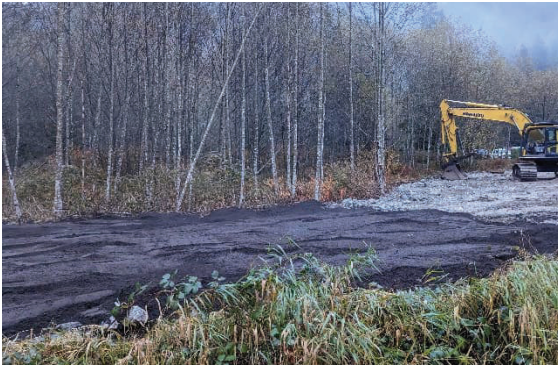
Figure - 1  
Facing SE – Topsoiling Eng Creek laydown  
area.

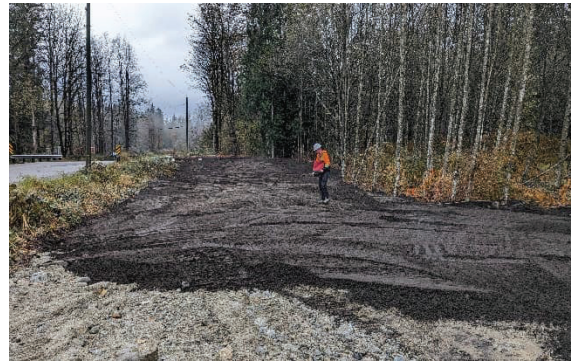
Figure - 2  
Facing N – Seeding the Eng creek disturbed  
extents of the laydown area.

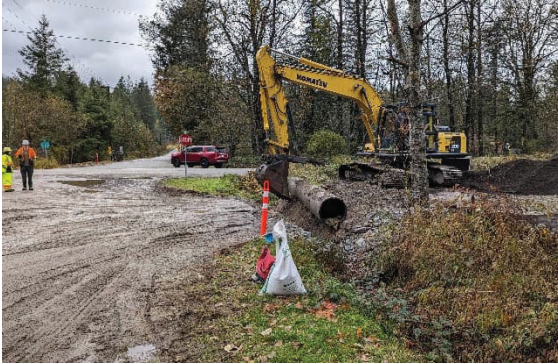
Figure - 3  
Facing W – Removing access ramp and temporary culvert from the Eng Creek laydown area.

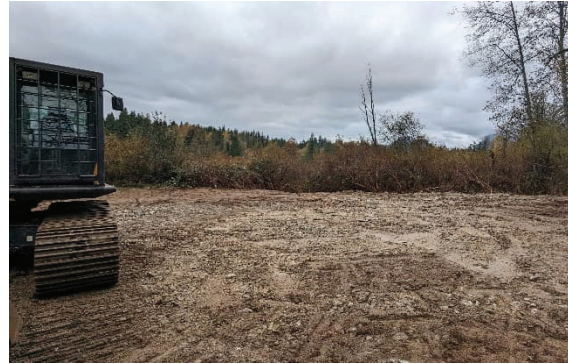
Figure - 4  
Facing NW – McNab laydown stockpiles removed.

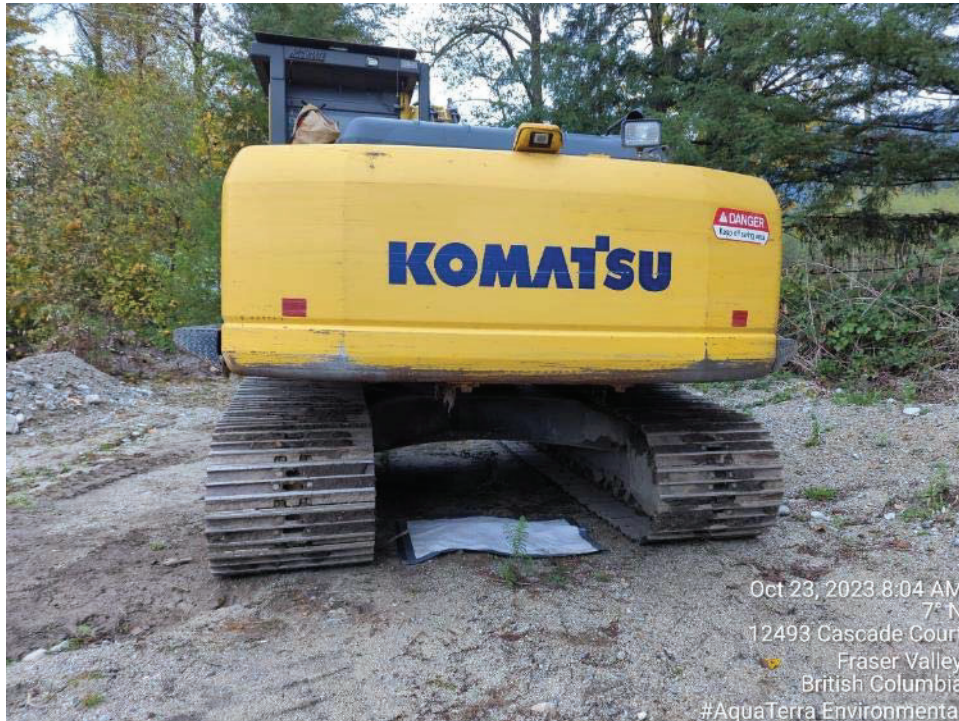
**Photo 2:** Drip pad observed under inactive excavator.

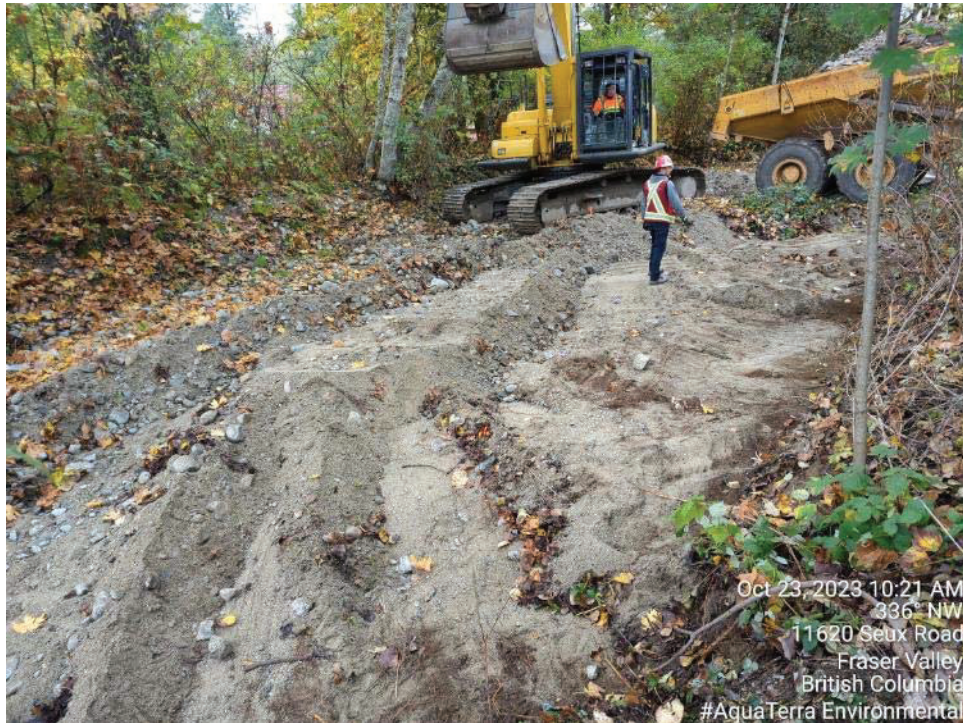
**Photo 4:** Japanese knotweed being excavated from the creek bed.

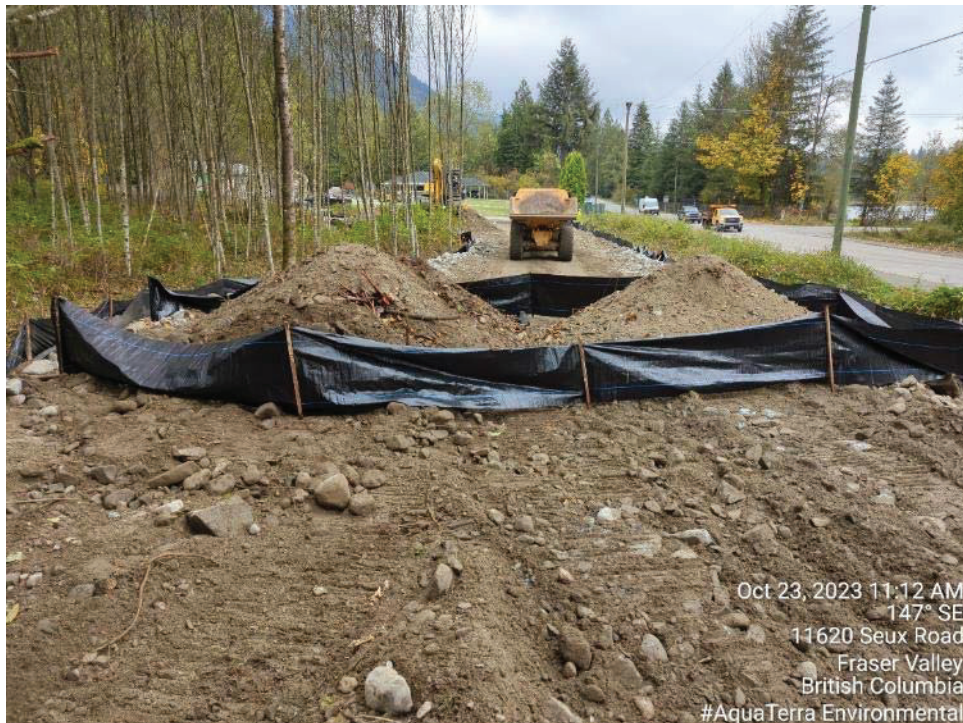
**Photo 5:** Excavated Japanese knotweed creek material stockpiled in laydown area.

1. Contact the EM if water is observed in the creek. Stop works until a bypass is installed.
2. The stockpiled Japanese knotweed infested material can be buried 3-5 m below ground or removed off site for disposal at an appropriate disposal facility.
3. Inspect equipment regularly for leaks or excess grease.

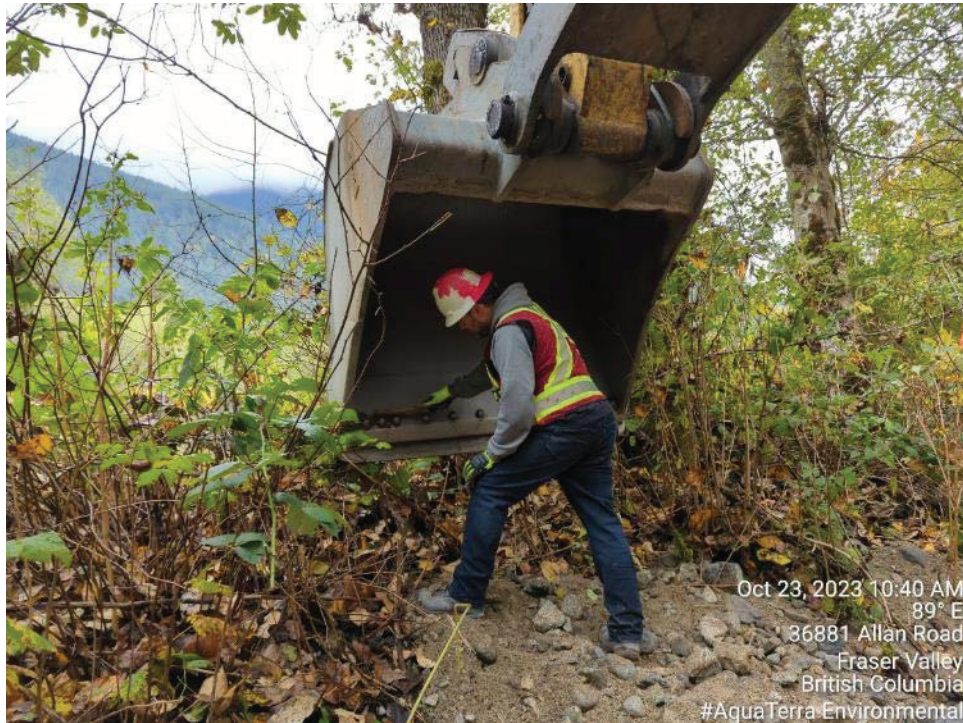
10:40 | The EM observed the interior and exterior of the excavator bucket being cleaned by crews with a stiff metal brush. The bucket was suspended over the excavated knotweed area during cleaning. The rock truck tailgate was also cleaned with the same wire brush.

**Photo 6:** Excavator bucket cleaned with stiff metal brush.

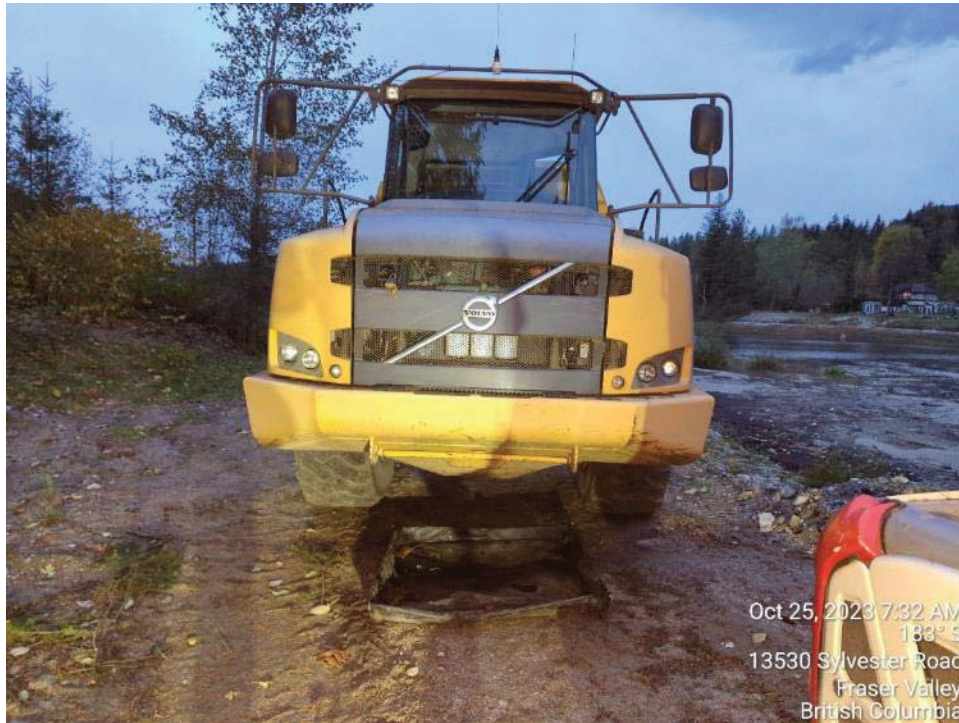
**Photo 8:** The rock truck adequately protected with a drip tray at the time of inspection.

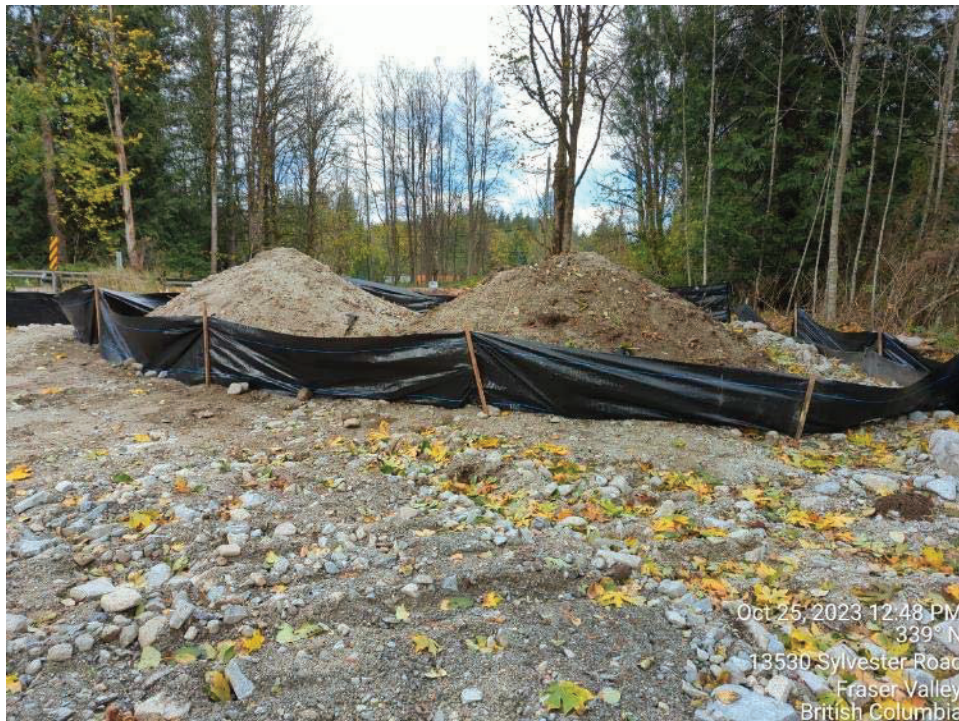
- No knotweed observed or identified in MacNab creek.
- Silt isolation fencing around knotweed contaminated stockpiles blown down and deficient. Site personnel promptly reinstalled fencing.

**Photo 13:** Stockpiles of Japanese knotweed infested material excavated from the creek.

1. Contact the EM if water is observed in the creek. Stop works until a bypass is installed.
2. The stockpiled Japanese Knotweed infested material should be buried 3-5 m below ground or removed off site for disposal at an appropriate disposal facility.
3. Inspect equipment regularly for leaks or excess grease.

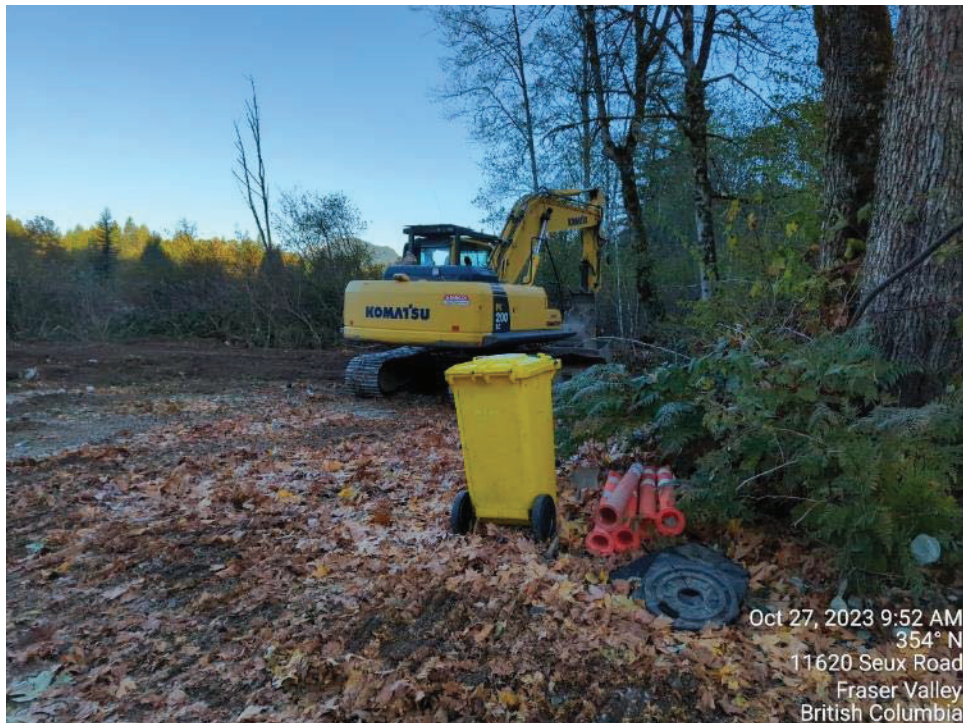
**Photo 16:** One (1) large and fully stocked spill kit observed in staging area.

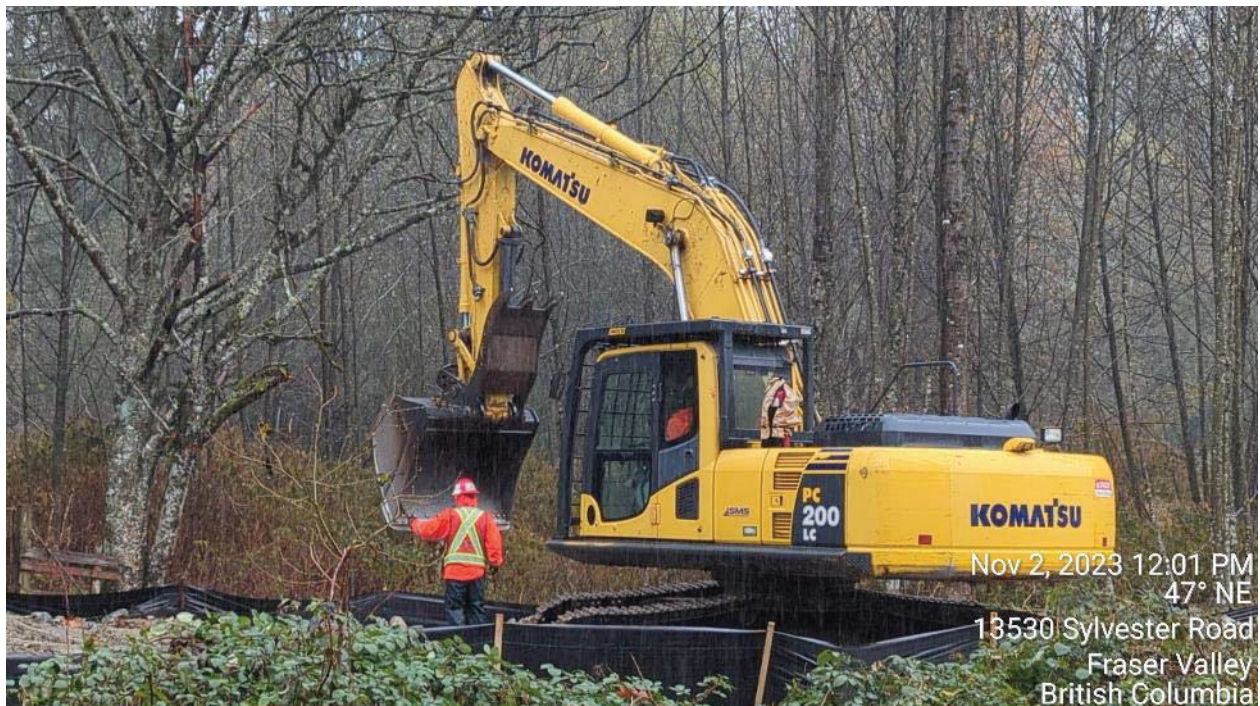
**Photo 21:** The excavator capping the stockpile area with clean creek gravel.

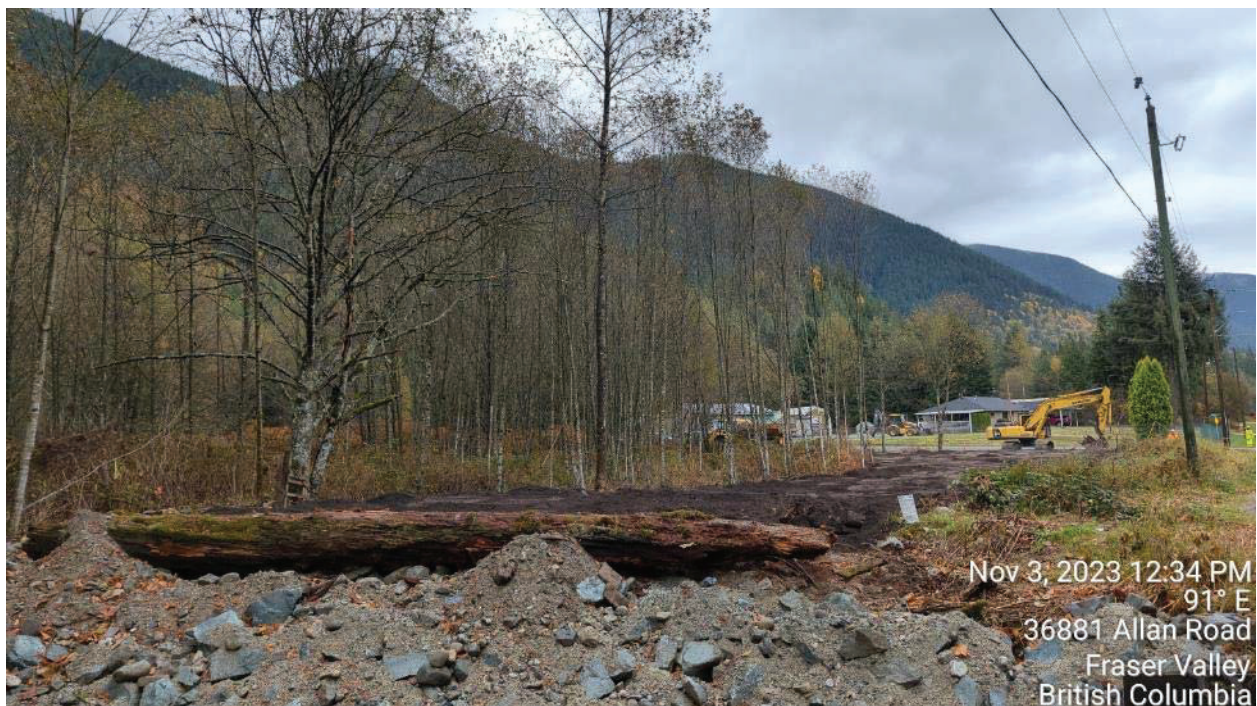
**Photo 23:** Laydown area facing south.

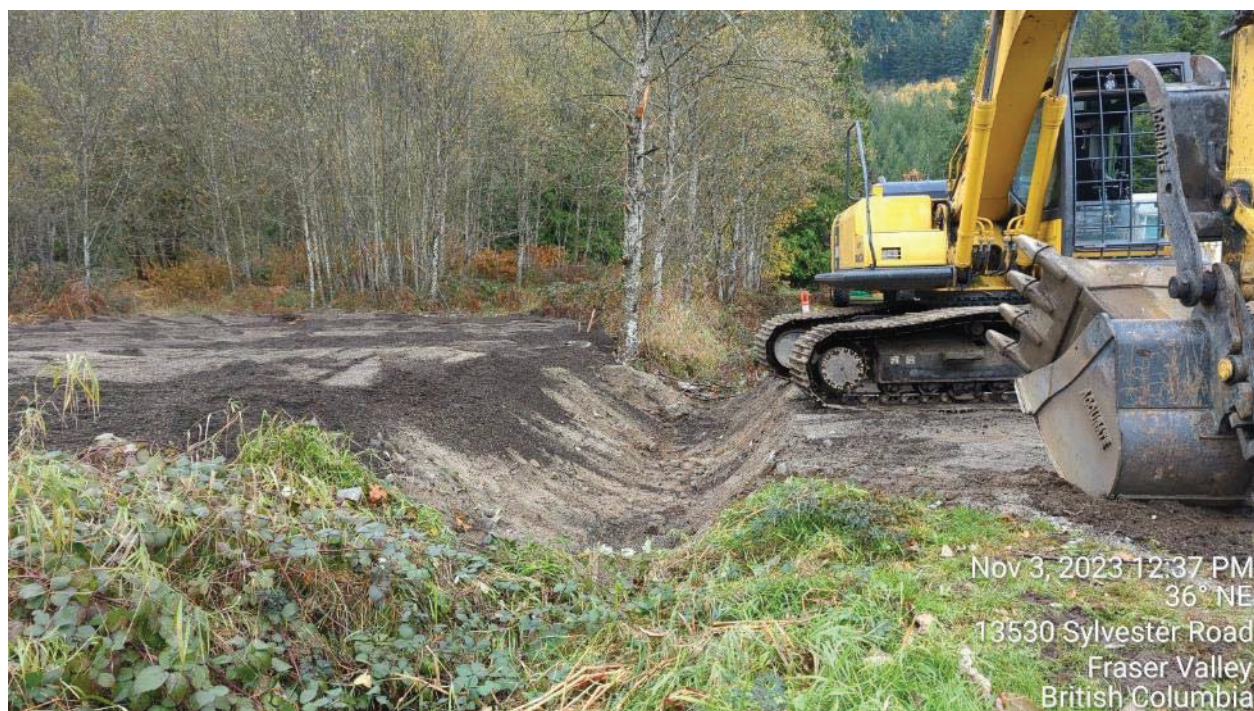
**Photo 24:** The culvert at Neilson Rd was removed.

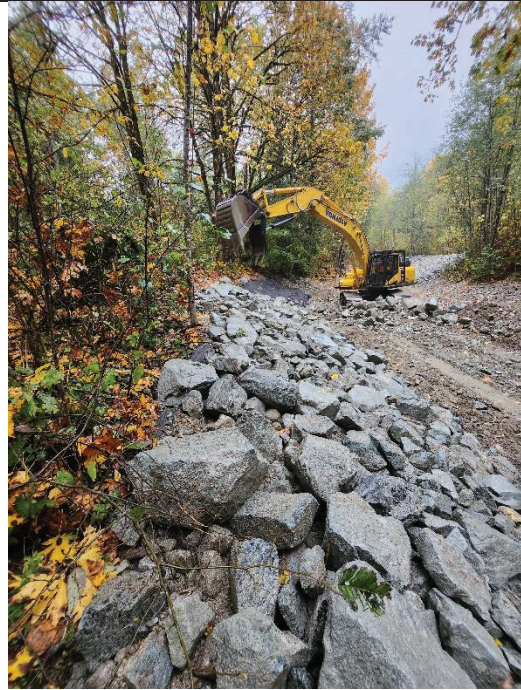
*Figure 1 - Upstream bank-right fabric/rip-rap installation*

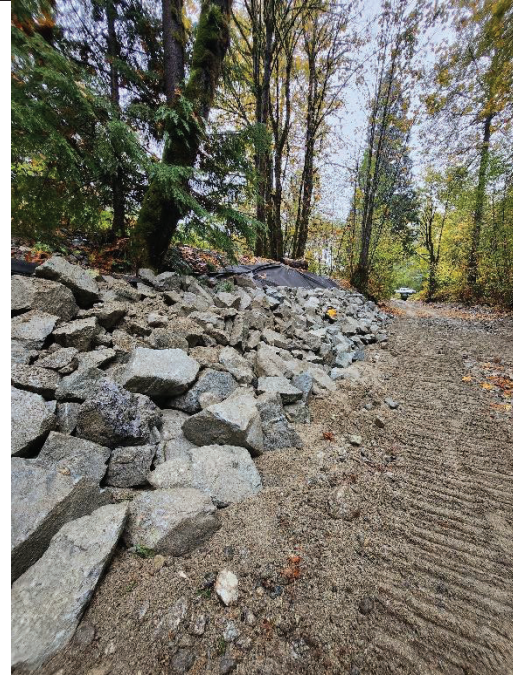
*Figure 3 - Upper bank-left and bank-right with completed rip-rap*

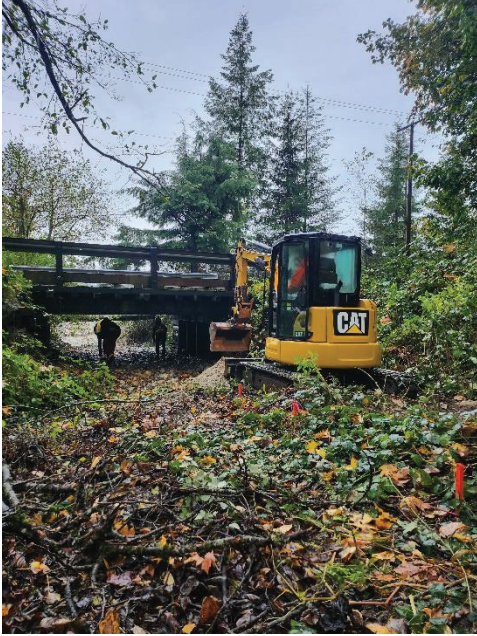
*Figure 4 - Lower section bank-right fabric/rip-rap installation*

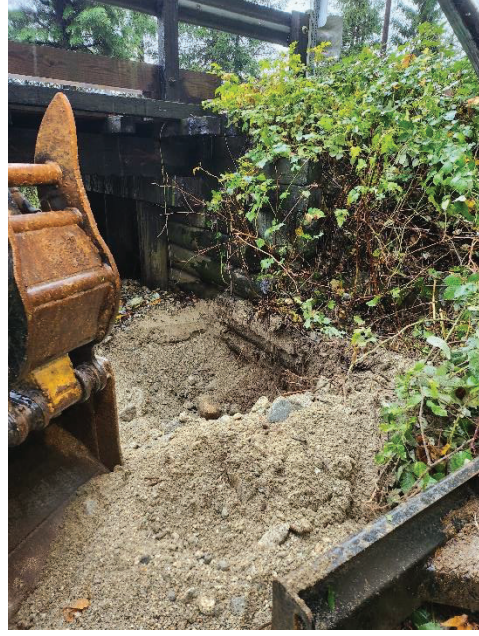
Figure 5 -Prep for middle section work between Sylvester & Hartley; Above Hartley Rd

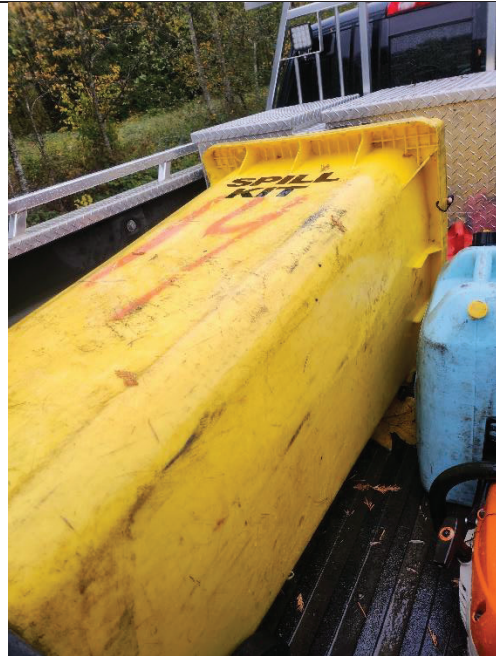
Figure 7 - Spill tray & kit onsite behind Allan Lake gate

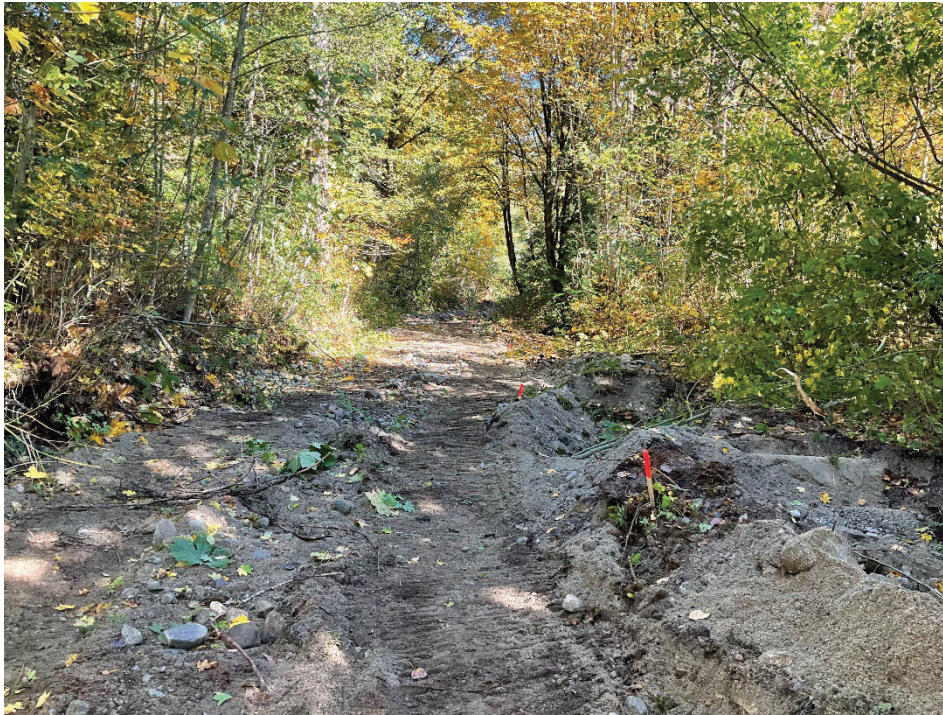
*Figure 3 Survey stakes looking East from lower entrance Eng Creek.*

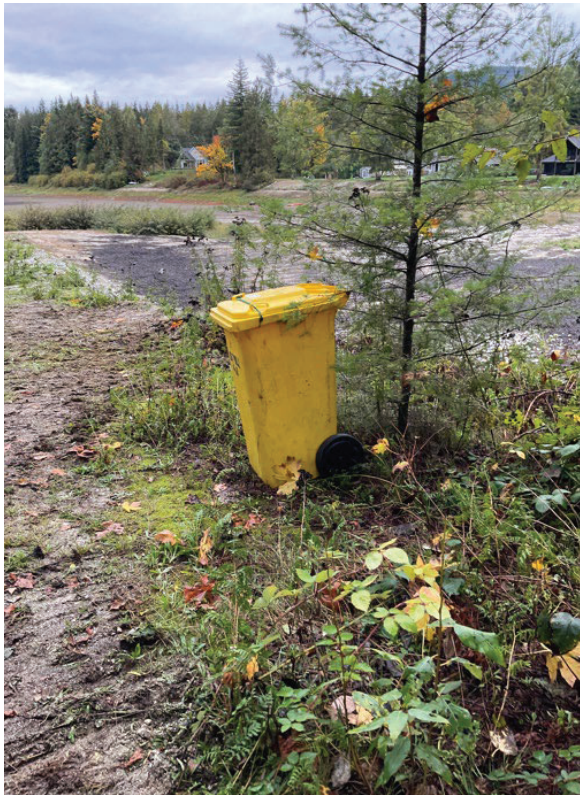
Figure 5 One of 2 Spill kits on site.

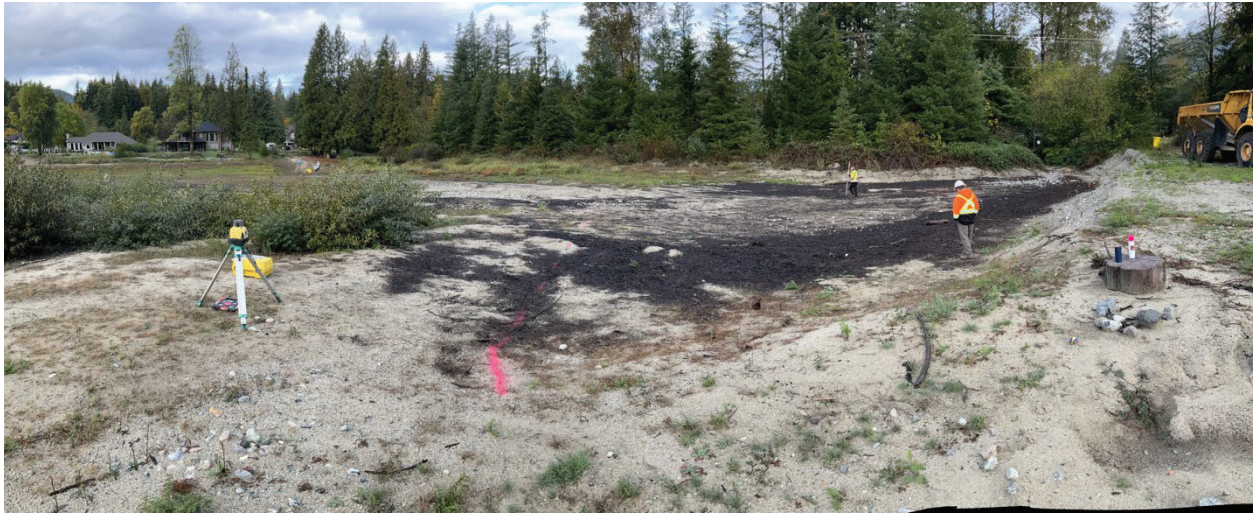
*Figure 1 Prepping sediment removal at confluence of Eng creek and Allan Lake.*

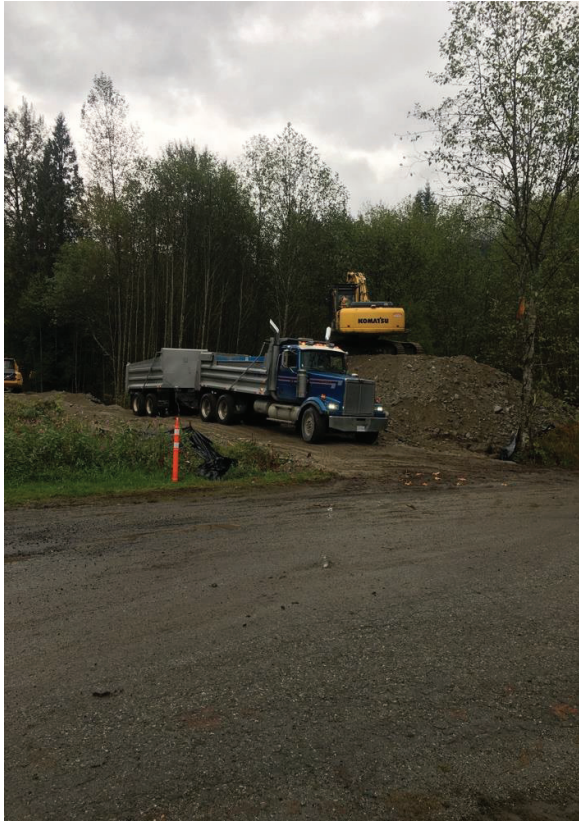
Image 3 – Loading and tipping point Hartley rd.

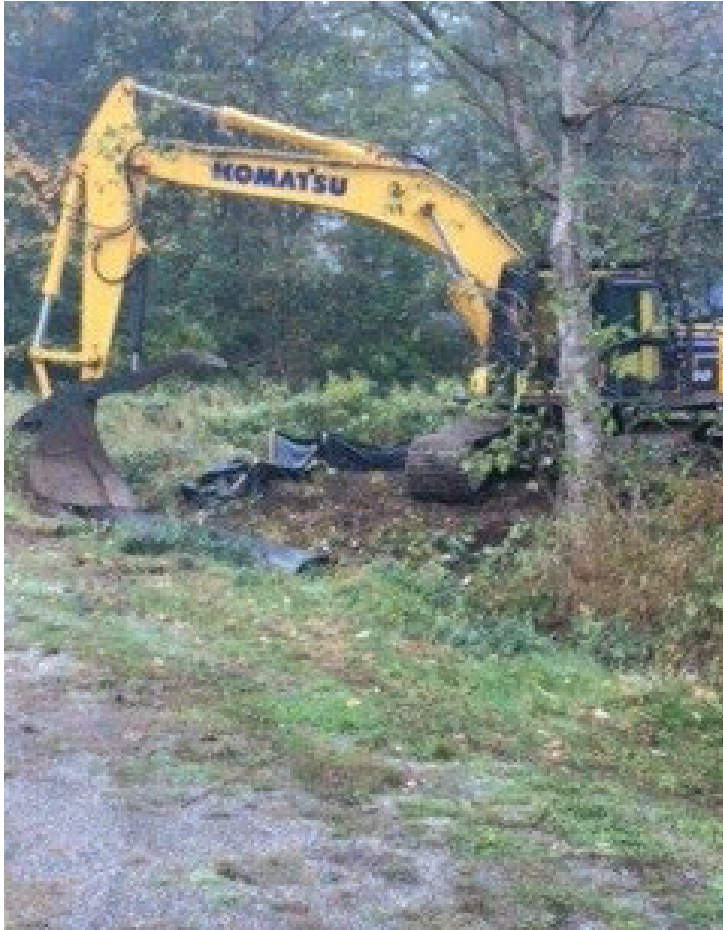
*Figure 2 Installing temporary culvert at Hartley Rd. entrance to lay down.*

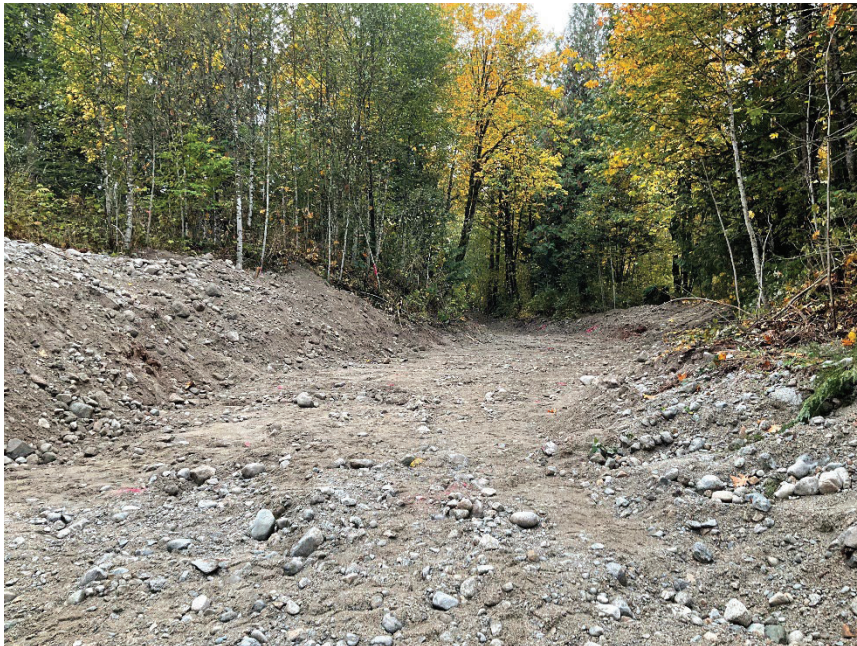
*Figure 4 Looking down stream at banks prepped for riprap on Monday.*

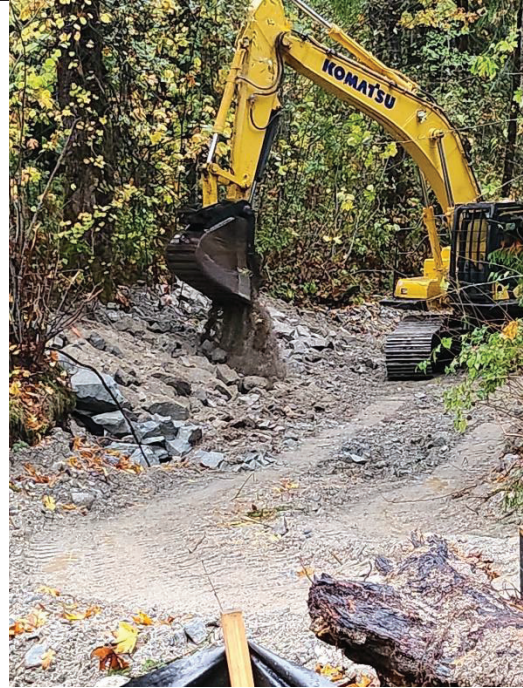
Figure 2 - Finishing of first rip-rap placement

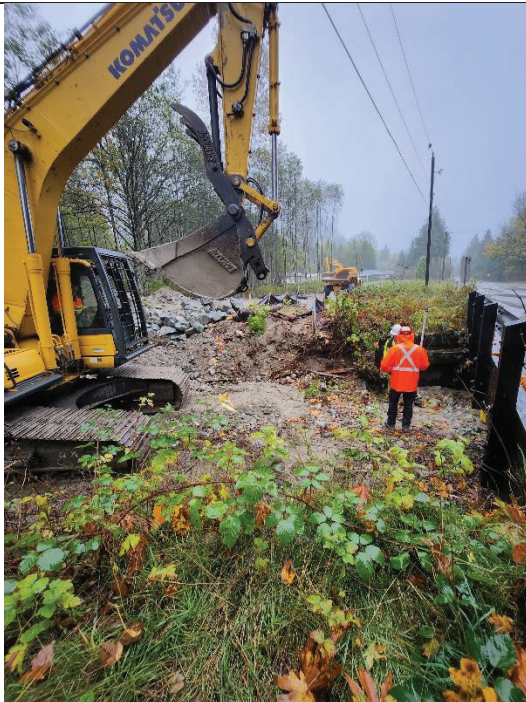
Figure 3 - Excavating bedload to creek level above Sylvester Rd Bridge
