# Ministry of Environment and Climate Change Strategy

## Hatzic Emergency Works Program Eng Creek and McNab Creek

## Post Construction Report

APRIL 2024

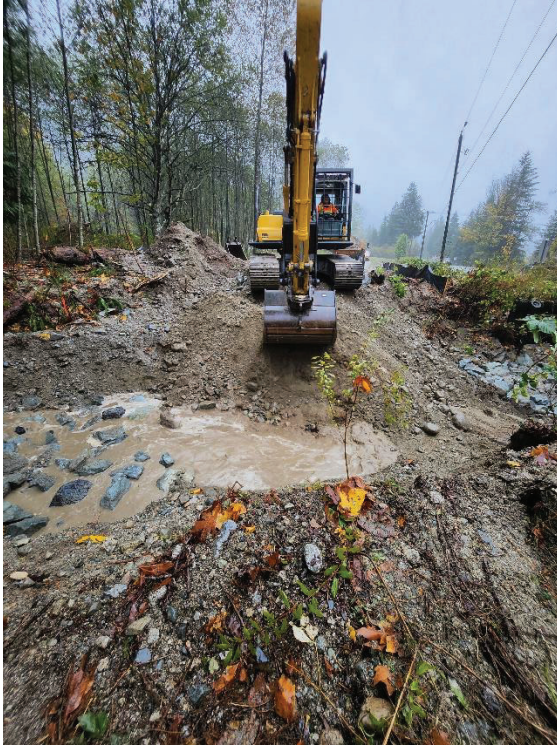
Figure 5 - Instream work area becoming wetted

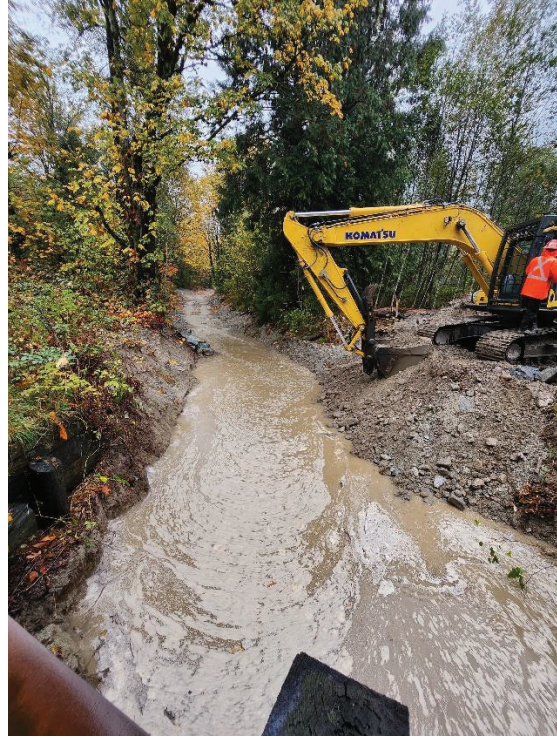
Figure 6 - Poor visibility preventing rip-rap placement

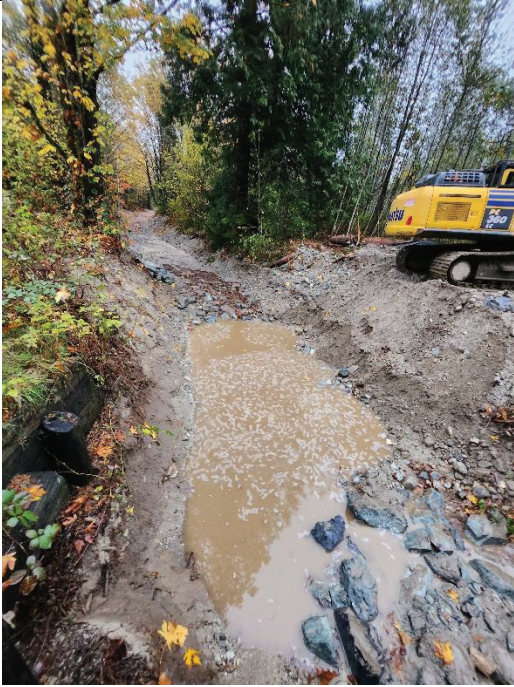
Figure 1 - Standing water with armor placement at creek bottom

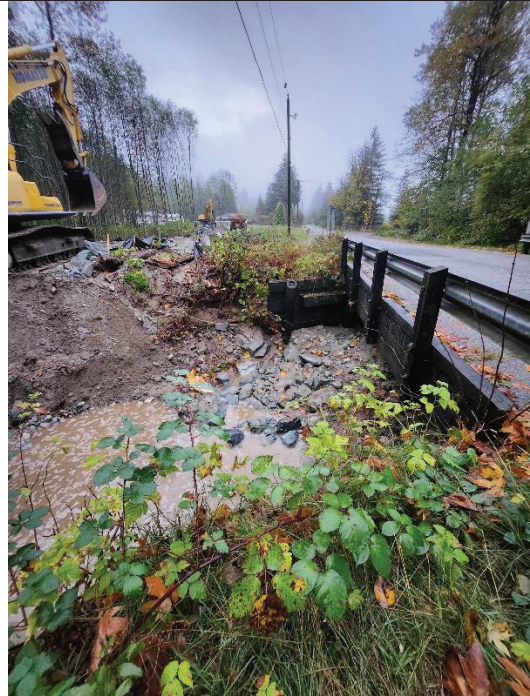
Figure 2 - Photo showing disconnection of water to below Sylvester Rd Bridge

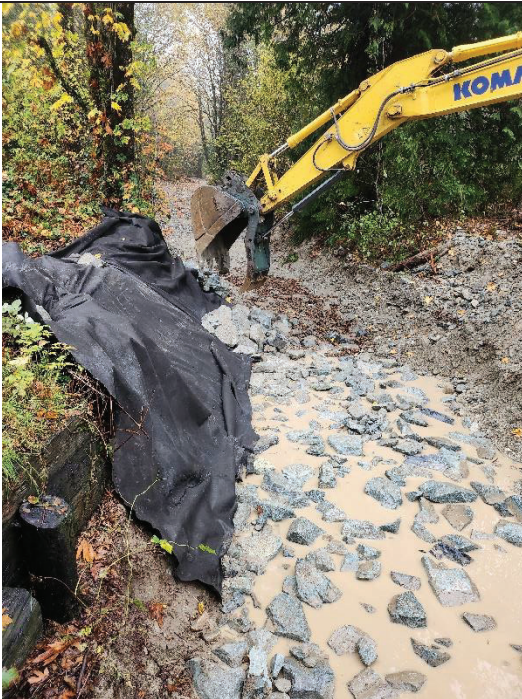
Figure 3 - Geo Fabric & rip-rap placement on NW bank above Sylvester Rd

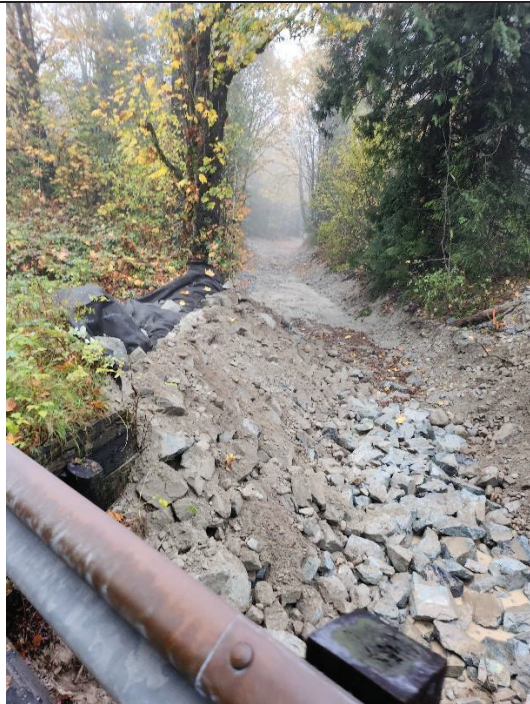
Figure 4 - Final armoring of NW bank

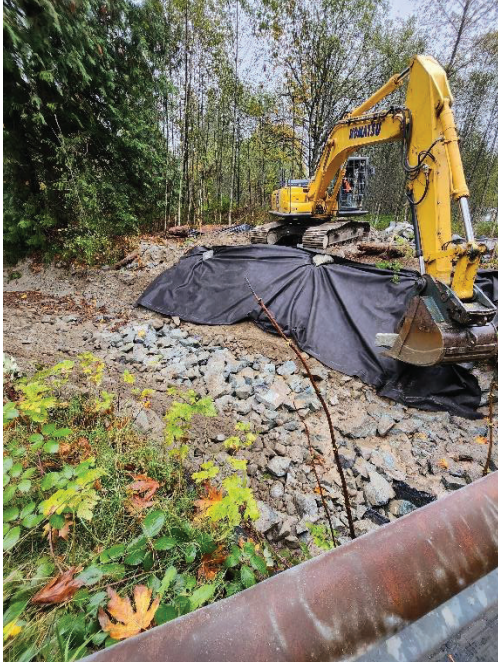
Figure 5 - Initial Geo Fabric/Rip-rap placement on NE bank

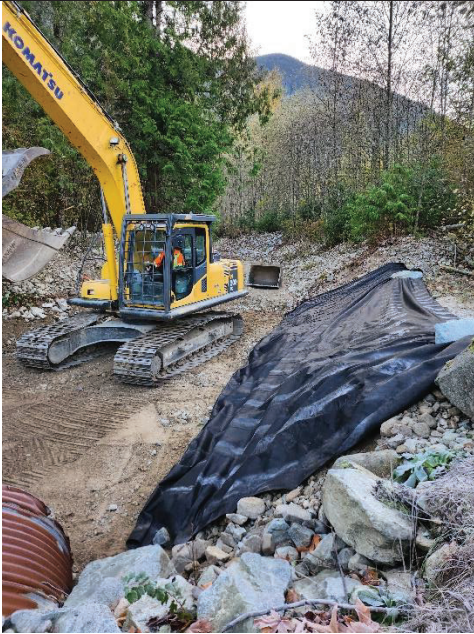
Figure 1 – Upstream Geo-Fabric/Armor around culvert

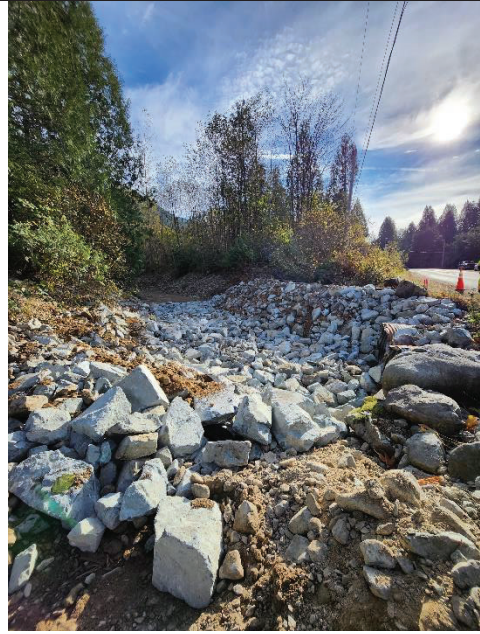
Figure 2 - Upstream Geo-Fabric/Armor around culvert complete

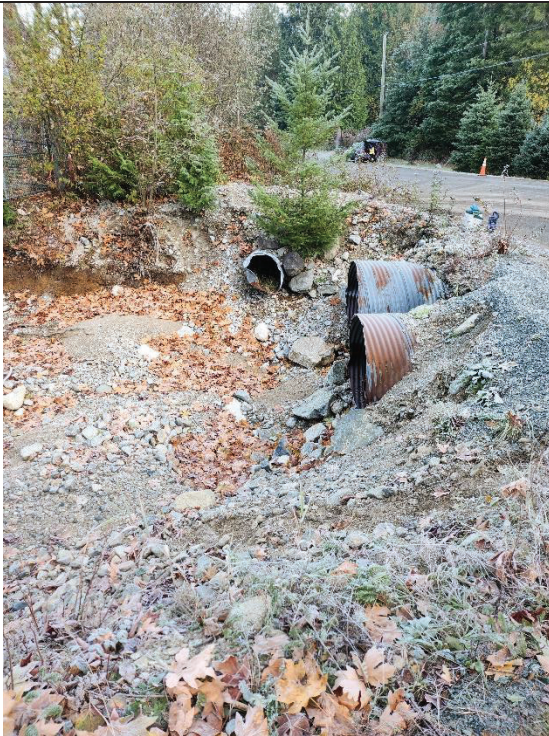
Figure 3 - Downstream culvert side before armor placement

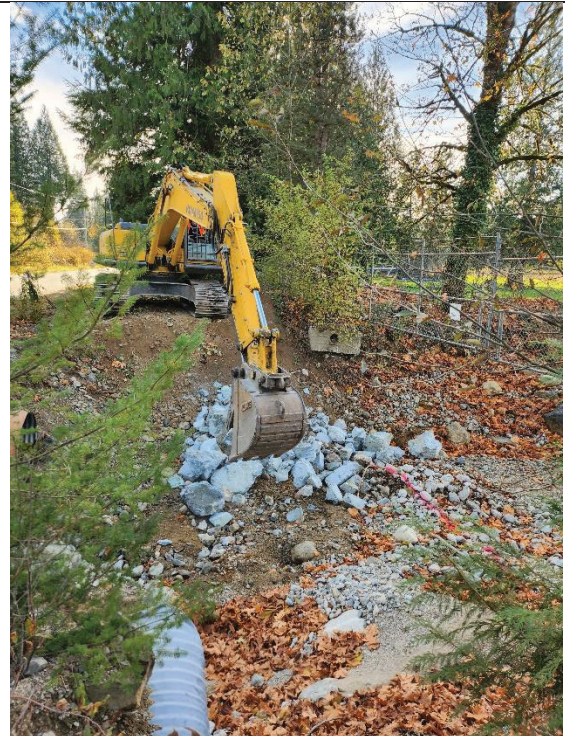
Figure 4 - Downstream culvert side after initial armor placement

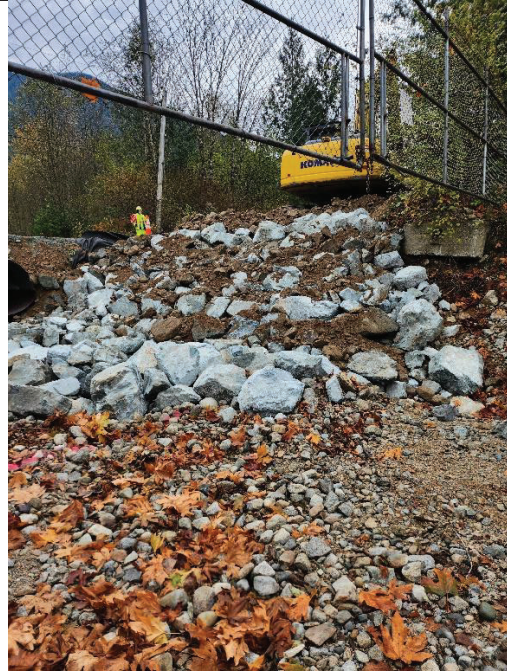
Figure 2 - Downstream Geo-Fabric/Armor around culvert complete

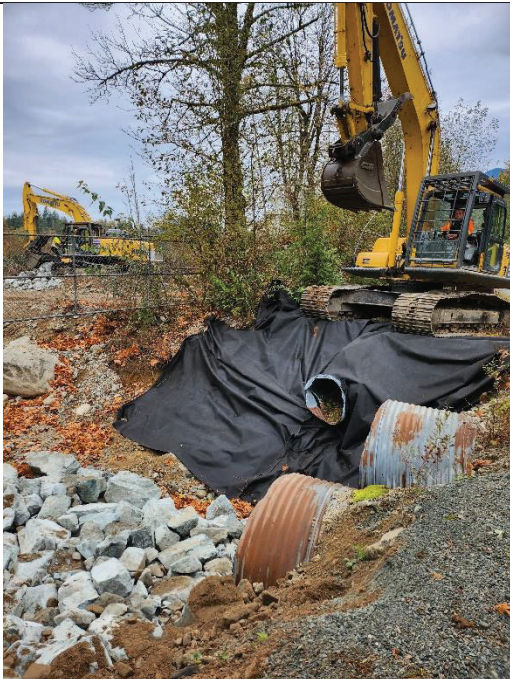
Figure 3 - Downstream culvert side before armor placement on west bank

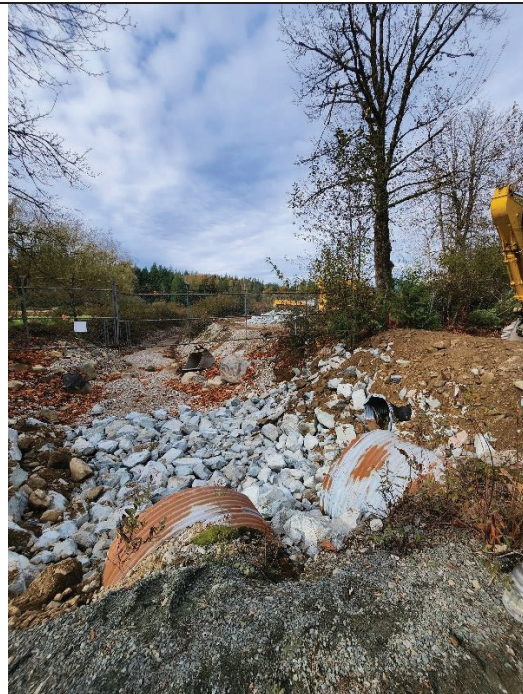
Figure 4 - Downstream culvert side after initial armor placement west bank complete

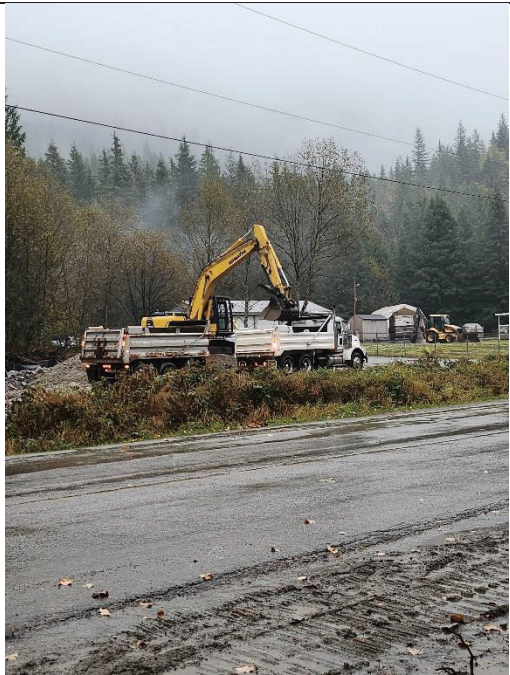
Figure 3 – Last of bedload loaded out from Eng Creek laydown yard

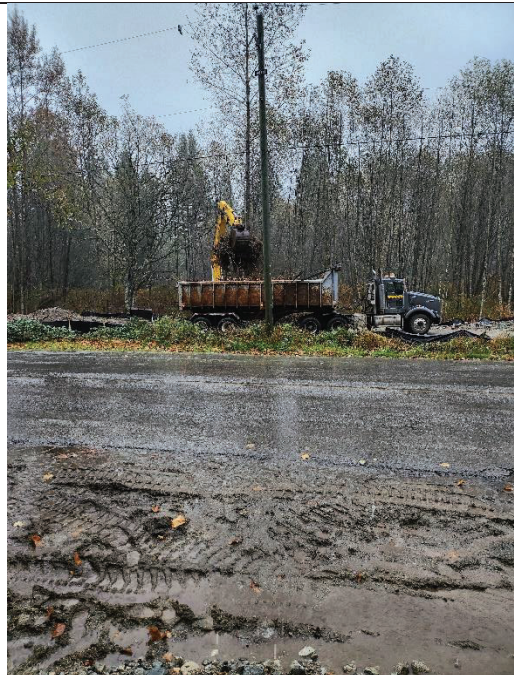
Figure 4 – Brush/woody debris loaded out from Eng Creek laydown yard

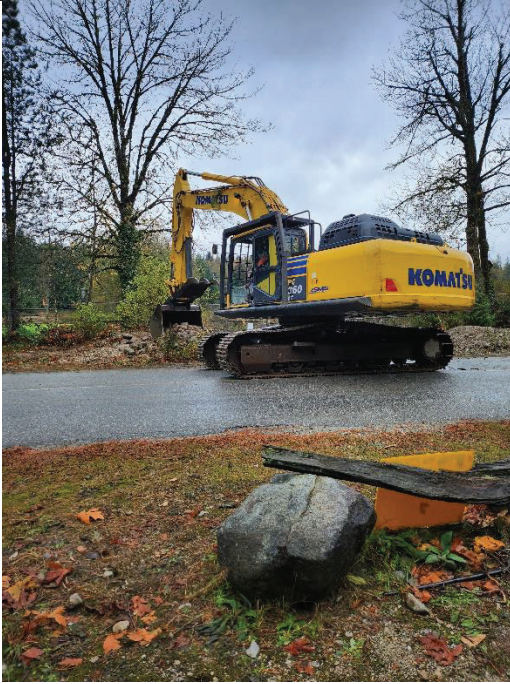
Figure 5 – 360 Ex. Removing excess material from berm

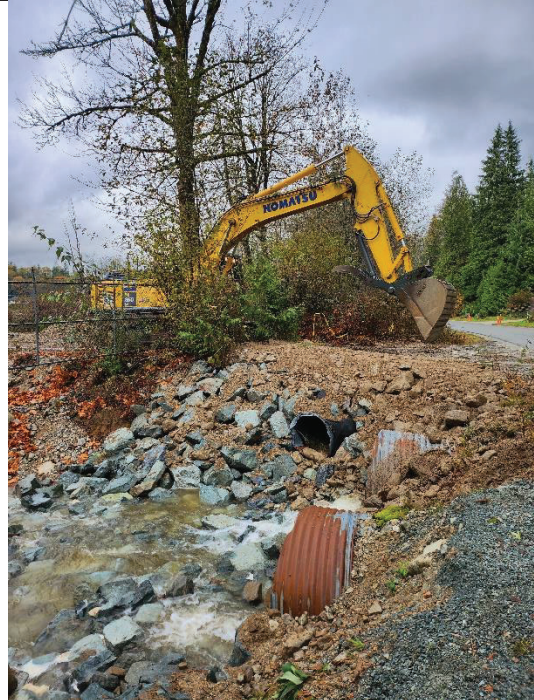
Figure 6 – 360 Ex. Removing excess material from berm

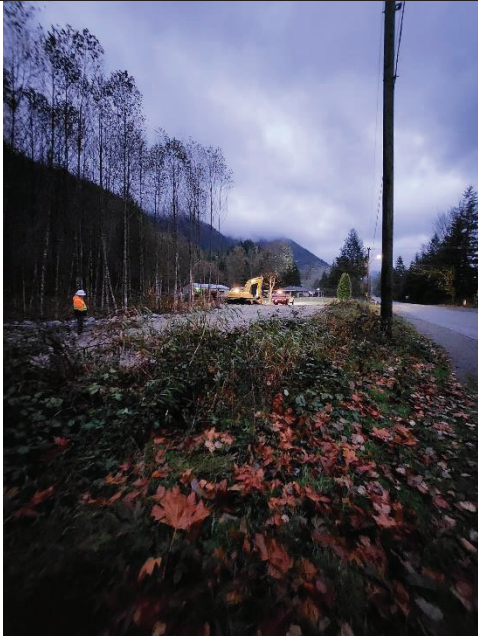
*Figure 1 – Topsoil delivery at Eng laydown area*

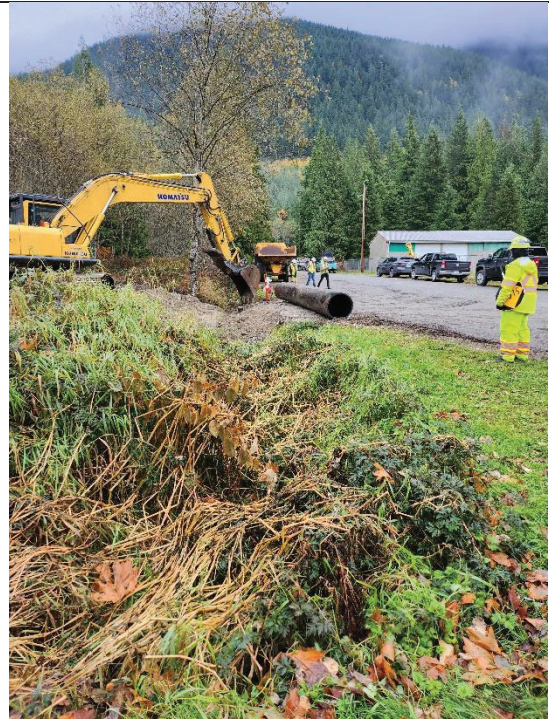
*Figure 4 – Removal of temporary culvert*

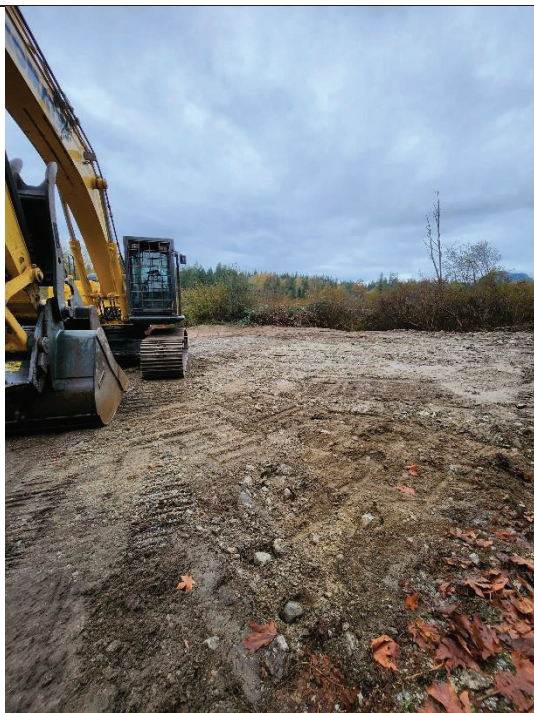
*Figure 5 – 360 Ex. Removing leveling excess soil/gravel at McNab laydown area*
