# Chemainus River Right Bank Recovery below Highway #1 Bridge

## 2024 Construction Completion

**Final Report**  
**December 30, 2025**  
**KWL Project No. 3427.025**

**Prepared for:**  
**BC Ministry of Environment and Climate Change**

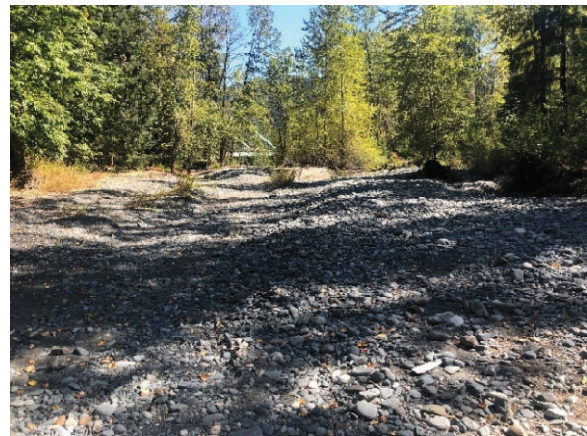
**Photo 2: Sediment Accumulated Inside Channel on Right Bank of Chemainus River**  
Note Highway 1 Bridge in background

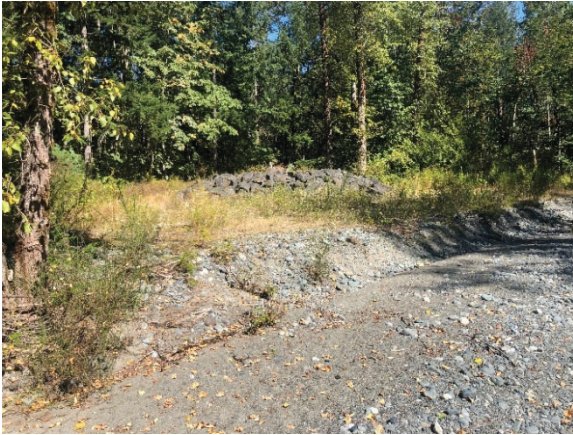
Well heads for the District of North Cowichan (DNC) water supply system are located adjacent to the side channel and are protected by riprap (Photos 3 and 4). The depth of riprap below the channel is unknown.

**Photo 3: DNC Water Supply Well Head Protected by Riprap Adjacent to Side Channel**

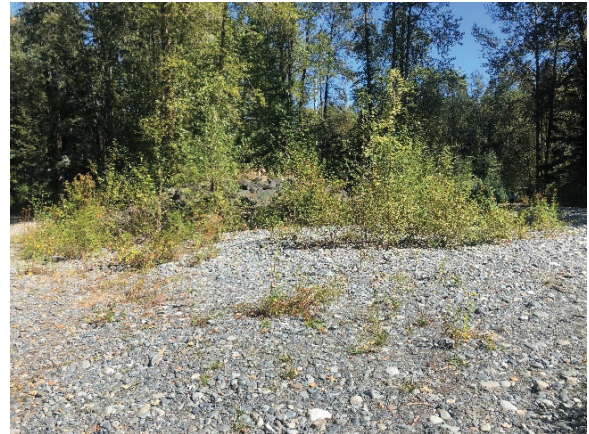
**Photo 4: DNC Water Supply Well Head Protected by Riprap Adjacent to Side Channel**

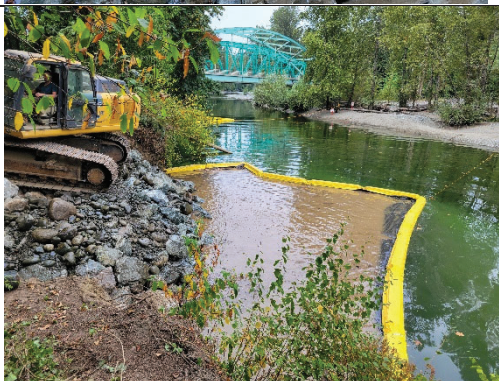
Photo 5:  
Weir #2  
under  
construction

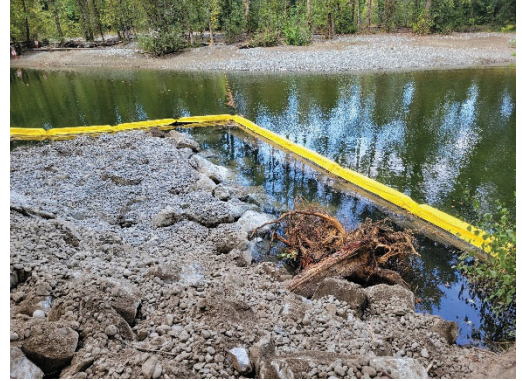
Photo 2:  
D84 on top  
of Weir #2

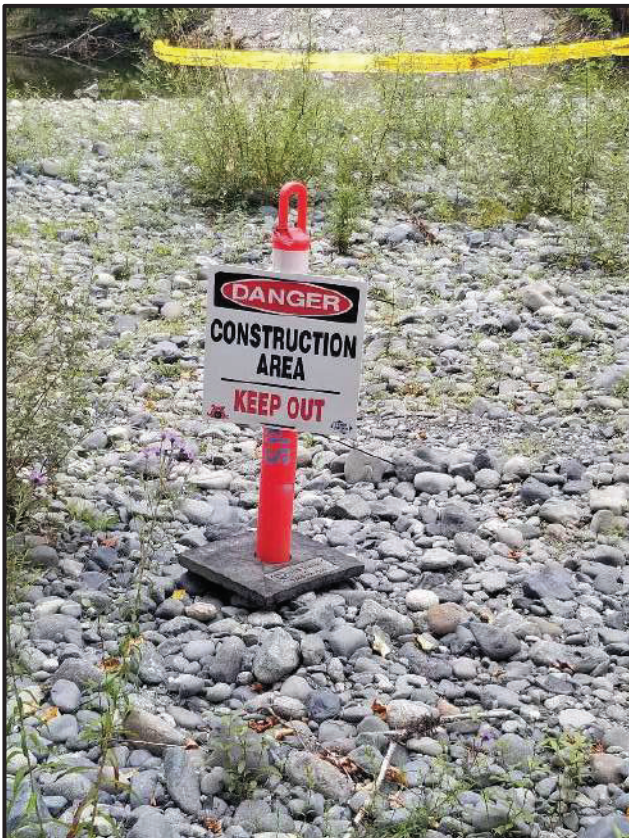
**WARNING SIGNAGE POSTED ON THE LEFT BANK OF THE CHEMAINUS RIVER OPPOSITE THE MAIN WORK AREA. SIGNS WERE PLACED AT THE MOST COMMON PEDESTRIAN ACCESS POINTS.**

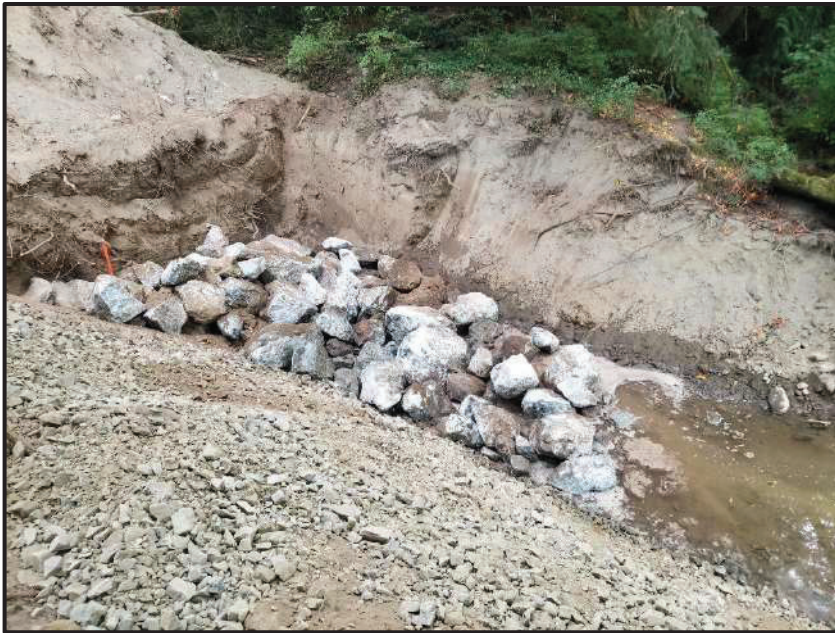
**PLACEMENT OF RIPRAP IN THE EXCAVATED TRENCH.**

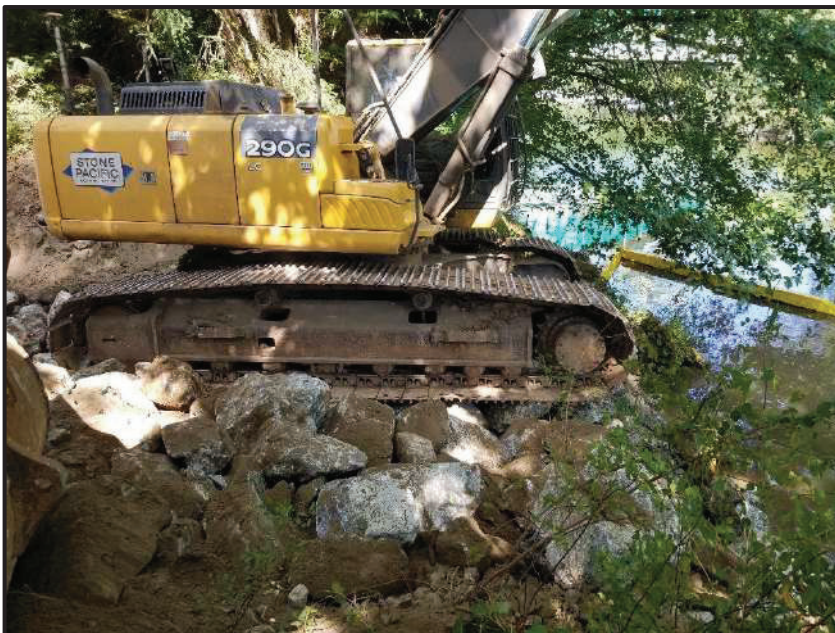
**EXCAVATOR ATOP THE RIPRAP OF WEIR 1. THE KEYED IN RIPRAP WAS USED TO PROVIDE A STABLE WORKING PLATFORM DURING THE EXCAVATION PROCESS.**

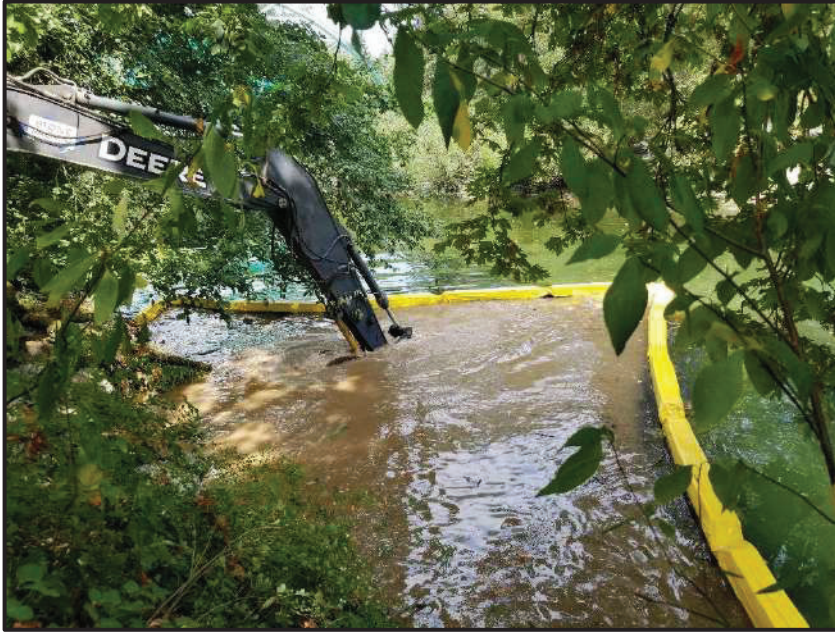
**EXCAVATIONS AS PART OF WEIR CONSTRUCTION. A TRENCH WAS DUG OUT TO ALLOW FOR THE BASE LAYER OF RIPRAP TO BE PLACED AND CREATE STABILITY FOR THE WEIR.**

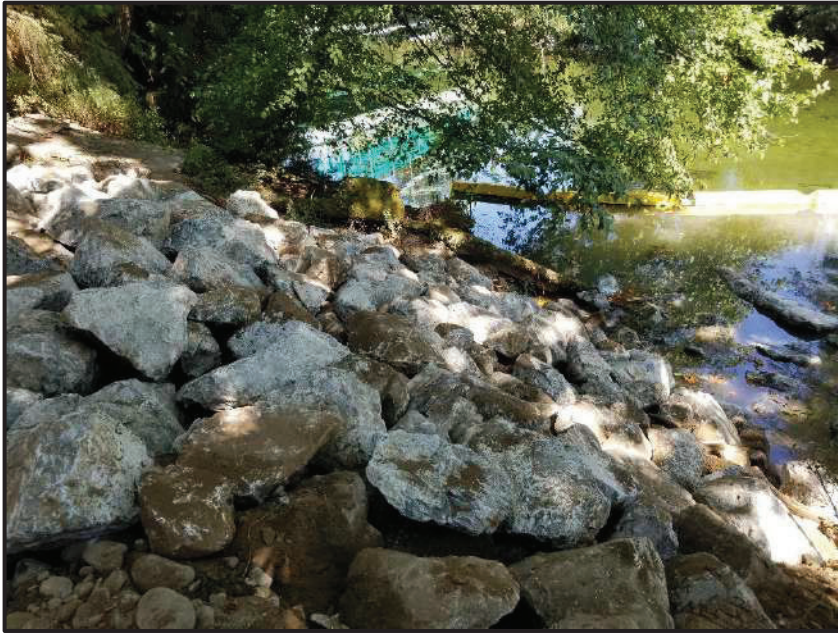
**THE FACE OF WEIR 1 PRIOR TO BEING CAPPED WITH D95 COBBLES.**

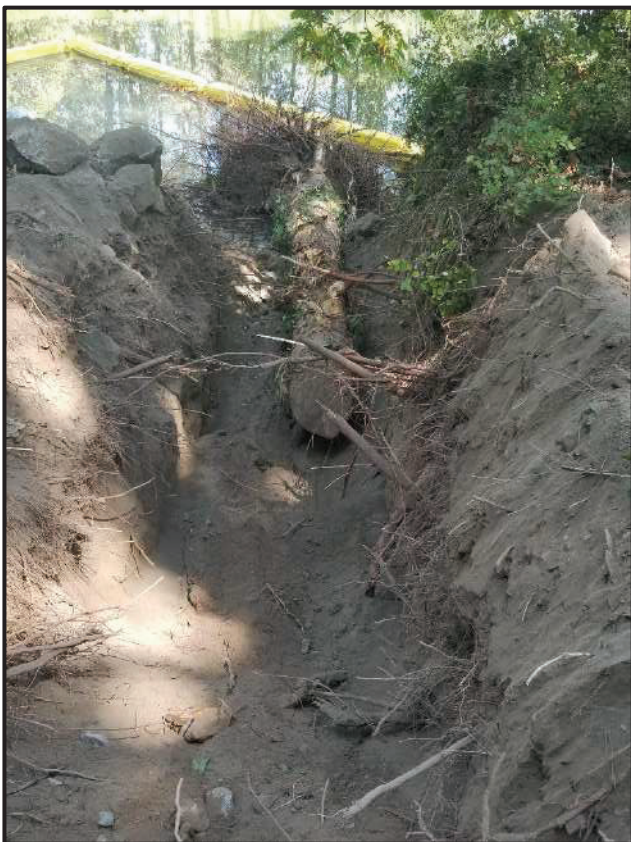
**LOOKING DOWN AT THE LWD THAT WAS PLACED IMMEDIATELY DOWNSTREAM OF THE WEIR TO INCREASE AQUATIC HABITAT COMPLEXITY.**

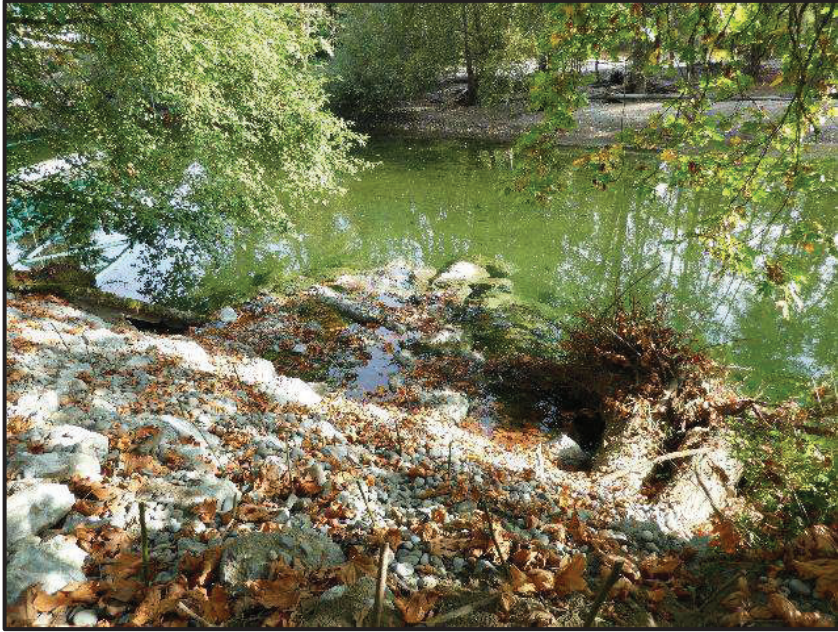
**LOOKING DOWN AT WEIR 1 AFTER CONSTRUCTION WAS COMPLETED.**

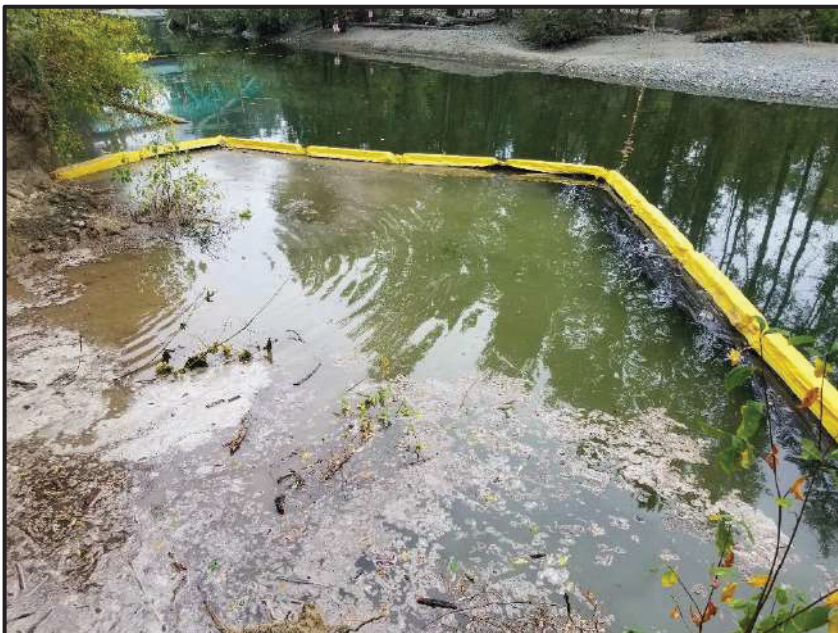
**THE ENCLOSED WORK AREA FOR WEIR 2. TO ENSURE ADEQUATE WORKING AREA, A THIRD SILT CURTAIN WAS ATTACHED. NOTE THE SILT CURTAIN WAS EFFECTIVE IN CONTAINING TURBID WATER THAT WAS GENERATED DURING EXCAVATIONS.**

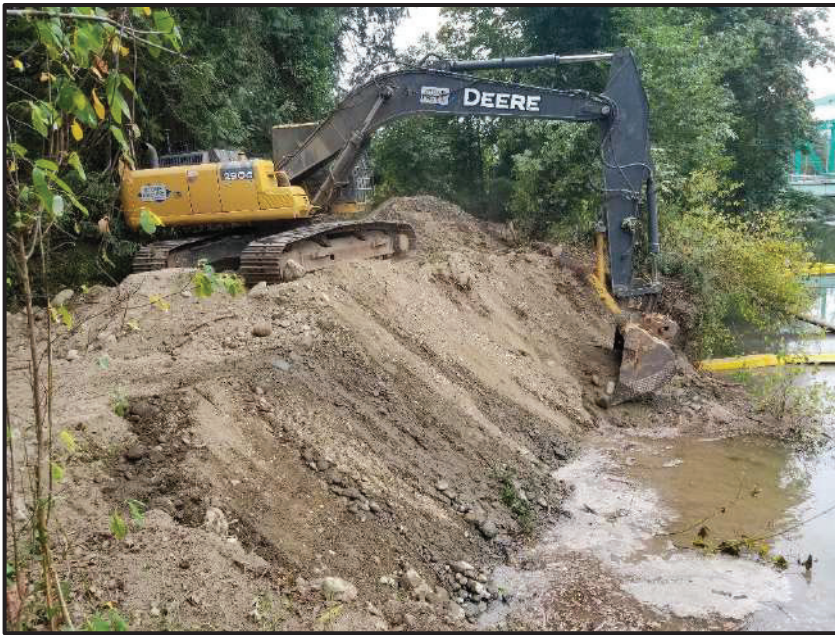
**PREPARATION OF THE BANK FOR CONSTRUCTION OF WEIR 2. EXCAVATIONS WERE REQUIRED TO ACHIEVE THE REQUIRED SLOPE PRIOR TO PLACEMENT OF RIPRAP.**

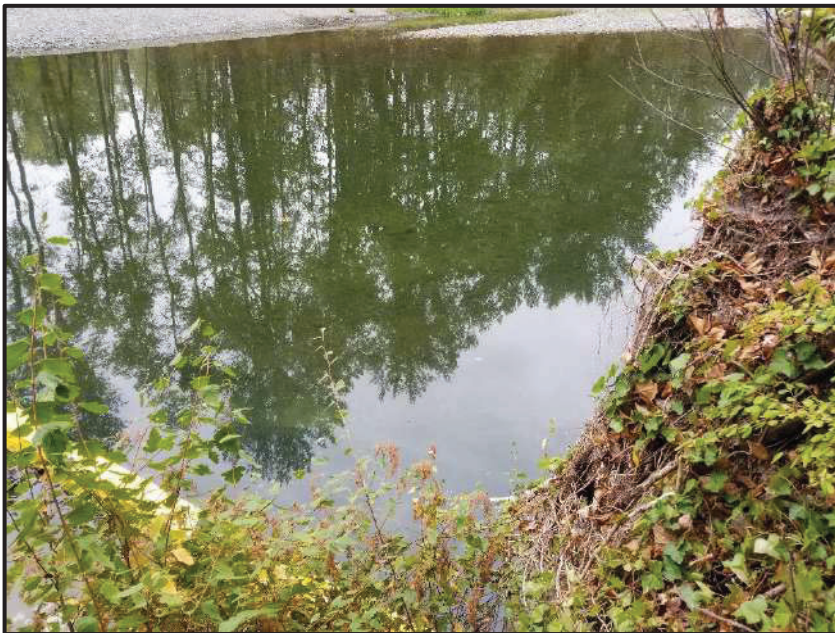
**LOOKING DOWNSTREAM IMMEDIATELY BELOW THE ENCLOSED WORK ZONE. THE WATER OUTSIDE THE ISOLATED AREA REMAINED CLEAR FOR THE DURATION OF WEIR 2 CONSTRUCTION.**

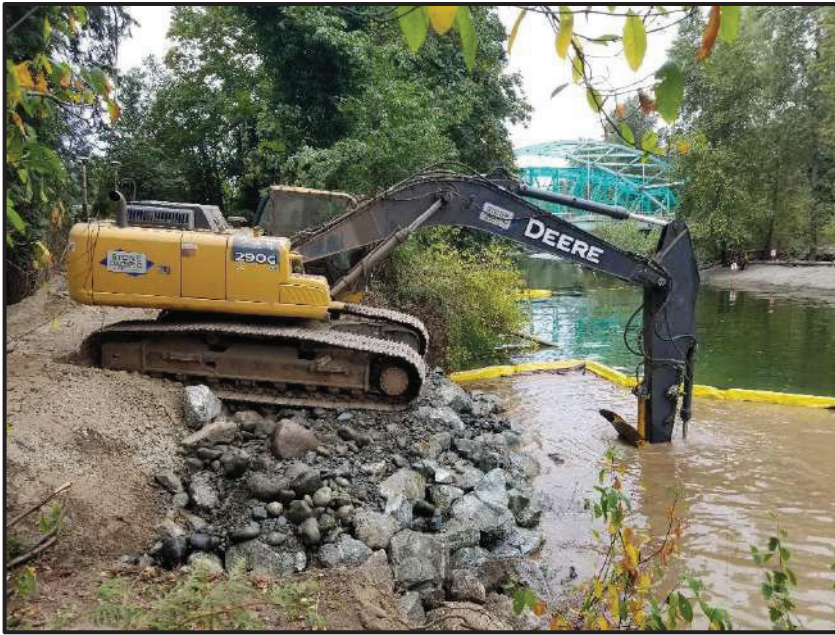
**INSTREAM EXCAVATIONS THAT WERE REQUIRED TO CONSTRUCT THE BASE LAYER OF WEIR 2. NOTE THAT THE ROCK PLACED ALONG THE BANK WAS USED AS A PLATFORM FOR THE EXCAVATOR.**

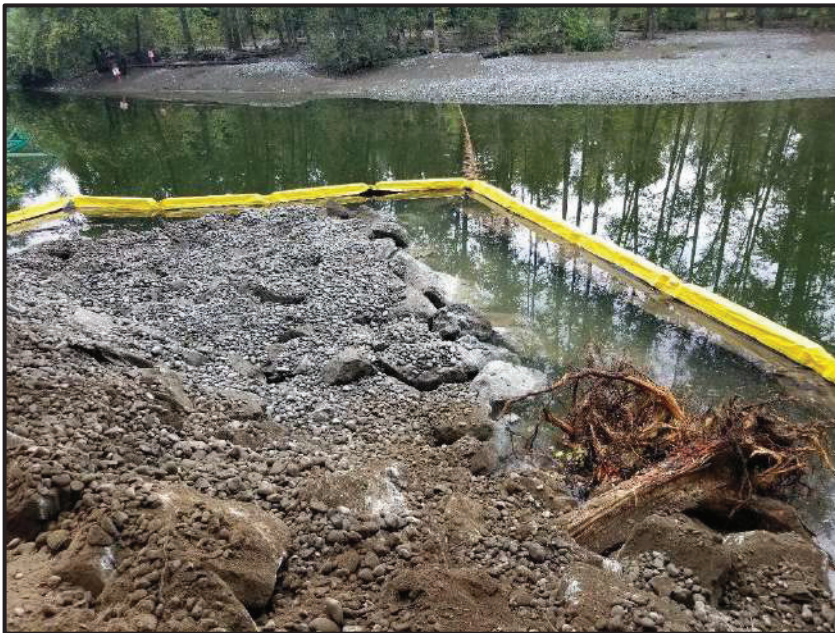
**LOOKING DOWN AT WEIR 2 AFTER CONSTRUCTION WAS COMPLETED.**

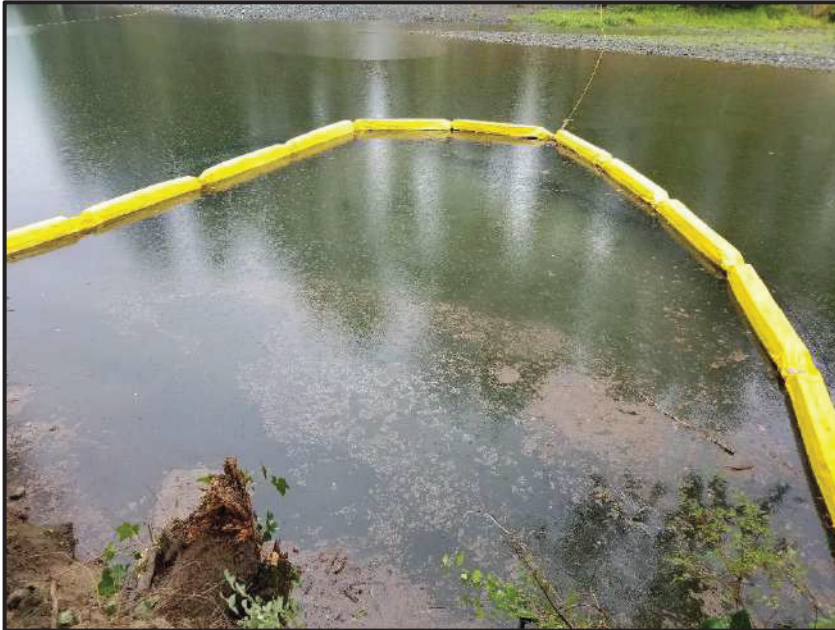
**THE ENCLOSED WORK AREA FOR WEIR 3.**

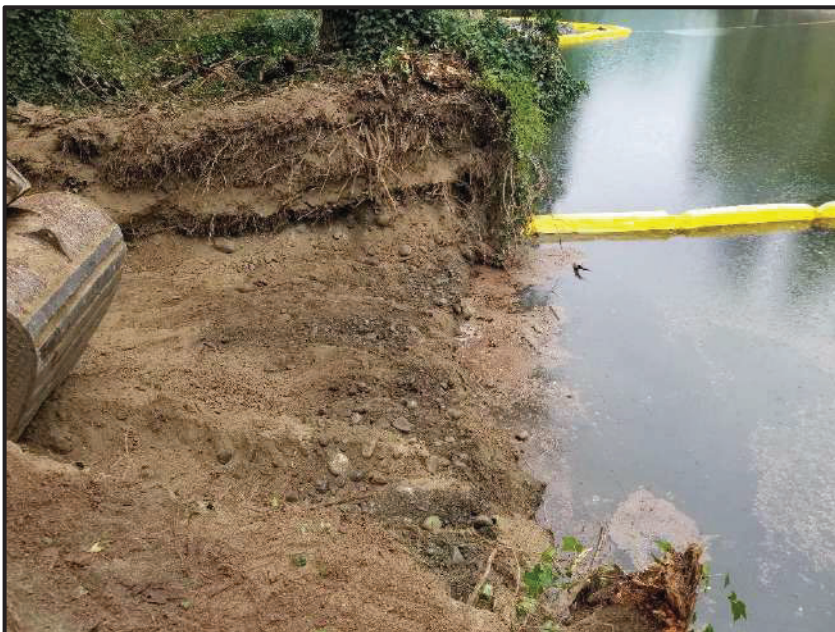
**EXAMPLE OF DEPTH OF BANK EXCAVATION FOR WEIR 3. THE PURPOSE OF THE EXCAVATION WAS TO KEY RIPRAP INTO THE RIVERBANK.**

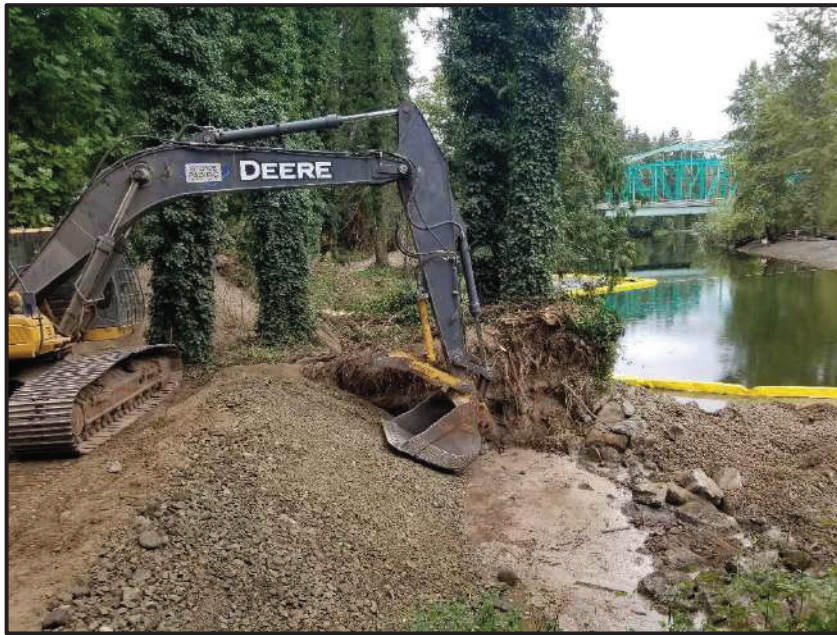
**DRAIN ROCK PLACEMENT. RIPRAP WAS PLACED OVER THE BANK, LEADING DOWN TO THE WEIR.**

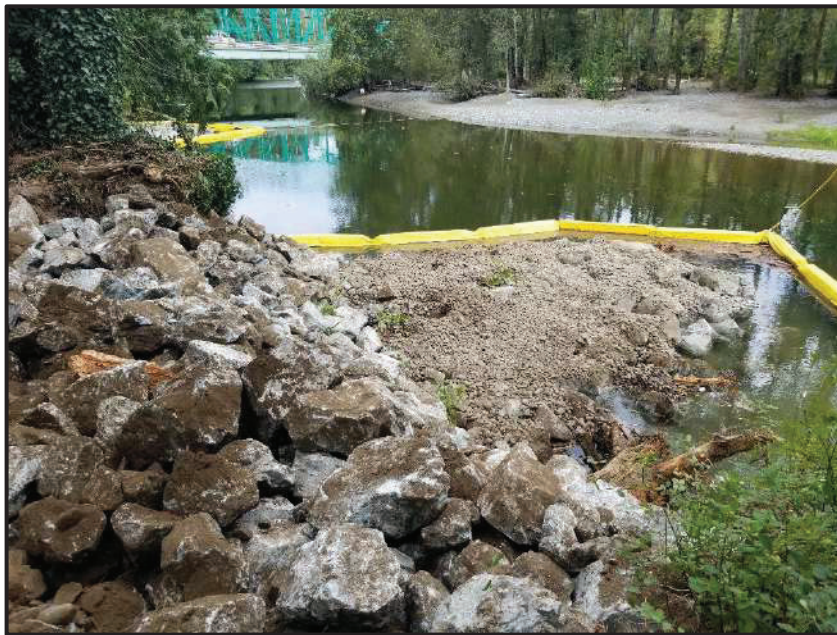
**LOOKING DOWN AT THE COMPLETED WEIR 3 STRUCTURE.**

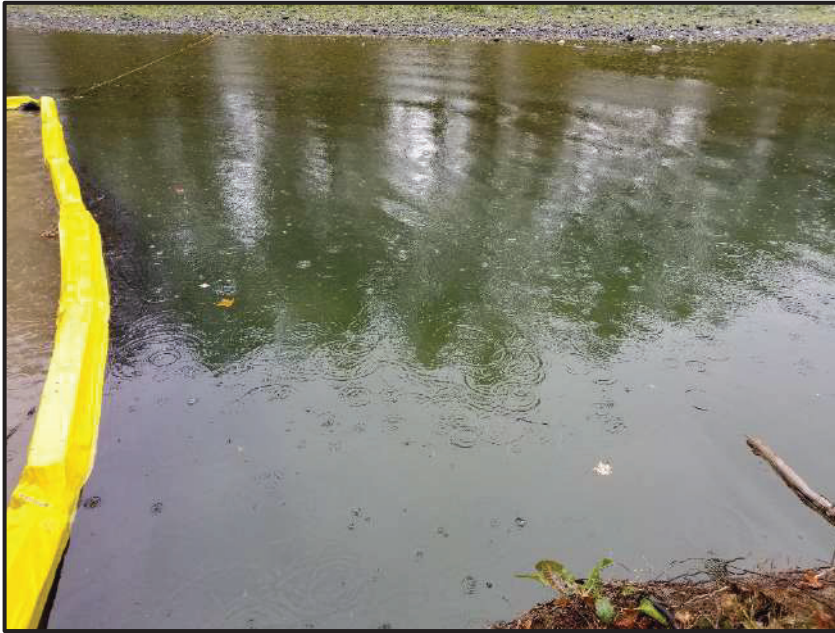
**SILT CURTAIN DURING CONSTRUCTION OF WEIR 4. NOTE THAT THE DIRTY WATER WAS CONTAINED BY THE CURTAIN.**

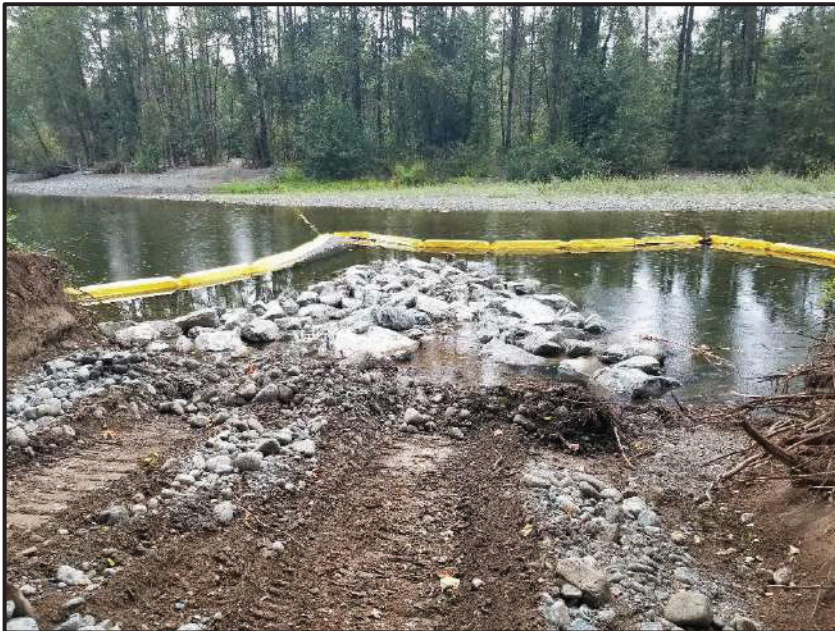
**LOOKING TOWARDS WEIR 4 DURING THE CONSTRUCTION PROCESS.**

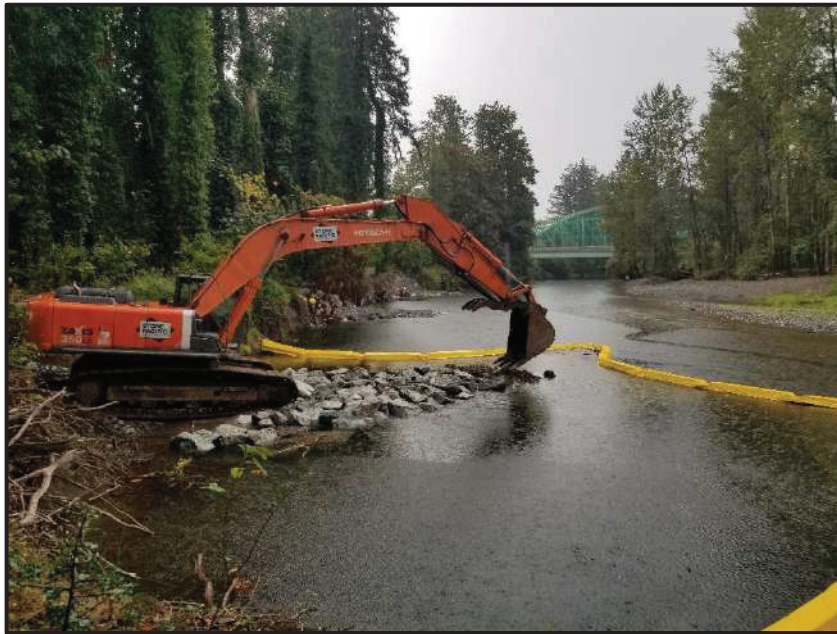
**PLACEMENT OF RIPRAP AT THE OUTER EXTENT OF WEIR 4. THE PORTION OF THE WEIR CLOSEST TO THE RIVERBANK WAS USED AS A PLATFORM FOR THE EXCAVATOR TO ENSURE ADEQUATE REACH.**

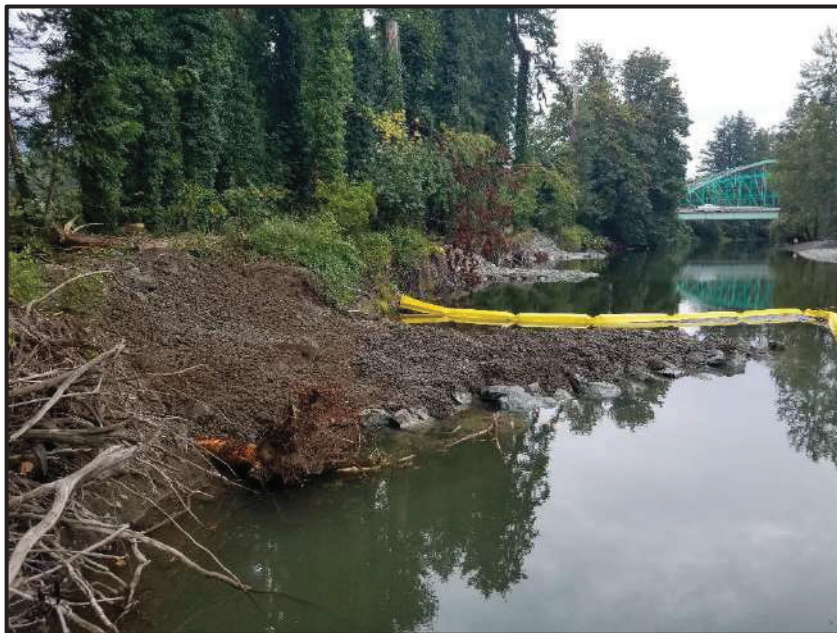
**WEIR 4 UPON COMPLETION.**

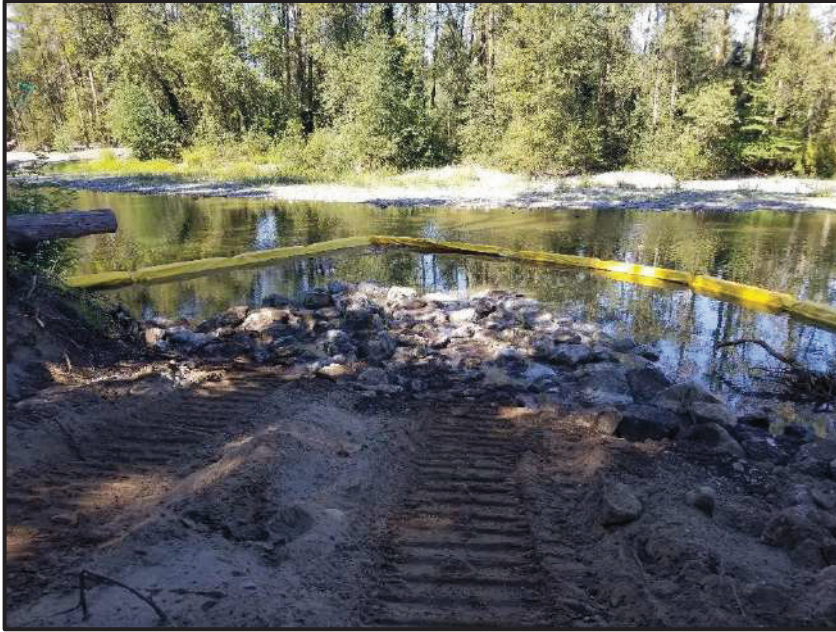
**THE EXTENT OF WEIR 5.**

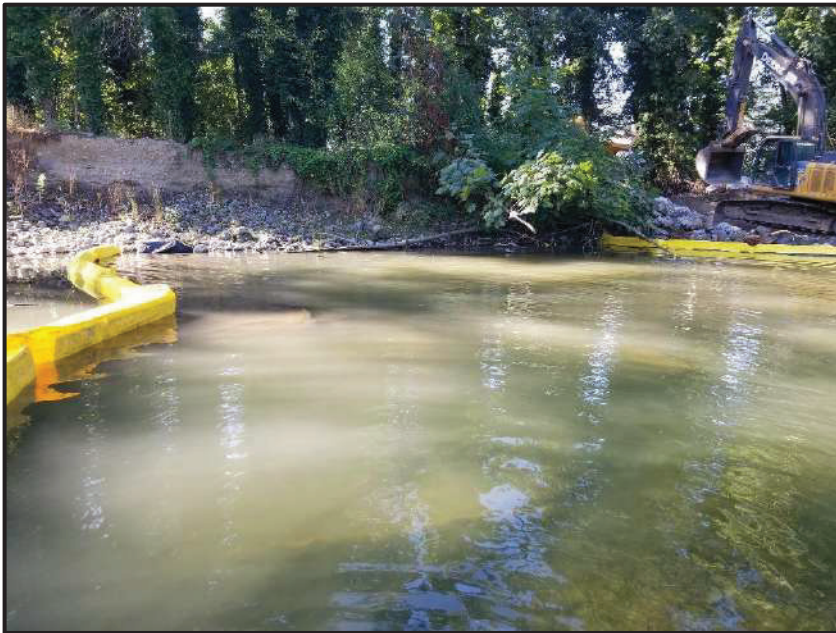
**TURBID WATER THAT SEEPED OUT OF THE ISOLATED AREA FROM UNDER THE SILT CURTAIN. TURBID WATER WAS CONTAINED IN THE IMMEDIATE AREA AND DID NOT REACH THE LOWER WATER QUALITY SITE.**

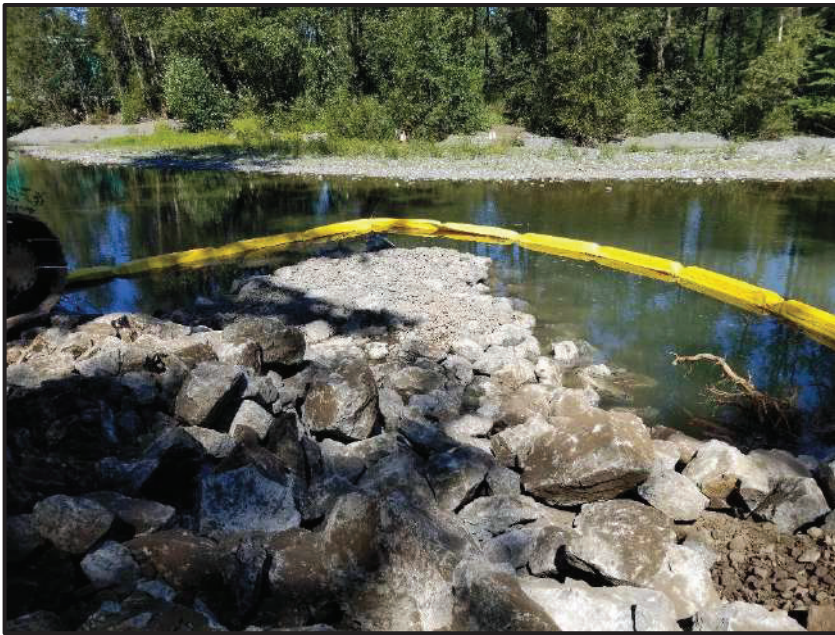
**WEIR 5 UPON COMPLETION OF RIPRAP PLACEMENT AND LWD.**

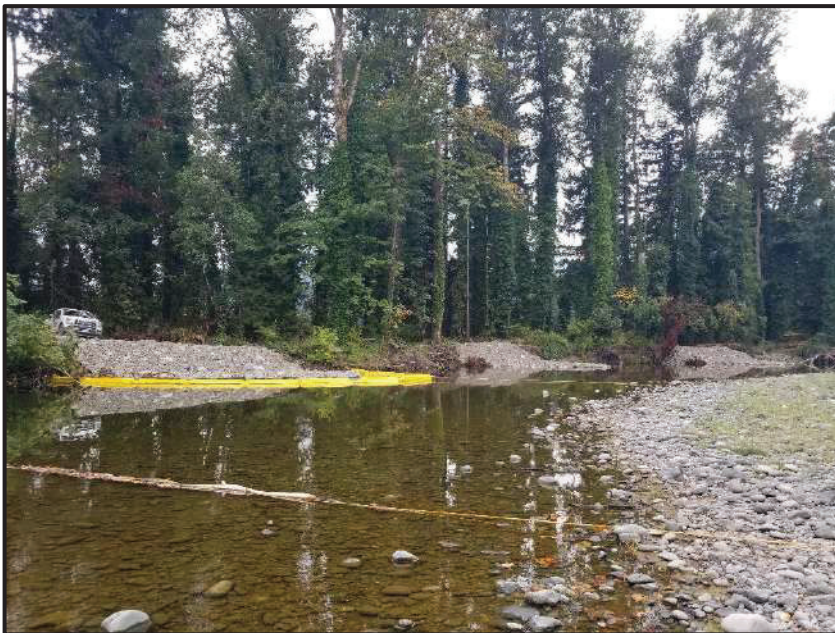
**LOOKING UPSTREAM AT COMPLETED WEIRS 3, 4 AND 5.**

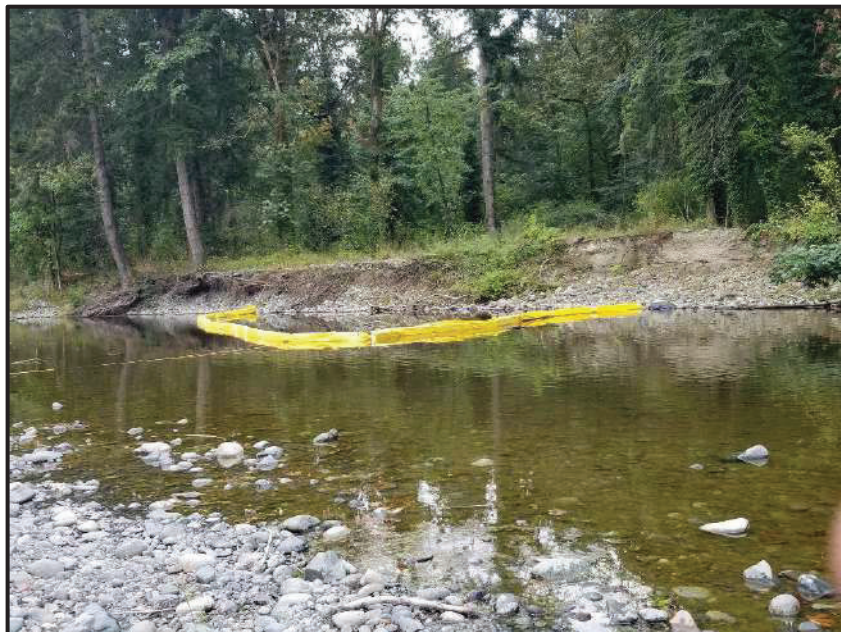
**THE WEIR 6 ENCLOSURE PRIOR TO INITIATION OF BANK EXCAVATIONS.**

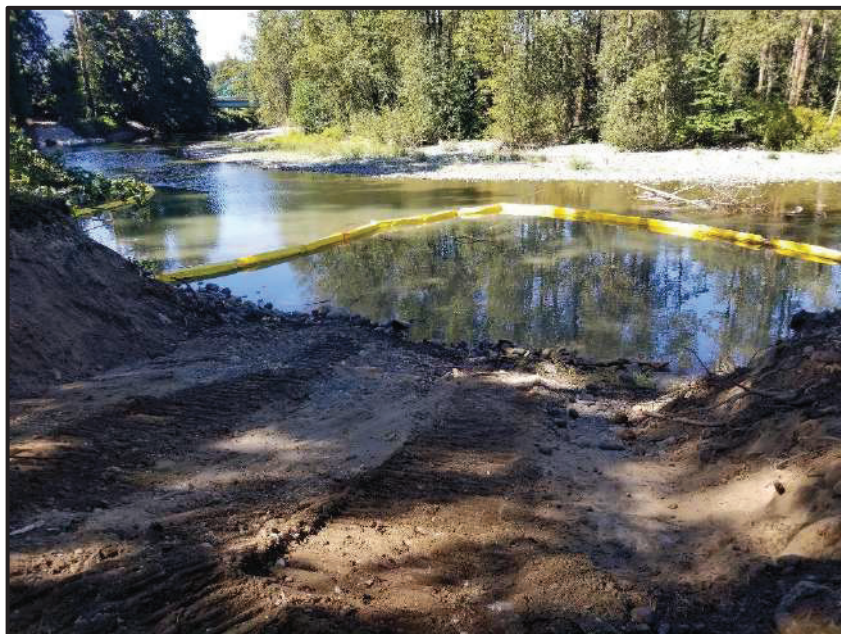
**LOOKING DOWN THROUGH THE BANK EXCAVATION OF WEIR 6.**

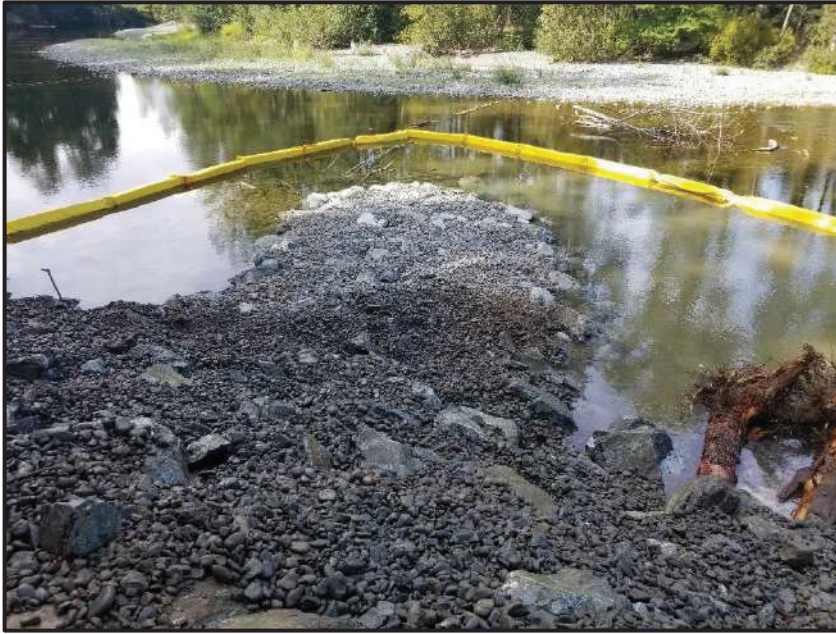
**LOOKING DOWN AT WEIR 6 AFTER RIPRAP WAS CAPPED WITH D95 COBBLES.**

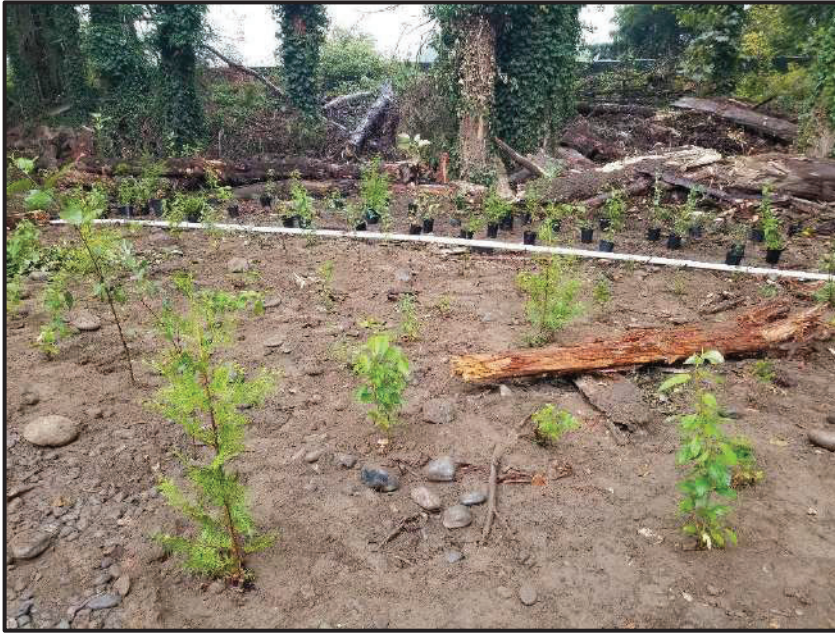
An irrigation system had been set up to water planted areas during the late summer period. As a result, soil moisture was adequate to allow establishment of planted stock. It was recommended to remove this system before the anticipated return of high river flows to prevent it from being damaged or washed away. The system should be reinstalled next summer (2025) to ensure that planted areas receive adequate irrigation during the drier months.

**A PORTION OF THE TEMPORARY ACCESS ROAD CORRIDOR DURING THE REPLANTING PROCESS. NOTE THAT THE CREW DISTRIBUTED AND POSITIONED THE PLANTS IN APPROXIMATE LOCATIONS PRIOR TO PLANTING. THE WHITE PIPE IS PART OF THE TEMPORARY IRRIGATION SYSTEM THAT WAS INSTALLED.**

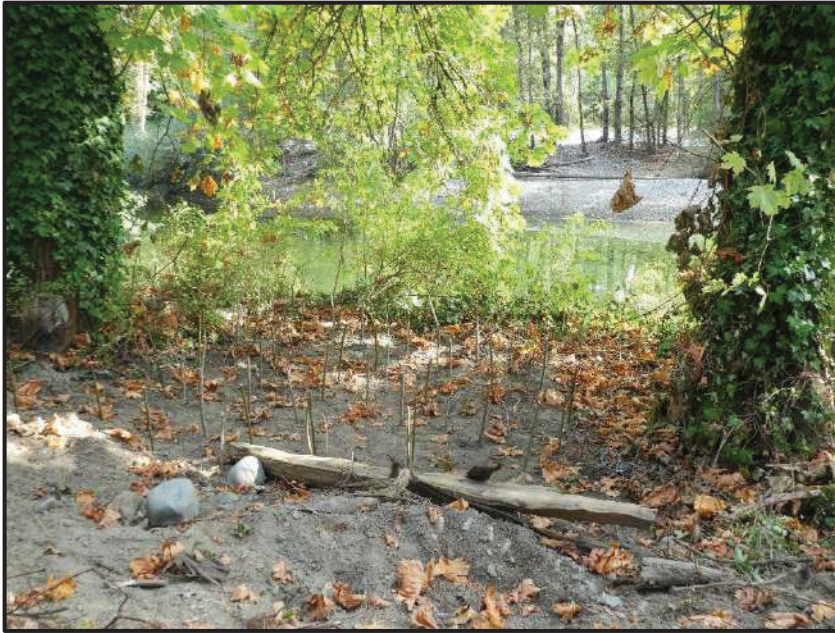
During the site visit conducted on September 19, 2024, it was noted that required planting medium had been placed over riprap in appropriate areas and live stakes had been inserted. Live stakes appeared to be a mix of Scouler's willow (*Salix scouleriana*), red alder (*Alnus rubra*), red-osier dogwood (*Cornus sericea*), and black cottonwood (*Populus balsamifera trichocarpa*). All these species are considered pioneer species that are well suited to the live staking method. The planting area extended beyond the 1 m strip covered with planting medium to include exposed riprap on each weir.

It is likely that survival will be very low for stakes inserted into exposed riprap, as stakes may become washed away during high flows. In addition, many of the stakes inserted into the riprap will likely become desiccated based on a lack of growing medium between interstitial spaces in the riprap. It should be noted, however, that any live stakes placed beyond the upper strips that were covered with planting medium are considered to exceed the planting area requirements. Any live stakes that do survive in the exposed riprap would, therefore, be considered a bonus.

**LIVE WILLOW LIVE STAKES THAT WERE INSTALLED ALONG THE UPPER EDGE OF WEIR 1.**

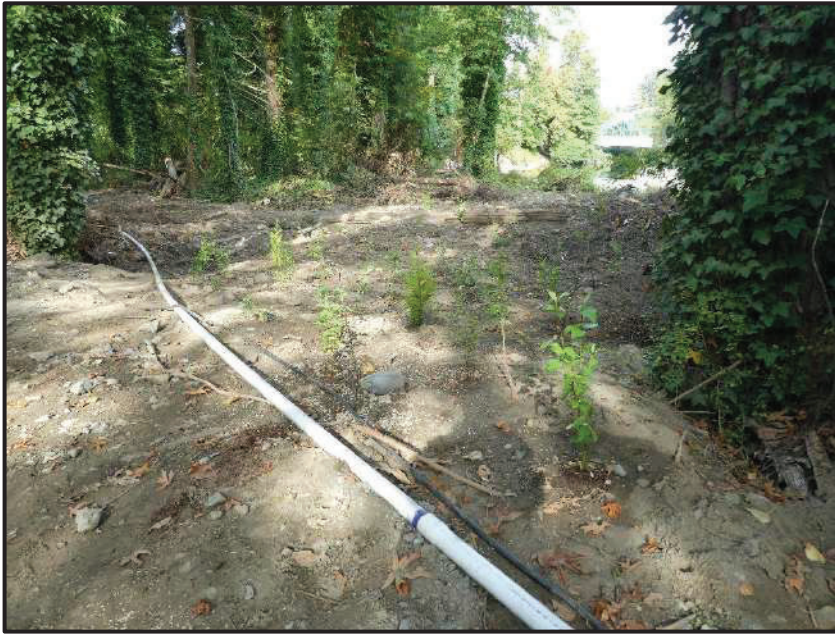
**WEIR 5 AFTER UPON COMPLETION OF REPLANTING.**

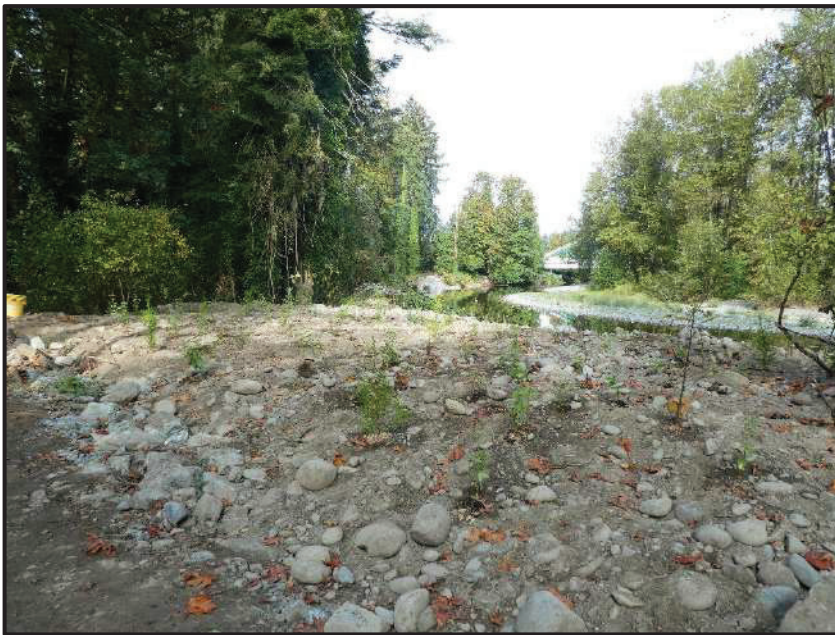
**THE AREA IMMEDIATELY ABOVE WEIR 6 AFTER BEING REPLANTED.**
