**Re: Warning Letter, Unauthorized Discharge, 810 Iverson Road, Lindell Beach, BC V2R 4X5, No Entry**

## Inspection Details:

On November 17, 2022, Ministry of Environment and Climate Change Strategy (Ministry) Environmental Protection Officer Katie Howett (Officer) conducted an onsite inspection of Fraser Valley Renewables Ltd. (FVR) land application on farm property (Site) located at 810 Iverson Road, Lindell Beach, BC to verify compliance with the Environmental Management Act (EMA). This inspection was initiated in response to additional information provided to the Ministry since Inspection Reports (IR) 196560 and 198530 were issued on September 29 and October 31, 2022, respectively. This inspection also includes additional information requested by the Officer after the November 17, 2022 onsite inspection. Currently, FVR does not have any EMA authorization at the Site to apply managed organic matter, conduct composting operations or discharge waste into the environment. Present during the inspection was Simon Thorogood (Business Development Manager, Fraser Valley Renewables), Bruce Vander Wyk (Landowner of 810 Iverson) and Paula Blanchard (ALC Compliance and Enforcement Officer

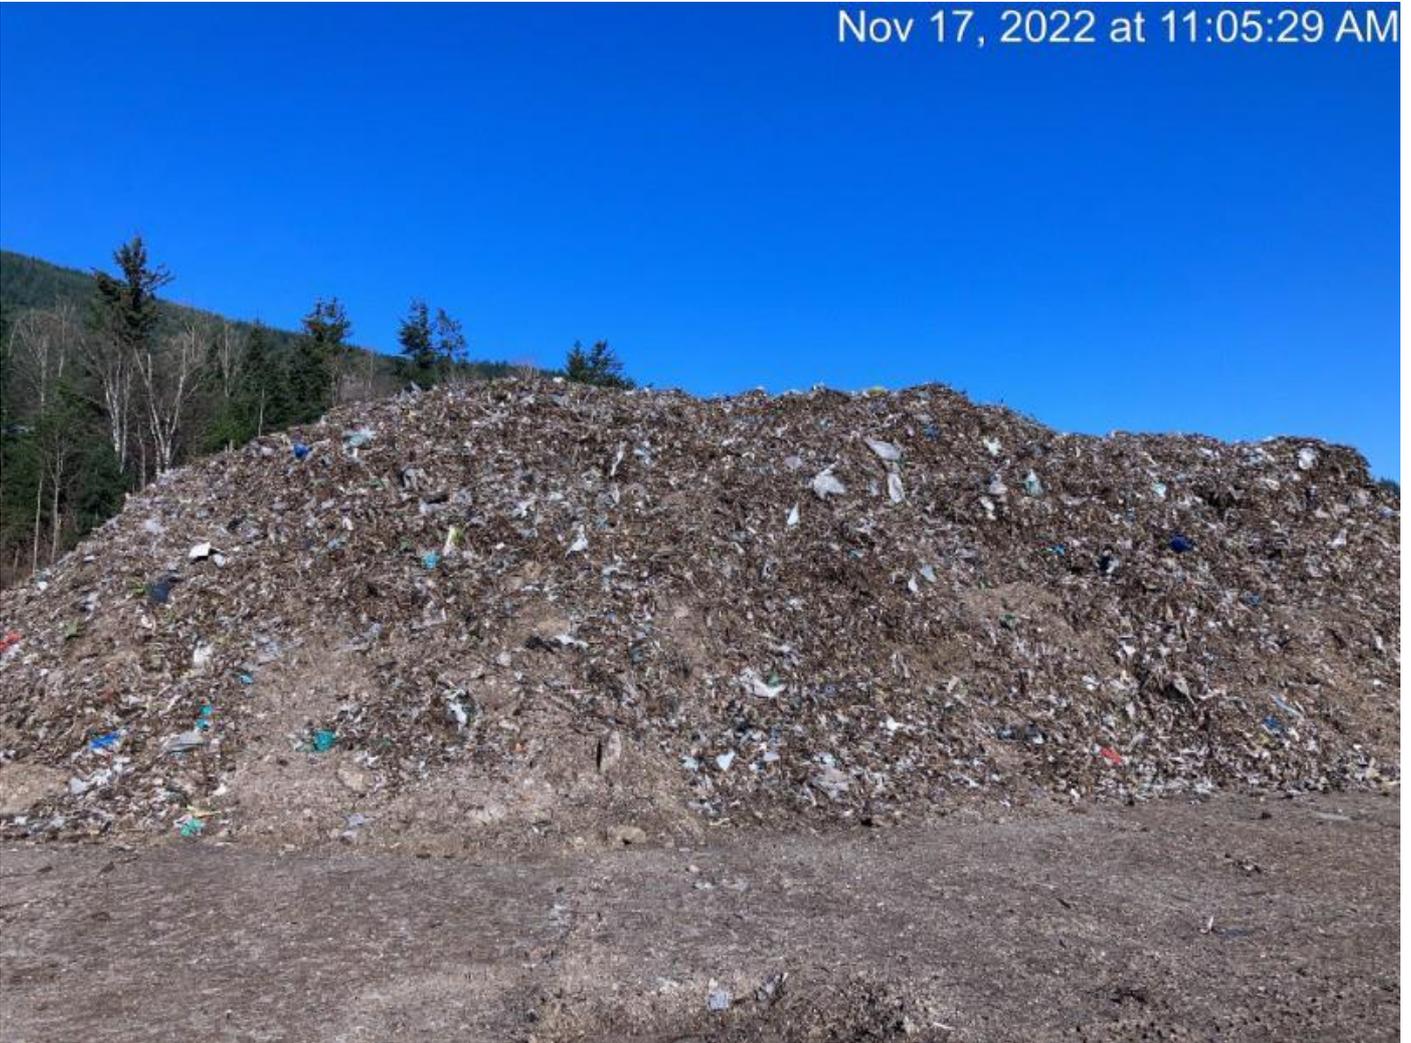
Photo 1: Material stored prior to screening

Actions to be taken:	<p>Currently there is no authorization under EMA, OMRR or CoPAEM for the material to be there or for further onsite processing of the material.</p> <p>Provide the Ministry a timeline of anticipated next steps to come into compliance with EMA as requested in the Warning letter above within 30 days of receiving this letter.</p>
----------------------	---
