## POST-WILDFIRE NATURAL HAZARDS RISK ANALYSIS OF THE 2023 MCDOUGALL CREEK WILDFIRE (K52767)

| Dated: | January 4, 2024 |
| Presented To: | Ministry of Forests – BC Wildfire Service |
| CGL Project # | 23-0106 |

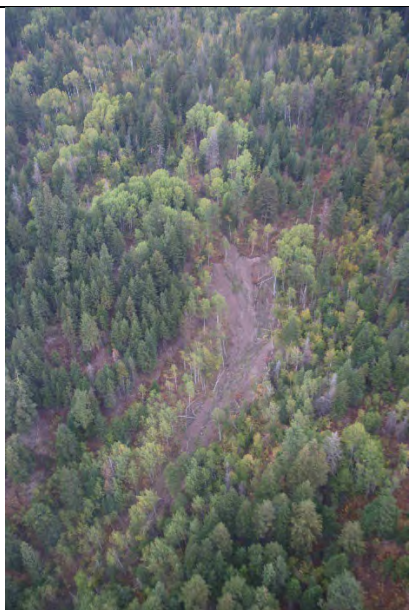
Photo 1: Landslide (spring 2022) in upper reaches of Powers Creek Tributary 1 (Powers-Trib-1)

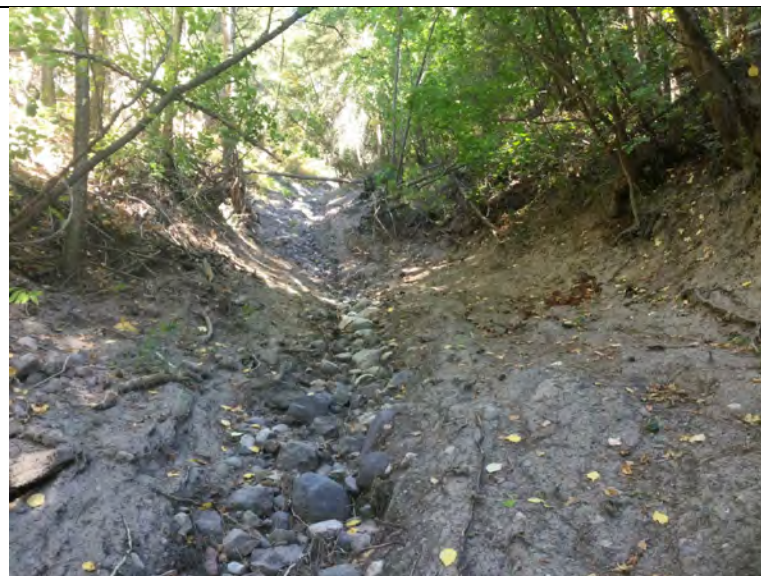
Photo 2: Washed out channel of Powers Creek Tributary 1 upstream from road crossing (Powers-Trib-2)

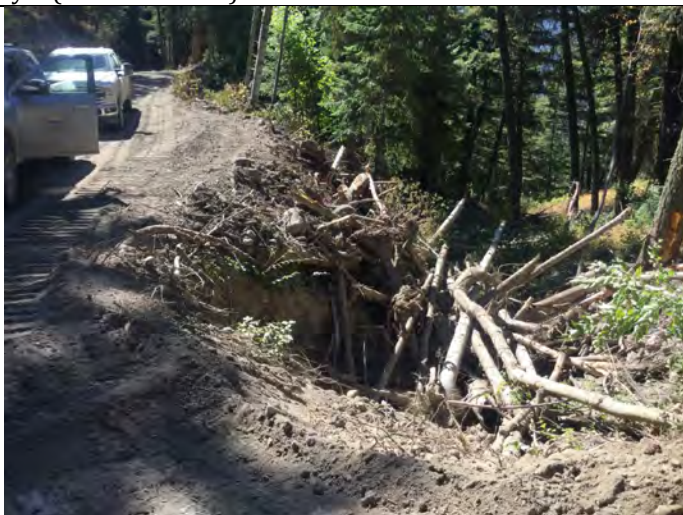
Photo 3: Road crossing (due to be rehabilitated) on Powers Creek Tributary 1 with abundant sediment and woody debris (Powers-Trib-2)

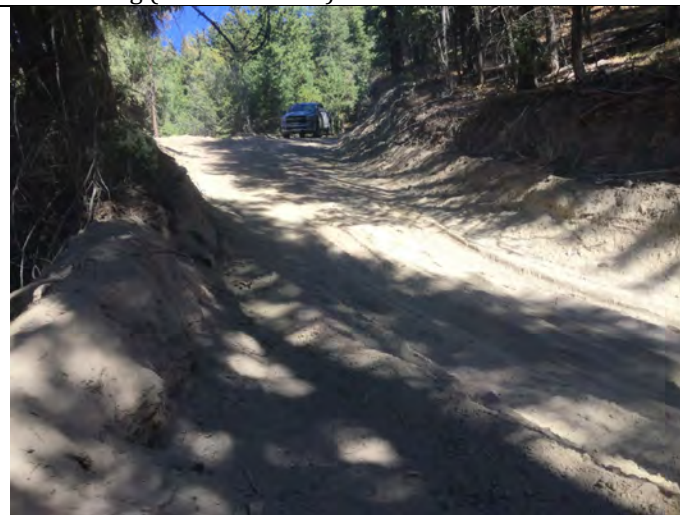
Photo 4: Downcutting of fine-textured silty sediments along road used to access the fire (downslope of Powers-Trib-2)

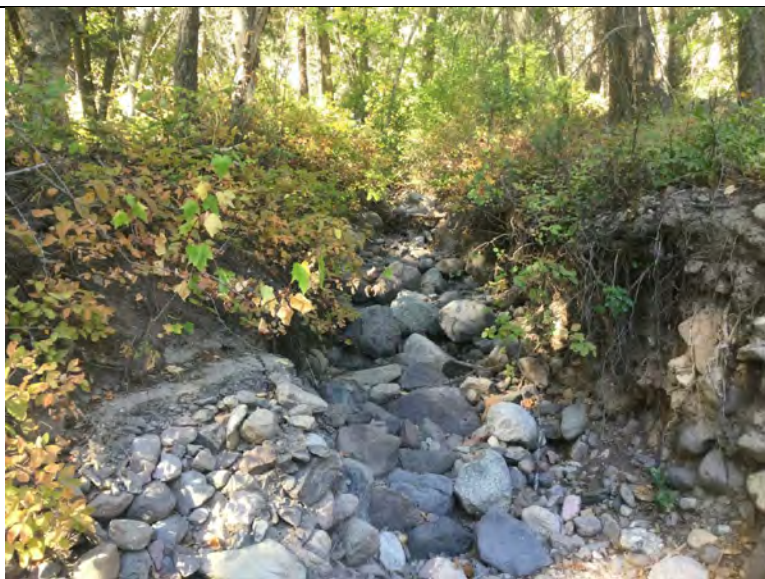
Photo 5: Lowest reach of Powers Creek Tributary 1 on private land, showing scour and sedimentation from 2022 debris flood event (Powers-Trib-3).

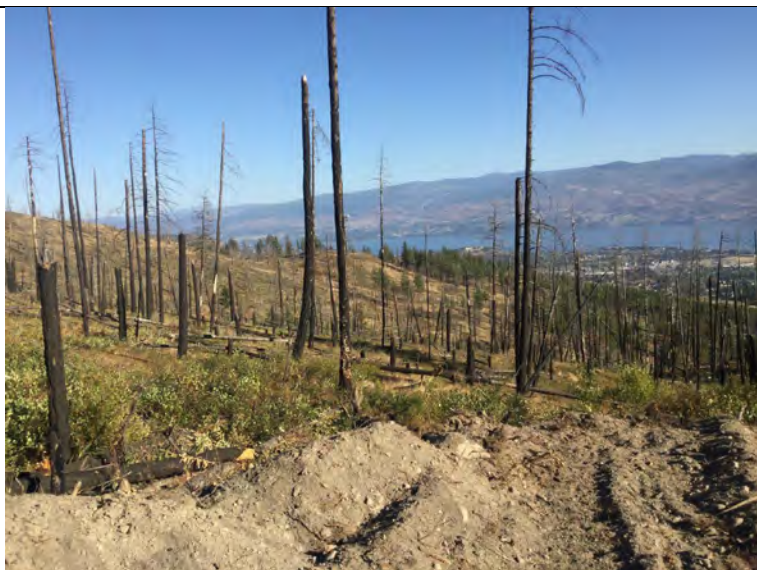
Photo 1: Upper Smith Creek in area of 2014 Wildfire along 2023 Fire Guard access trail. Note, moderate slopes and fine-textured (highly erodible) soils (Upper Smith-1).

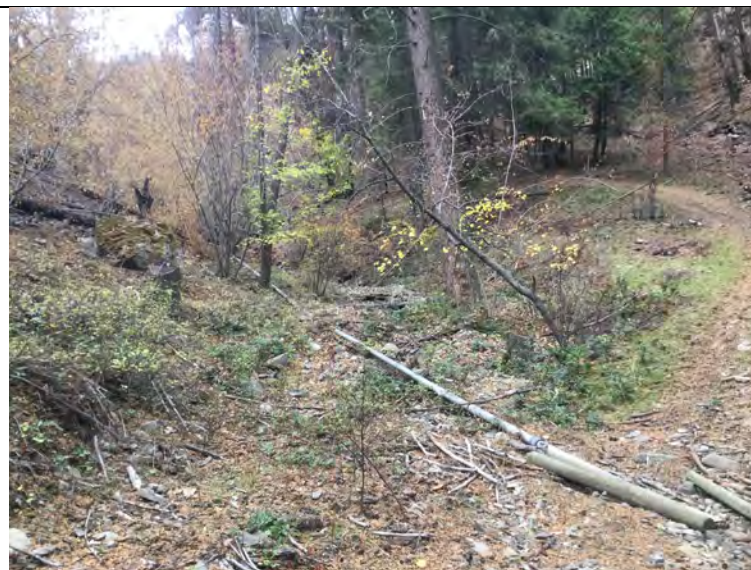
Photo 2: John Moore Creek near fan apex, with evidence of shallow seasonal flow (John Moore-1).

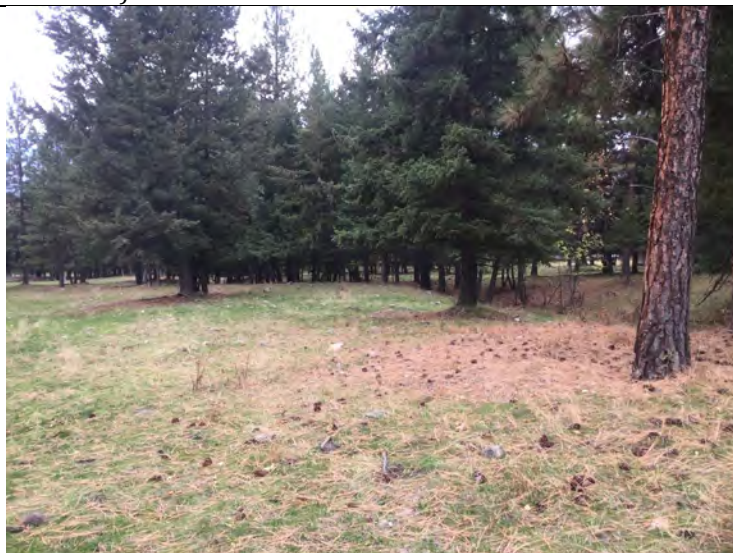
Photo 3: Downslope fan of John Moore Creek, with indistinct channel (John Moore-2)

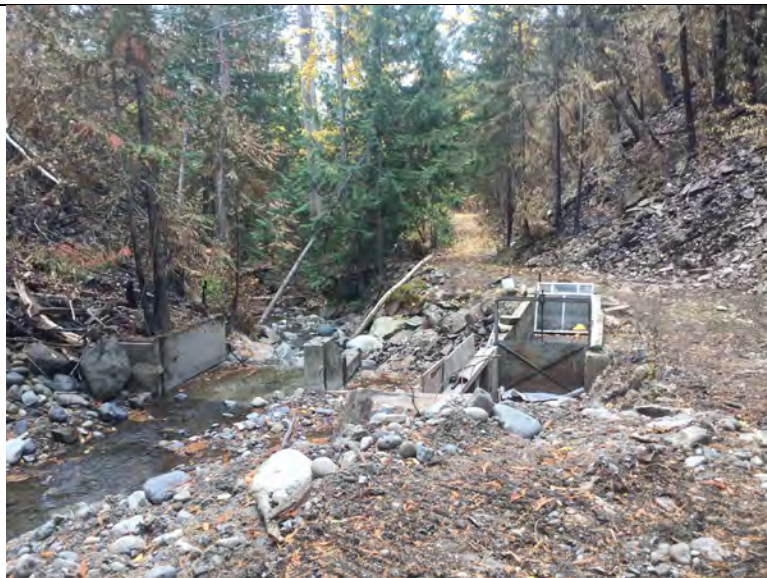
Photo 3: Water intake structure on McDougall Creek within lower canyon (view downstream) (McDougall-1).

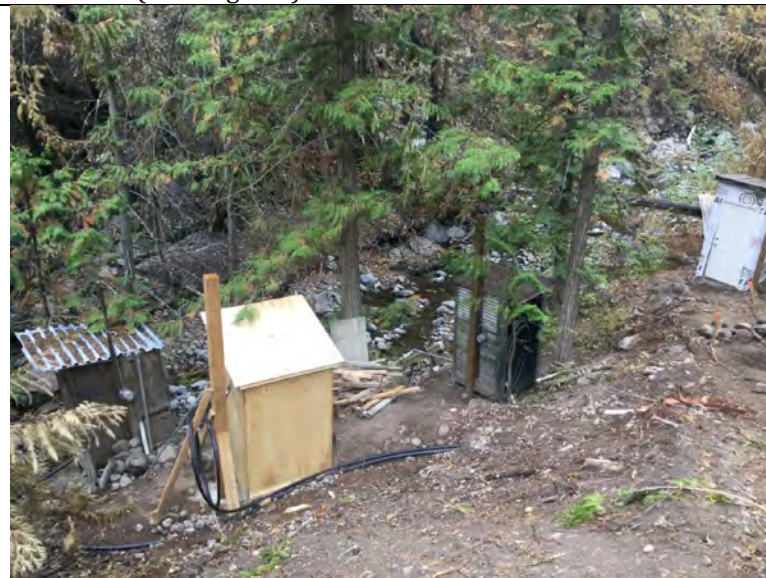
Photo 4: Water intakes accessed off the end of Bartley Road on lower McDougall Creek.

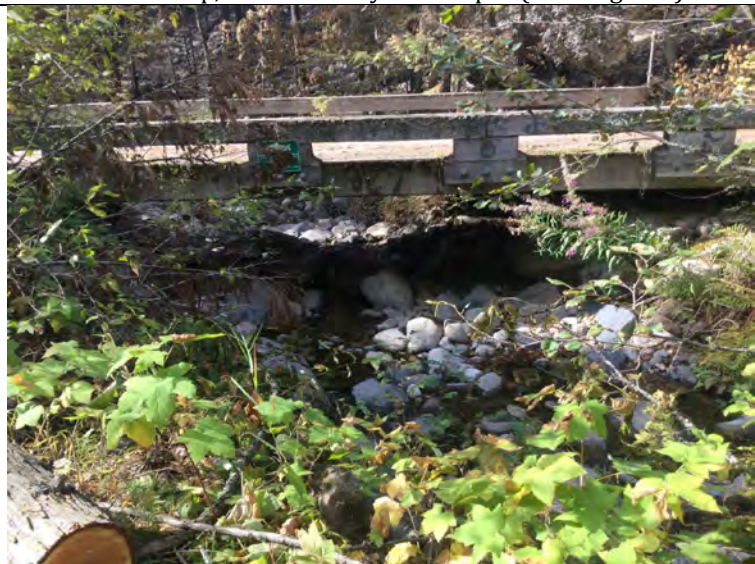
Photo 7: Resource road bridge over McDougall Creek mainstem channel (McDougall-4)

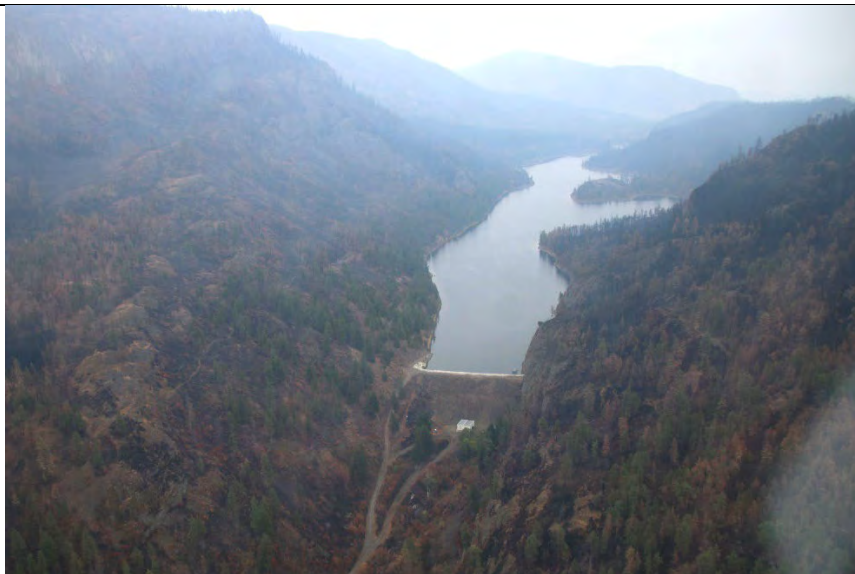
Photo 1: View north of the Rose Valley Dam and Reservoir (RV Dam POI).

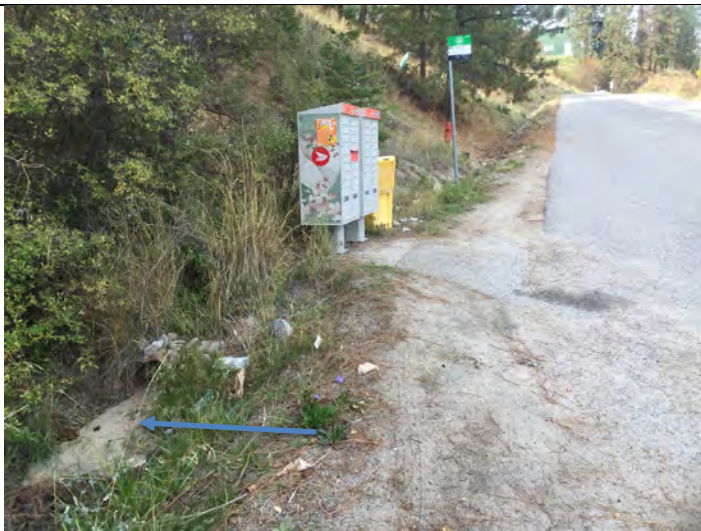
Photo 5: Shallow ditch along Bear Creek Rd (at McNaughton) with small culvert under mailbox. Note recent sediment in ditch (arrow) (Keefe-1)

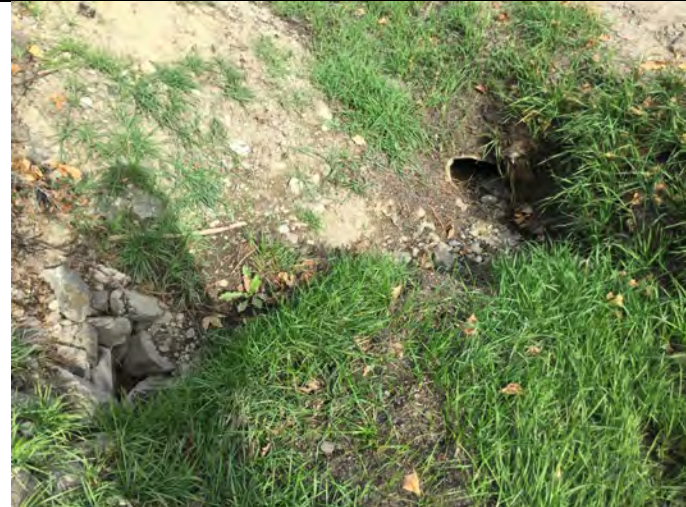
Photo 8: Partly-plugged 400 mm and 250 mm culverts under Bear Creek Road (Keefe-3)

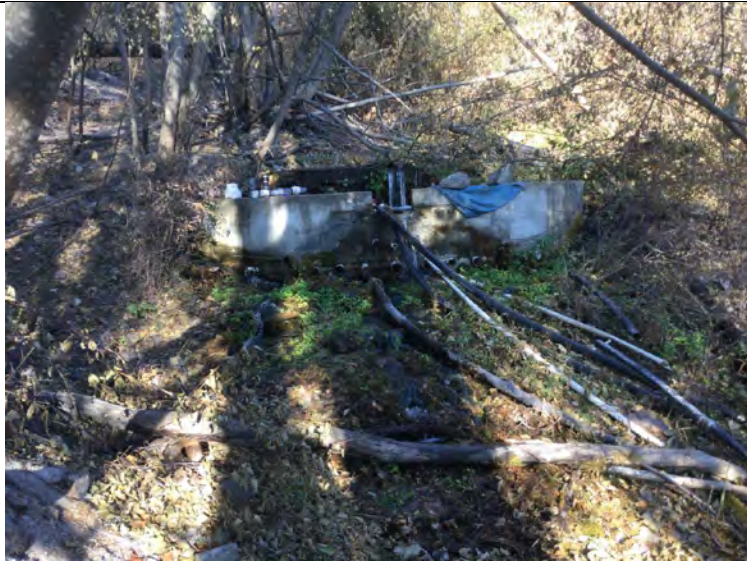
Photo 9: Water intake structures on Lower Luluwap Creek, upslope of Westside Road (upslope of Lower Luluwap-1)

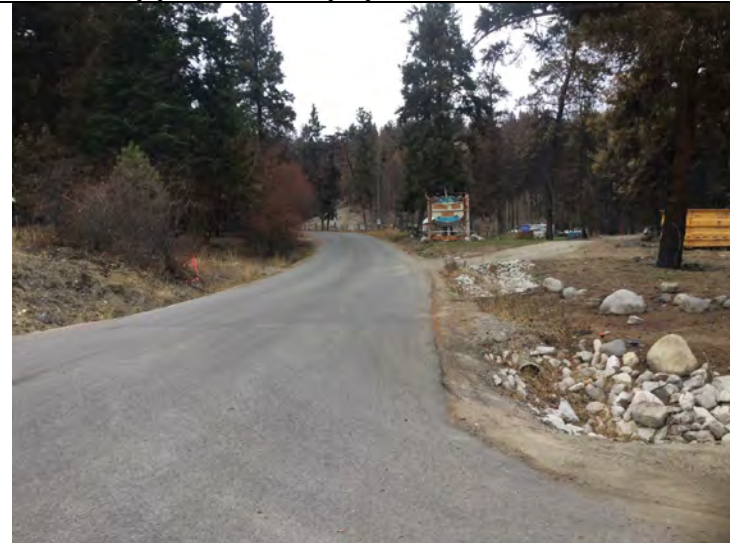
Photo 12: View of ditch line along Petterson Road (at Bear Creek Road), conveys surface water runoff from Upper Luluwap Creek area.

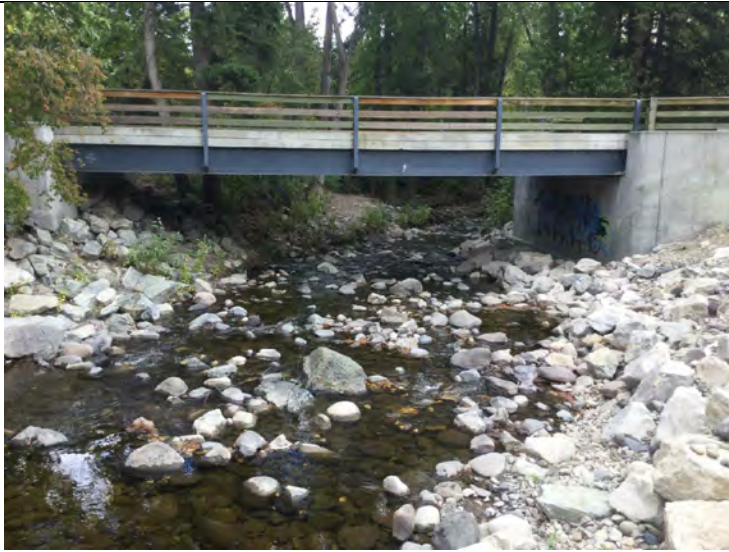
Photo 1: Lambly Creek bridge crossing within the Bear Creek Provincial Park Campground, showing good clearance (Lambly-1).

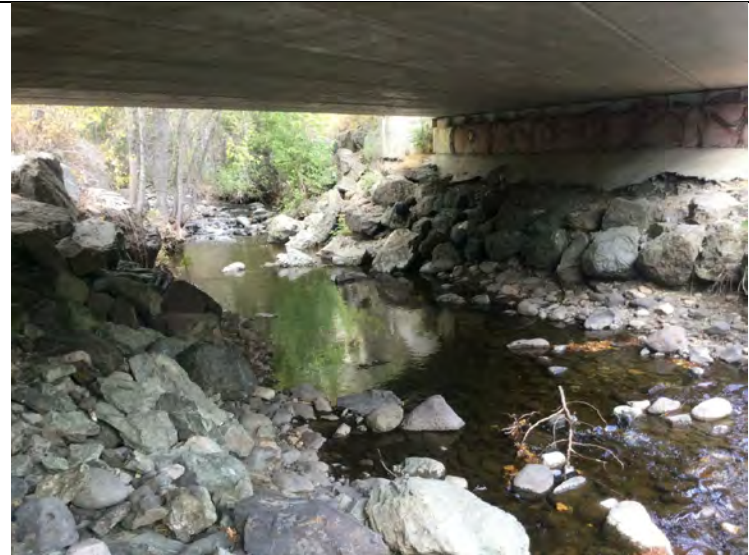
Photo 2: Lambly Creek bridge crossing on Westside Road, showing good clearance (Lambly-2).

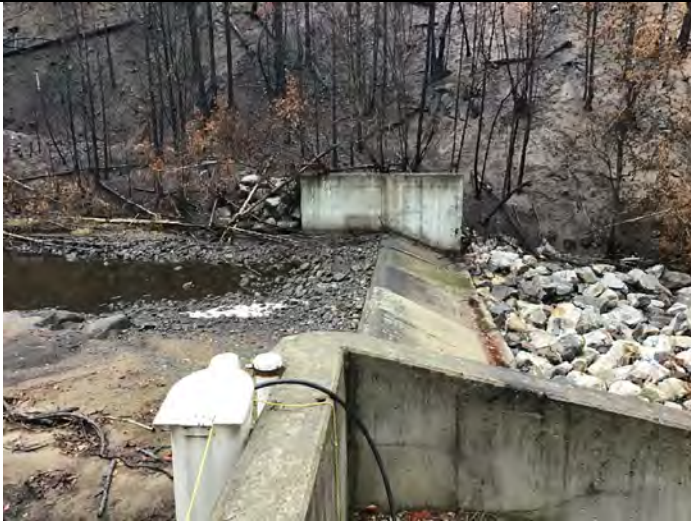
Photo 10: Lambly Creek Diversion Structure (Lambly-6 (Lambly-6 - POI at Intake))

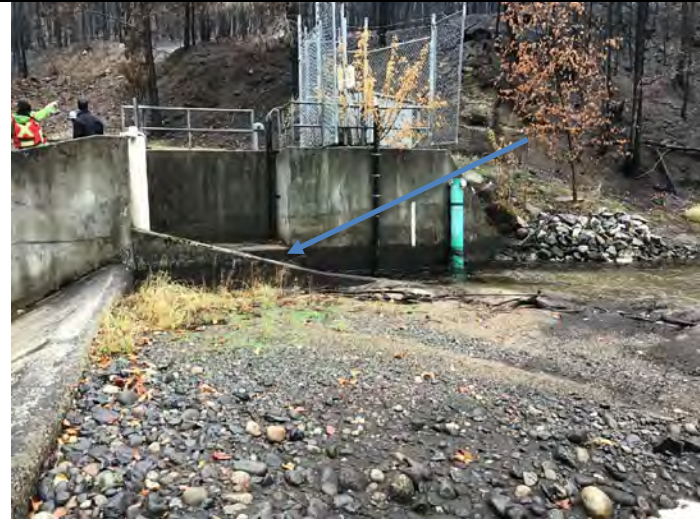
Photo 11: Lambly Creek Diversion - Water Intake at arrow (Lambly-6 (POI at Intake))

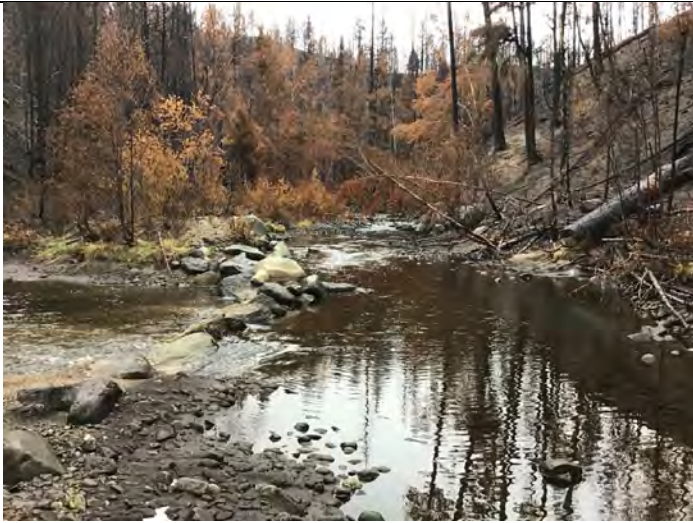
Photo 12: Lambly Creek, view upstream from diversion (Lambly-6)

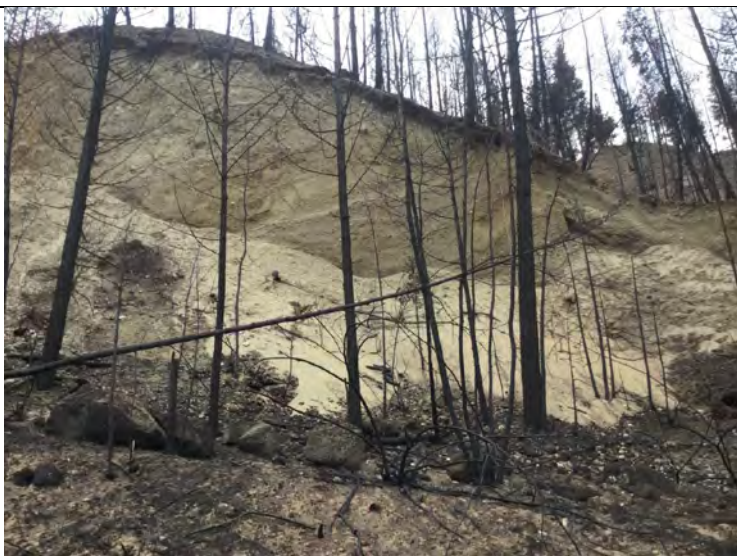
Photo 16: Stratified glaciofluvial and glaciolacustrine sediments exposed along side slopes above water pipeline and Lambly Creek (Bear Ck Rd-2)

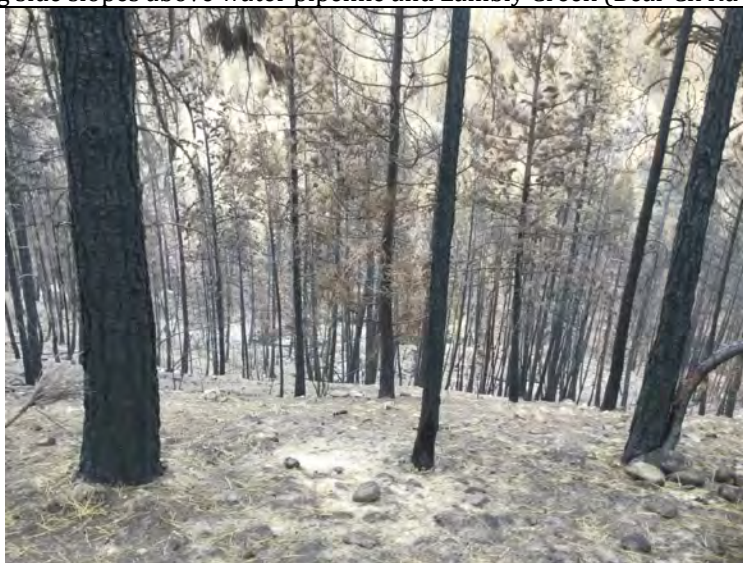
Photo 18: View downslope from Bear Creek Rd towards Lambly Creek (Bear Ck Rd-3)

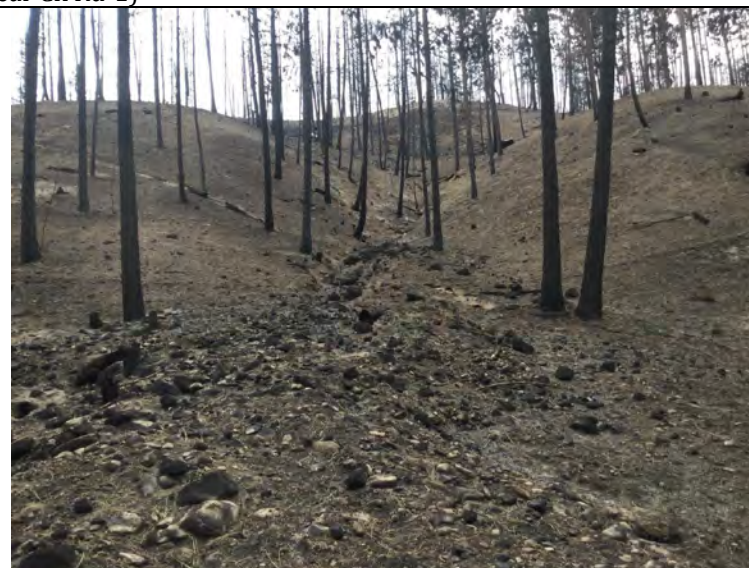
Photo 19: View of small debris-flow gully upslope of Bear Creek Rd (Bear Ck Rd-3)

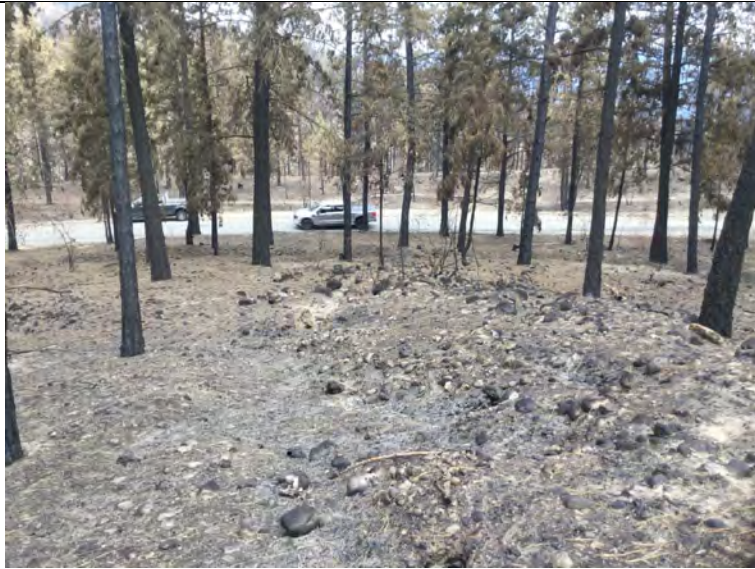
Photo 20: View downslope along fan of small debris flow gully. Note that Bear Creek Road is located at the distal end of the fan (Bear Ck Rd-3)

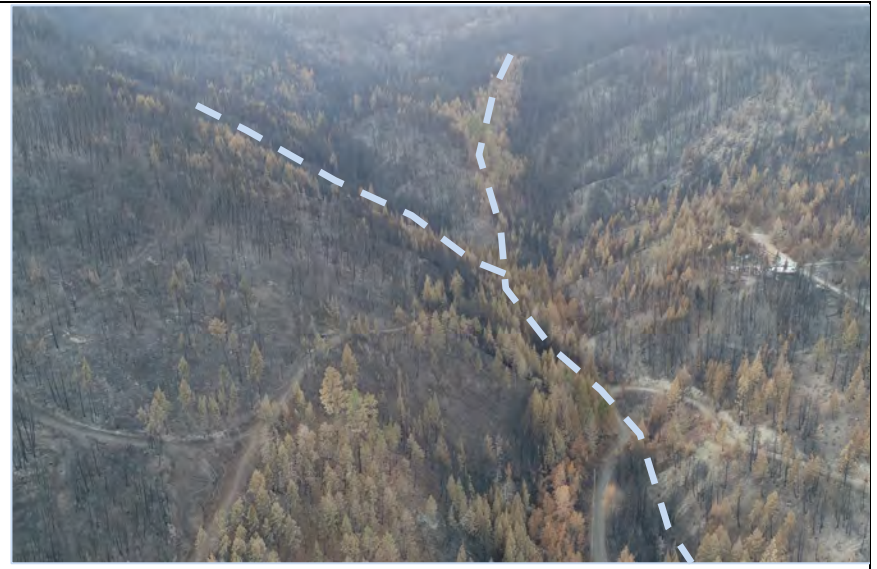
Photo 21: Overview of lower Cedar Creek catchment at Bear Creek Road crossing (photo provided by L. Jensen 910 Bear Ck Rd)

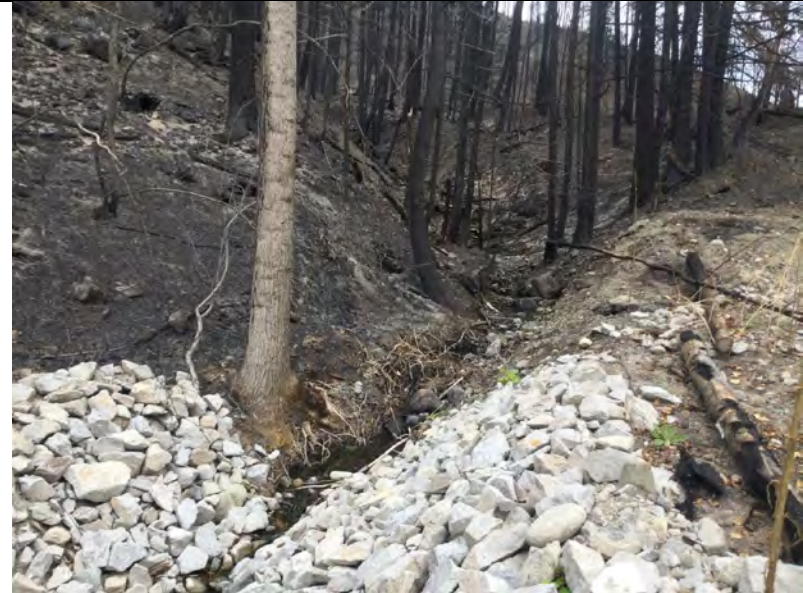
Photo 23: Cedar Creek, view upstream from water pipeline crossing (Cedar-1)

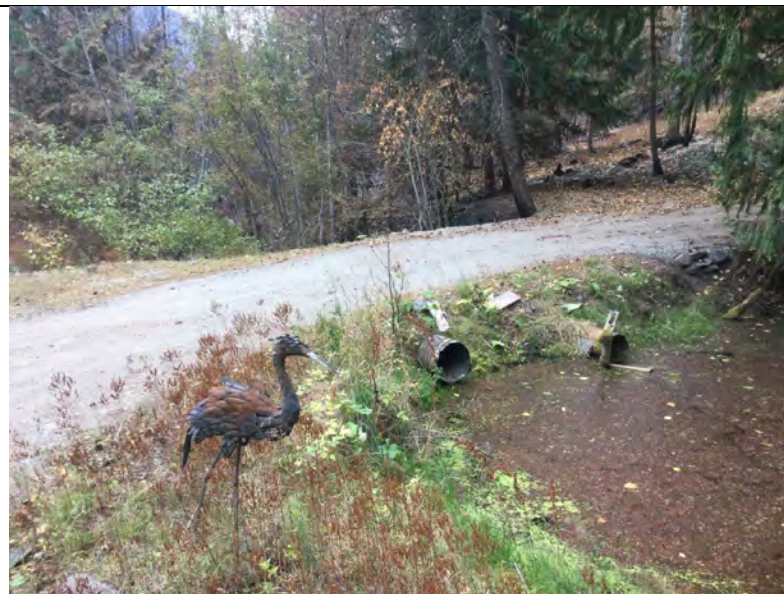
Photo 25: Pond at Cedar Creek at private driveway crossing (Cedar-3)

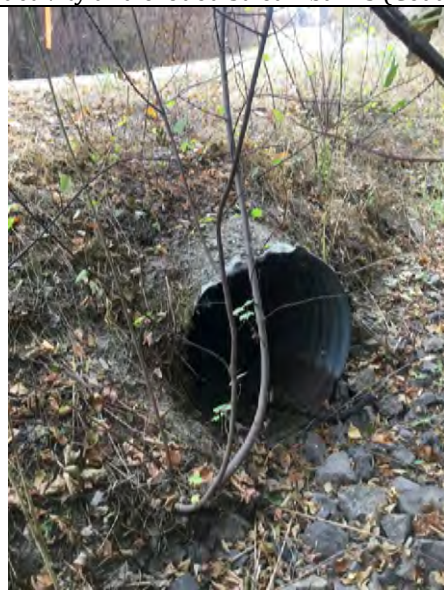
Photo 26: 800 mm culvert on Cedar Creek at Bear Creek Rd (Cedar-4)

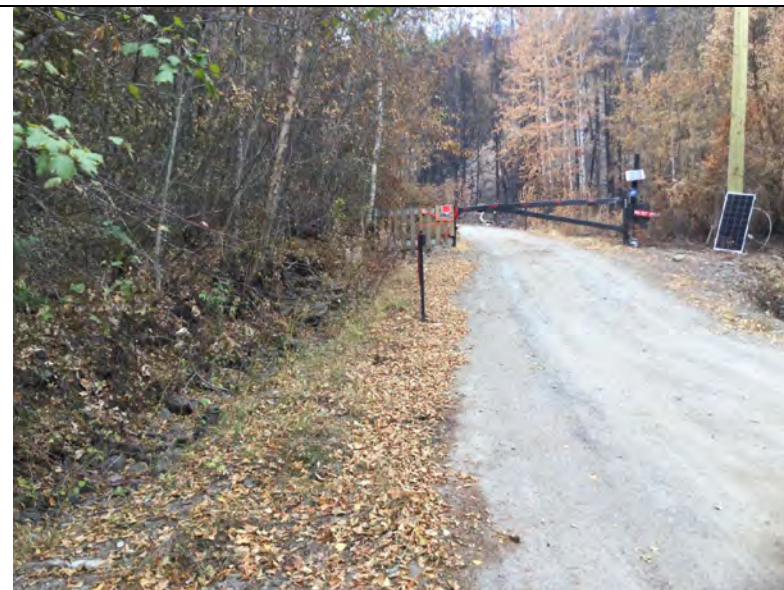
Photo 27: View upstream from culvert at Bear Creek Road, along private driveway (944 Bear Ck Rd). Cedar Creek flows along ditchline on left side of photo (dry at time of assessment) (Cedar-4)

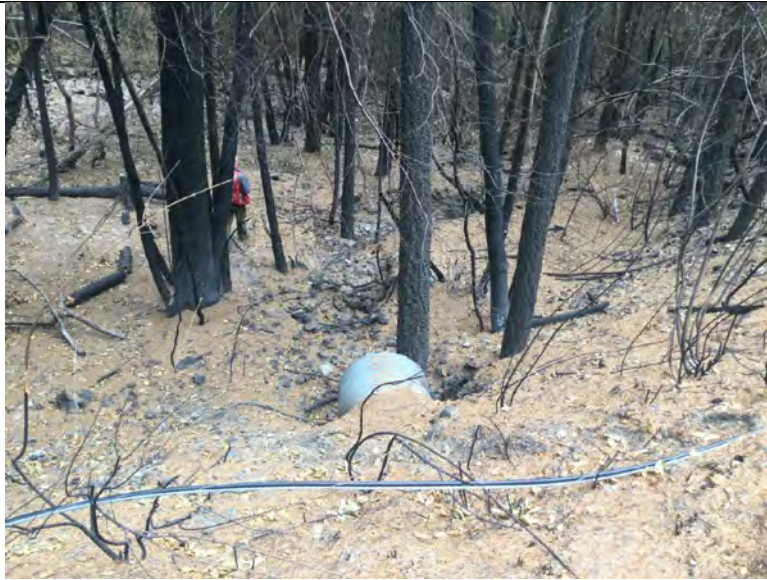
Photo 28: View downstream from Bear Creek Road at culvert crossing. Note abundant colluvium, and hummocky terrain indicative of past flood events. (Cedar-4)

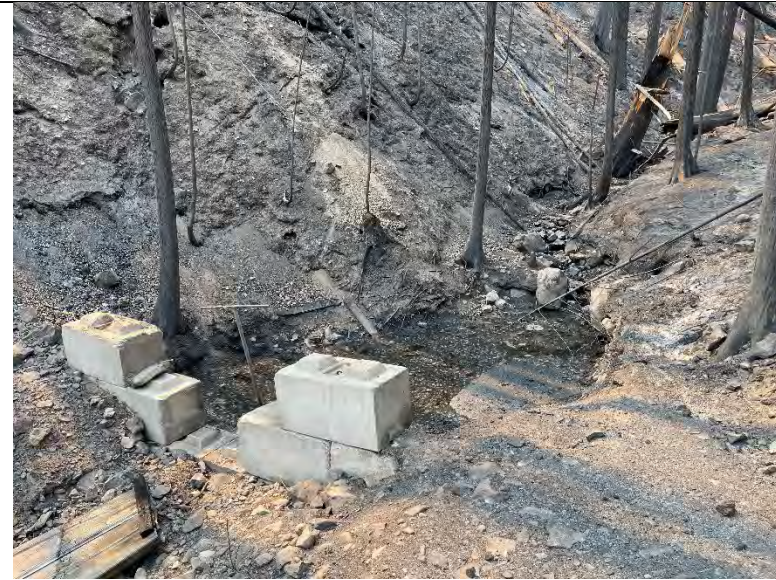
Photo 29: Domestic Water Intake on Cedar Creek (photo provided by L. Jensen 910 Bear Ck Rd) (Cedar-5)

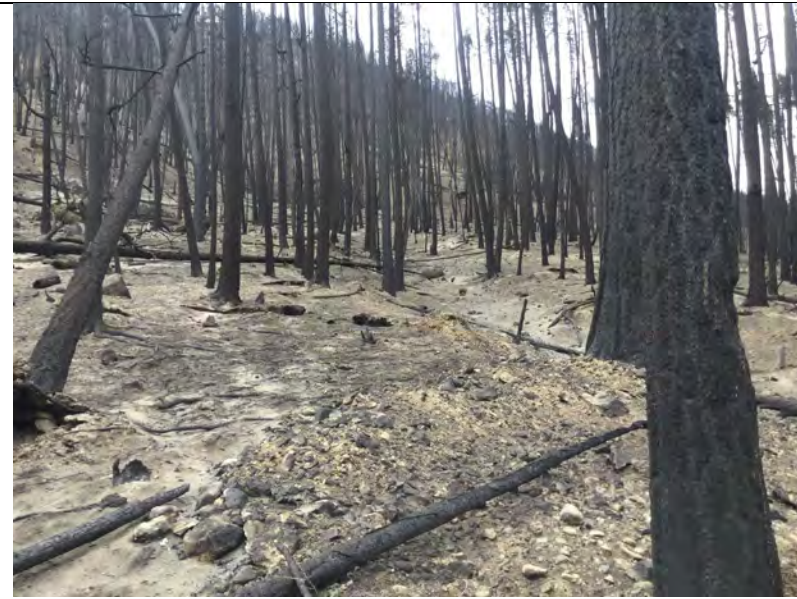
Photo 31: Lower end of colluvial fan on Lambly Tributary 2 (no visible channel) located south of 524 Bear Creek Road (Lambly Trib2-1)

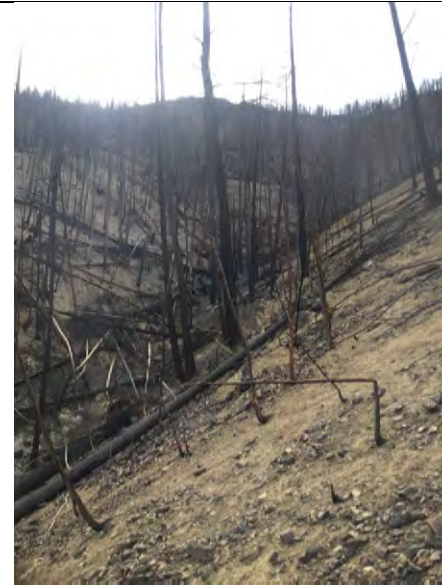
Photo 33: View upslope into gully on Lambly Trib 2. Domestic water well is located in channel (above the fan) (Lambly Trib2-3).

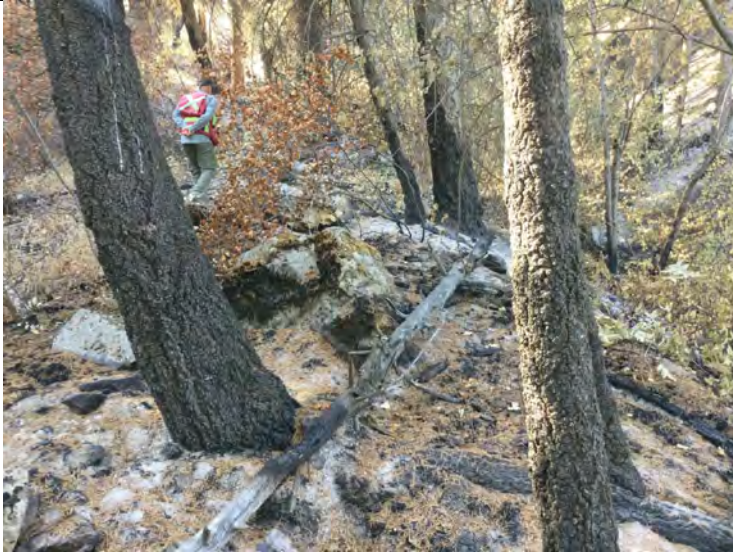
Photo 1: Old debris flow levee and boulders within gully upslope of Westside Road along Cinnabar Creek (Cinnabar-1).

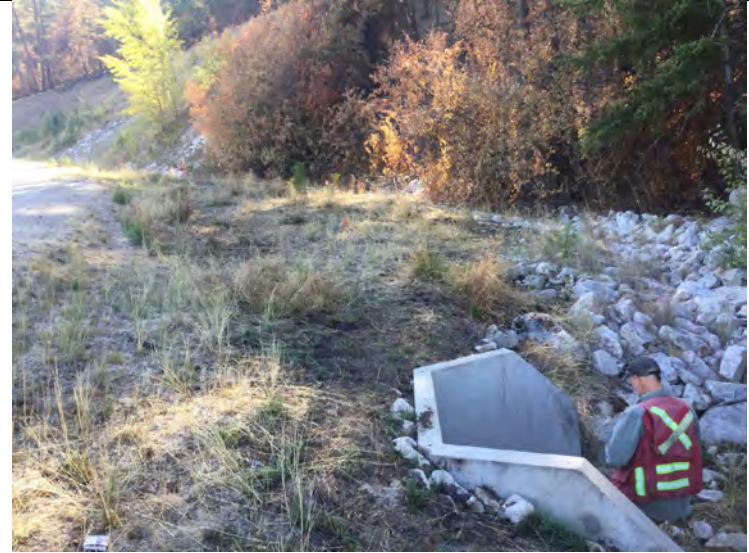
Photo 2: New 900 mm culvert with concrete baffles and rock armour on Cinnabar Creek crossing Westside Road (Cinnabar-1).

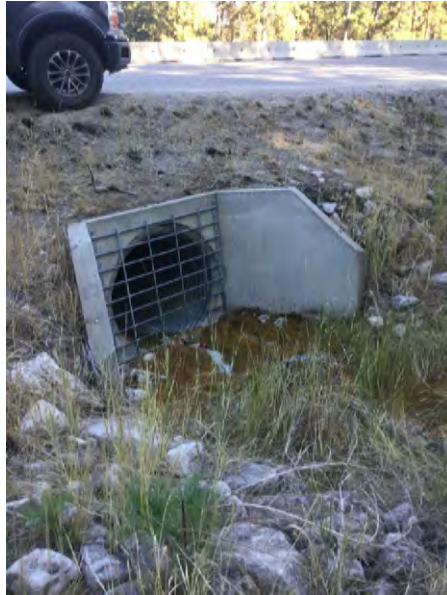
Photo 3: New 1200 mm culvert with trash rack and rock lined channel on Dimetri Creek at Westside Road (Dimetri-1)

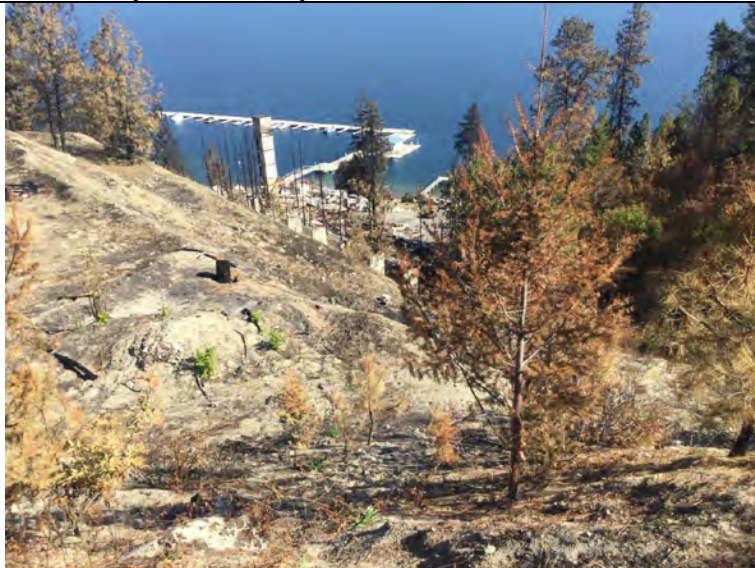
Photo 7: View downslope along Cedar Gulch Creek gully below Westside Road towards Lake Okanagan Resort (Cedar Gulch-1)

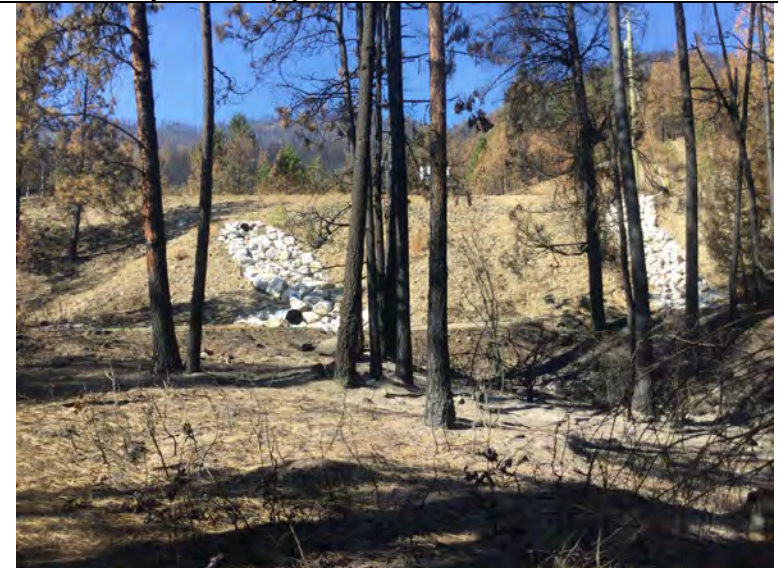
Photo 8: View upslope towards two culverts under Westside Rd on Wilson Creek (Wilson-1)

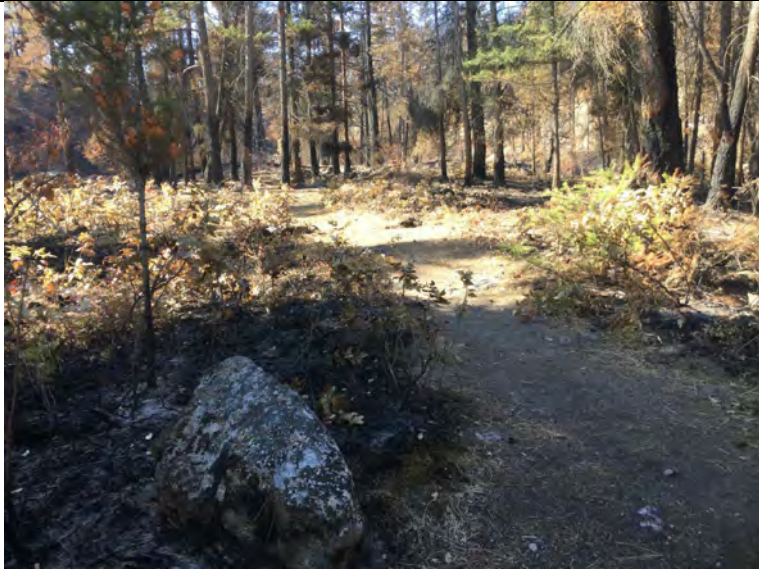
Photo 9: View upslope along Wilson Creek fan, with scattered boulders on ground surface (Wilson-2)

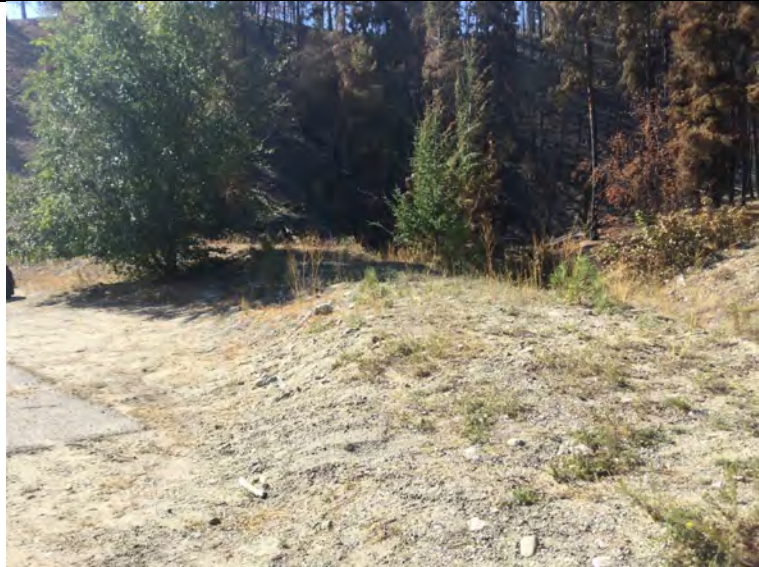
Photo 11: Shallow, discontinuous berm along upslope edge of Fire Hall Parking lot (Wilson-1)

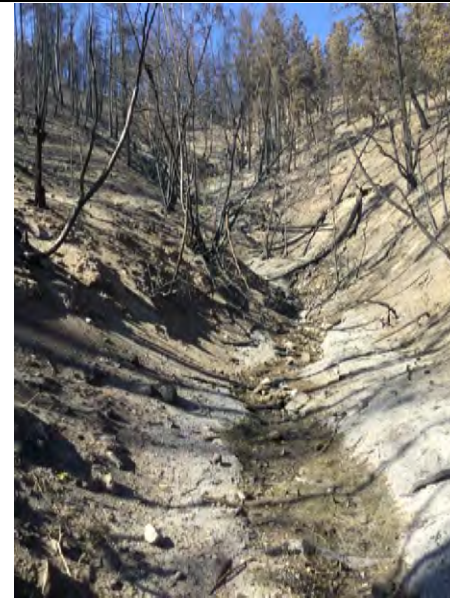
Photo12: View upslope along Wilson Creek, upstream of the fan. Channel is contained within steep-sided gully. (Wilson-3)

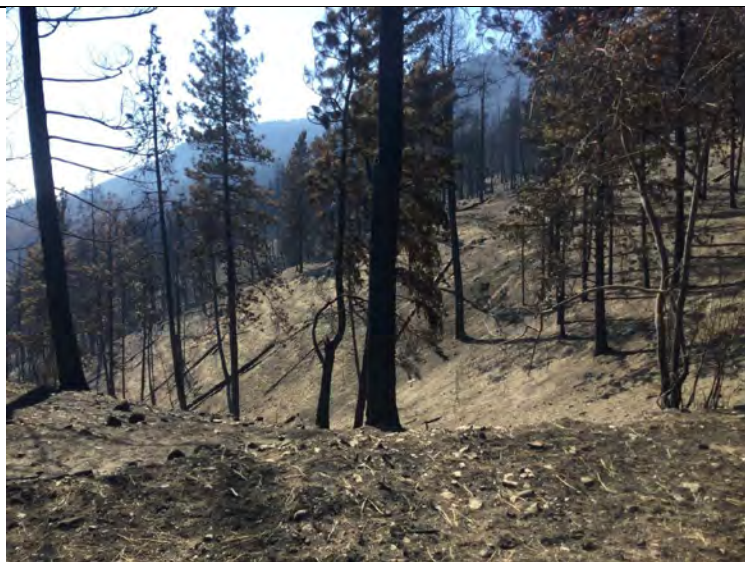
Photo 13: Slopes at ~600 m elevation showing benched slopes and upper slope breaks at gully headwalls (north of Wilson Creek) (Wilson-4)

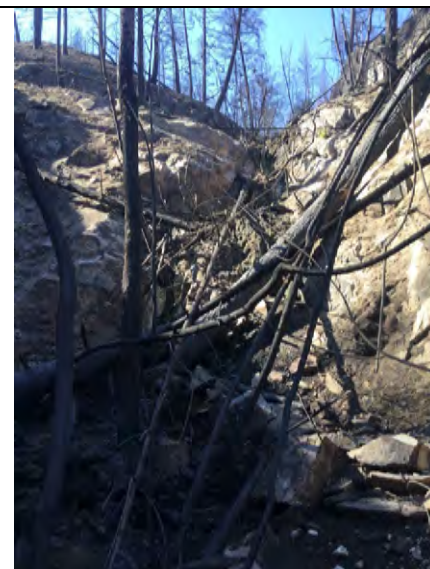
Photo14: View upslope along bedrock-controlled reach of Wilson Creek. Abundant rockfall and exposed soils available to the channel (Wilson-5).

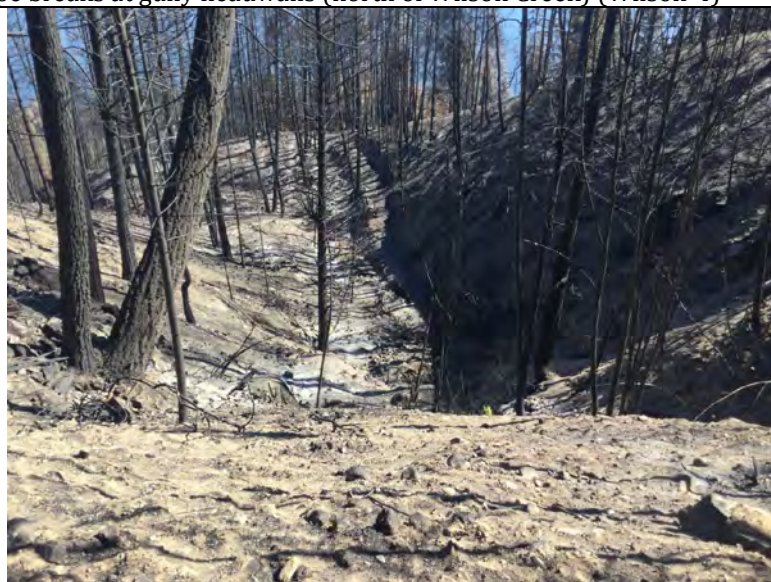
Photo 15: Bedrock canyon along Wilson Creek, note narrow trail (access to water license) downstream (Wilson-6)

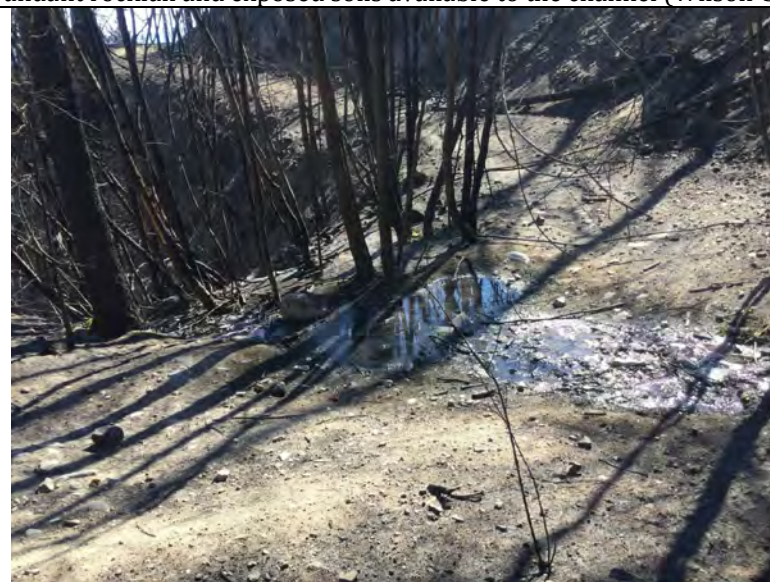
Photo16: Water flowing across old trail crossing on Wilson Creek, mid-watershed (Wilson-6)

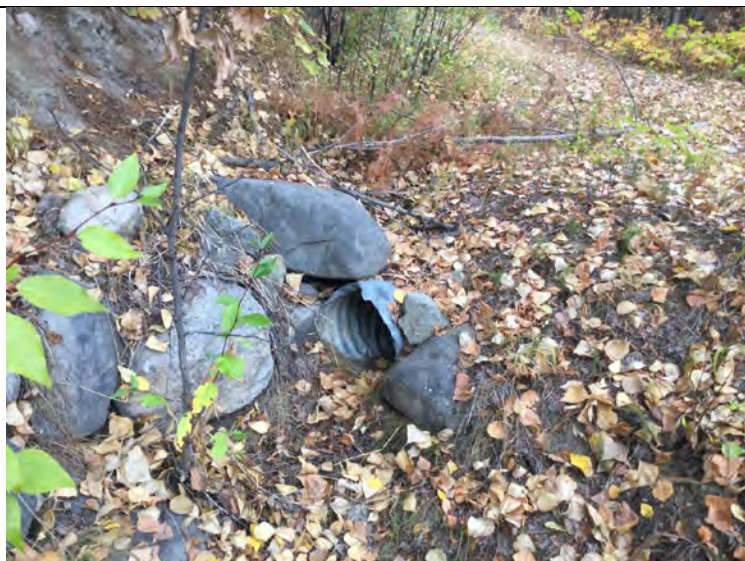
| Catchment | Waypoint #<br>(see Map 006) | Observations (Photo # in Appendix C-7) | Hazard Indicator |
|---|---|---|---|
| | | The top of the catchment transitions sharply from the low gradient plateau to steep (50-75%) slopes into a large gully. There is an old resource road traversing the top of the catchment, with a clear 400 mm culvert at Wilson-7 (Photo 17). There is abundant windthrow (appears to be related to the strength of the wildfire-generated winds) with lots of exposed soil and observed small-scale landslides (Photo 18; Wilson-8). At Waypoint Wilson-9 there is observed headscarp for a small (50 m <sup>3</sup> ) landslide that has transitioned to a downstream debris flow. There is evidence of channel scour and deposition in the gully associated with early-stage debris flow initiation. | |

Photo 17: A 400 mm culvert along an old resource road traversing the top of Wilson Creek gully. (Wilson-7)

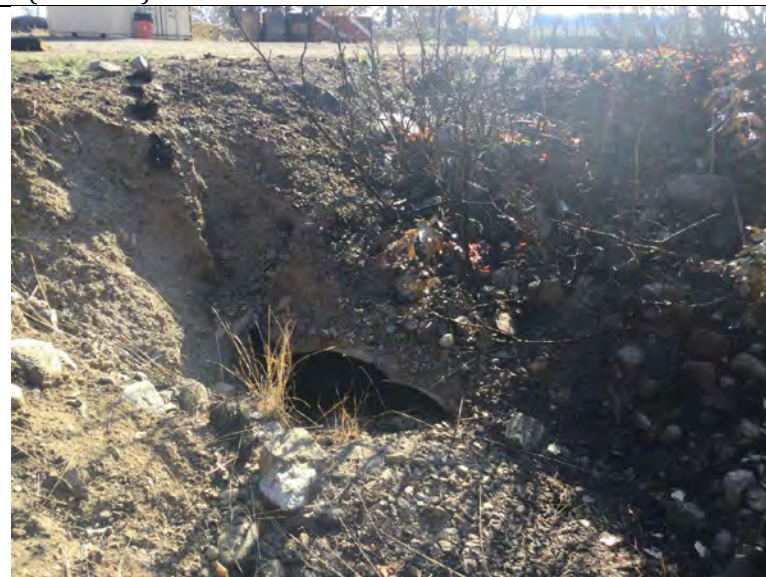
| Catchment | Waypoint #<br>(see Map 006) | Observations (Photo # in Appendix C-7) | Hazard Indicator |
|---|---|---|---|
| Jennie Creek | Jennie-1 | There is a 1000 mm culvert at Westside Road (inlet mostly plugged with sediment) (Photo 16). Upslope road, channel gradient 20% with boulders (0.7 m diameter) on ground surface and other debris flow deposits apparent (Photo 17). There is evidence of an old trail extending up the channel. No recent large events due to moss on boulders and ~40 year old trees in ravine (but past events likely less than 100 years old). There is direct connectivity of the steep channel and Westside Road (Photo 18). There is no channel visible below road. | Partly blocked culvert increases partial risk of sediment-laden flood or debris flow to Westside Road. |

Photo16: Inlet of 1000 mm culvert on Jennie Creek at Westside Road is mostly blocked with sediment (Jennie-1)

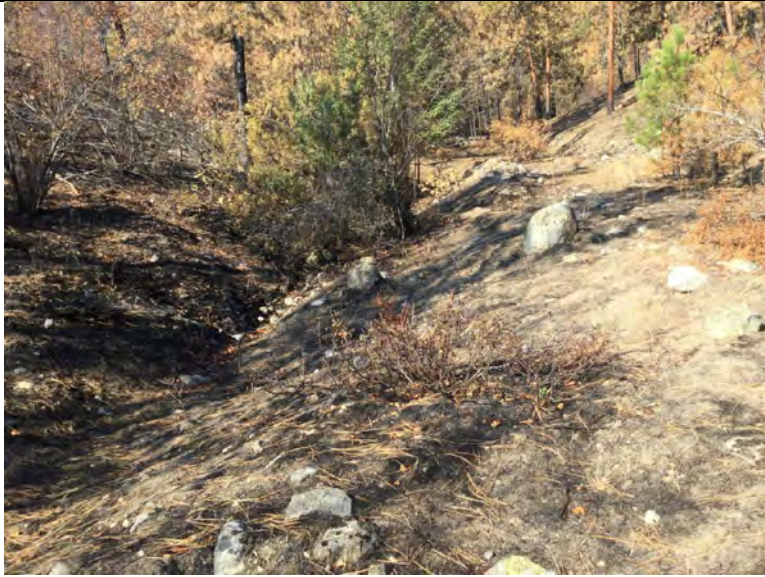
Photo 17: View upslope along Jennie Creek, note scattered boulders. Constructed trail extends up along north (right side of photo).

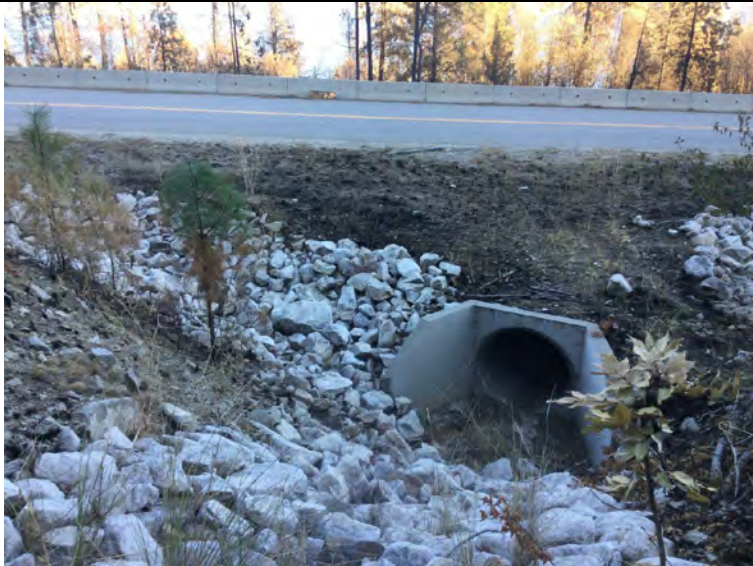
Field observations along Westside Road (Waypoint Westside-1) noted that wide ditches can capture and detain sediment-laden runoff from burned slopes above. An example of this is shown in Photo 4 (Appendix C-7). Sections of Westside Road have upgraded drainage structures, such as the 1200 mm diameter culvert with concrete baffles and rock-lined ditches (at Waypoint Westside-2; Photo 19). These newer structures may be able to accommodate post-wildfire runoff, but not moderate-sized debris flows. A section of Westside Road has been improved, with stabilized rock cuts and installed rockfall mitigation fencing (Westside-3; Photo 20). This structure will reduce the likelihood of rockfall reaching the road.

Photo 19: Newer 1200 mm culvert with concrete baffle and rock-lined ditch along Westside Road.

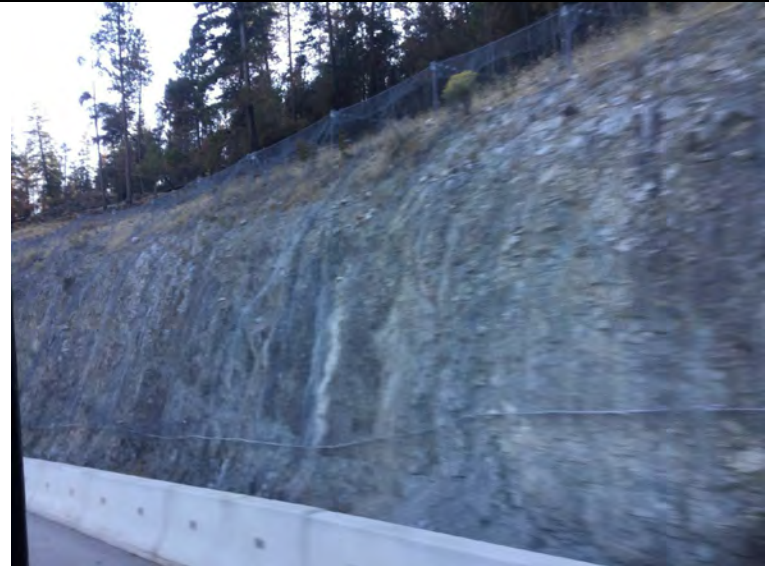
Photo 20: Rock cut with rockfall protection fencing along Westside Road.
