Chemainus River Emergency Sediment Removal

# Construction Completion Report

**Final Report**  
**February 1, 2023**  
**KWL Project No. 3427.021**

**Prepared for:**  
**BC Ministry of Environment and Climate Change**

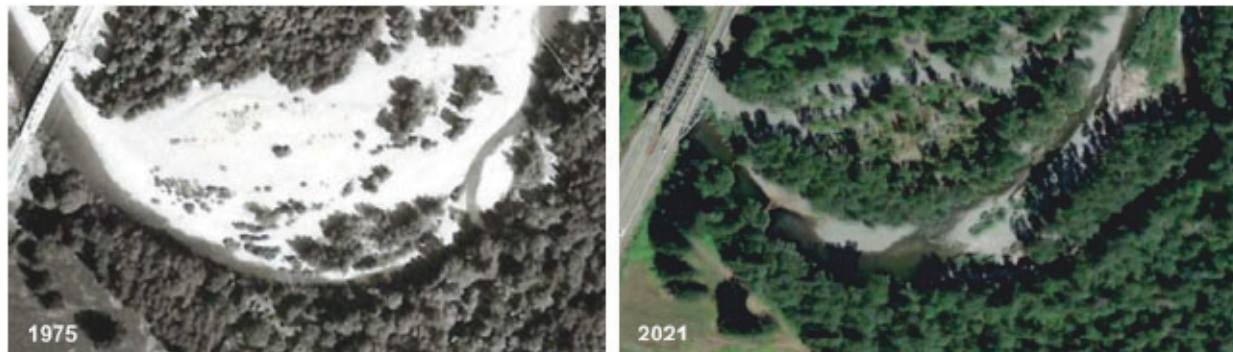
Air photo review in the Geomorphic Atlas indicates that the point bar and side channel area has become more vegetated since 1975 (see Figure 2-1) indicating the bar is becoming more stable and at higher elevation over time.

**Figure 2-1: Changes in Vegetation Cover on Point Bar Downstream of Highway 1 Bridge**  
(Source: NHC, 2022)

Accumulation of sediment on the point bar and within the side channel on the left bank concentrates flow in the Chemainus River mainstem channel along the opposite right bank which tends to increase potential for erosion of the right bank. Some of the trees growing on the point bar have eroded and were partially spanning the channel in the 2021 photo.

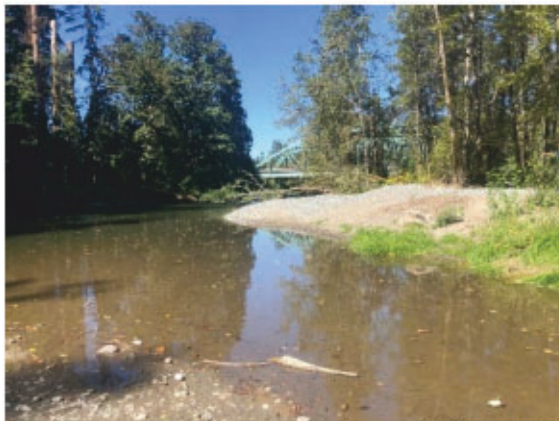
Site 1 consists of a gravel/cobble point bar on the mainstem and a relic side channel consisting of finer gravel and sand. Over time, sediment has built up in the side channel such that the elevation is about 1 to 2 m higher than the mainstem channel elevation and is only activated during high flow events. Photos 3 and 4 below show the point bar and side channel.

**Photo 3: Gravel Accumulation at U/S End of Point Bar on Right Bank of Chemainus River**

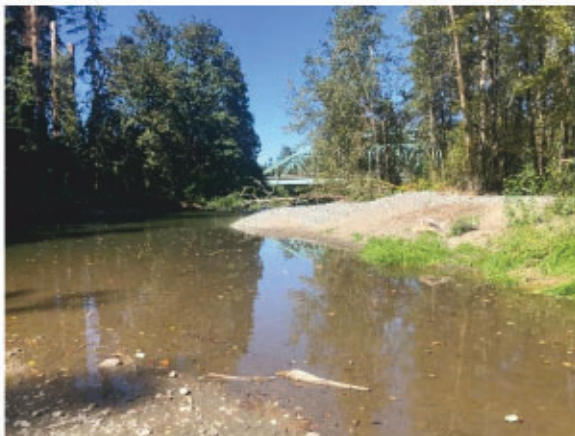
The point bar and side channel on the left bank of the Chemainus River downstream of the Highway 1 bridge consists of gravel/cobble material on the point bar in the mainstem of the river and finer gravel and sand in the side channel. Over time, sediment appears to have built up in the side channel such that now the side channel elevation is about 1 to 2 m higher than the mainstem channel elevation and is only activated during high flow events. Photos 1 and 2 below show the point bar and side channel.

**Photo 1: Gravel Accumulation at U/S End of Point Bar on Right Bank of Chemainus River**

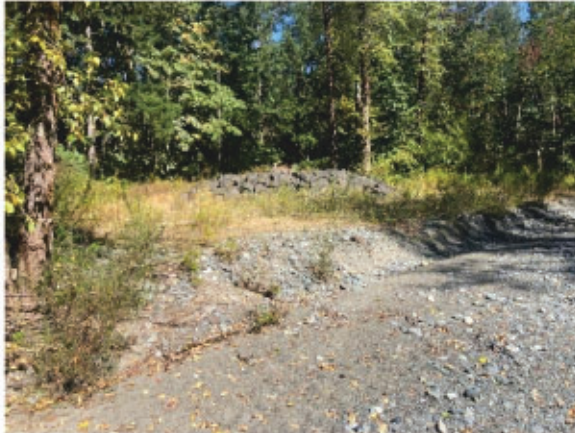
Well heads for the District of North Cowichan (DNC) water supply system are located adjacent to the side channel and are protected by riprap (Photos 3 and 4). The depth of riprap below the channel is unknown.

**Photo 3: DNC Water Supply Well Head Protected by Riprap Adjacent to Side Channel**

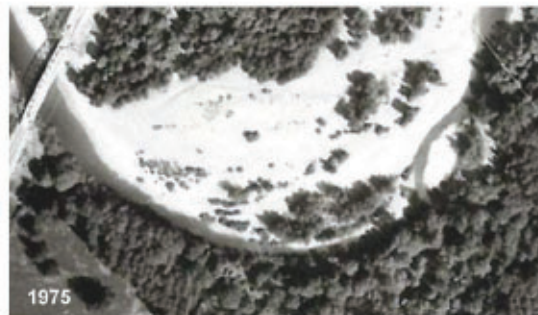
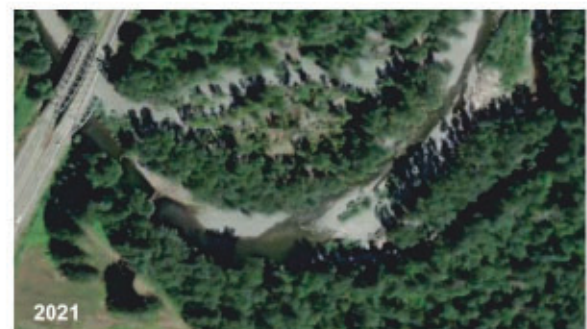
Air photo review in the Geomorphic Atlas indicates that the point bar and side channel area has become more vegetated since 1975 (see Photo 5) indicating the bar is becoming more stable and at higher elevation over time.

**Photo 5: Changes in Vegetation Cover on Point Bar d/s of Highway 1 Bridge**  
(Source: NHC, 2022)

Accumulation of sediment on the point bar and within the side channel on the left bank concentrates flow in the Chemainus River channel along the opposite right bank which tends to increase potential for erosion of the right bank and increase potential for channel avulsion across the right bank floodplain. This erosion is discussed further in Site 2 and Site 3.

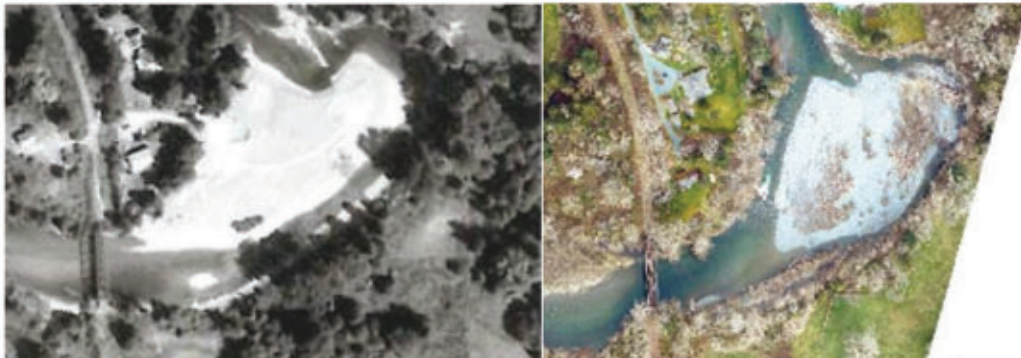
Site 4 is located between the E&N Railway Bridge and the Chemainus River Bridge (Reach 2 in the NHC Geomorphic Atlas). This area is a depositional zone with a 10,000 m<sup>3</sup> (approximate) gravel bar. The right bank of the channel is protected by riprap between the E&N bridge and a bedrock outcrop upstream of the Chemainus Road bridge. Since 1992, the channel has migrated from the right bank to the left bank (Photo 10).

**Photo 10: Air photos from 1992 (left) and 2021 (right) showing how channel morphology has changed in the depositional area over time**

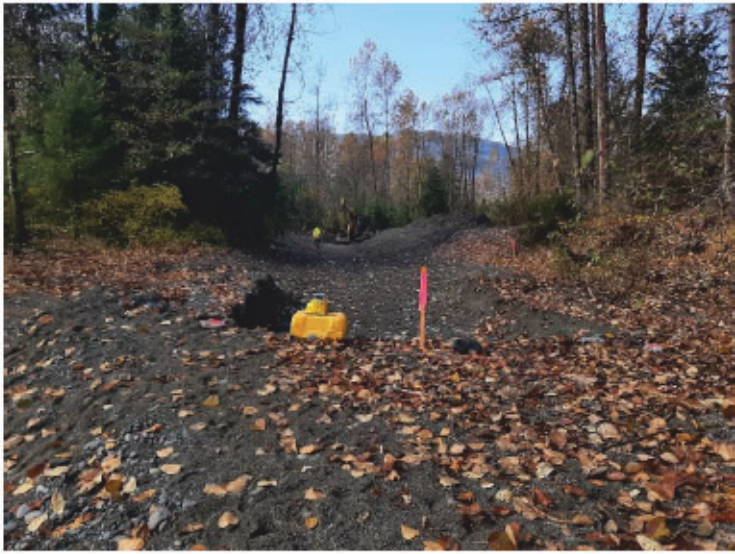
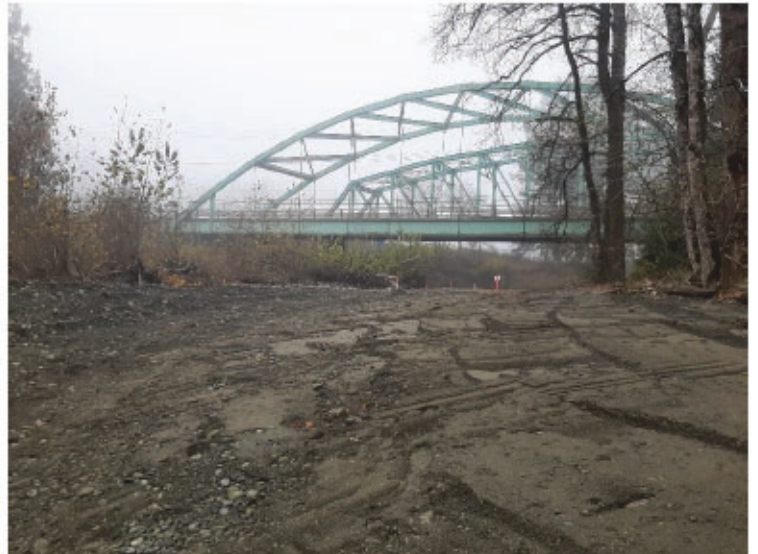
**Photos 8 and 9: Sediment berms at the downstream (left) and upstream (right) end of the side channel excavation.**

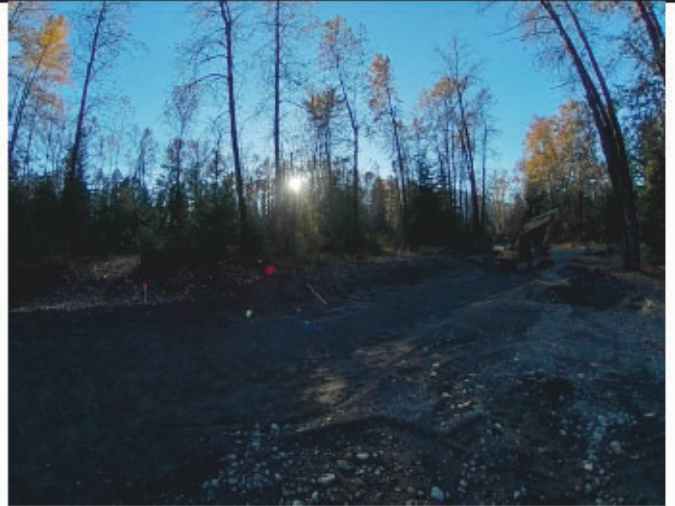
Photo 4:

- Some over-excavation found when grading downstream end. Material filled from channel side. See photo 4, on the right bank.

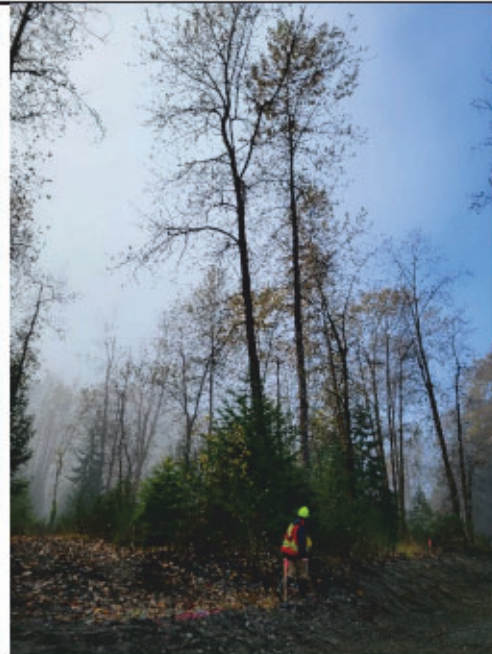
**Photo 2:** A copse of trees flagged for removal

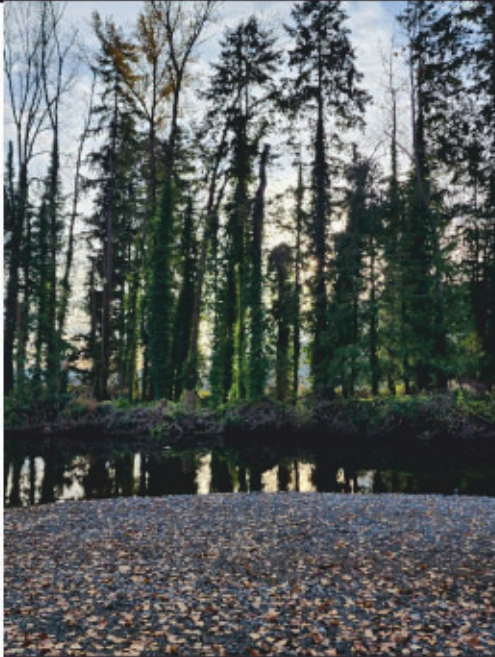
Photo 5: View from Point Bar
