# Ministry Of Environment and Climate Change Strategy

## Hatzic Emergency Work Program Pattison Creek

FEBRUARY 2024

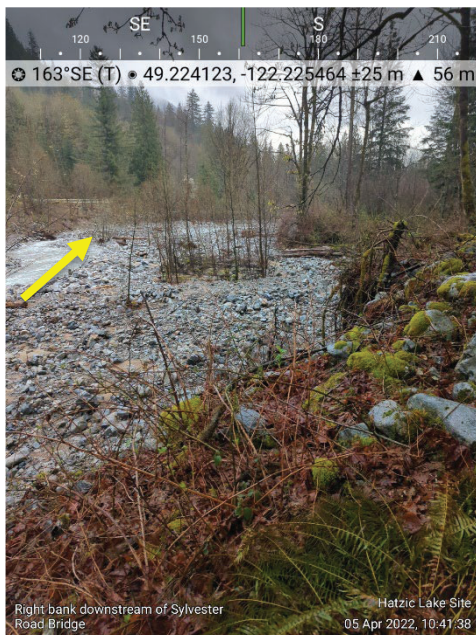
Right Bank of Pattison Creek:  
Downstream of Sylvester Road

1. Remove sediment within Pattison Creek downstream of the Sylvestor Road Bridge; and
2. Repair the right (west) bank of Pattison Creek to reduce the risk of a channel avulsion. The repair work includes installation of riprap erosion protection.

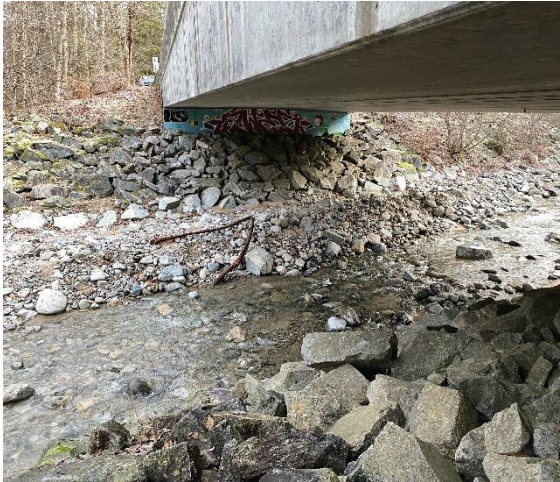
Figure -1

Looking northerly under the bridge to excess material on north bank

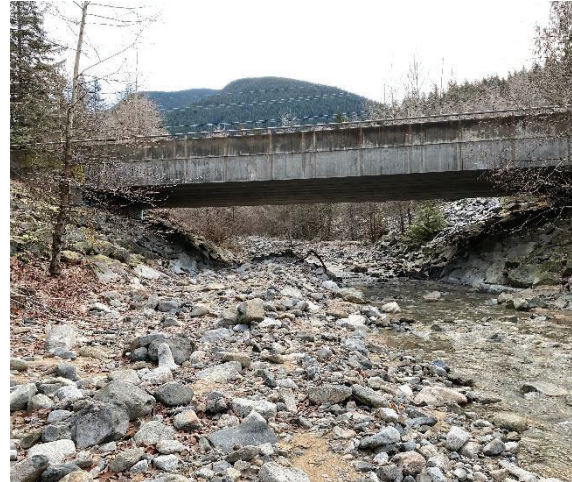
Figure -2

Looking northeasterly to deposited material on north bank

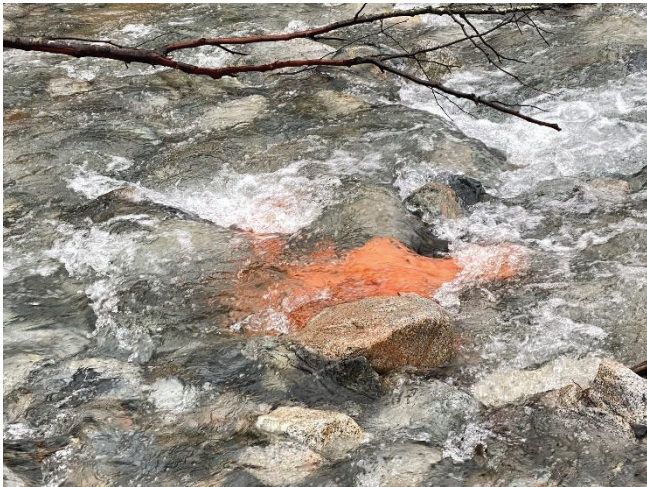
Figure -4

Looking at found tarp in the creek

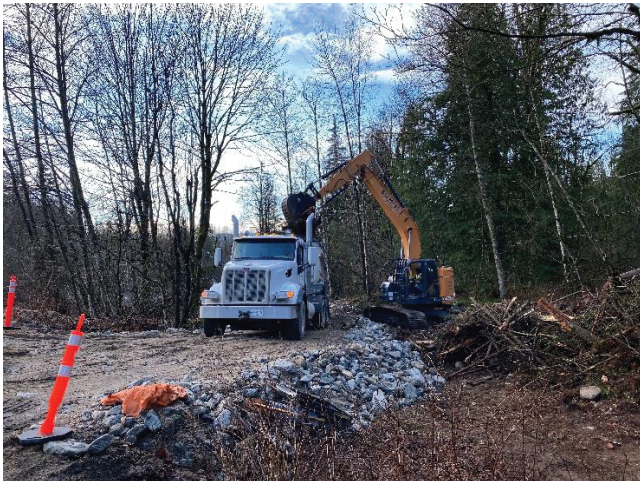
Figure -1  
Looking westerly at the debris/tree loading

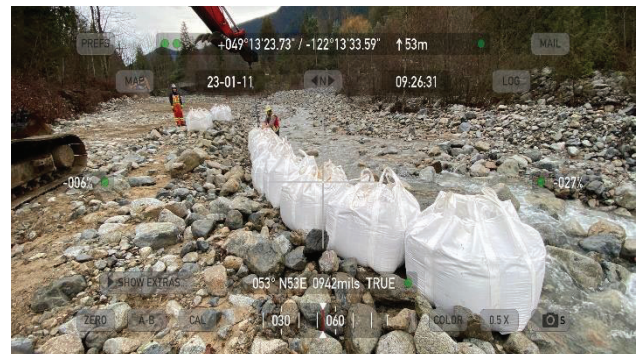
Figure -2  
Looking northerly at meg bags in place

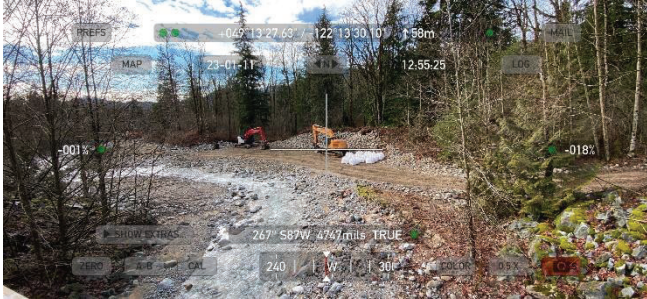
Figure -3

Looking at upper section with meg bags at 0 0 0  
west bank

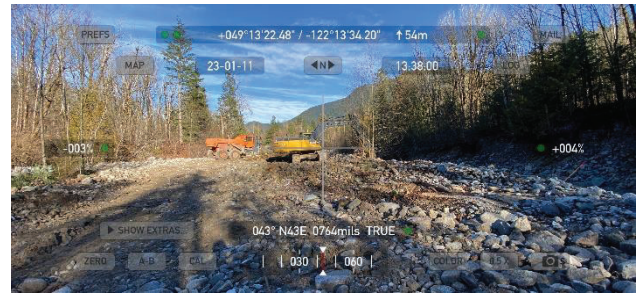
Figure -4

Looking at removed trees at the outfall 0 01 0

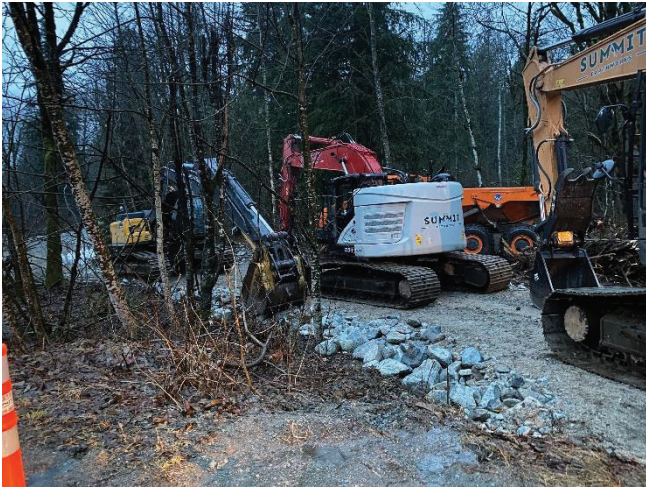
Figure -1

Looking southerly at the equipment on site

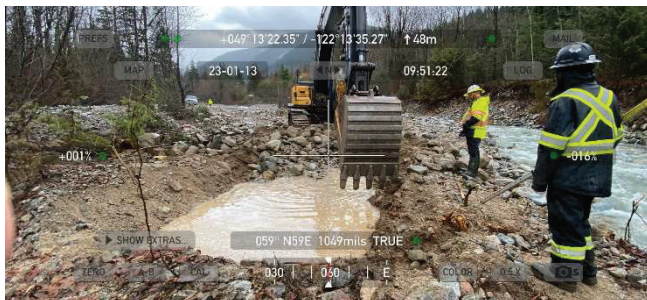
**Figure -3**

Looking northerly at start of the excavation

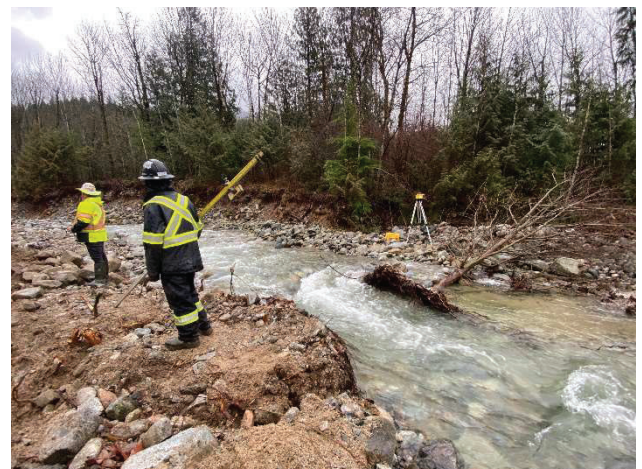
**Figure -4**

Looking at laser giving grade & outfall 0+0200

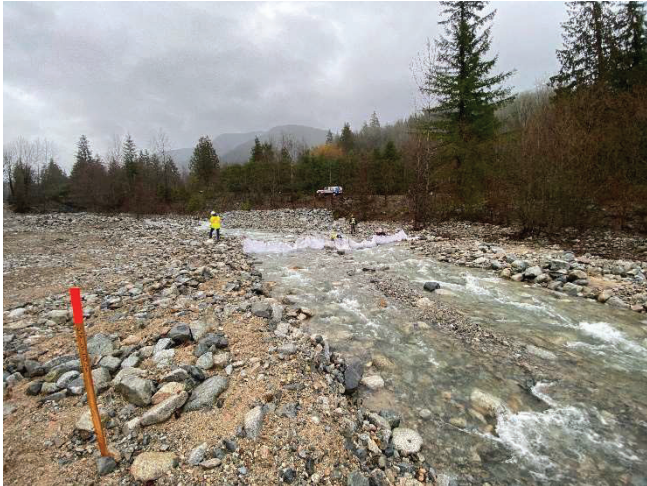
**Figure -5**  
Looking northerly at fish nets

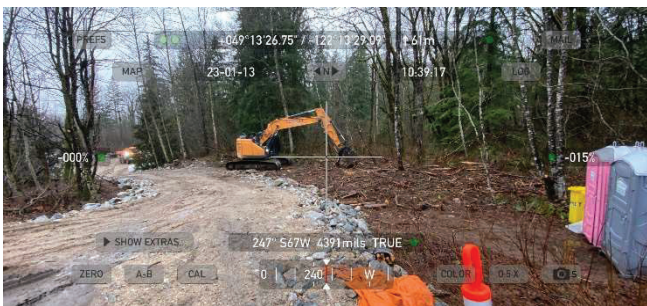
**Figure -7**  
Looking southerly at the remainder debris stockpile

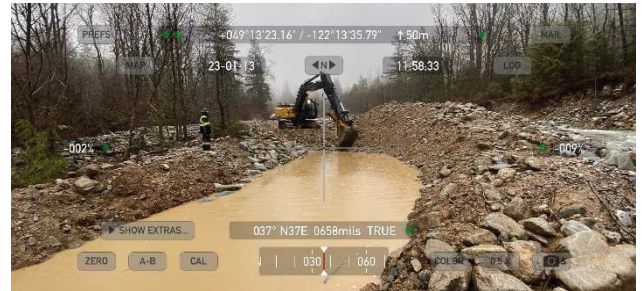
**Figure -10**  
Looking northerly at first 20m of creek design excavation

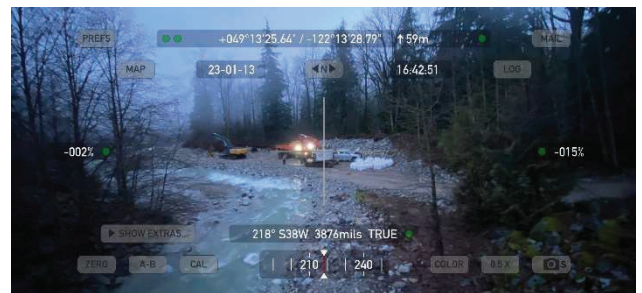
**Figure -12**  
Looking westerly at the end of day servicing of equipment

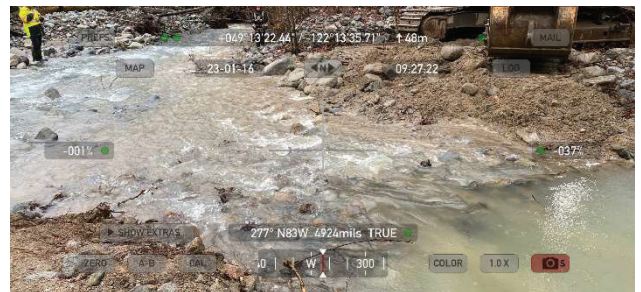
**Figure -2**  
Looking at opening of downstream/outflow of the diversion channel

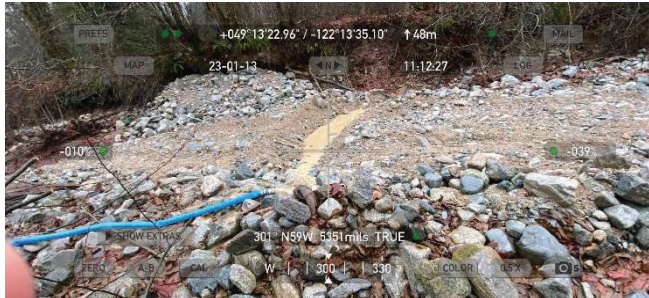
**Figure -9**  
Looking westerly at pumped out excess water settlement

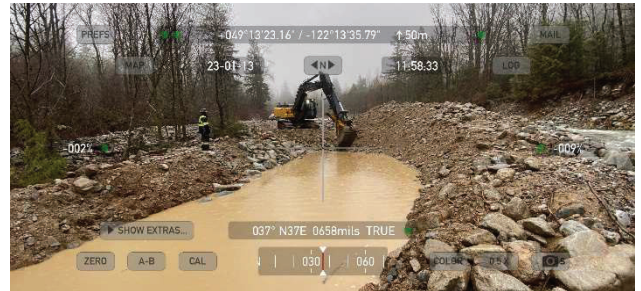
**Figure -10**  
Looking northerly at first 20m of creek design excavation

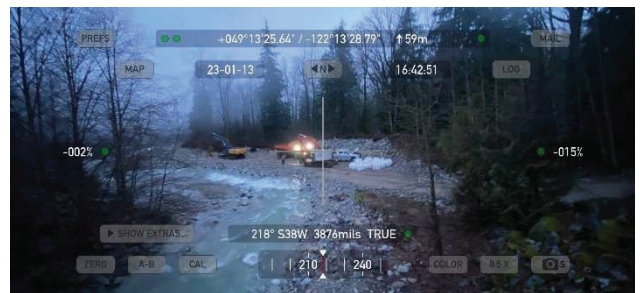
**Figure -12**  
Looking westerly at the end of day servicing of equipment

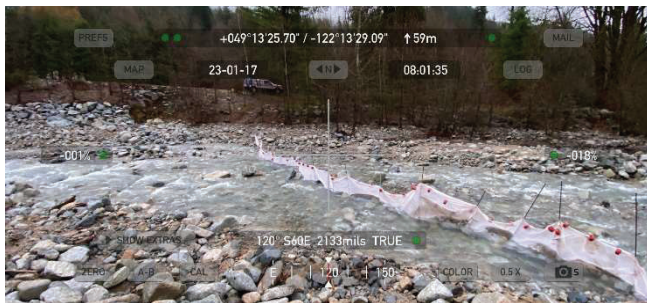
**Figure -1**  
Looking easterly at upstream fish net

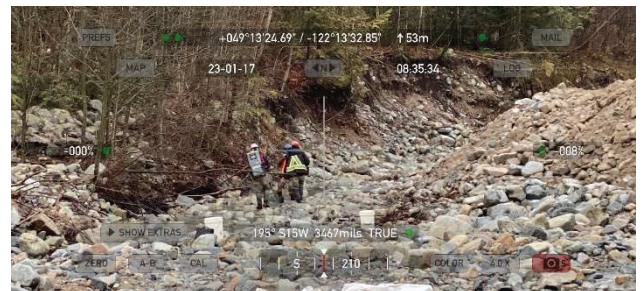
**Figure -2**  
Looking southerly at Sartori doing fish salvage in the infill section at low water

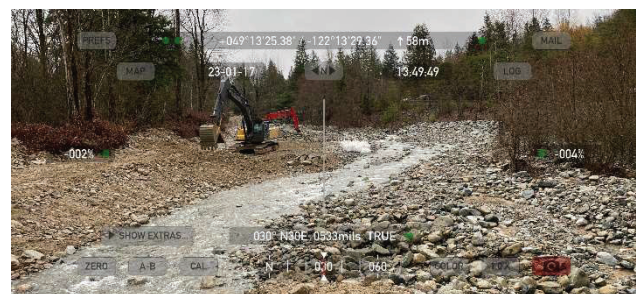
**Figure -6**  
Looking northerly at west bank being sloped to 2:1

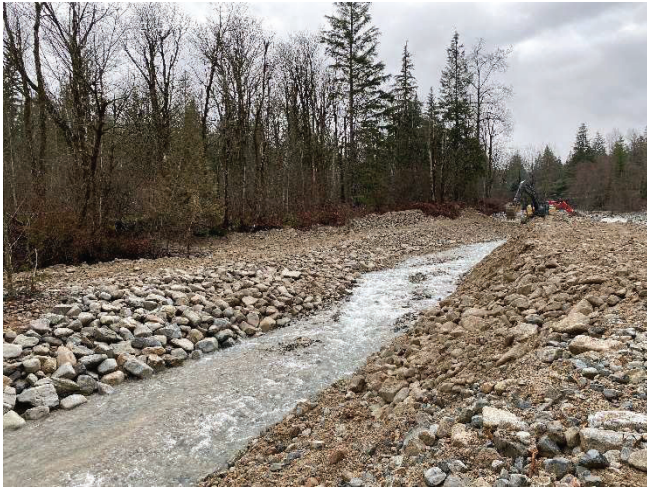
**Figure -7**  
Looking northerly at the west bank of diversion

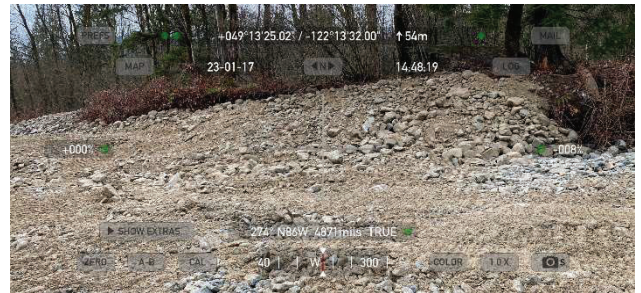
**Figure -8**  
Looking westerly at the west bank sloping

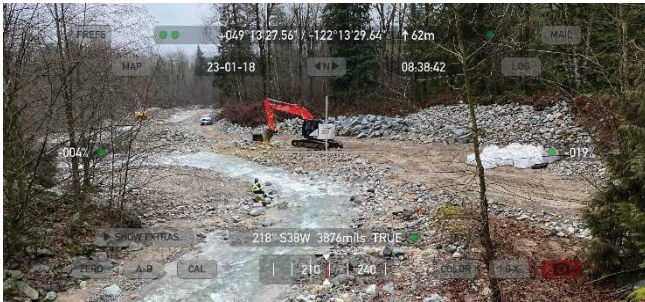
**Figure -1**  
Looking southerly at clear water at 8:38am

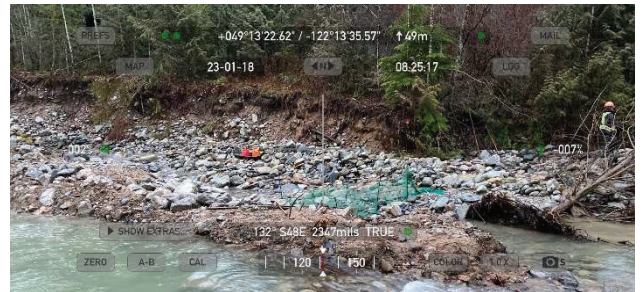
**Figure -6**  
Looking easterly at down stream section of the infill-east bank

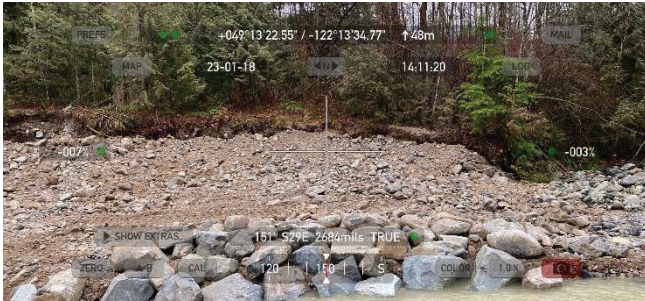
**Figure -7**

Looking easterly at the south section of the infill -east bank

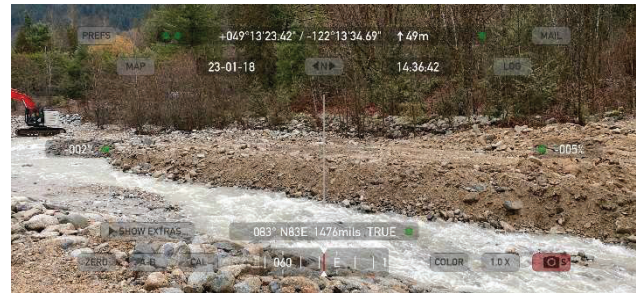
**Figure -8**

Looking northeasterly at the north section of the infill - west section

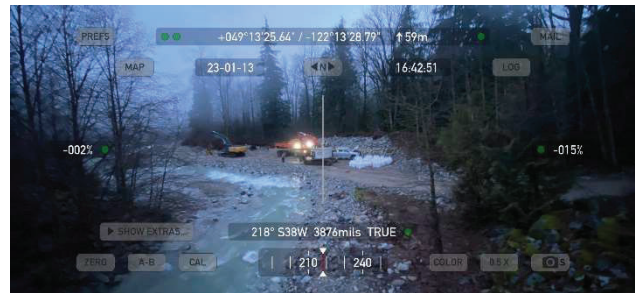
**Figure -12**  
Looking westerly at the end of day servicing of equipment

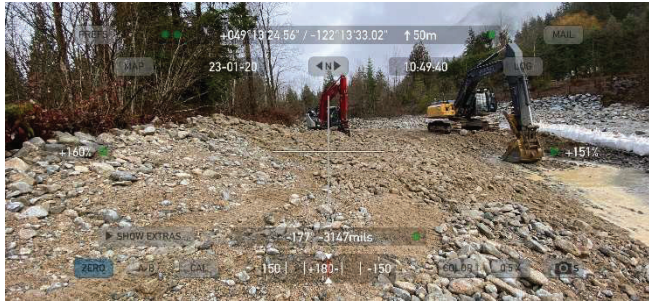
**Figure -3**

Looking northerly at start of the 3;1 SLOPE at sta 0+100

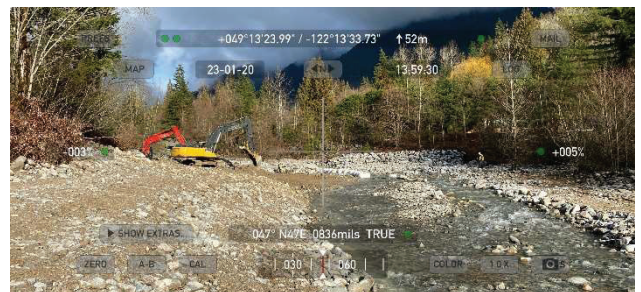
**Figure -6**

Looking northerly at the progress at second diversion channel

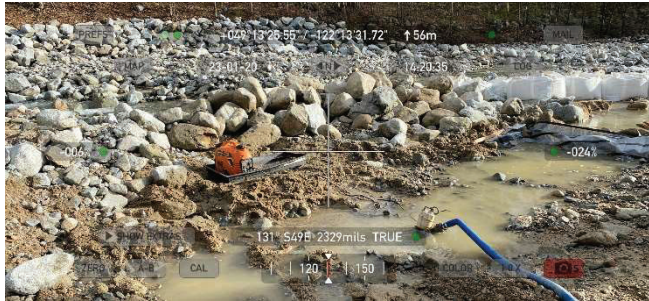
Figure -7

Looking southeasterly at the pumping of sediment-water at the excavation

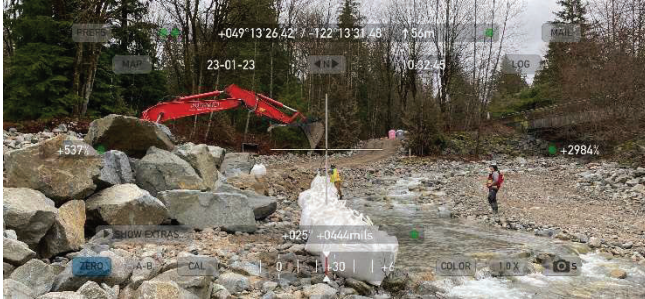
**Figure -3**

Looking northerly at mega bags going into place for the new diversion at rip-rap area 0+060

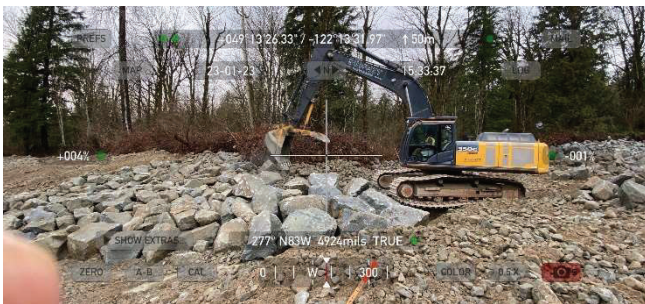
**Figure -5**

Looking westerly at creek bend of 500/1000kg placement on the west bank

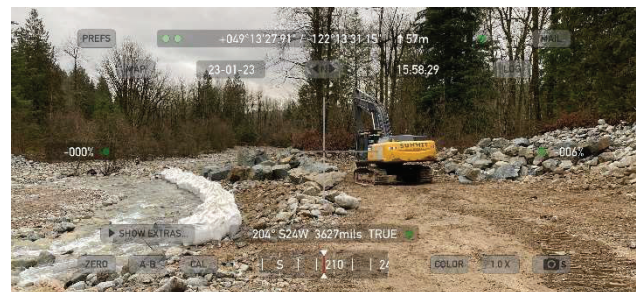
**Figure -6**

Looking southerly at the progress at second diversion channel/west bank riprap

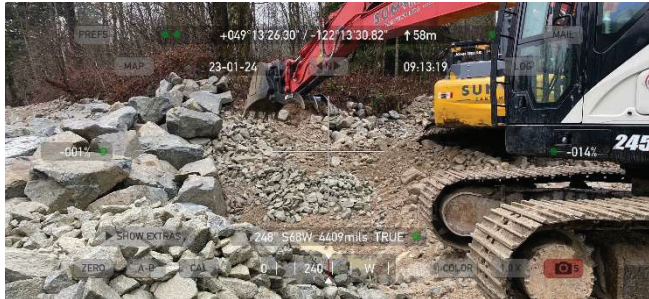
**Figure -3**

Looking westerly at the start of placement of 1000kg rock on the west bank

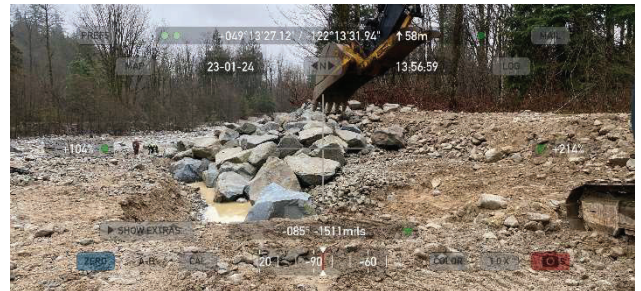
**Figure -4**

Looking southerly at 1000kg rock on the west bank

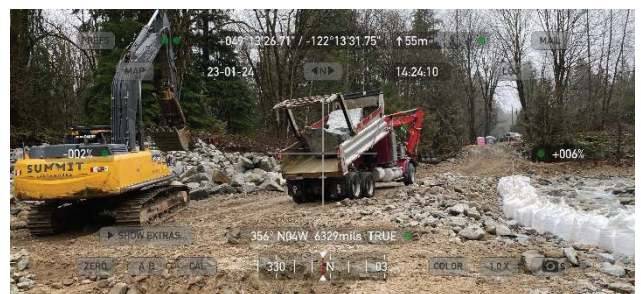
**Figure -6**

Looking northerly at the delivery of 1000kg rock

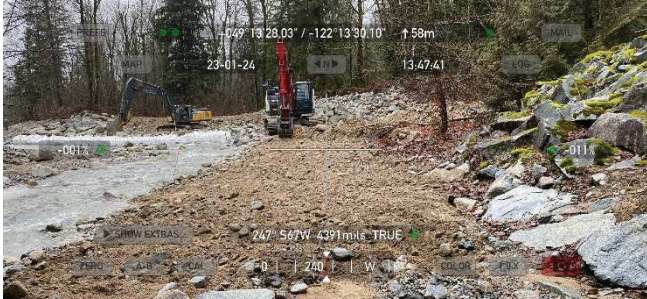
**Figure -7**

Looking westerly at the debris removal at the west bank at 0+000 to 0+025

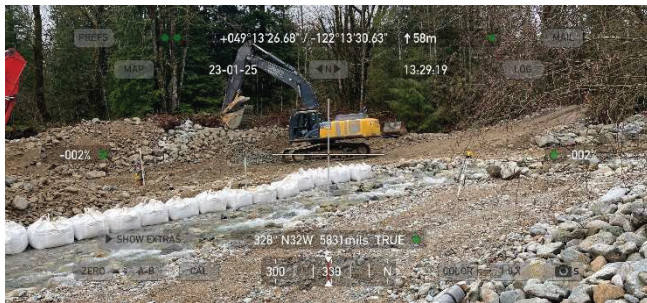
**Figure -1**

Looking northwesterly at 1000kg rock placement at west bank of rip rap

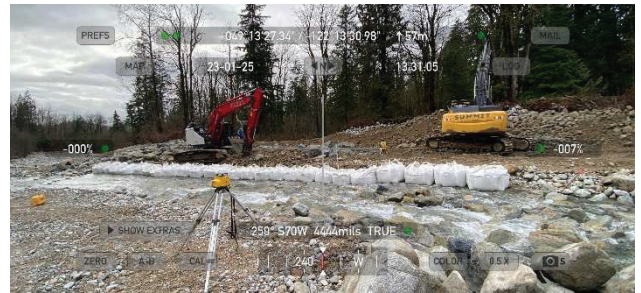
**Figure -4**

Looking southerly at 1000kg rock on the west bank

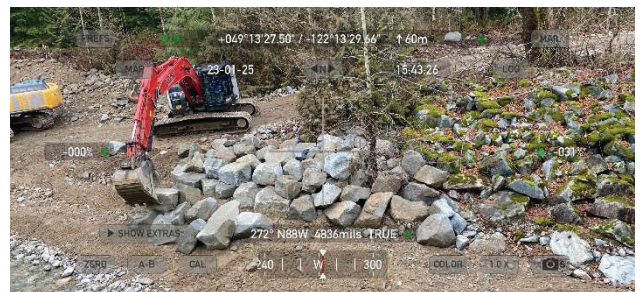
**Figure -6**

Looking westerly at the start of 500kg rock placement adjacent to the bridge & access road

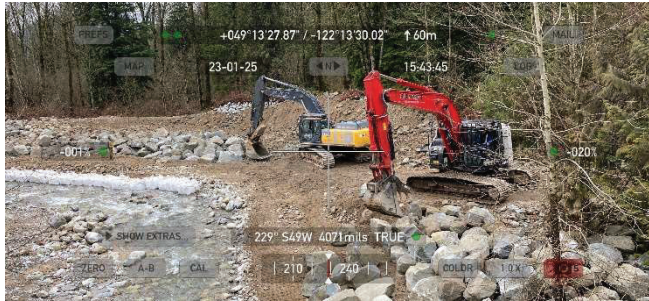
**Figure -7**

Looking westerly at the end of the day placement of 1000kg rock at 0+0028

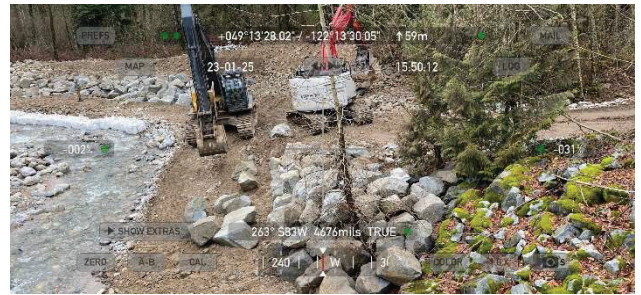
**Figure -8**

Looking westerly at end of the day placement of 500kg placement on the northerly section of the west bank

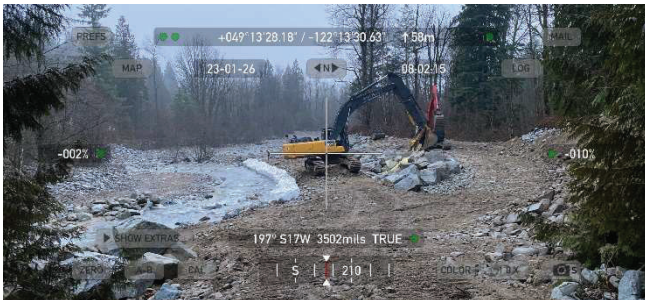
**Figure -1**

Looking southerly at rip-rap placement at sta 0+0030 on the west bank

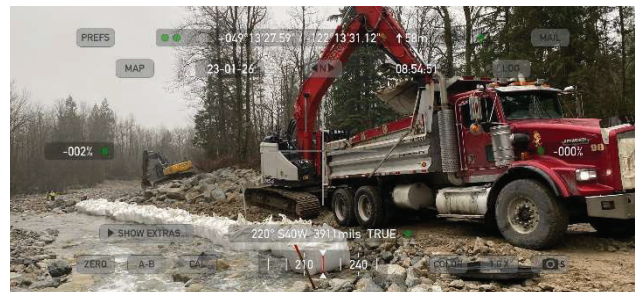
**Figure -2**

Looking southerly diversion excavation at 0+0030

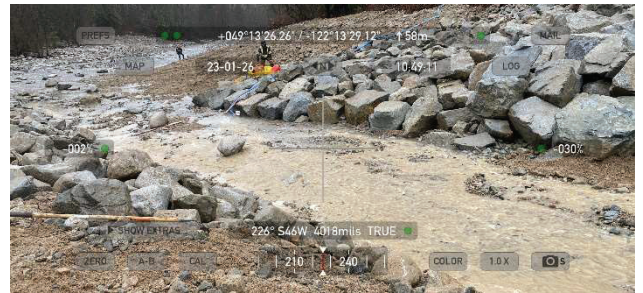
**Figure -4**

Looking southerly at water flow at 0+075 on the west bank

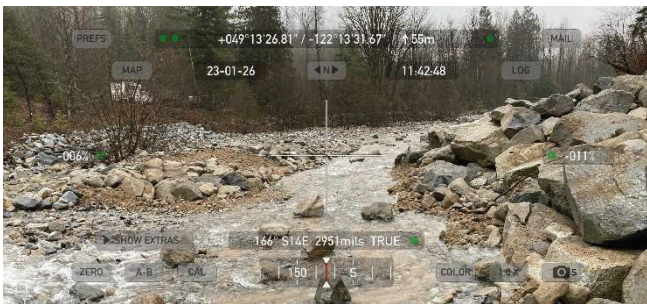
**Figure -5**

Looking southerly at normal flow at 0+075 new diversion

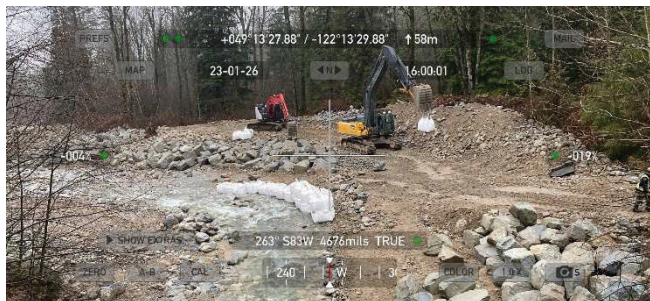
**Figure -7**

Looking westerly at the mega bag demob from the creek site

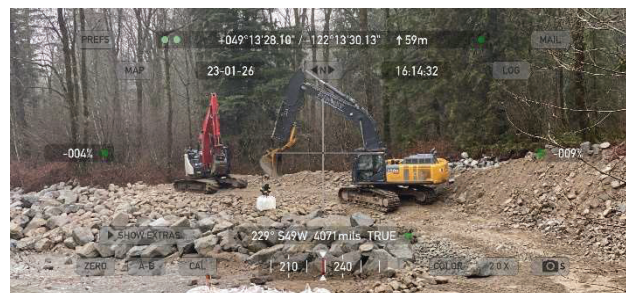
**Figure -8**

Looking westerly at remainder excavation for rip-rap placement on the northerly section of the west bank

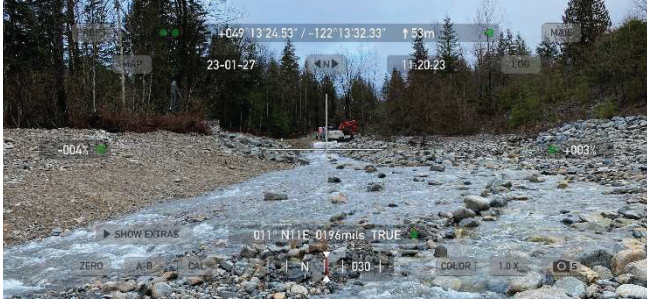
**Figure -3**

Looking northerly at the new opening of the creek diversion

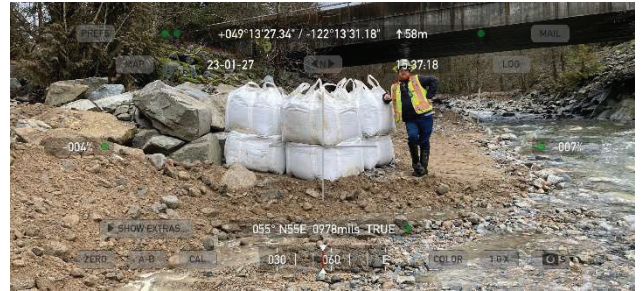
**Figure -4**

Looking northeasterly at remainder of mega bags removal on the west bank

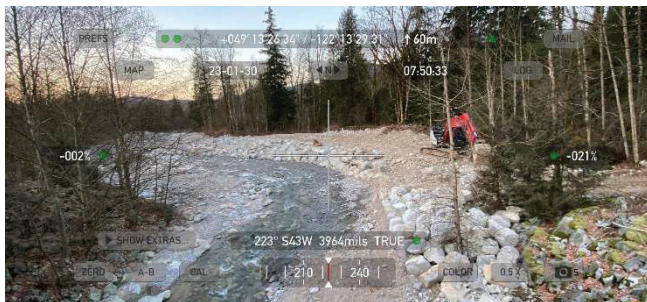
Figure -1

Looking southwesterly at rip-rap placement at on the west bank

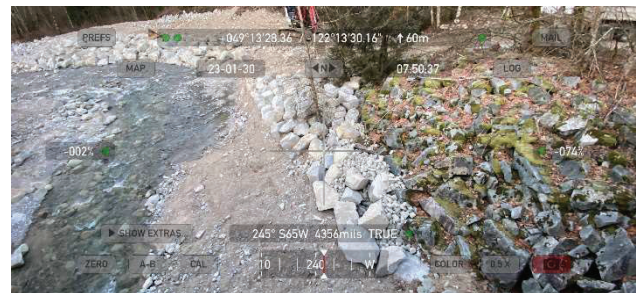
Figure -2

Looking westerly at northerly riprap (500kg) on the west bank

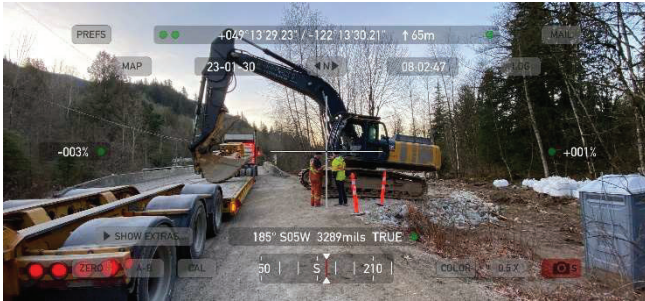
**Figure -3**

Looking southerly at the demob of JD350 excavator

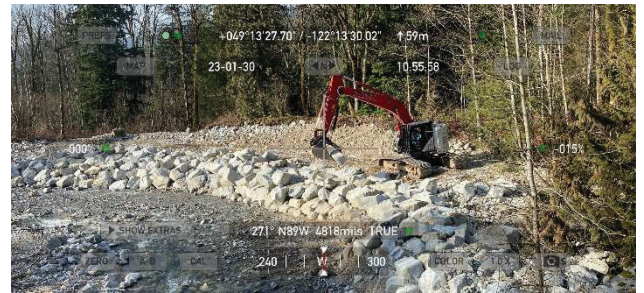
**Figure -4**

Looking westerly at final rock placements of the 500kg

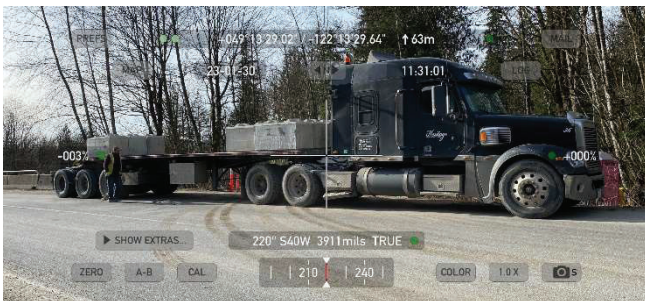
**Figure -5**

Looking southwesterly at delivery of lock-blocks to site

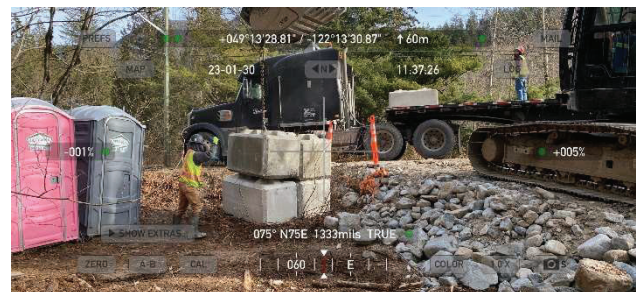
**Figure -6**

Looking easterly at the unloading the lock-blocks

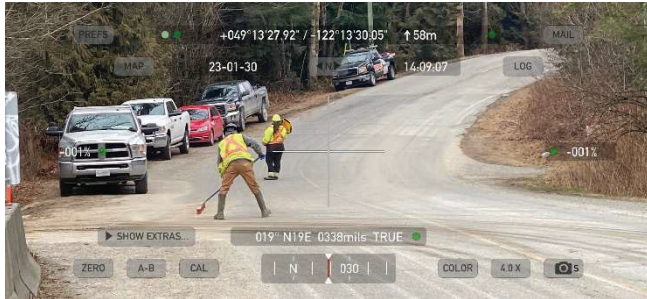
**Figure -7**  
Looking northerly at the road sweeping

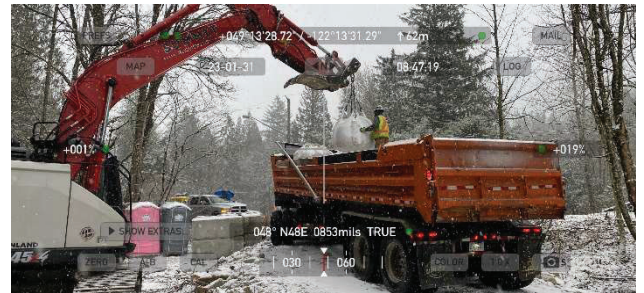
Figure -2

Looking easterly at loading of the mega bags onto end dump

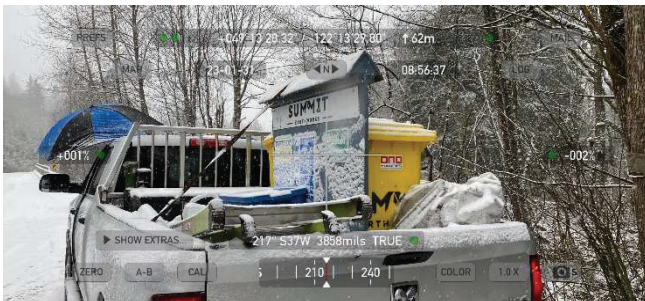
Figure -3

Looking southerly at the demob of spill kits and misc. equipment

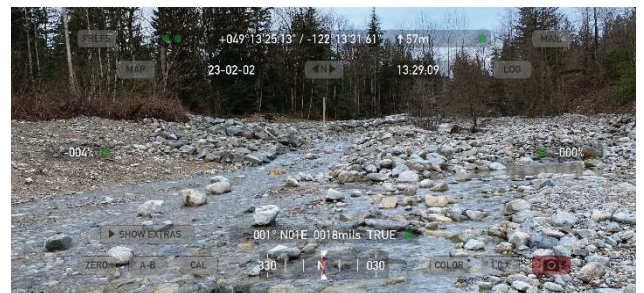
**Figure -4**  
Looking northerly from station 0+0120 at creek rip-rap on west(left)

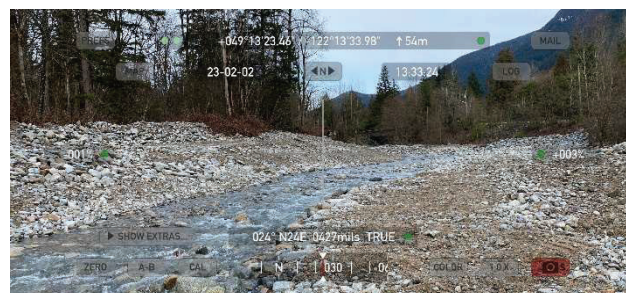
**Figure -6**  
Looking northerly at the creek at 0+0160

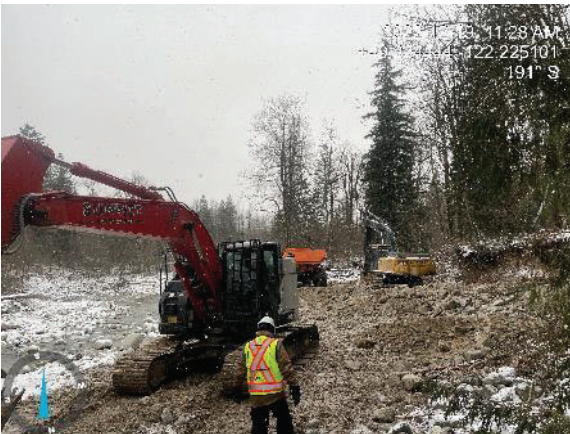
Photo 3. South-facing view of grading within the Pattison Creek floodplain above the wetted perimeter of surface water (Dec. 19, 2022).

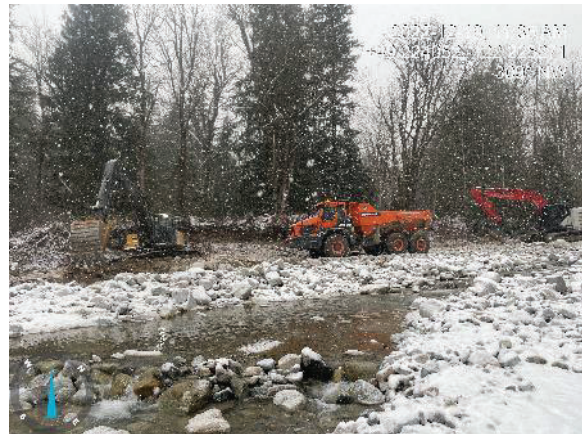
Photo 4. Northwest-facing view of site conditions and clear conditions within Pattison Creek (Dec. 19, 2022).

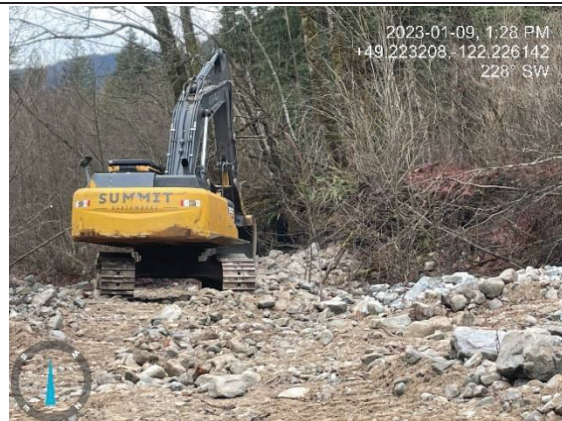
Photo 4. West eroded embankment stabilizing with boulders (Jan 09, 2023).

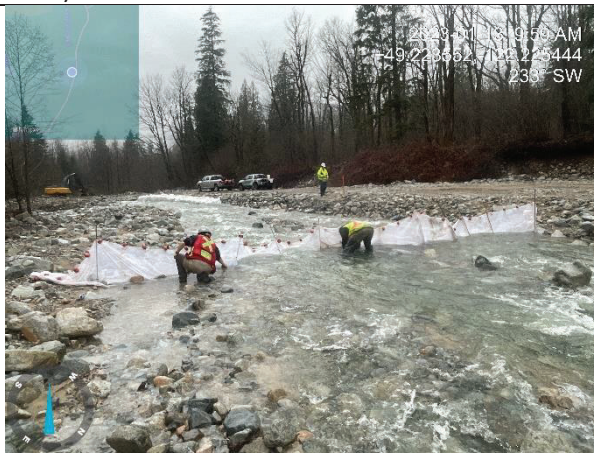
Photo 11. Install fish fencing in creek upstream of the works. The fence was removed after flows increased (Jan 13, 2023).

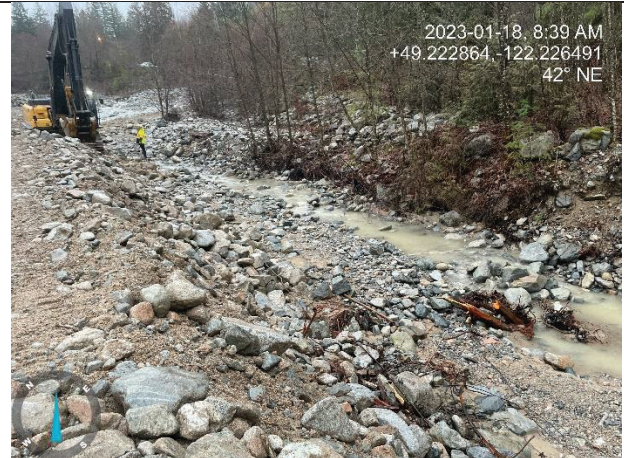
Photo 10. Old creek channel back filling after all electrofishing has been finished and salvage complete (Jan. 18, 2023).

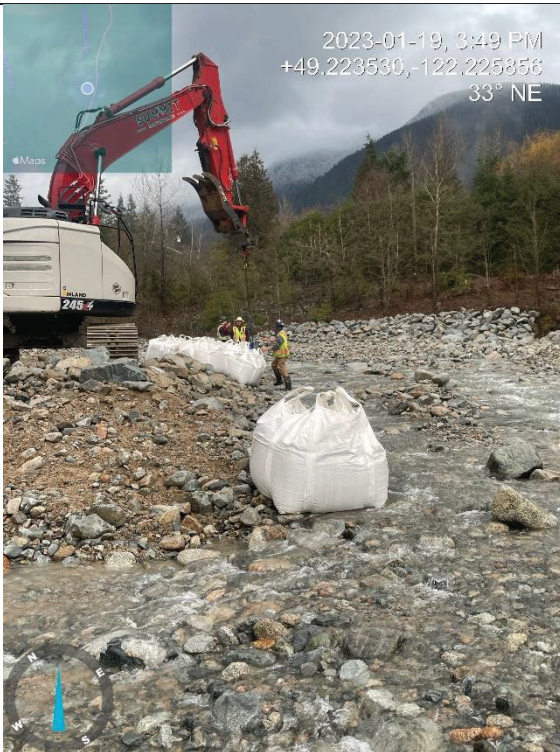
Photo 23. Deflection berm gravel bags installed for widening creek inside of berm bags (Jan 19,2023).

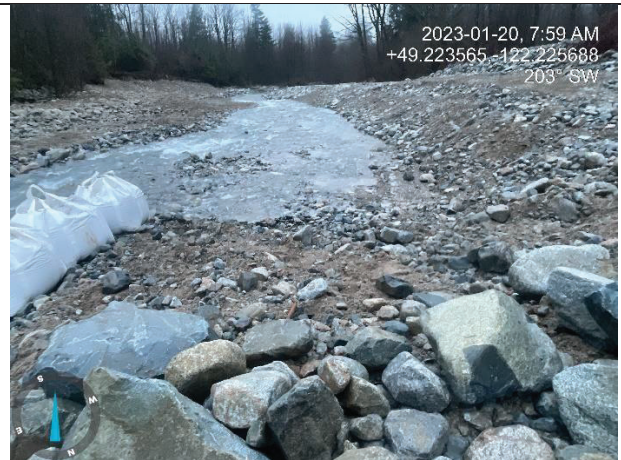
Photo 24. Before works. Widening creek channel beside the deflection berm gravel bags (Jan 20, 2023).

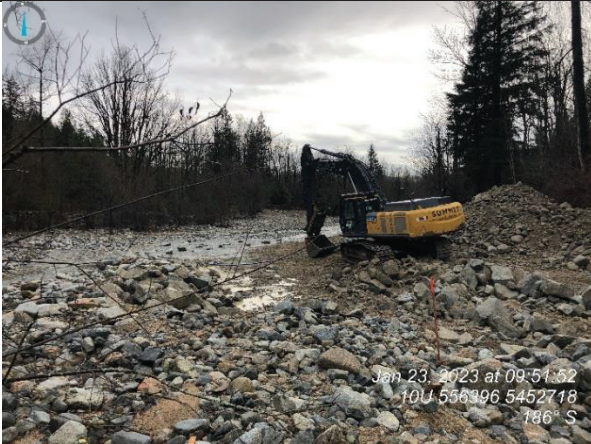
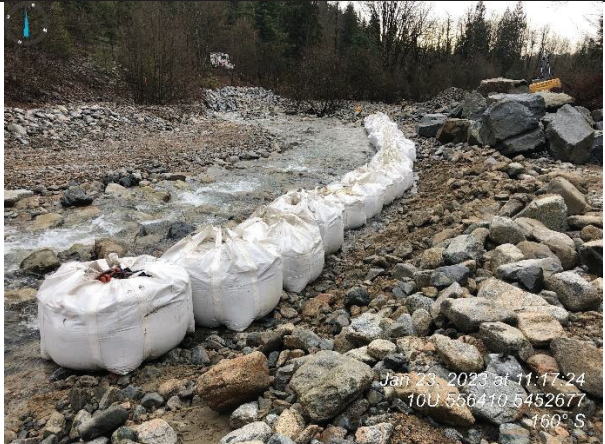
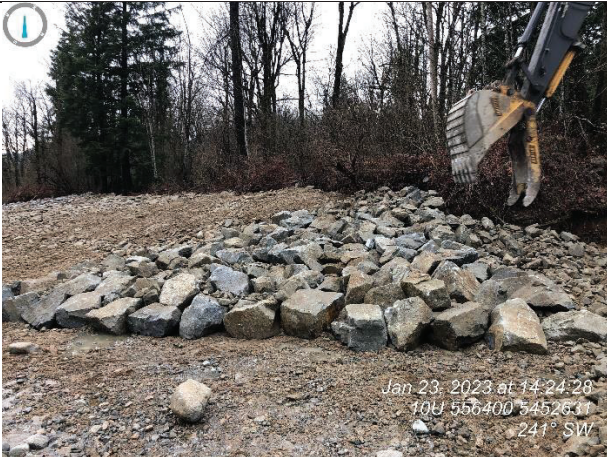
| <p>Photo 1. South facing view, prior to works. Summit will excavate for the right diversion creek channel and use the material for the West bank stabilization (Jan. 23, 2023).</p> | <p>Photo 2. South-facing view prior to diversion deflection gravel bags installed right side of creek (Jan. 23, 2023).</p> | |
| <p>Photo 3. Southwest-facing view of right creek side west bank riprap placement for stabilization (Jan 23, 2023).</p> | | |

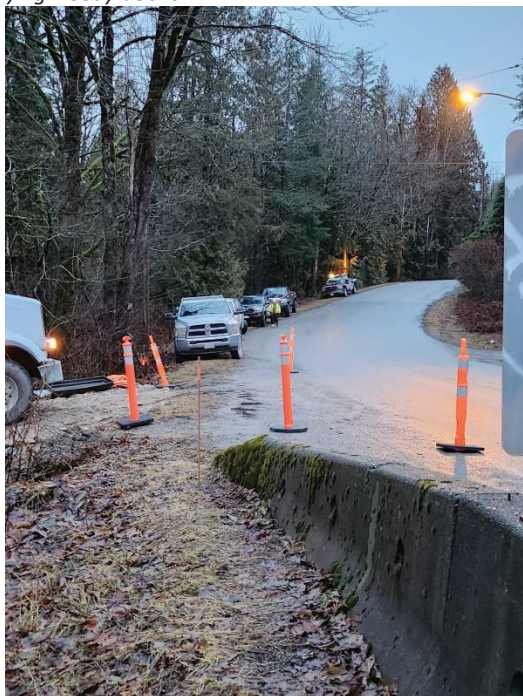
PHOTO #1 – Traffic control onsite to support transport truck carrying woody debris

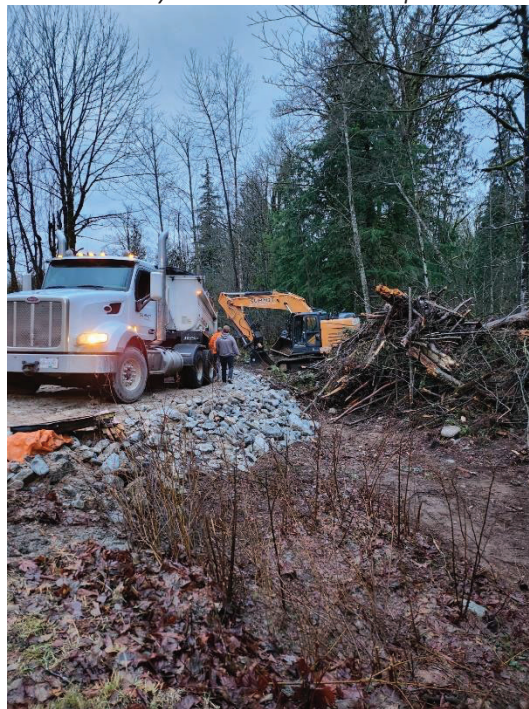
PHOTO #2 - Woody debris loaded into transport truck

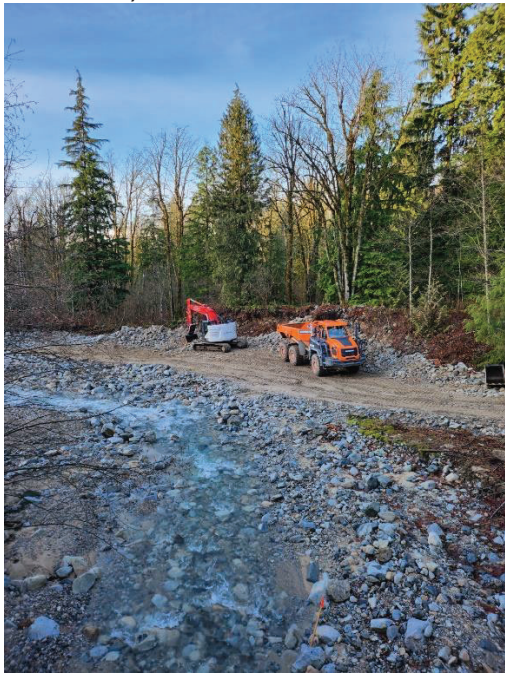
PHOTO #3 – Boney material used to armor eroded bank

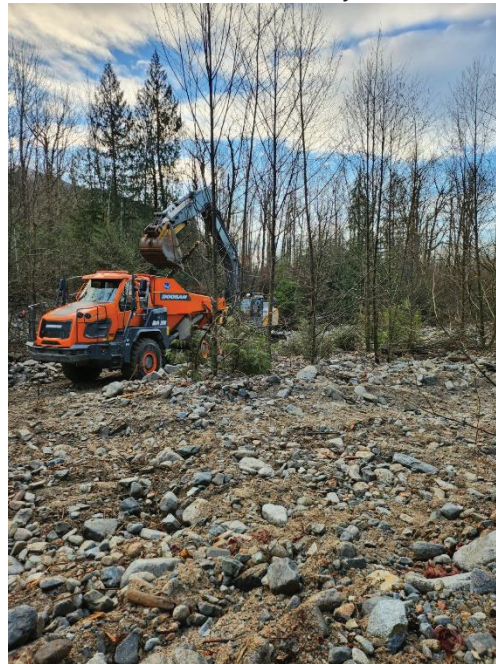
PHOTO #4 – Small trees removed at outflow

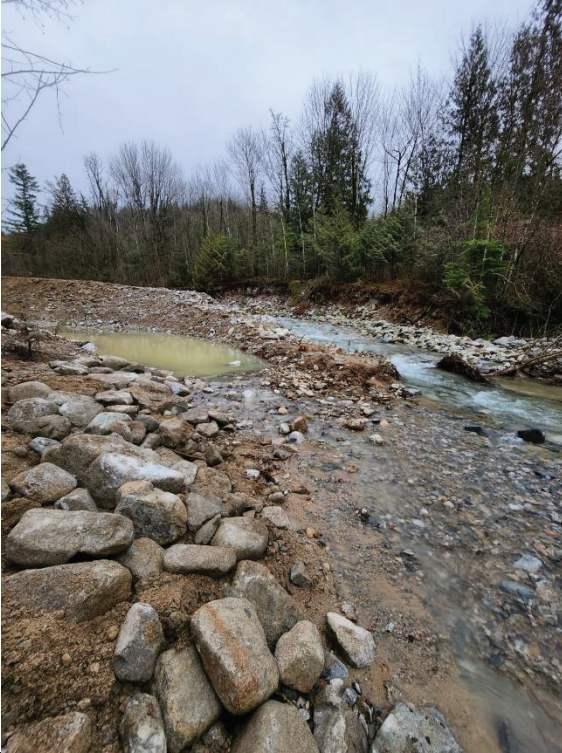
**PHOTO #1** – Bottom of diversion channel and flood channel before sand bag removal, silt fence removed

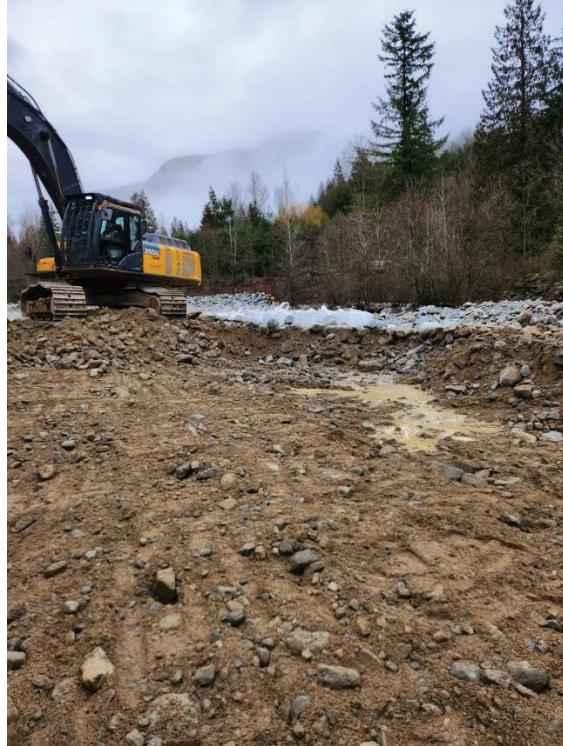
**PHOTO #2** - Initial sand bag removal at upper headwall

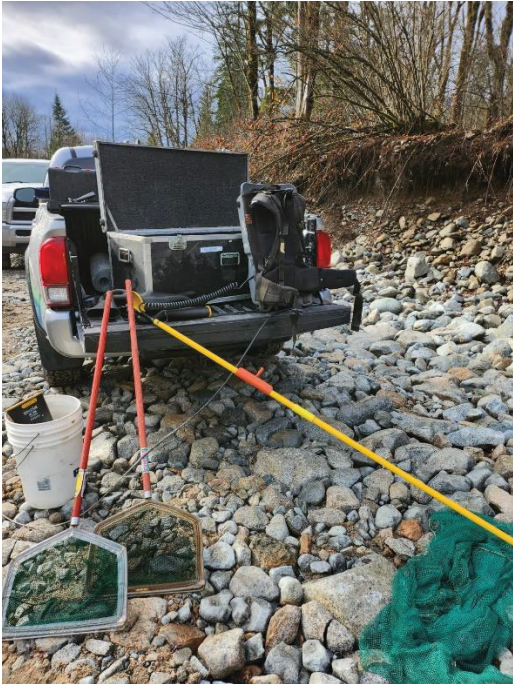
**PHOTO #3** – Electro-fisher, seine net/fence and fish salvage equipment

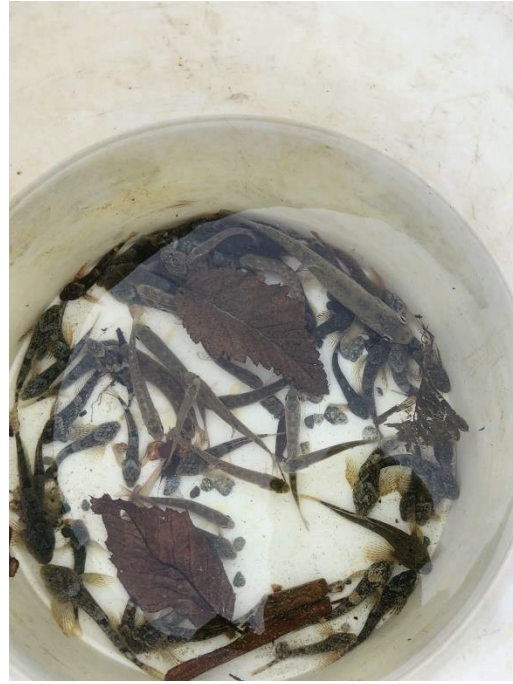
**PHOTO #4** – First pass with Electro-fisher in flood channel produced Coast Range Sculpin, Rainbow Trout, and Coho

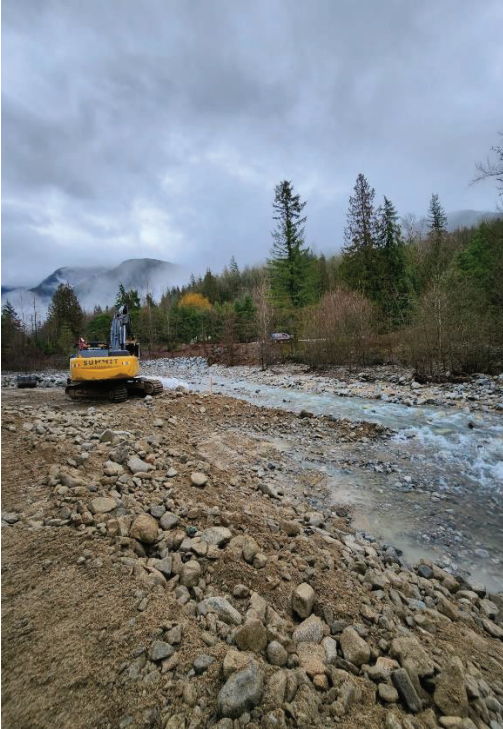
**PHOTO #1** – Sand bag removal completed at upper headwall for full creek diversion

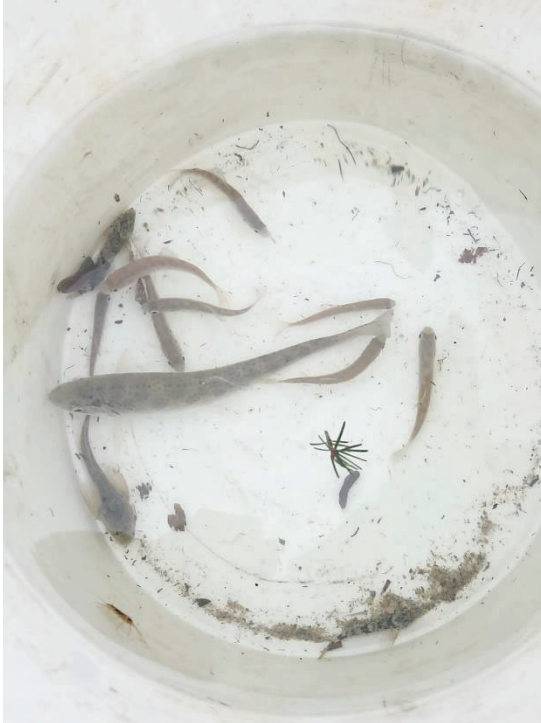
**PHOTO #3** – Initial fish salvage on second day produced Sculpin, Rainbow Trout and Coastal Tailed frog tadpole

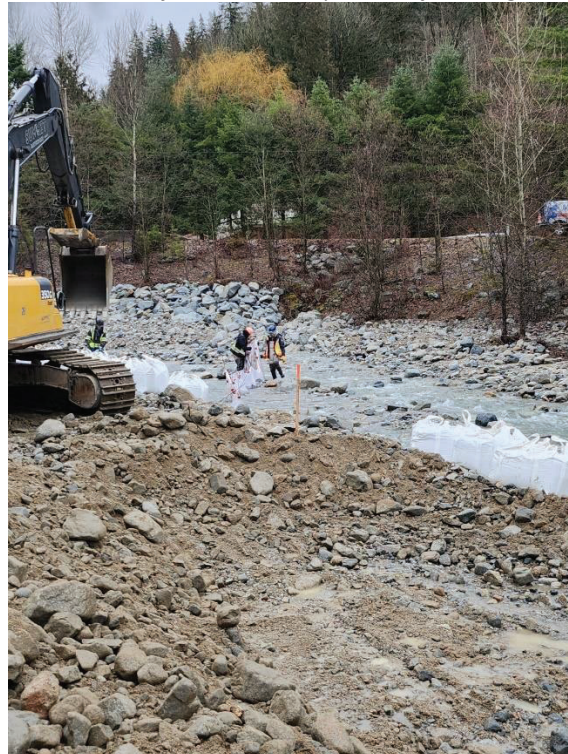
**PHOTO #4** – Fish fence removed upstream of sandbags
