# Ministry Of Environment and Climate Change Strategy

## Hatzic Emergency Work Program Pattison Creek

FEBRUARY 2024

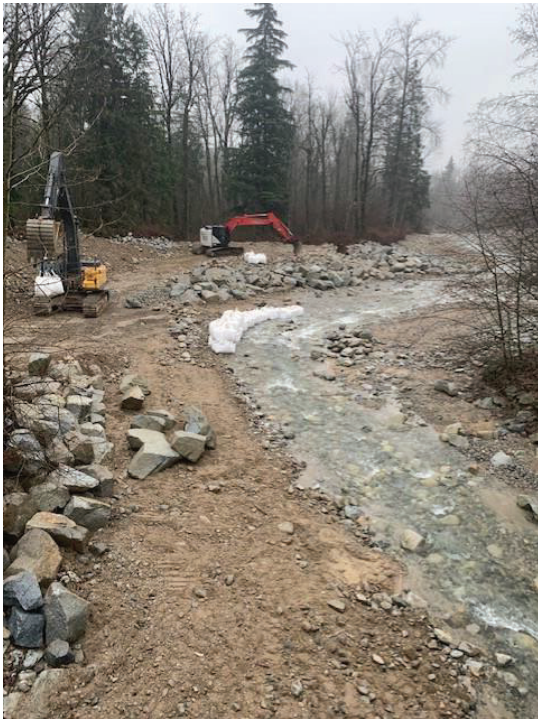
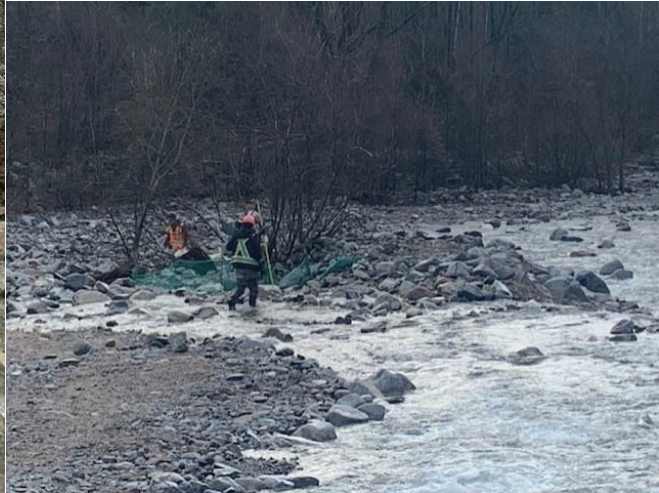
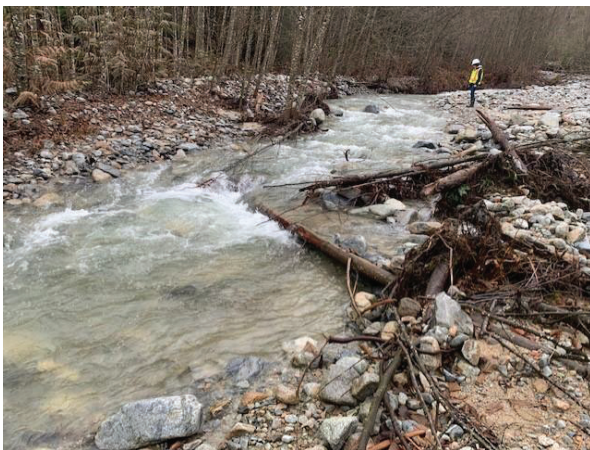
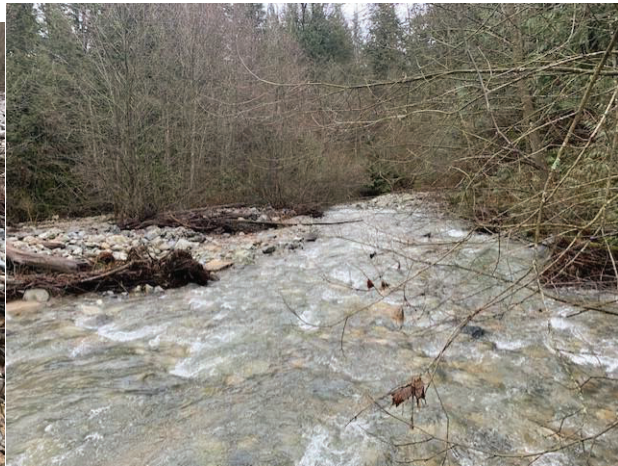
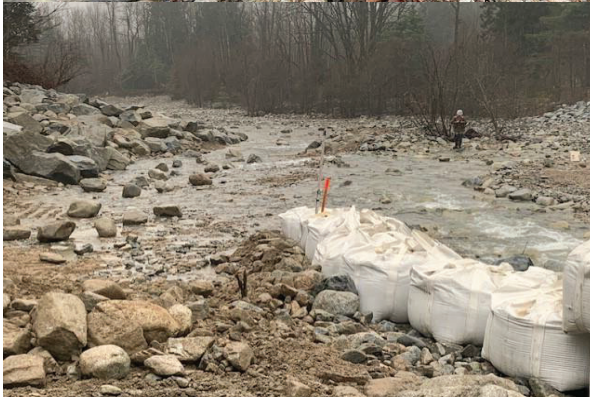
| <b>General Observations &amp; Comments (Wildlife, New Sensitive Features, etc.):</b><br>Flow was diverted from to the new channel. A reduction of flow was observed to the west and mid channels causing need for fish salvage. Fish salvage was successful with only one mortality observed. Fish protective fencing was adjusted to meet the need and ensure no fish passage into the low flow channels. Turbidity was greatly minimized by the contractor supervisor observing and directing flow change within the stream and Satori Environmental consistent check of turbidity reading in stream.<br><br>Tina Pederson (LFN Guardian coordinator) and I walked downstream to the confluence of the Legacy Creek and Pattison Creek observing no impacts due to the days work in sediment deposition. Flow below the project through to the Legacy Creek confluence remains in center channel and away from any erosion stress points. | | | | | <b>Photos:</b> | |

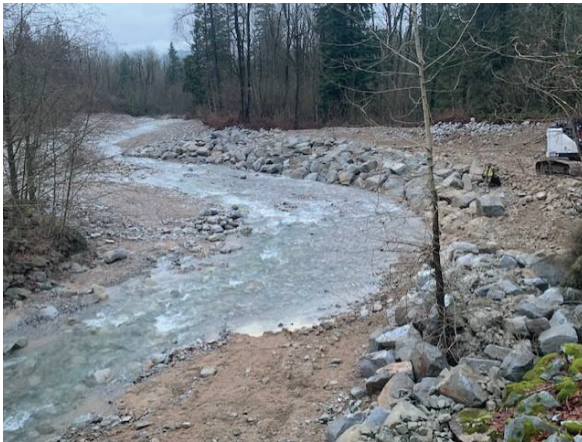
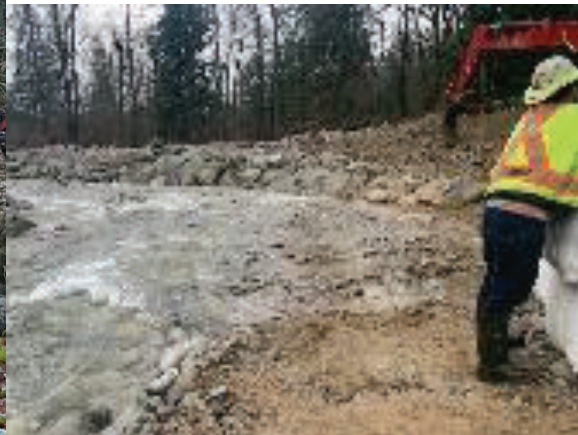
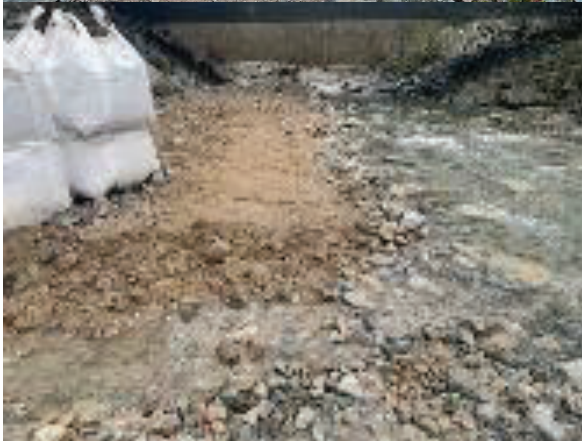
| <b>General Observations &amp; Comments (Wildlife, New Sensitive Features, etc.):</b><br>Final stream flow was diverted to the newly excavated channel. Once again a reduction of flow was observed to the west and mid channels causing need for fish salvage. Fish salvage was successful with no mortality observed. Fish protective fencing was removed to the low flow channels. Turbidity was greatly minimized by the contractor supervisor observing and directing flow change within the stream and Satori Environmental consistent check of turbidity reading in stream.<br><br>All instream component of sediment removal was completed leaving only top bank finishing to complete project | | | | | <b>Photos:</b> |

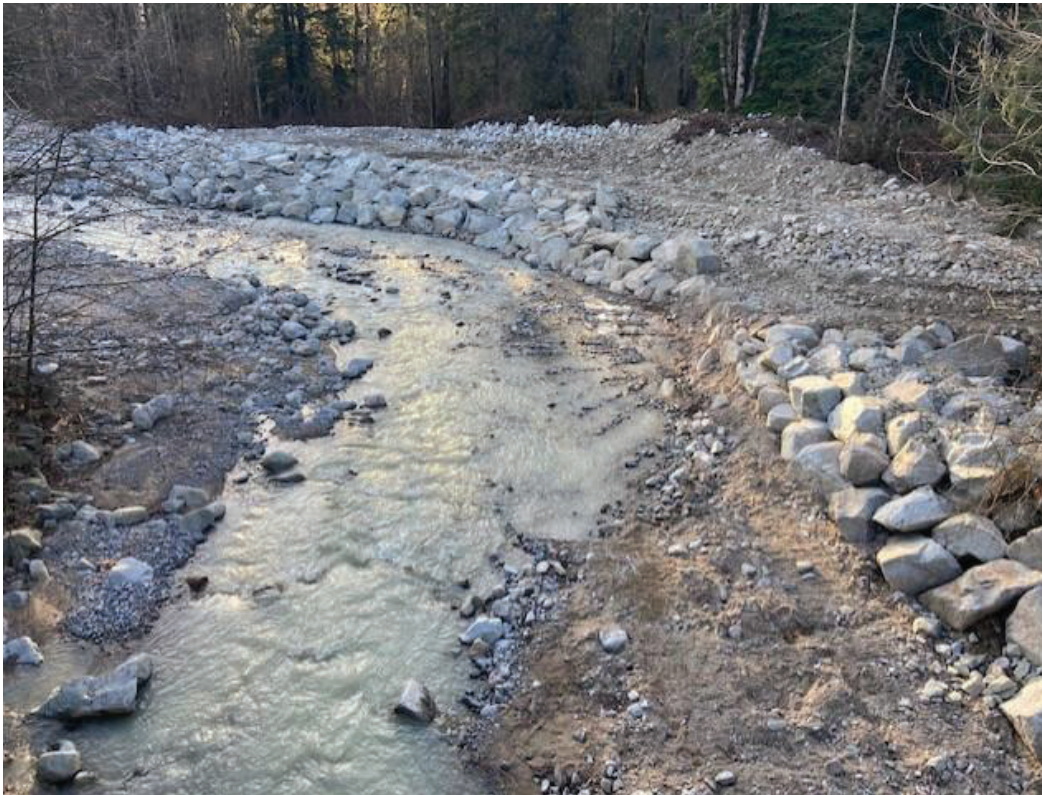
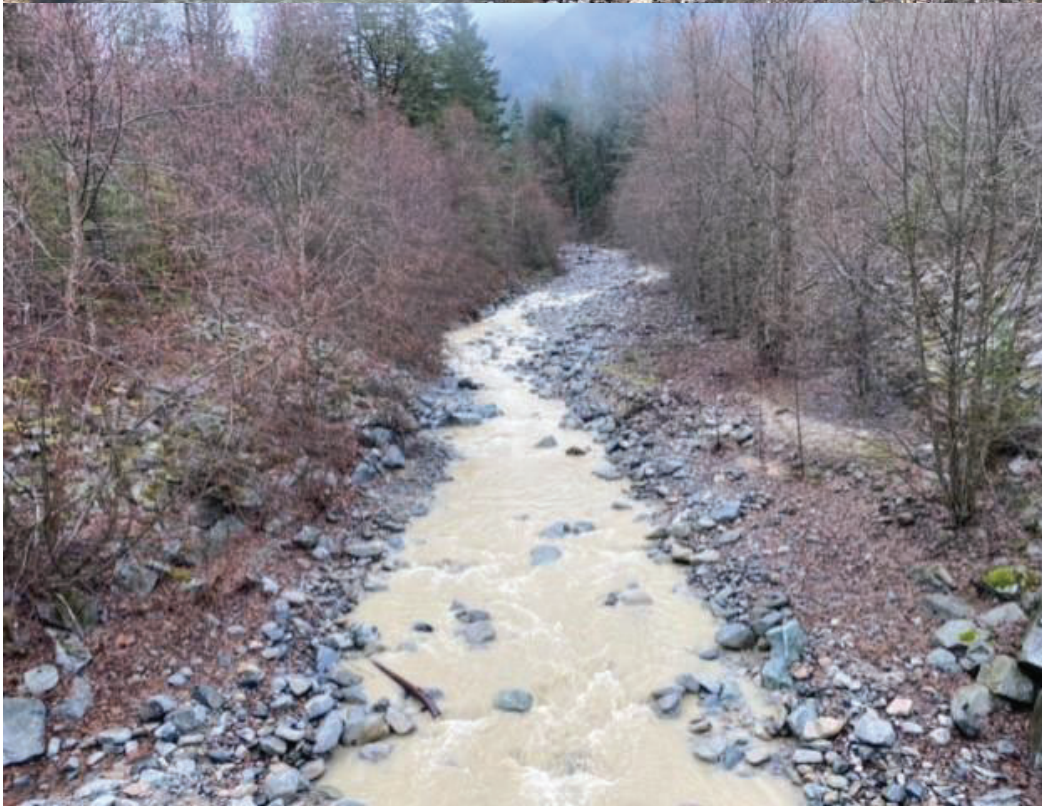
| Erosion & Sediment Control | OK | NC | NA | Comments & Mitigation | Photos: |
|---|---|---|---|---|---|
| <b>General Observations &amp; Comments (Wildlife, New Sensitive Features, etc.):</b><br><br><p>A call alerted LFN of a possible slide event in the upslope once again. An altered rise in daily flow and increased turbidity indicated a blockage upstream flow that released. The event flowed through similar to the previous weeks event. Photos indicate and evidence the caused alteration of flow and turbidity approx. 1 hour after it was first noted by a local resident. Short video footage is also available,</p> <p>I have filed this monitoring report to ensure the event is documented.</p> <p>Photo 1 is captured down flow of the MoTi Bridge structure and phot 2 shooting upstream of the MoTi bridge structure.</p> | | | | | <b>Photos:</b><br><br><div style="border: 1px solid black; height: 100px; width: 100%;"></div> |

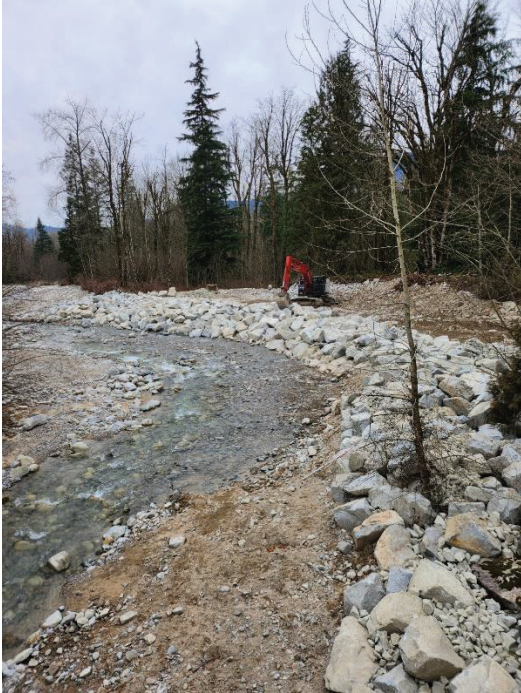
PHOTO #1 – 245 Excavator final rip rap placement

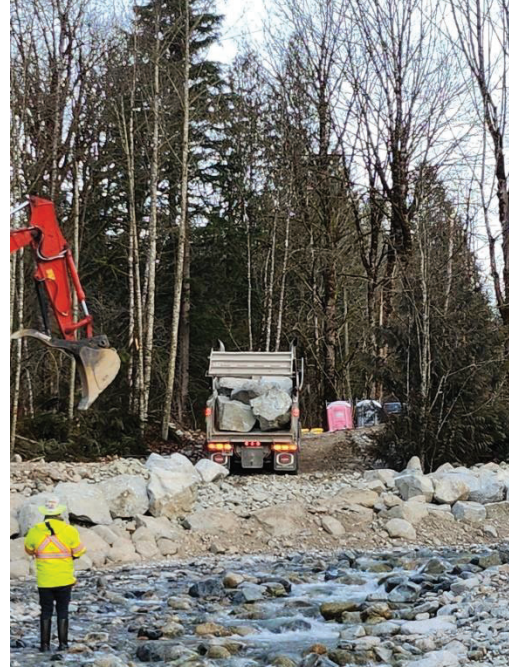
PHOTO #2 - Hi-Tech trucking delivering rip rap

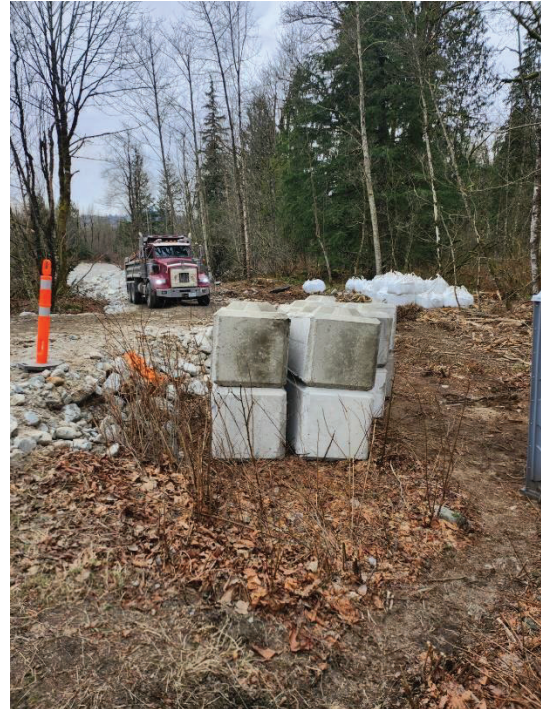
PHOTO #4 – Sang bags stockpiled for removal; lockblocks onsite ready for placement

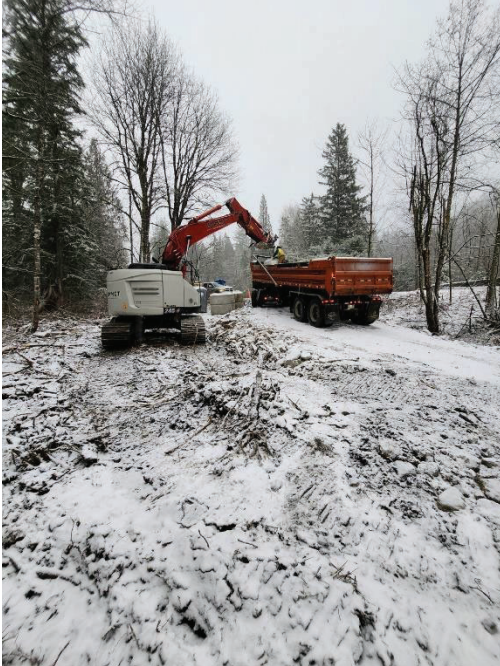
PHOTO #1 – 245 Excavator loading sandbags for removal

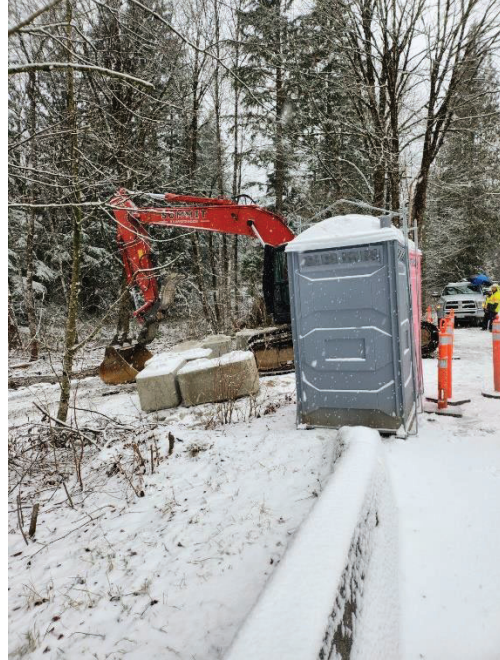
PHOTO #2 - Porto-potties placed at roadside for pickup

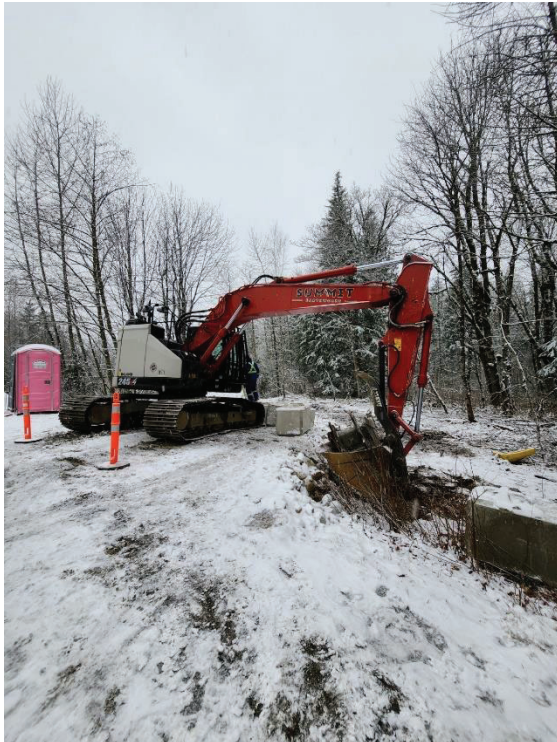
PHOTO #3 – Lockblocks placed on and adjacent to road access

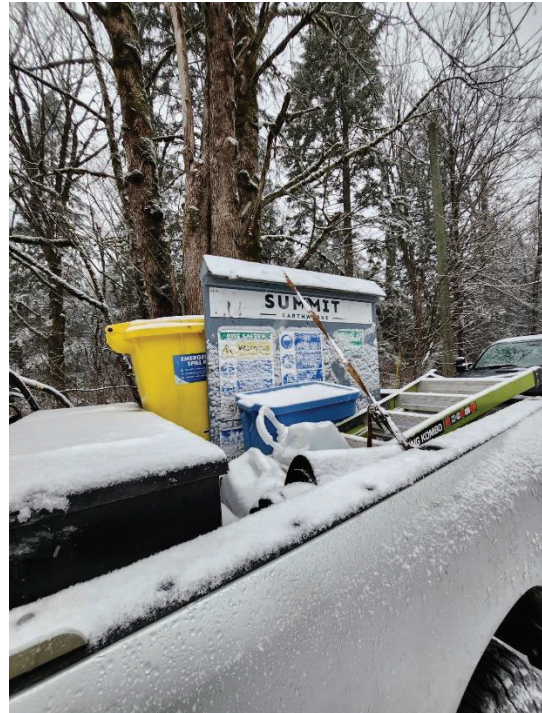
PHOTO #4 – Site equipment, spill kits, signage loaded for removal

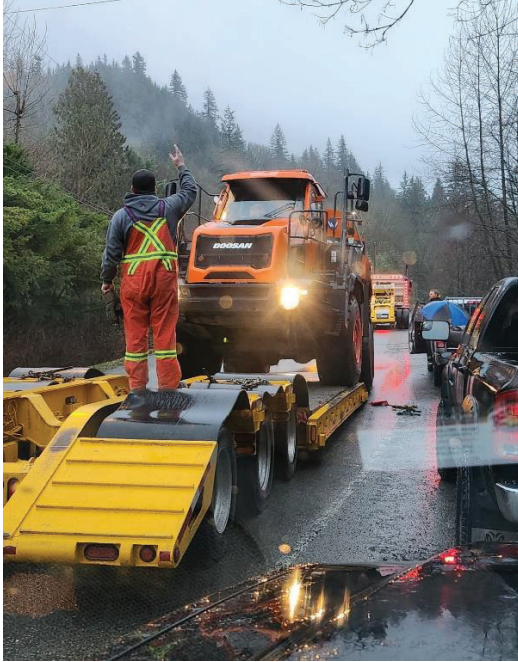
PHOTO #1 – Doosan Rock Truck loaded for removal from site

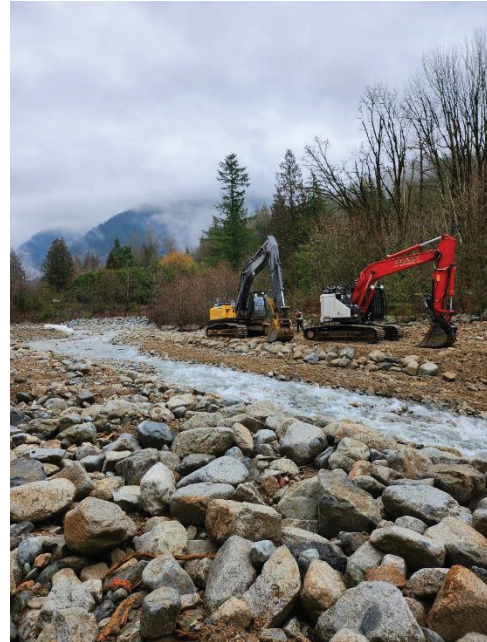
PHOTO #2 - Excavators armoring along diversion channel on east bank

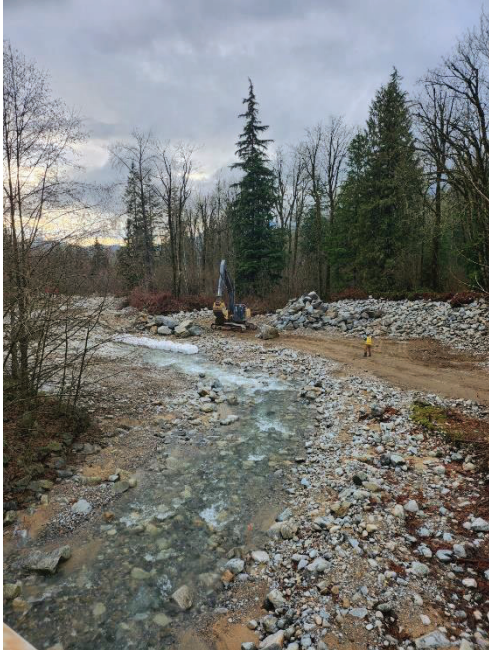
PHOTO #3 – Excavator sorting rip rap below bridge

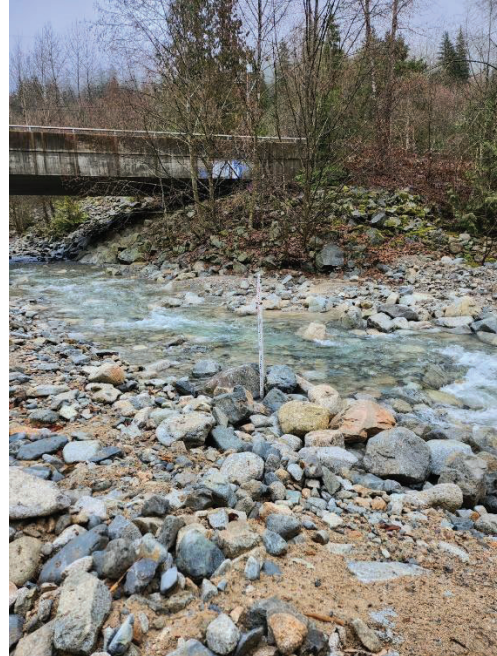
PHOTO #4 – Water meter placed below bridge to observe water level

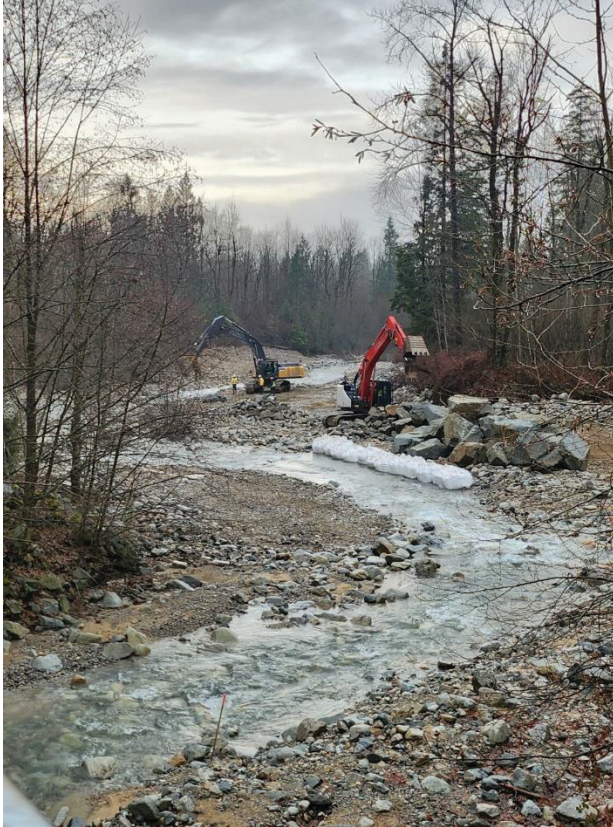
**PHOTO #1** – 350 beginning work at top of diversion channel;  
245 sorting rip rap

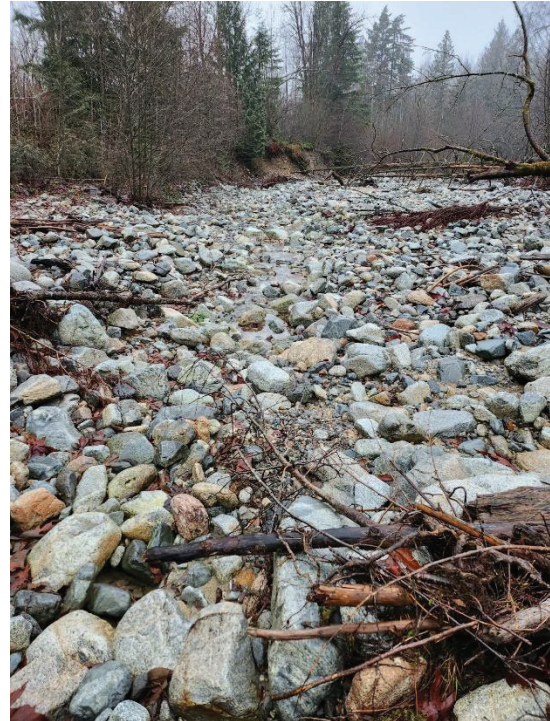
**PHOTO #4** –Small amount of flow still wetted after east  
bank infill (South facing, below bottom of diversion channel)

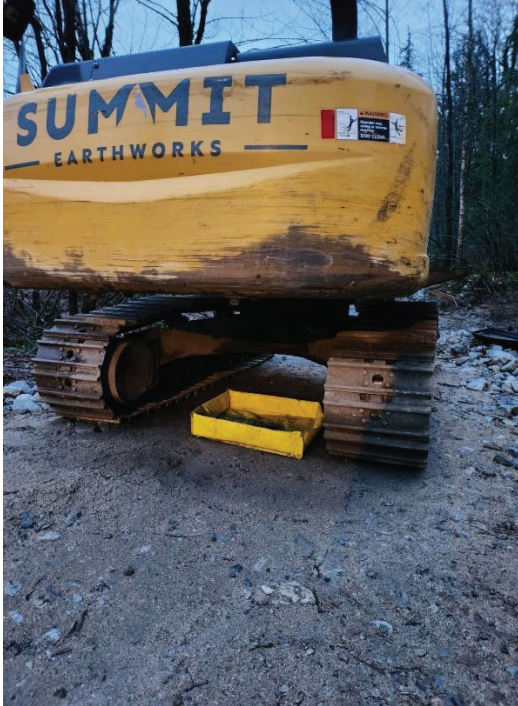
PHOTO #1 – Spill trays in use onsite

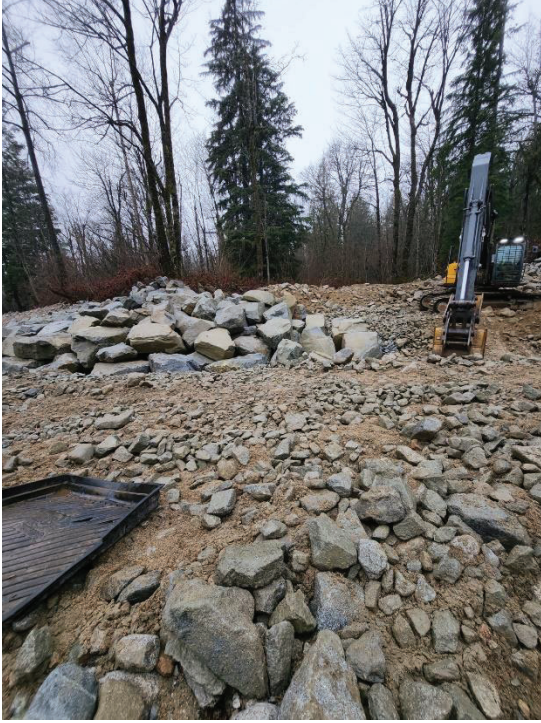
**PHOTO #1** – 350 Excavator armoring west bank and digging diversion channel, spill tray on hand

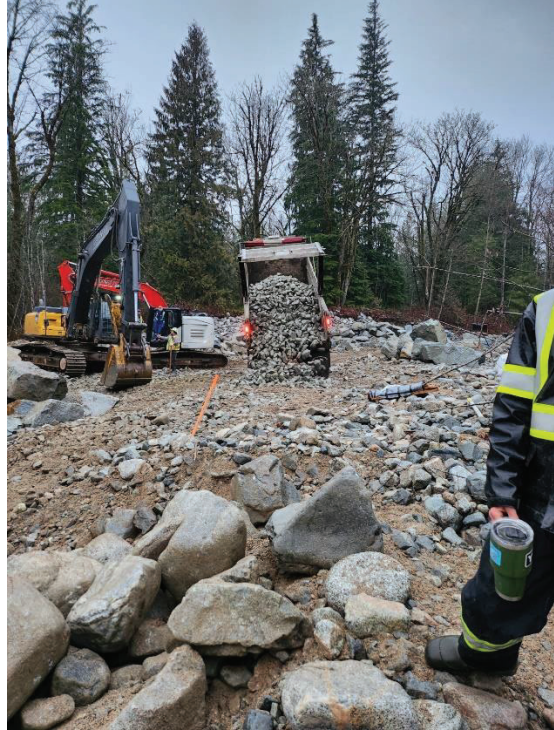
**PHOTO #2** - 350 & 245 Excavators placing/sorting rip rap and gravel deliveries

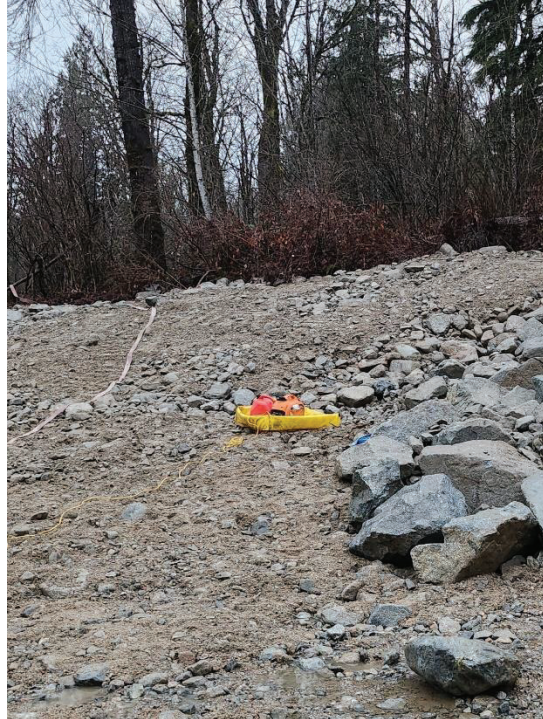
**PHOTO #4** – Fuel and generator sitting in spill tray adjacent to wetted diversion channel

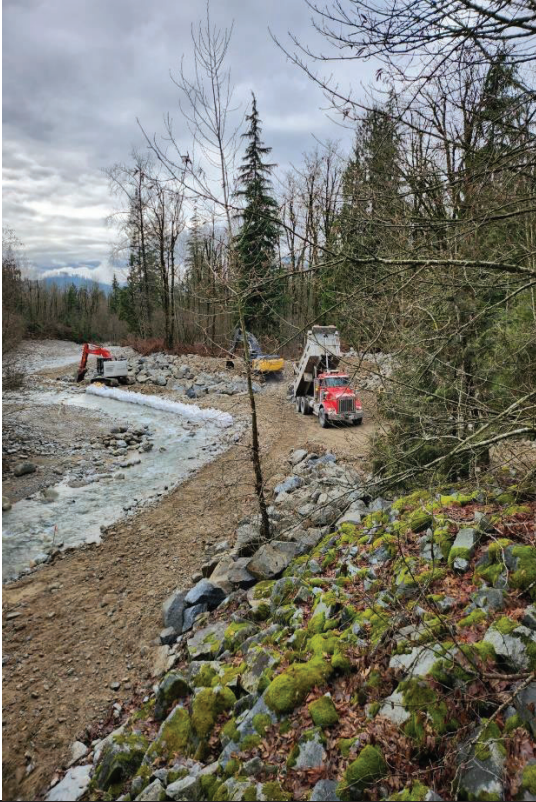
**PHOTO #1** – 350 Excavator placing rip rap; 245 Excavator working behind sand bags; gravel truck rip rap delivery

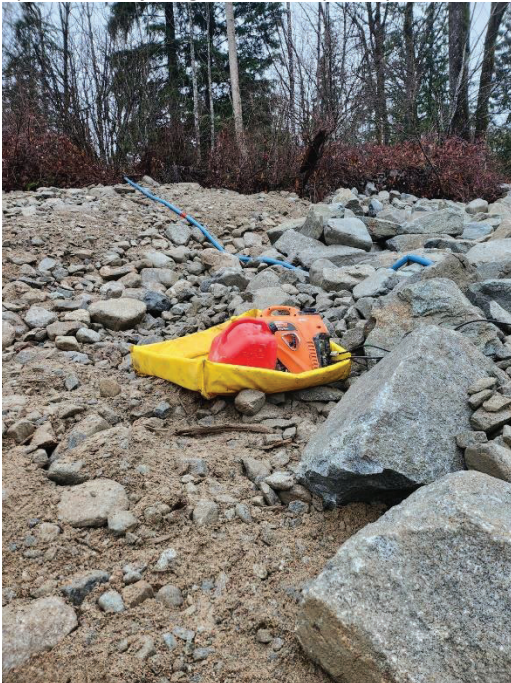
**PHOTO #3** – Water pump on hand to disburse turbid water into riparian area; fuel/generator in spill tray
