# Ministry Of Environment and Climate Change Strategy

## Hatzic Emergency Works Program Carratt Creek

FEBRUARY 2024

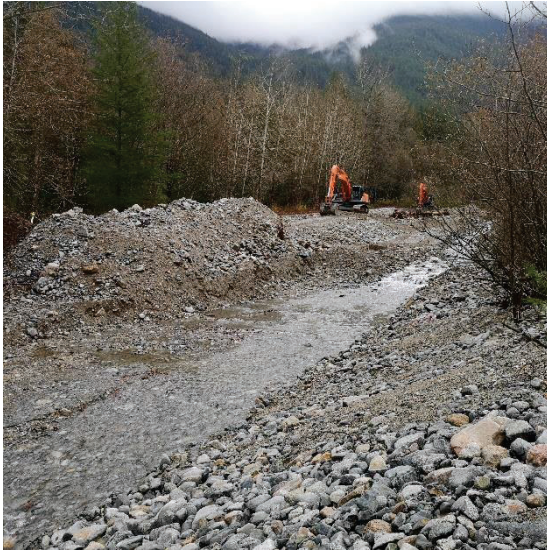
Figure 2-1  
Richco – Sediment Removal

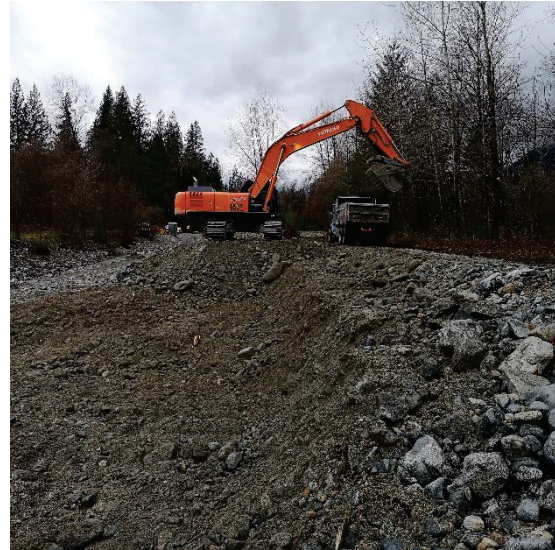
Figure 2-2  
Richco – Sediment Removal

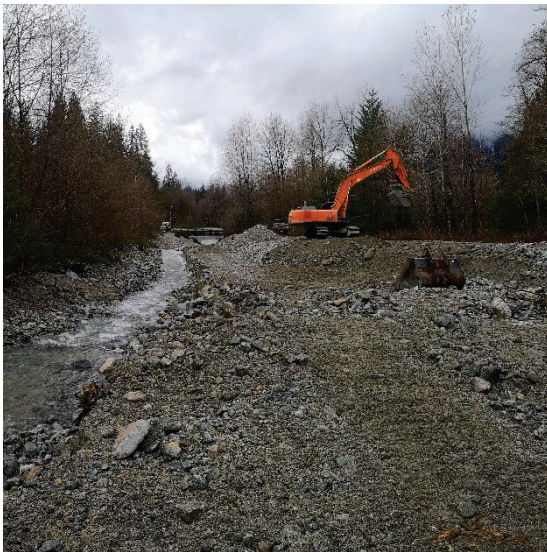
Figure 2-3  
Richco – Sediment Removal

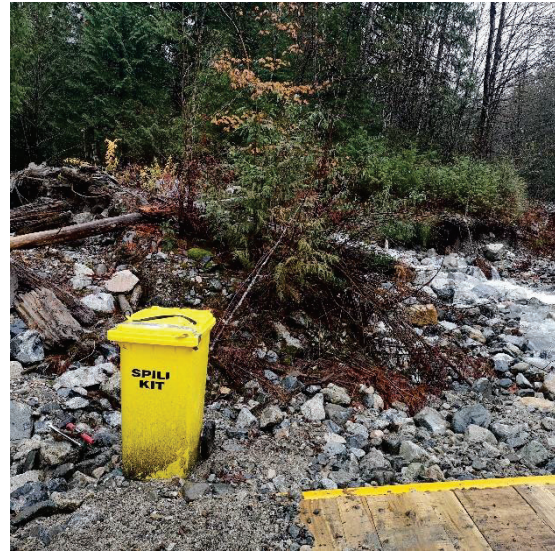
Figure 2-6  
Jakes - Spill Kit On-Site

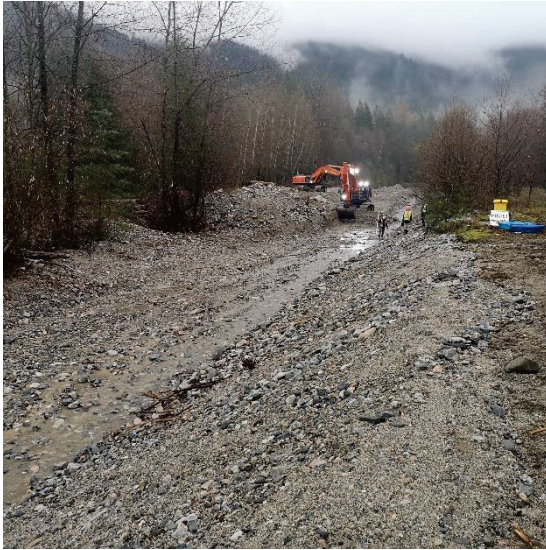
**Figure 2-1**  
**Richco – Sediment Removal**

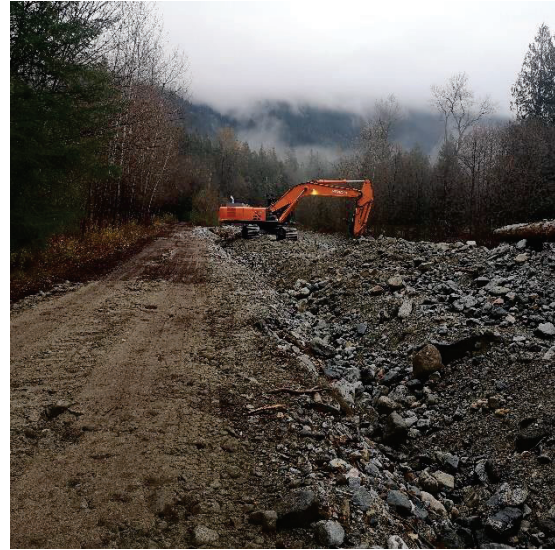
**Figure 2-2**  
**Richco – Sediment Removal**

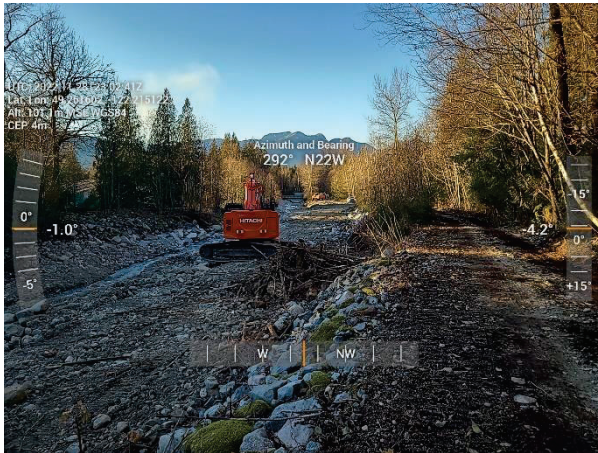
**Figure 2-1**  
Richco – Sediment Removal

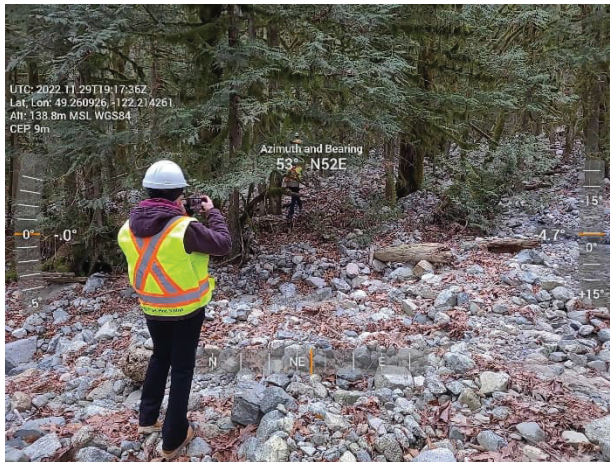
**Figure 2-1**  
Richco - HESCO Alignment Layout

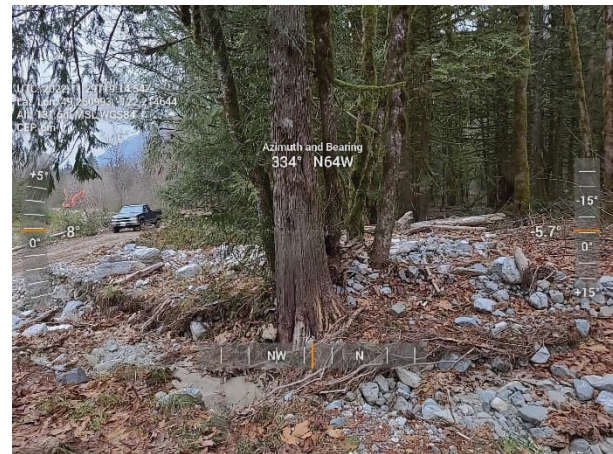
**Figure 2-2**  
Richco - Potential Tree Removal (HESCO baskets)

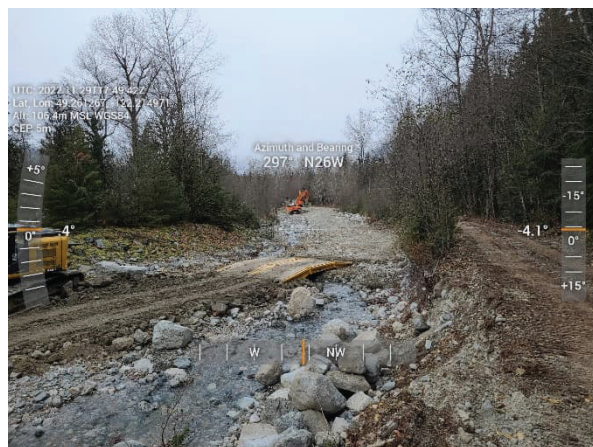
**Figure 2-5**

Jakes - New Location of Temporary Bridge

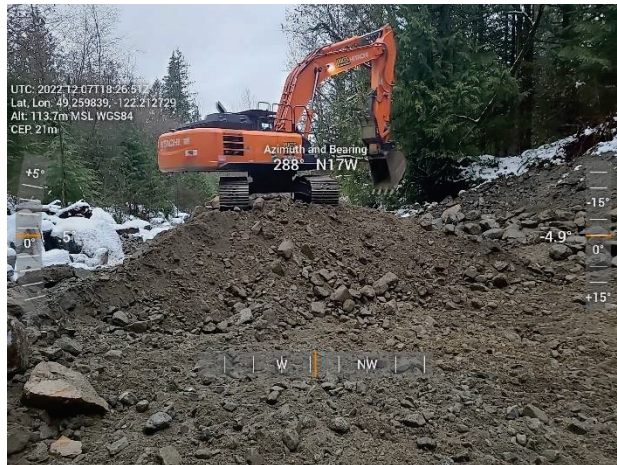
Figure 2-5

Jakes - New Location of Temporary Bridge

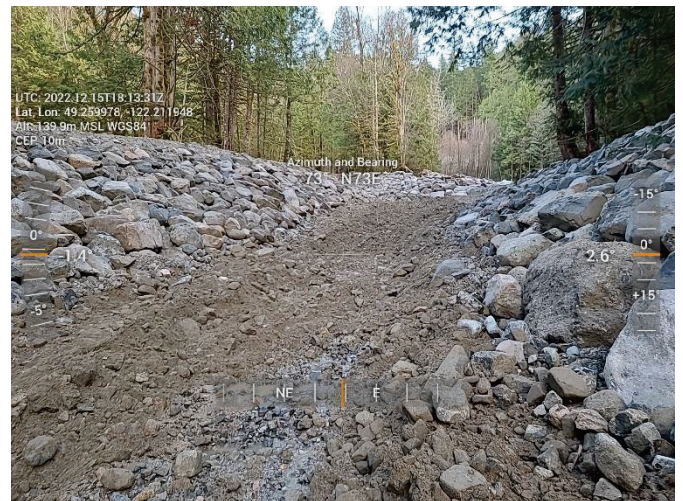
- Contractor found excavating a trough through new channel (See photos below):
  - Trough did not follow design drawings (which calls for a flat channel bed)

Figure 2-7  
Jakes – Trough Creation

Figure 2-8  
Jakes – Trough Creation

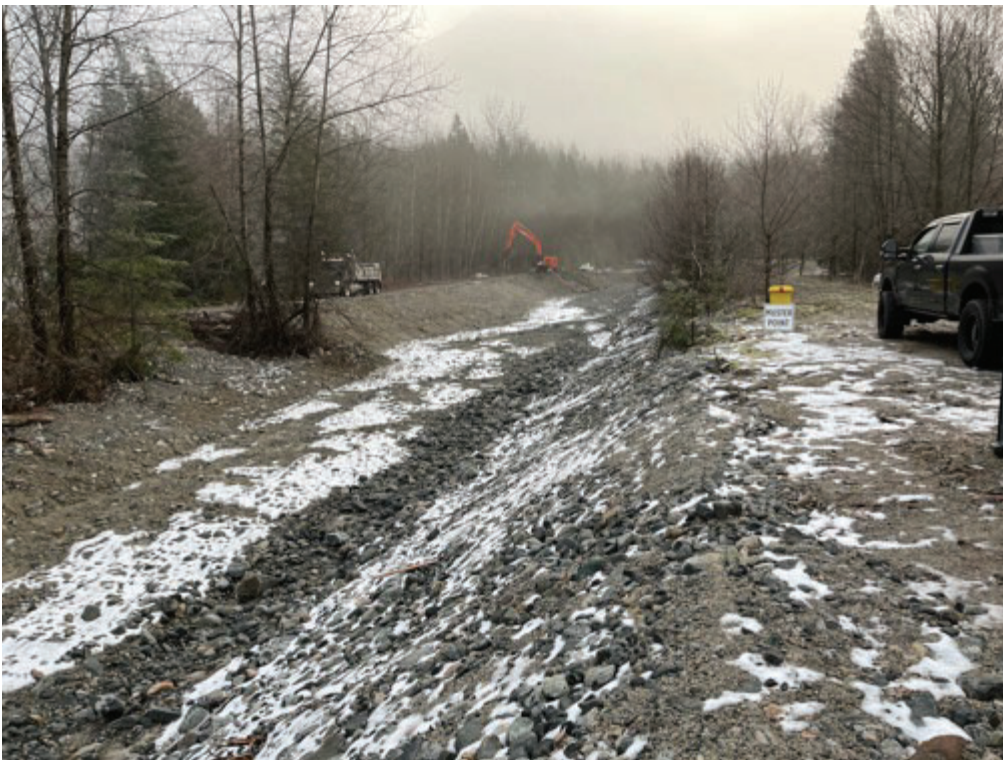
Photo 1. Upstream view; dry channel.

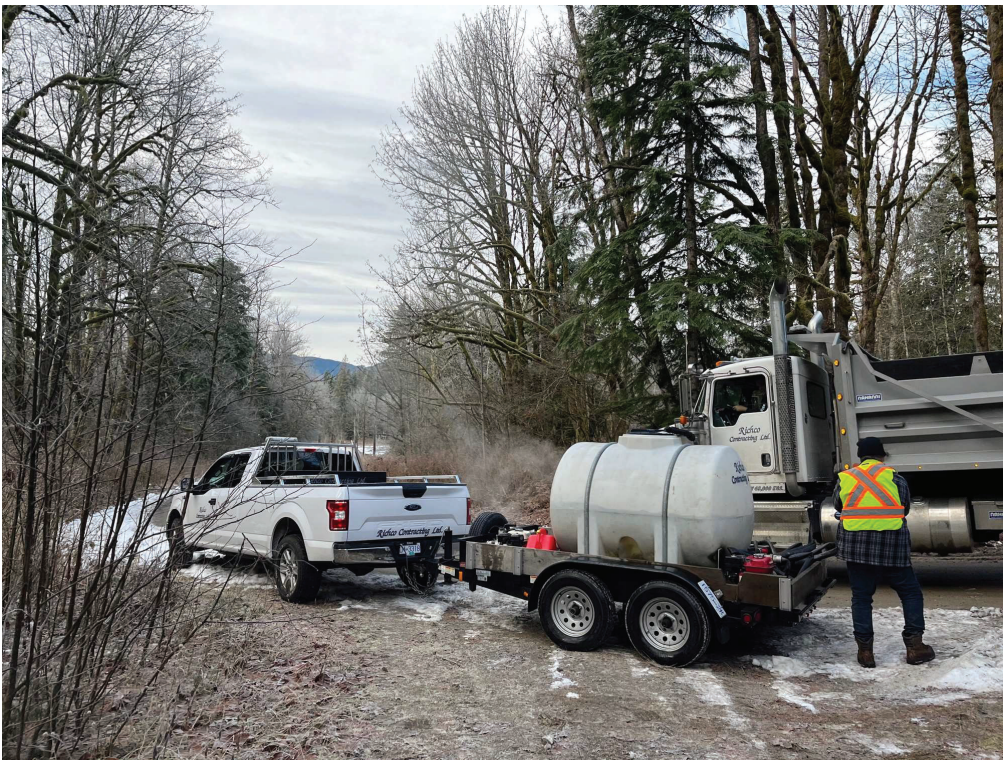
Photo 3. Wash station on Eng Road to clean off haul trucks when exiting Eng Pit.

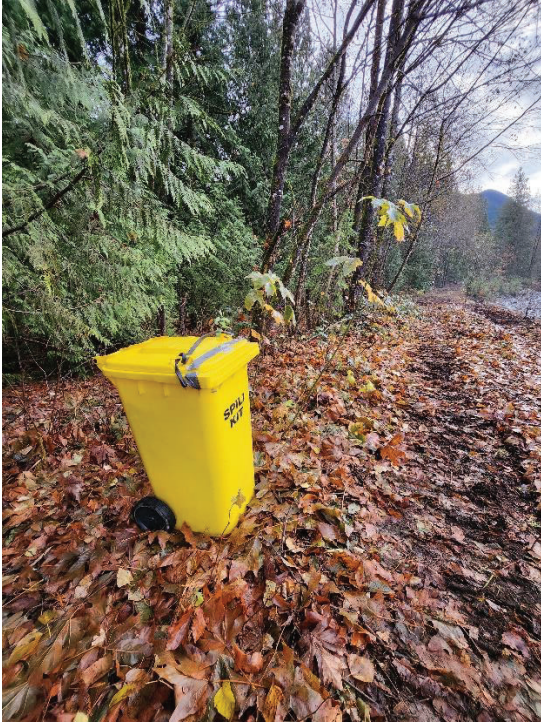
PHOTO #1 – Spill Response kits located onsite

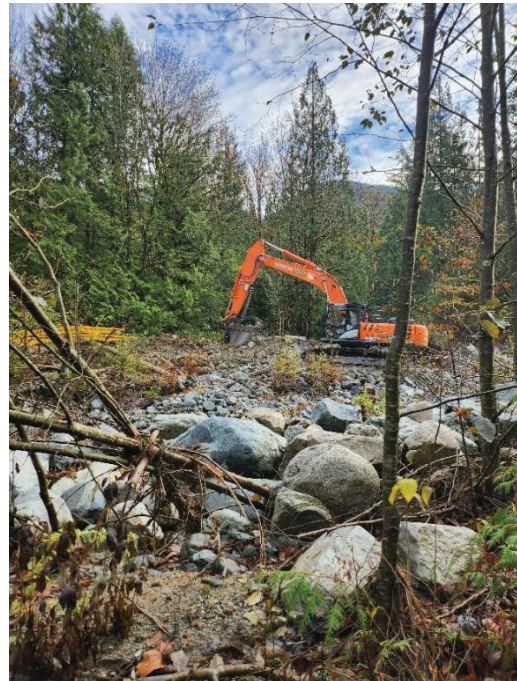
PHOTO #4 – Richco's excavator prepping access for temporary crossings to upper reach

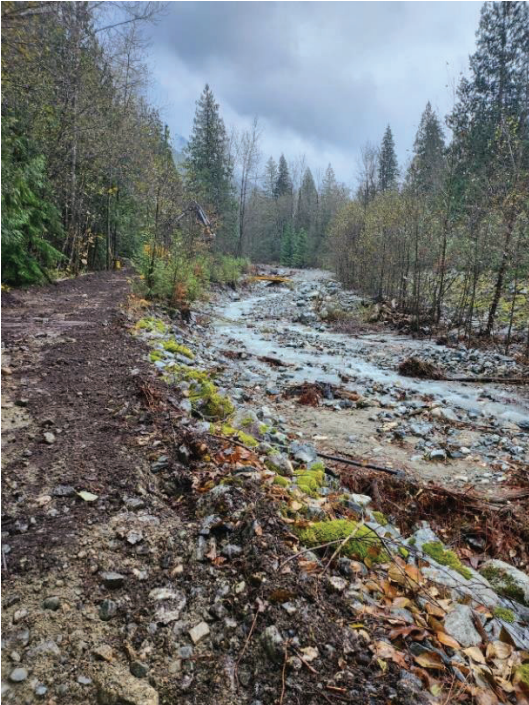
**PHOTO #1** – Richco working on temporary crossing into upper reach

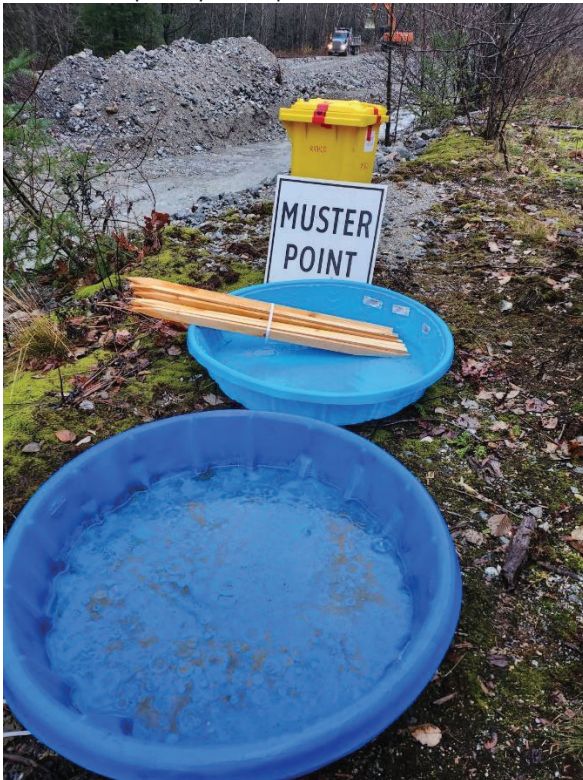
**PHOTO #3** – Spill trays and Spill kit onsite

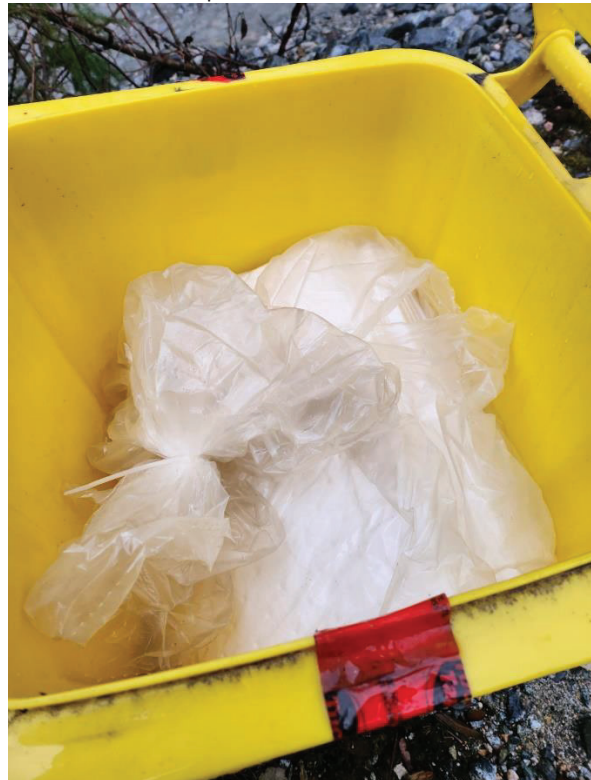
**PHOTO #4** – Inside spill kit

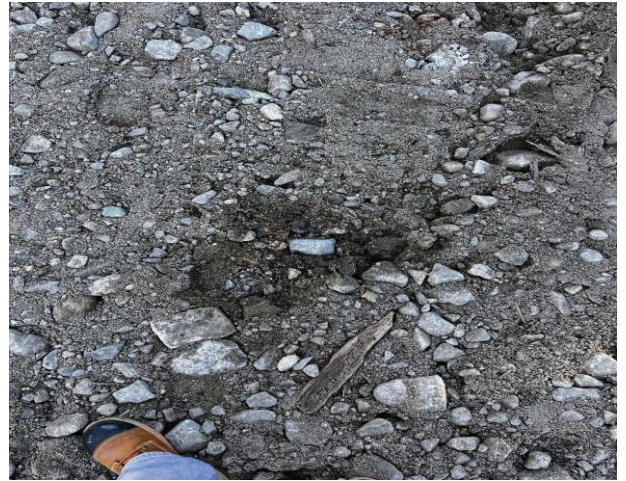
Photo #4

| Condition (leaks, etc.) | | NC | | Leak/spill spotted in upper reach (JAKES machines area). Operator & Hoyan (A&E) notified. | #4 |

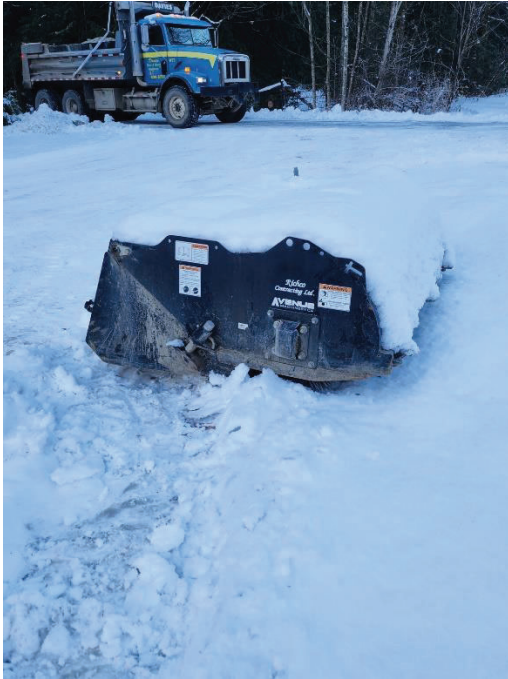
PHOTO #1 – Street sweeper for Skid Steer

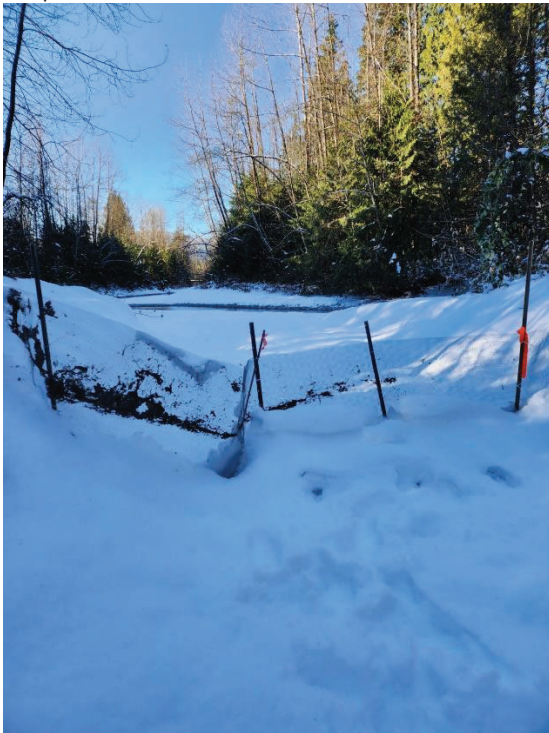
PHOTO #3 – Fish fence at bottom of Carratt Creek, approx.. 20m upstream of main channel

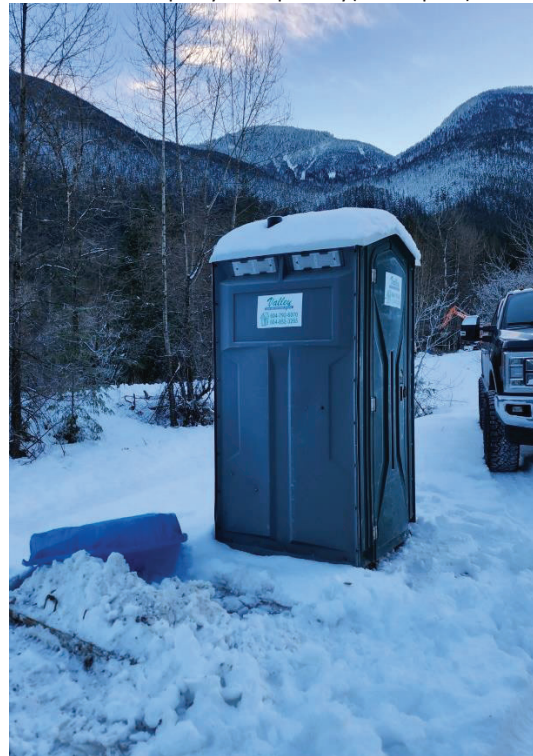
PHOTO #4 – Porto-potty and spill tray(kiddie pool)

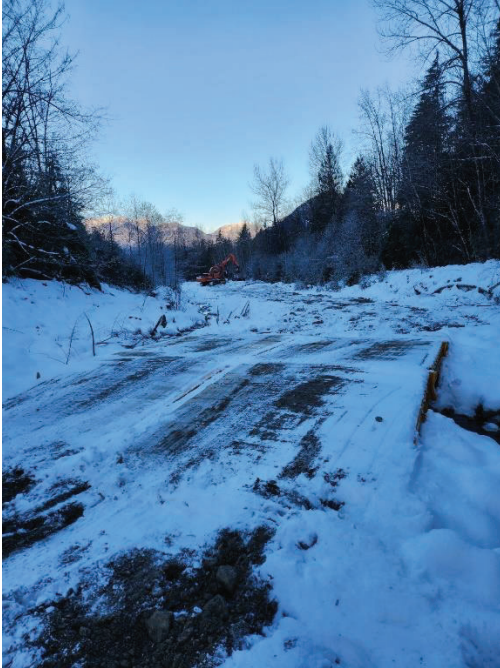
**PHOTO #5 – Temporary crossing to access upper reach**

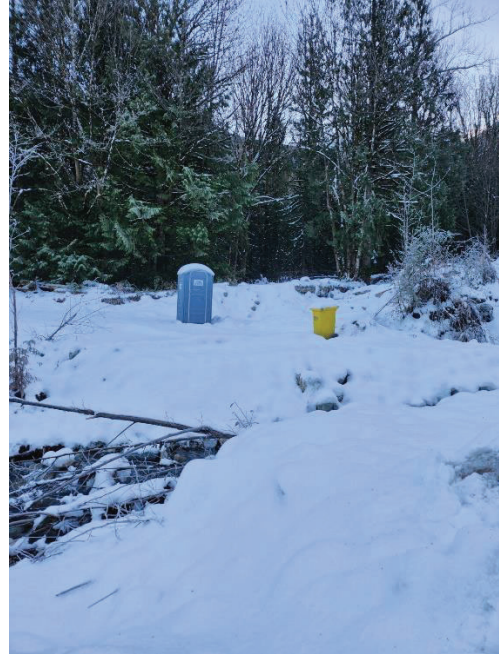
**PHOTO #6 - Porto-potty and spill kit located in upper reach, adjacent to temporary crossing**

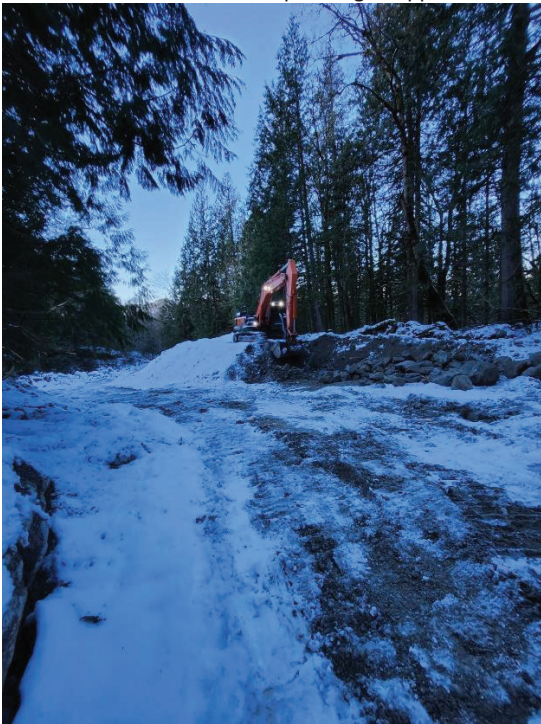
**PHOTO #7 – 1 of 2 excavators operating in upper reach**

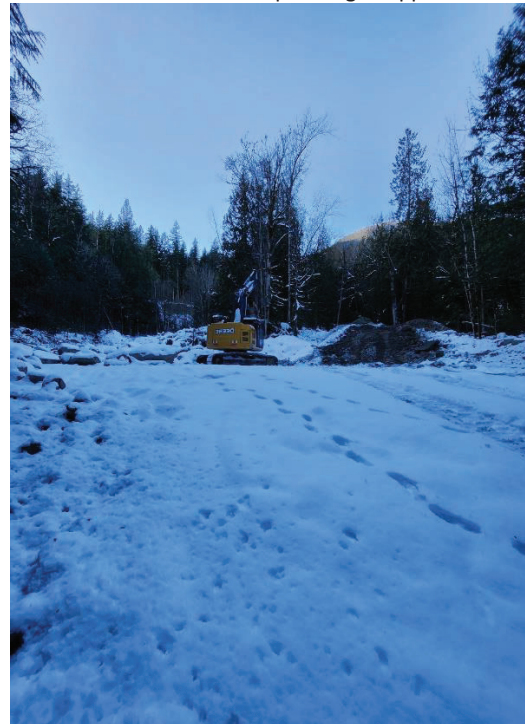
**PHOTO #8 – 2 of 2 excavator operating in upper reach**

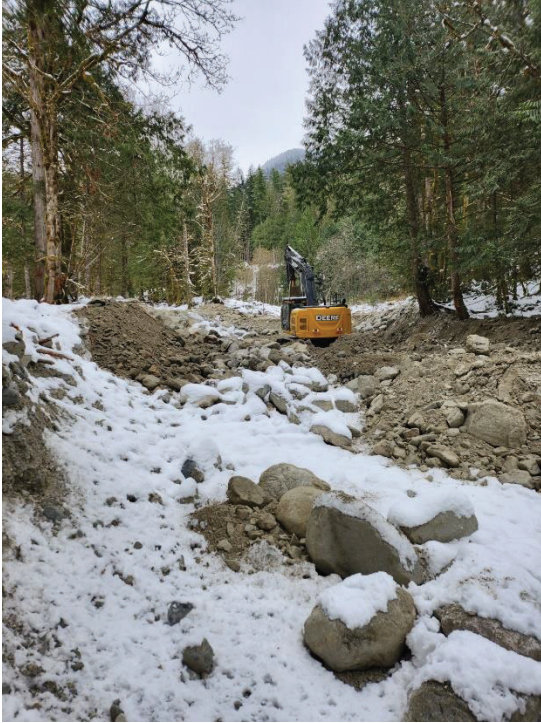
**PHOTO #1** – Boulder placement for berm at top of upper reach

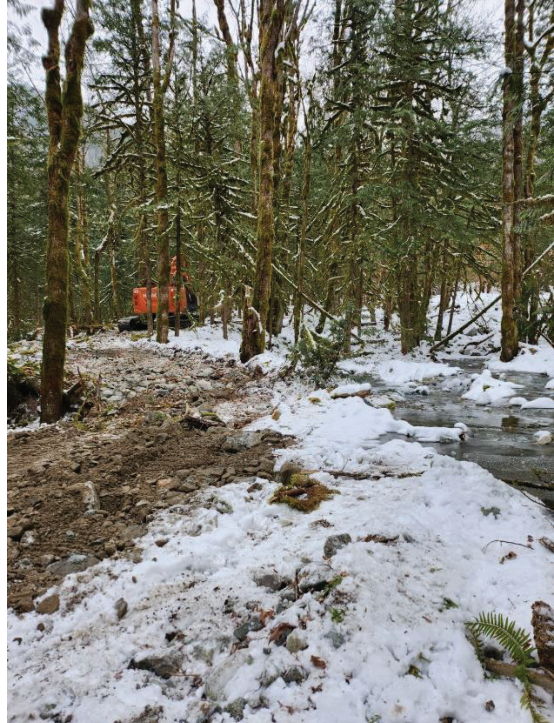
**PHOTO #2** - Tree and access road clearing in lower reach in preparation for Hesco Baskets

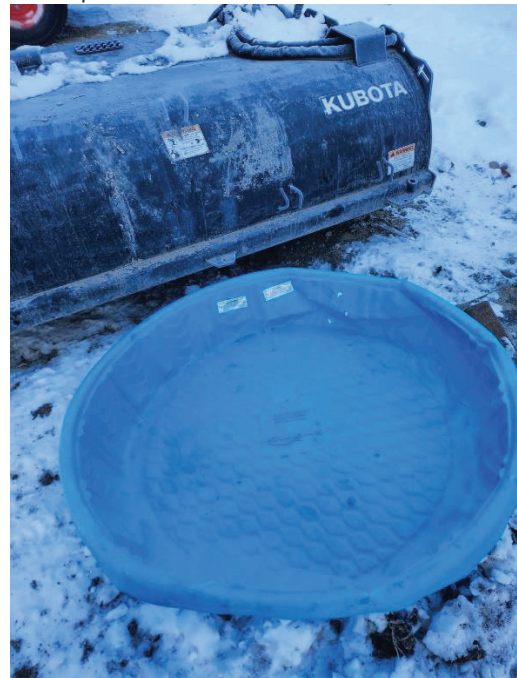
**PHOTO #4** – Spill tray at beginning of worksite, adjacent to street sweeper

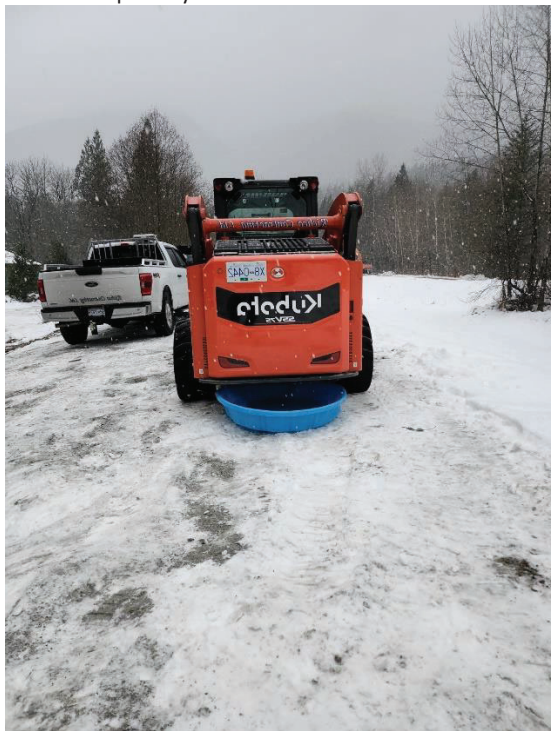
**PHOTO #3** – Spill-tray under skid steer

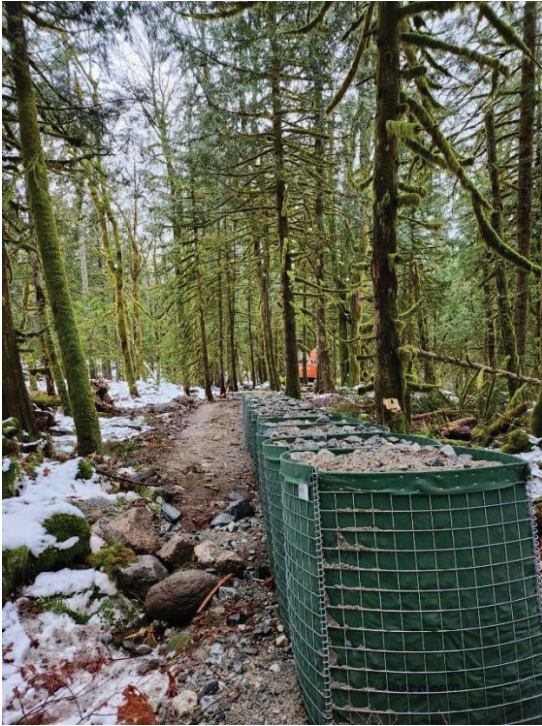
**PHOTO #3 –** Hesco Baskets assembled, filled, placed along wetted area in lower reach

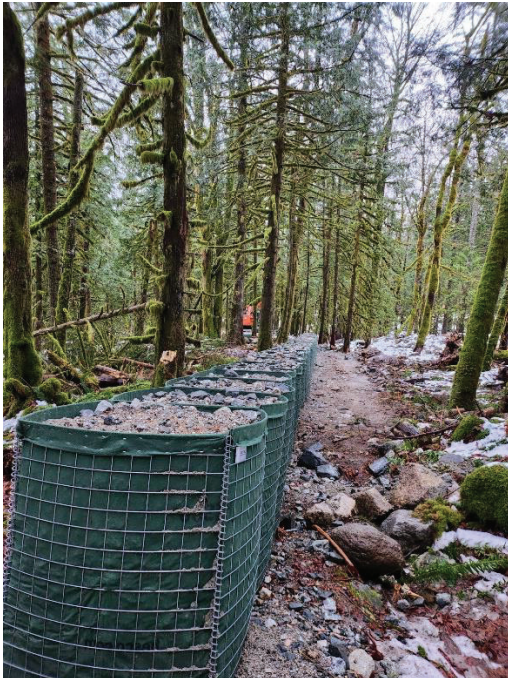
PHOTO #3 – Hesco Baskets assembled, filled, placed along wetted area in lower reach

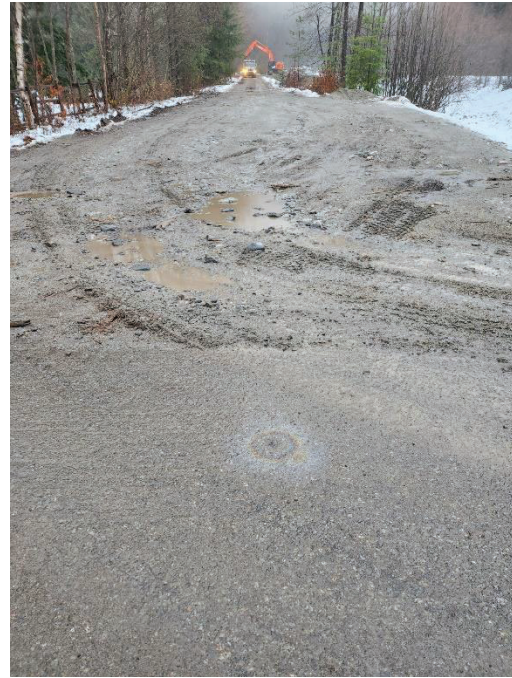
PHOTO #4 – Fuel sheen visible on Carratt Rd & dyke access road

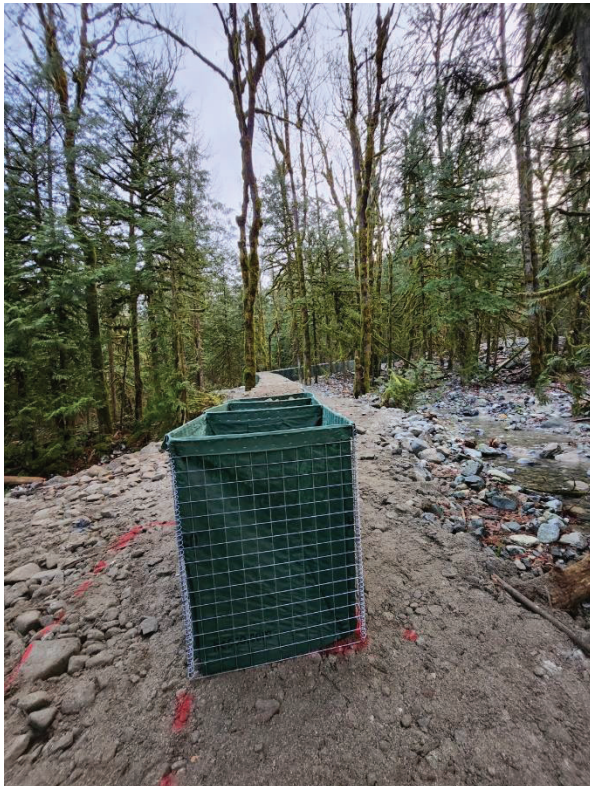
PHOTO #3 – Hesco Baskets assembled, filled, placed along wetted area in lower reach

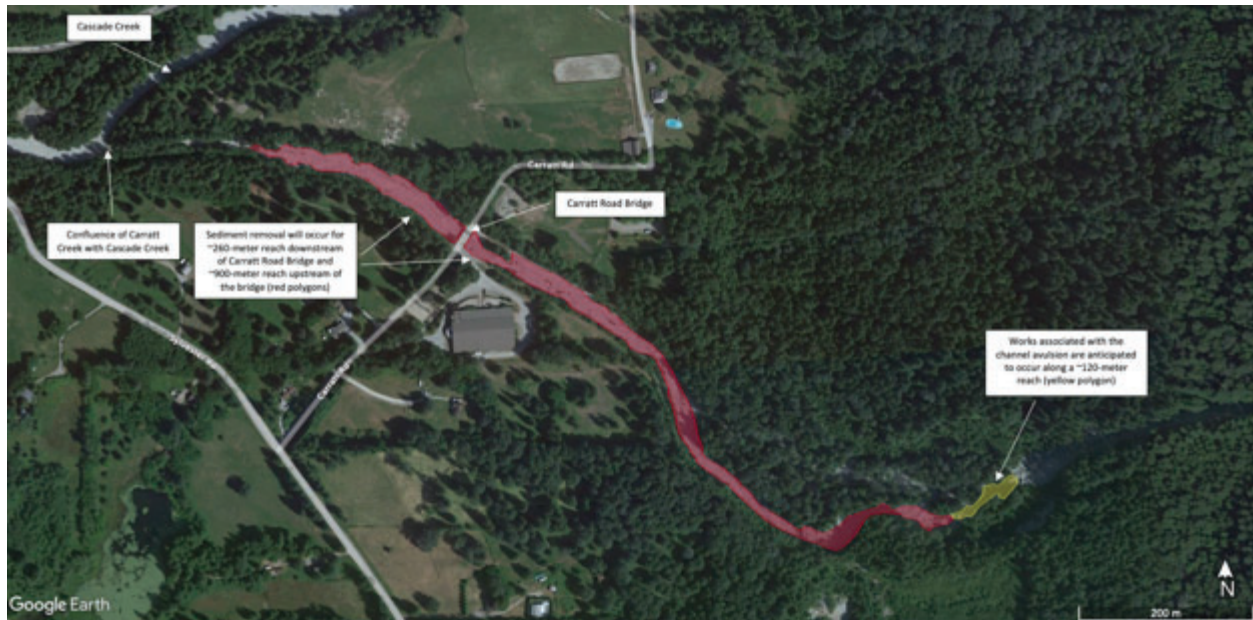
Works will be completed along 1.2km of Carratt Creek from the channel avulsion to ~260m downstream of Carratt Road Bridge. See Figure 2.

**Figure 2. Site location. Annotated Google Earth Image, 2022.**
