Associated  
Engineering

# Ministry of Environment and Climate Change Strategy Completion Report for Davies Creek

FEBRUARY 2024

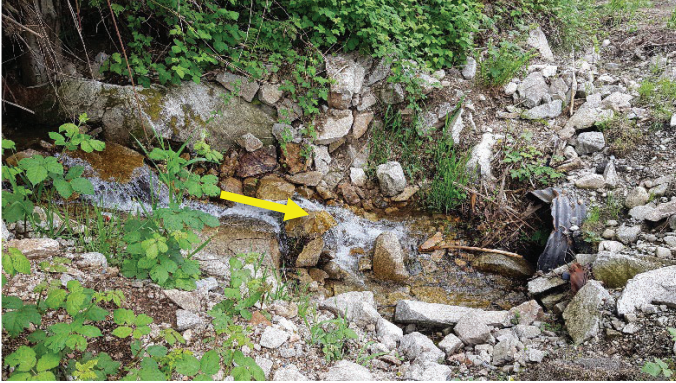
Davies Creek upstream of Sylvester Road

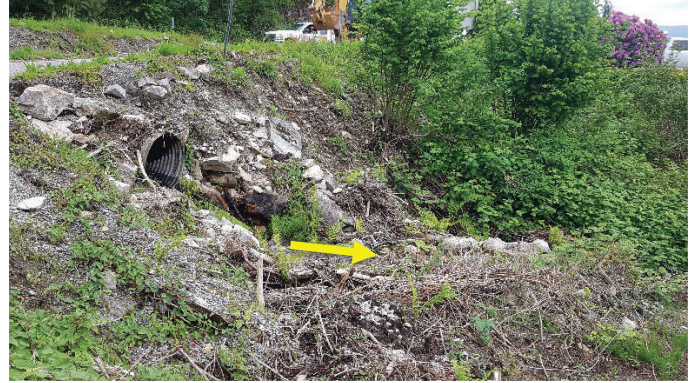
Davies Creek downstream of Sylvester Road

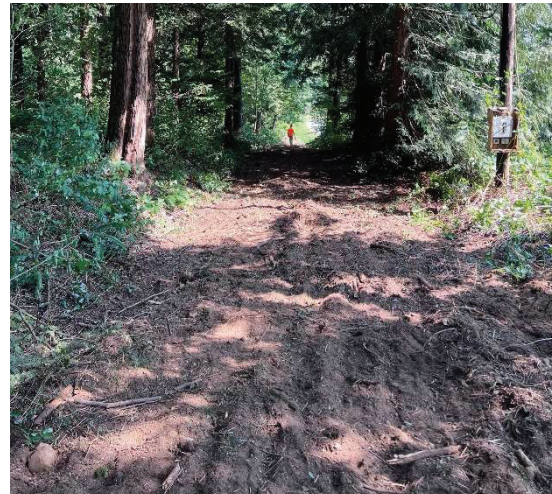
Figure -4  
Looking Down the Entrance of Access Road

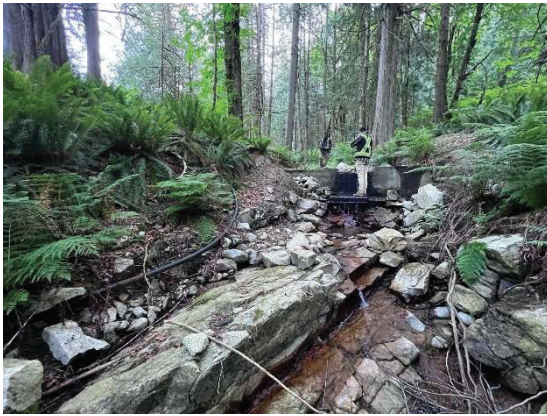
Figure 1  
Davies Creek

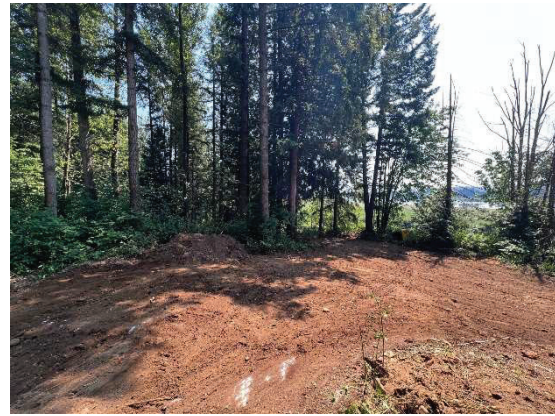
Figure 2  
Open Area Looking Towards Access Road

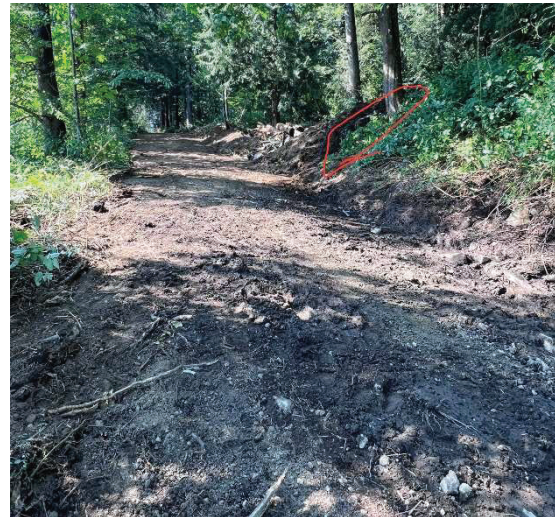
Figure 4  
Looking Up from the Entrance of Access Road

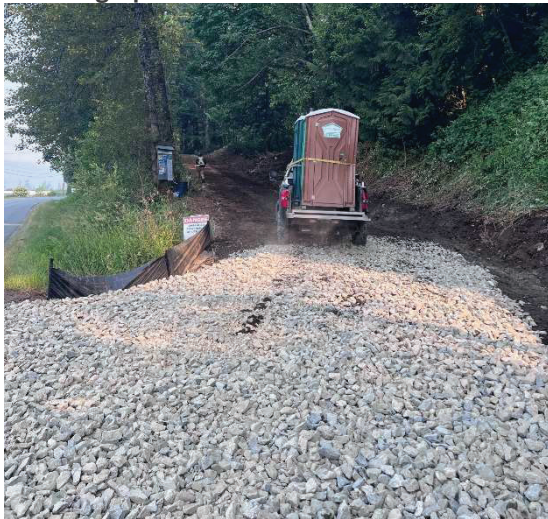
Figure 1

Gravel Partially Spread on Road and Portable Toilet Delivery

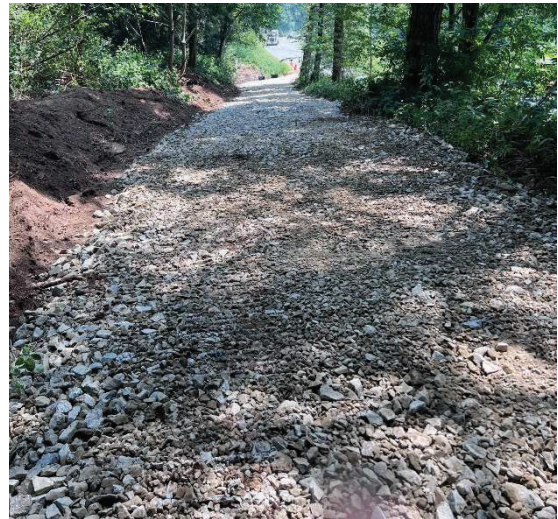
Figure 2

Looking Down to the Access Road with Gravel Base

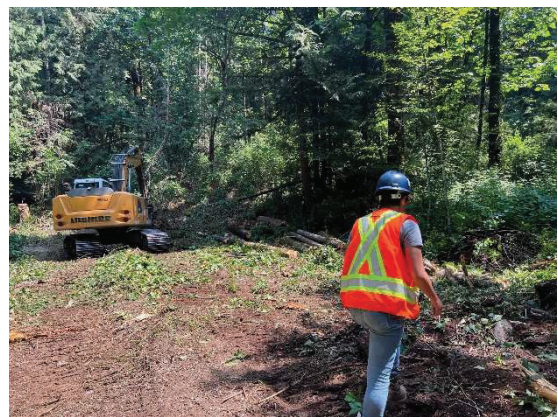
Figure 4

Clearing Up after Tree Removal

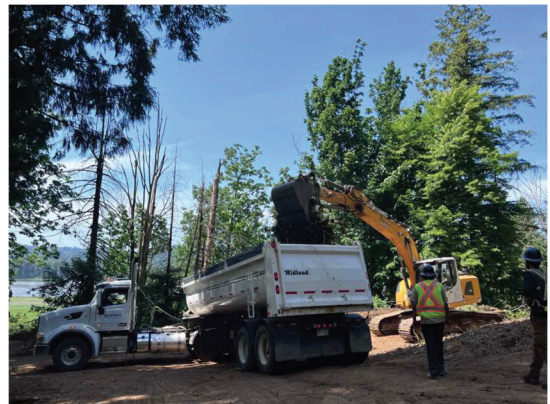
Figure 4  
Loading Organic Materials to Dump Truck

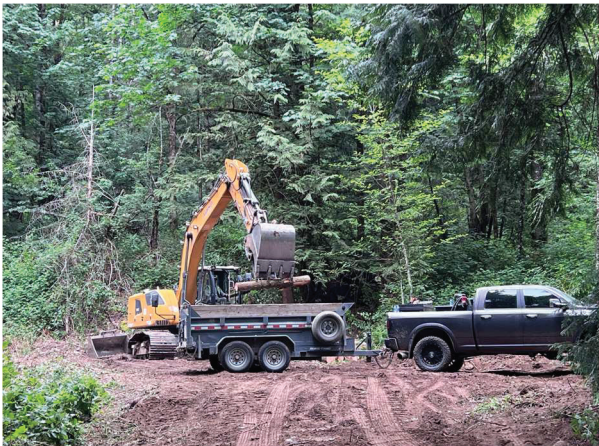
Figure 1  
Loading Logs into the Dump Trailer

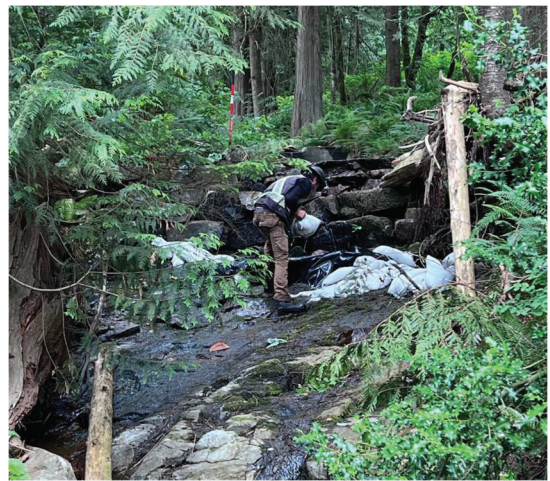
Figure 2  
Sandbags Placed on Creek

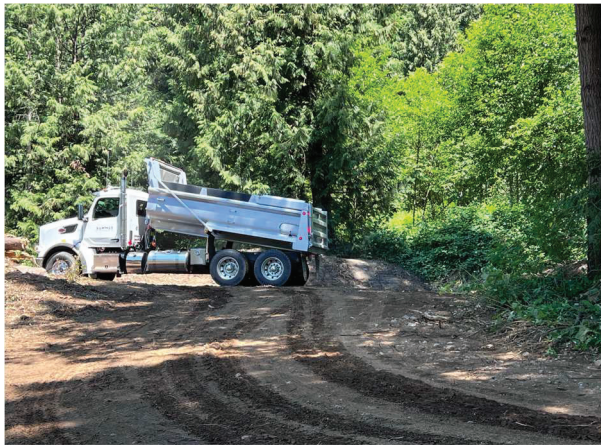
Figure 3  
Tandem Truck Unloading Gravels

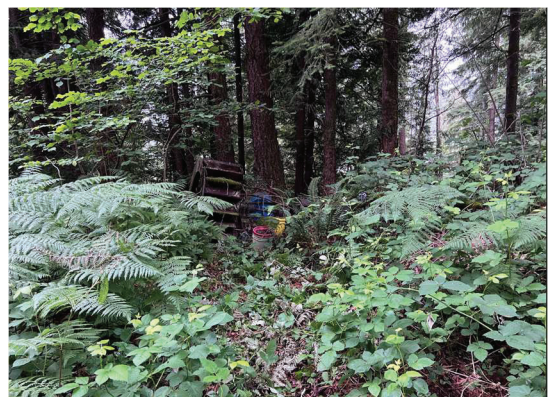
Figure 4

- Jeffrey performed environmental assessment (bird surveying, etc).
- Pegasus Tree Service performed tree felling to allow access to lower portion of the creek.
- Abandoned materials, such as metal waterwheel and containers filled with fossil fuels, were found near the project site. Jeffrey mentioned that it is up to the contractor to decide whether to remove them.

Metal Waterwheel and Containers with Fuels

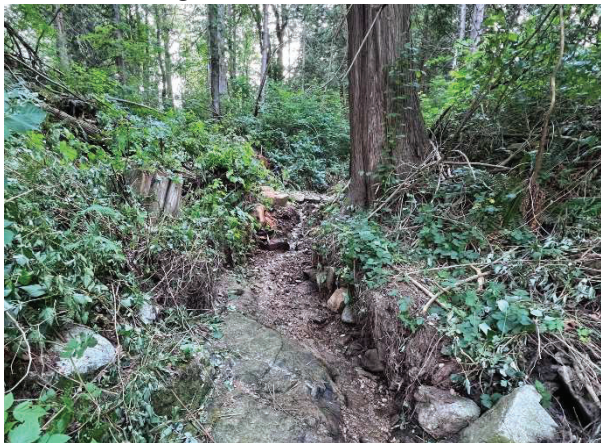
**Figure 3**  
**Lower Debris Jam Looking Upstream**

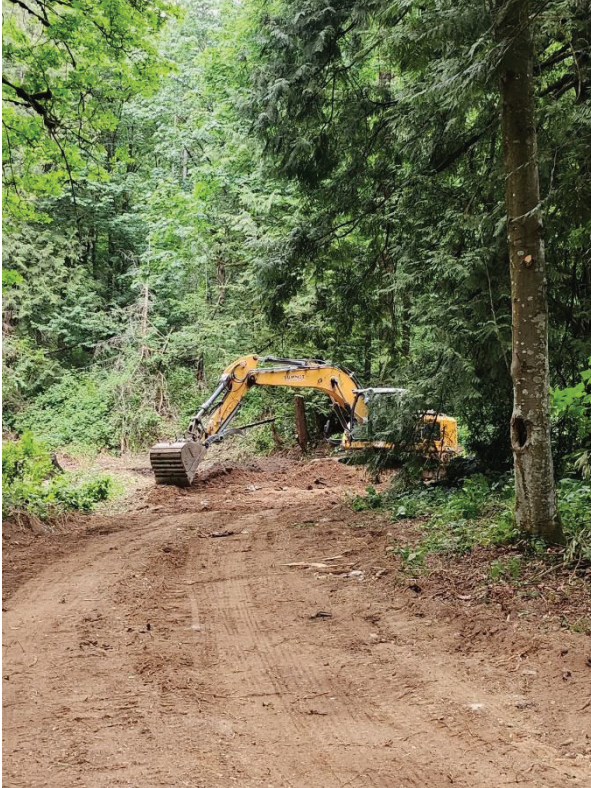
Cont'd stripping of top soil upper access road

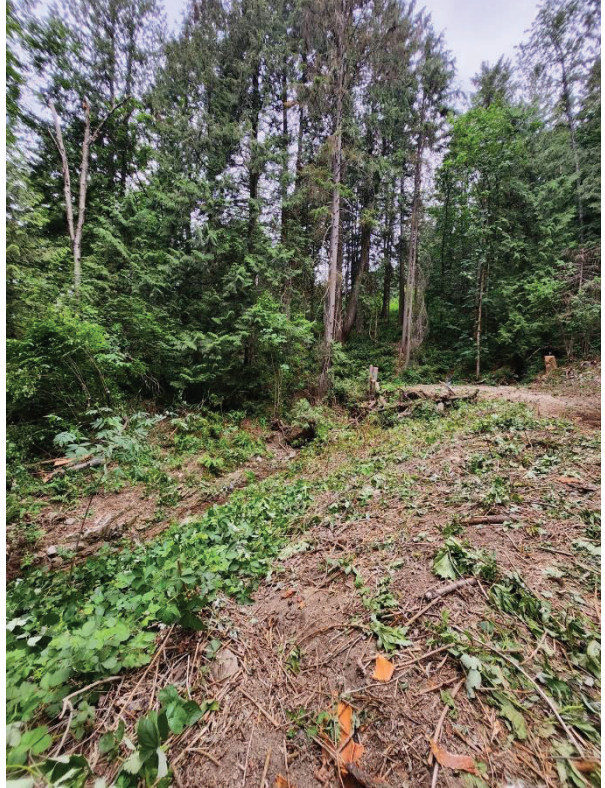
Over-hanging brush removed

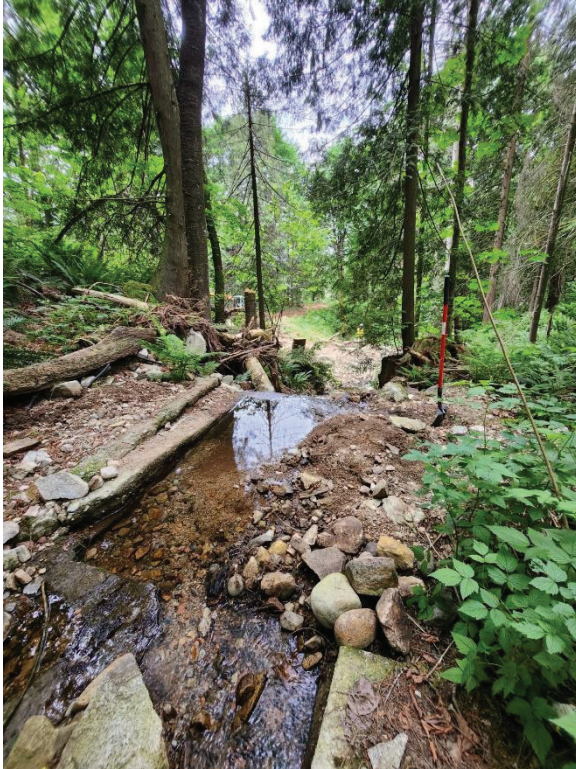
Pool dug for sump-pump preparation

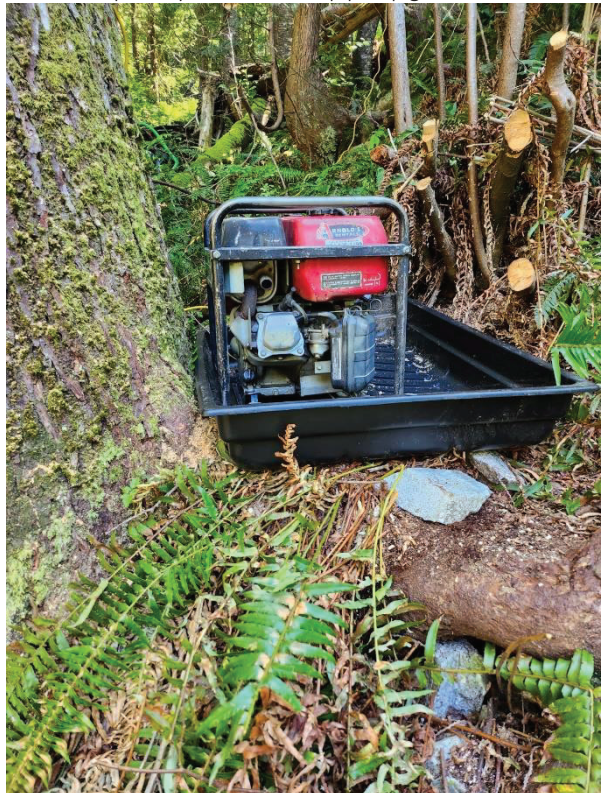
Spill-tray in use for sump pump generator

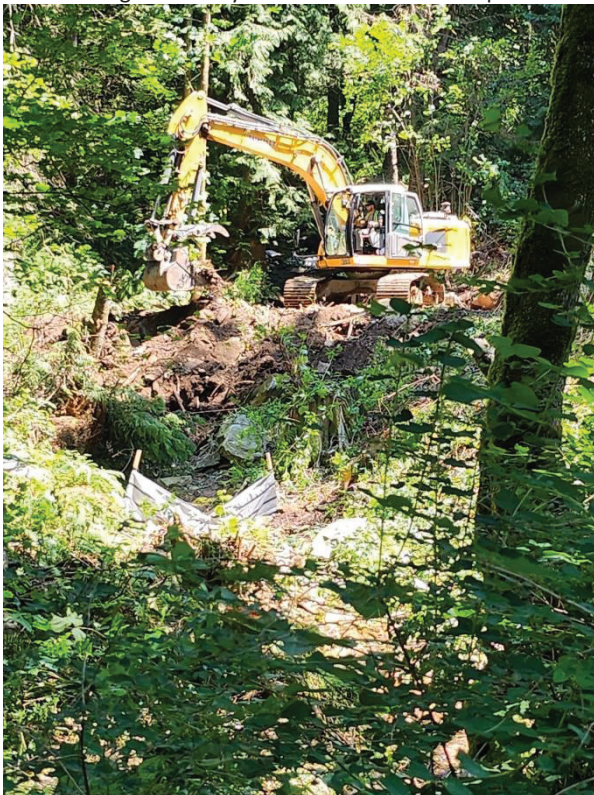
Pulling out woody debris from sediment deposit

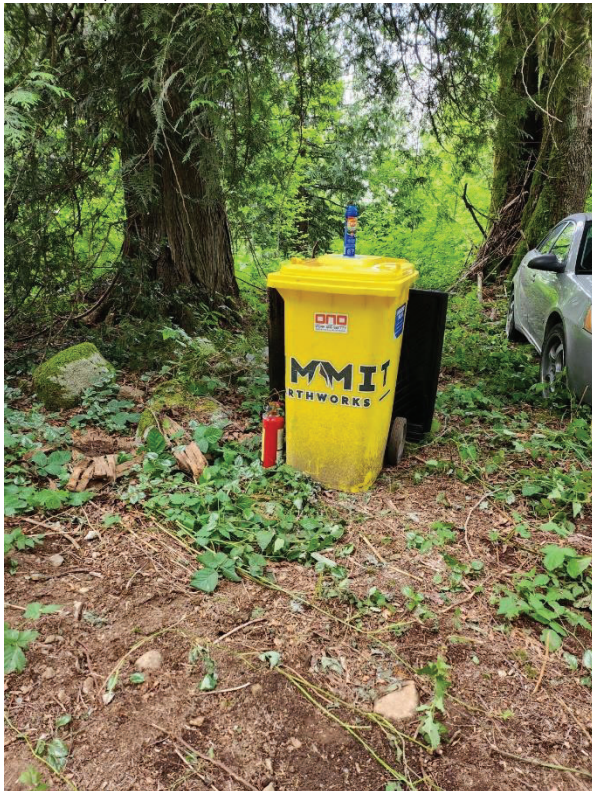
Spill kit relocated closer to excavation work

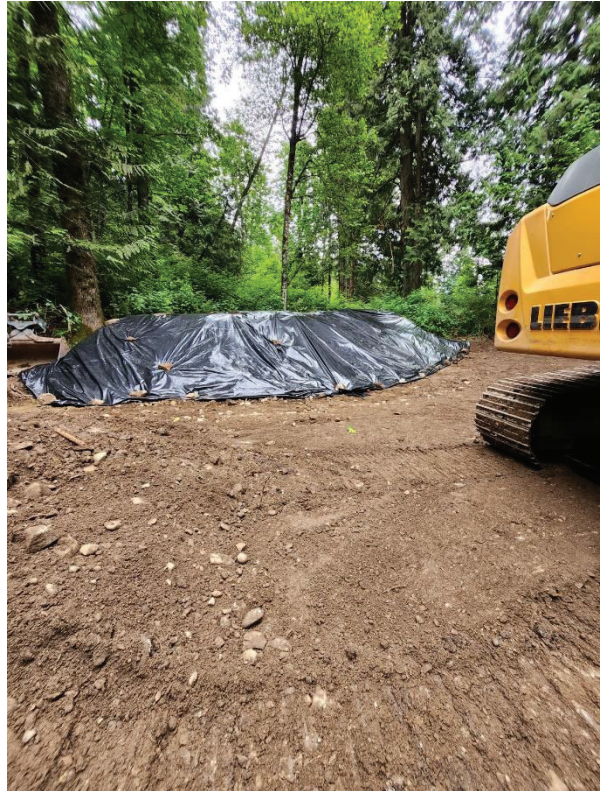
Stockpile covered with poly-sheeting

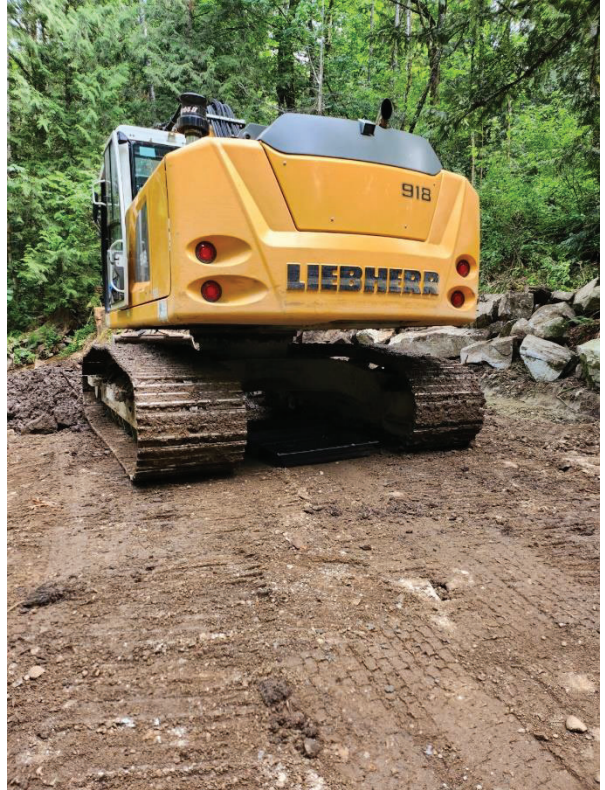
Spill trays in-use as intended

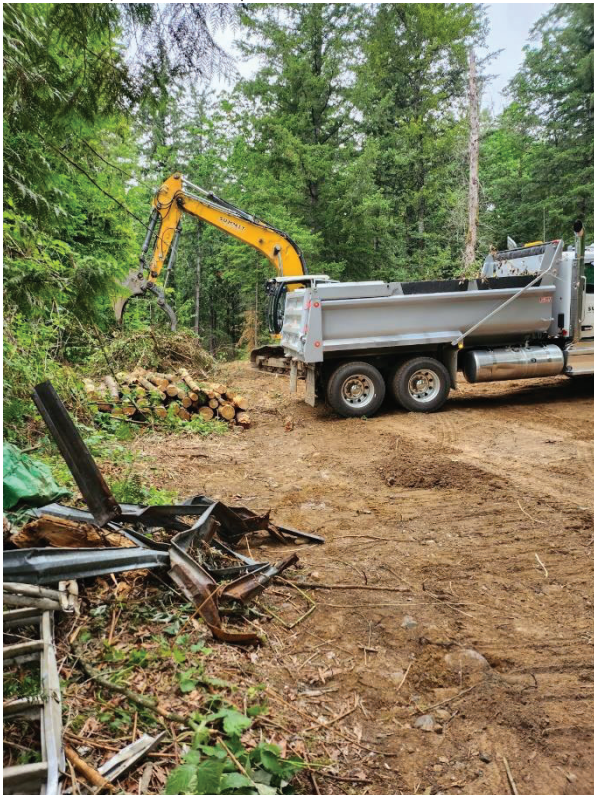
Woody debris stockpiles loaded out in Summit truck

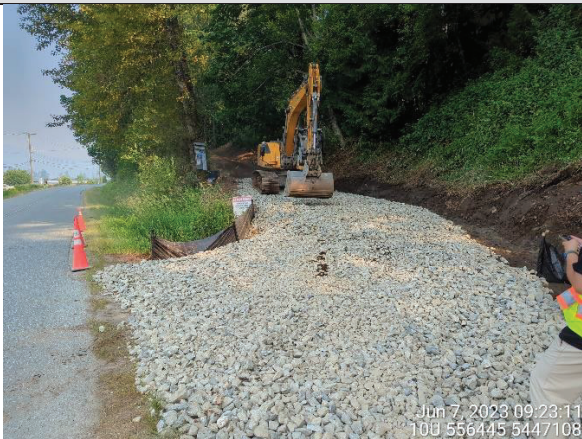
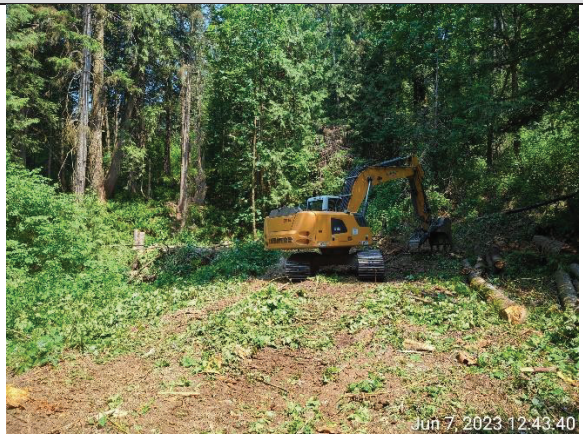
| Contaminated Soils Management | | |
|---|---|---|
| <p style="font-size: small; text-align: right; margin-top: 5px;">Jun 7, 2023 09:23:11<br/>100 556445 5447108</p> <p>Photo 1. North-facing view of clear crush gravel being placed on cleared access road. (Jun. 07, 2023).</p> | <p style="font-size: small; text-align: right; margin-top: 5px;">Jun 7, 2023 12:43:40</p> <p>Photo 2. View of Davies Creek after tree falling. Excavator removing fallen logs and vegetation. (Jun. 07, 2023).</p> | |

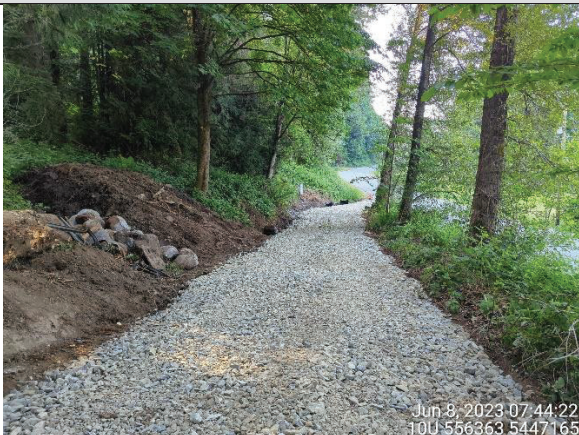
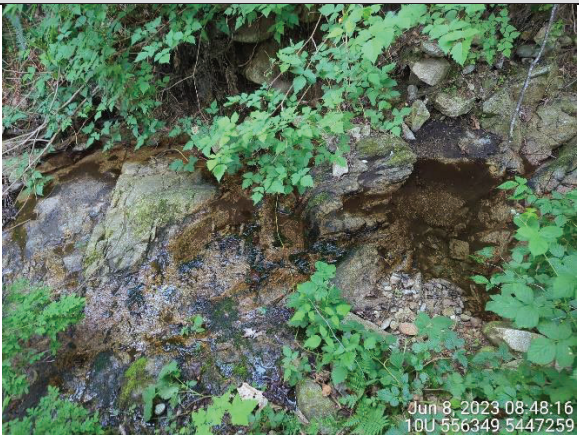
| Contaminated Soils Management | | |
|---|---|---|
| <p style="text-align: right; font-size: small; margin-top: 5px;">Jun 8, 2023 07:44:22<br/>10U 556363 5447165</p> <p>Photo 1. South-facing view of clear crush gravel access road. (Jun. 08, 2023).</p> | <p style="text-align: right; font-size: small; margin-top: 5px;">Jun 8, 2023 08:48:16<br/>10U 556349 5447259</p> <p>Photo 2. View of Davies Creek during removal of fallen logs and vegetation within the creek. (Jun. 08, 2023).</p> | |

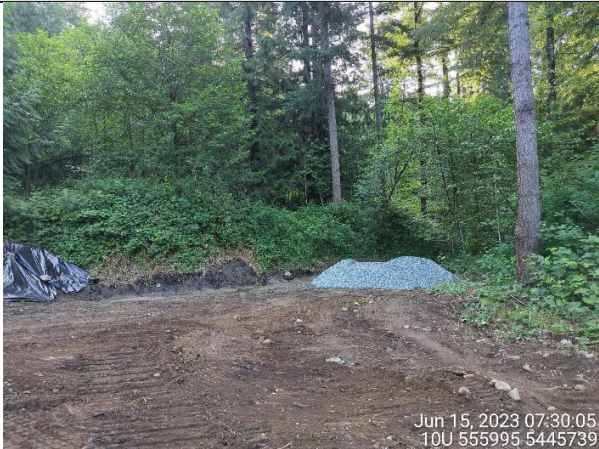
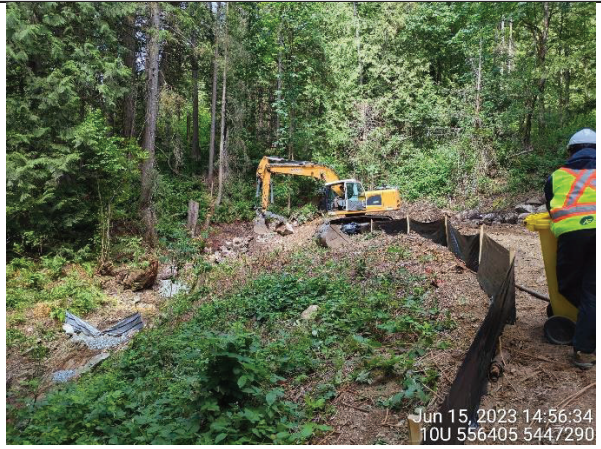
| Contaminated Soils Management | | |
|---|---|---|
| <p style="text-align: right; font-size: small; margin-top: 5px;">Jun 15, 2023 07:30:05<br/>10U 555995 5445739</p> <p>Photo 1. View extra gravel on site and protected stockpile. (Jun. 15, 2023).</p> | <p style="text-align: right; font-size: small; margin-top: 5px;">Jun 15, 2023 14:56:34<br/>10U 556405 5447290</p> <p>Photo 2. View of armoring of the northern bank of Davies Creek. (Jun. 15, 2023).</p> | |

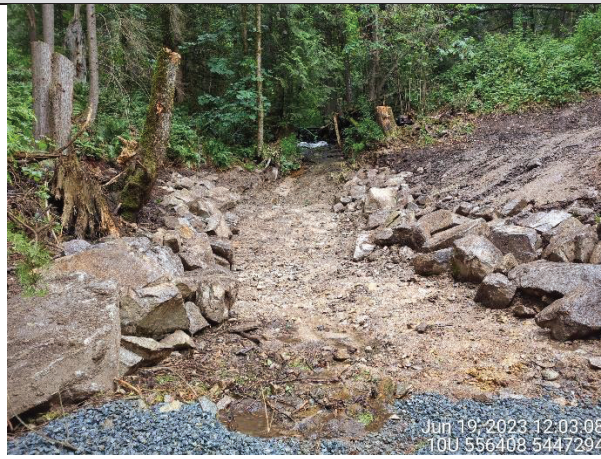
Photo 2. View of Davies Creek after armouring works have completed. (Jun. 19, 2023).

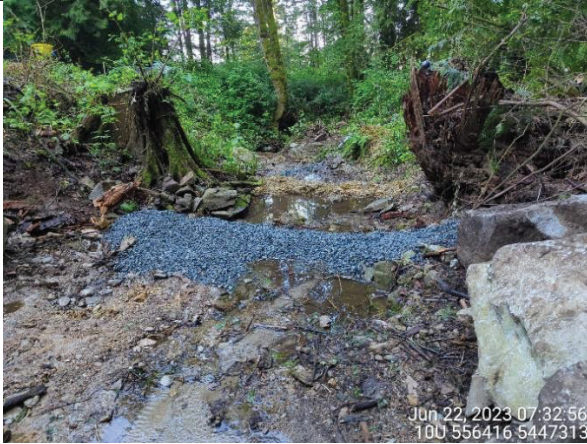
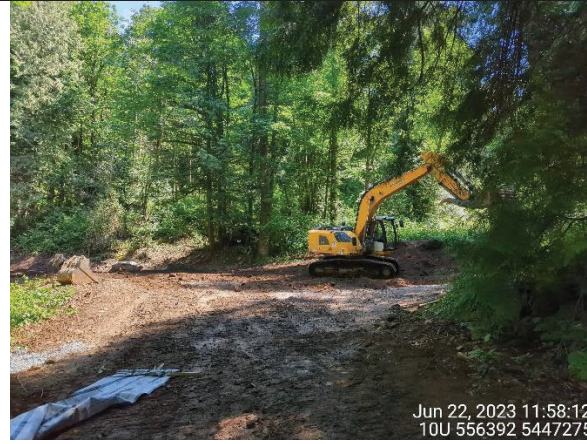
| Environmental Monitoring Activity | Y/N/NA | Comments |
|---|---|---|
| <p>Photo 1. View of gravel, straw, and silt fence check dams set up at the top of Davies Creek. (Jun. 22, 2023).</p> | <p>Photo 2. View of top soil being spread out on site. (Jun. 22, 2023).</p> | |

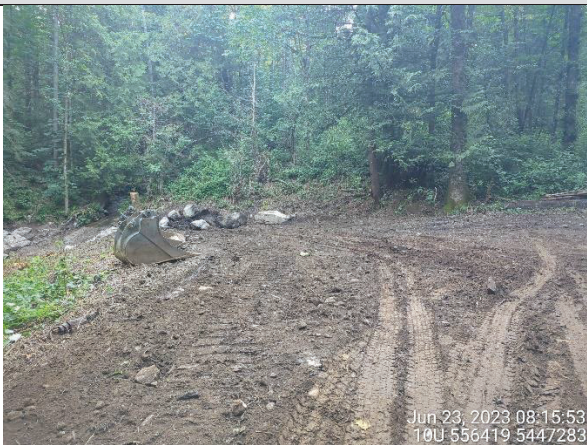
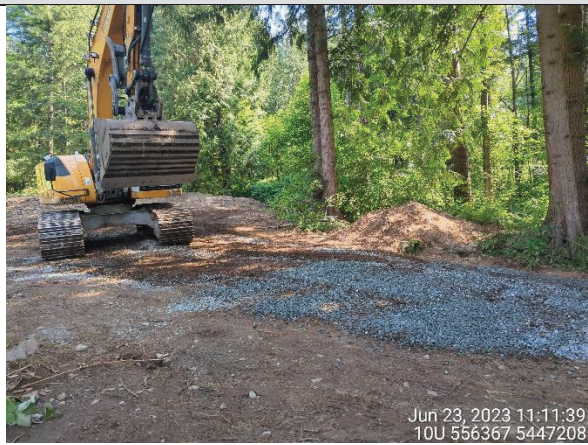
| Environmental Monitoring Activity | Y/N/NA | Comments |
|---|---|---|
| Photo 1. View of top soil spread out at the top of Davies Creek. (Jun. 23, 2023). | Photo 2. View of gravel being placed on top of access road. (Jun. 23, 2023). | |

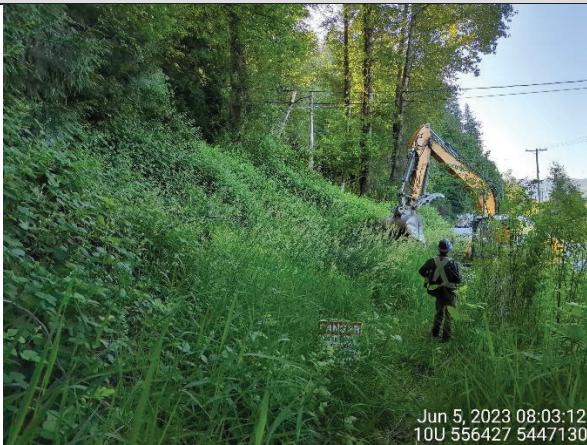
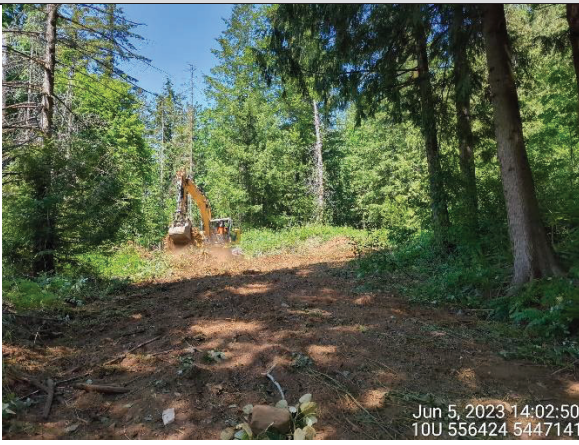
| Contaminated Soils Management | | |
|---|---|---|
| <p style="text-align: right; font-size: small; margin-top: 5px;">Jun 5, 2023 08:03:12<br/>10U 556427 5447130</p> <p>Photo 1. South-facing view, prior to works. Summit will clear base of access road (Jun. 05, 2023).</p> | <p style="text-align: right; font-size: small; margin-top: 5px;">Jun 5, 2023 14:02:50<br/>10U 556424 5447141</p> <p>Photo 2. North-facing view of turn-around area cleared north of the base of access road (Jun. 05, 2023).</p> | |

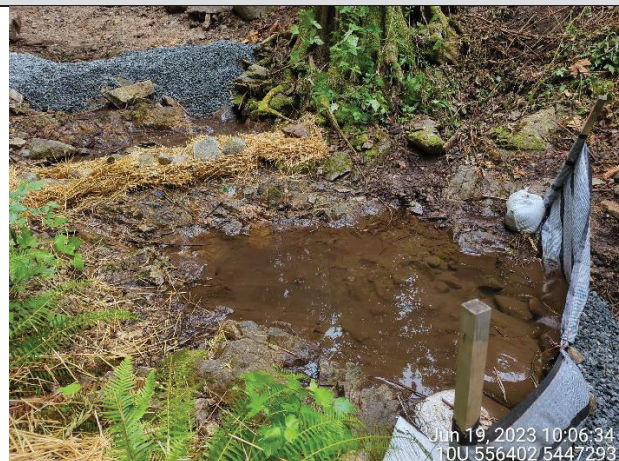
Photo 1. View of gravel, straw , and silt fence check dams set up at the top of Davies Creek. (Jun. 19, 2023).

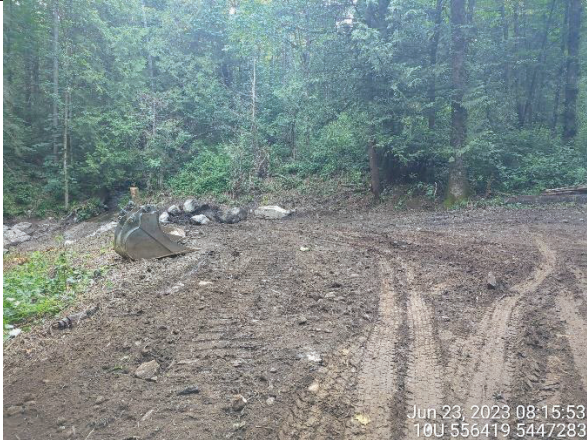
| Environmental Monitoring Activity | Y/N/NA | Comments |
|---|---|---|
| <p>Jun 23, 2023 08:15:53<br/>10U 556419 5447283</p> <p>Photo 1. View of top soil spread out at the top of Davies Creek. (Jun. 23, 2023).</p> | | |

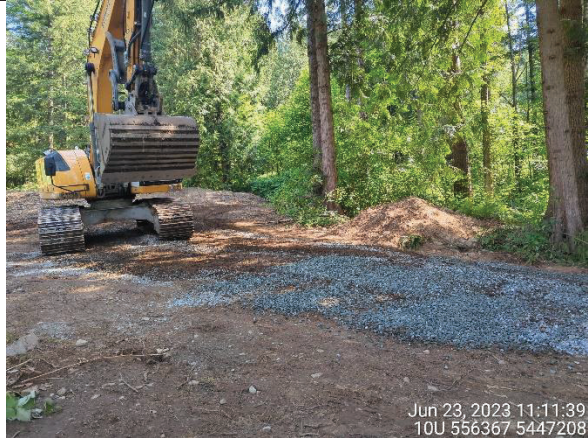
| Environmental Monitoring Activity | Y/N/NA | Comments |
|---|---|---|
| <p>Jun 23, 2023 11:11:39<br/>10U 556367 5447208</p> <p>Photo 2. View of gravel being placed on top of access road. (Jun. 23, 2023).</p> | | |
