# Ministry of Environment and Climate Change Strategy

## Hatzic Emergency Works Program Eng Creek and McNab Creek

## Post Construction Report

APRIL 2024

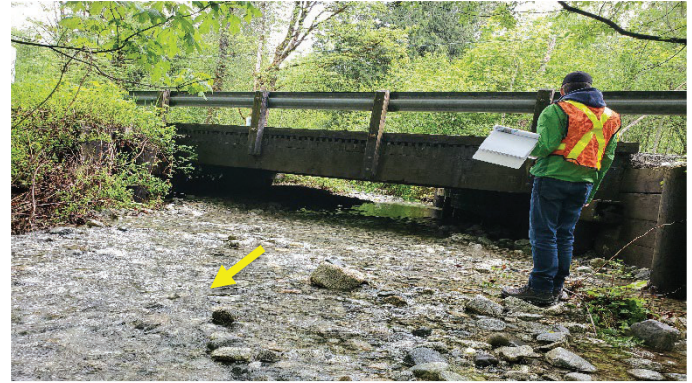
Eng Creek  
Downstream of Sylvester Road Bridge – Looking Upstream

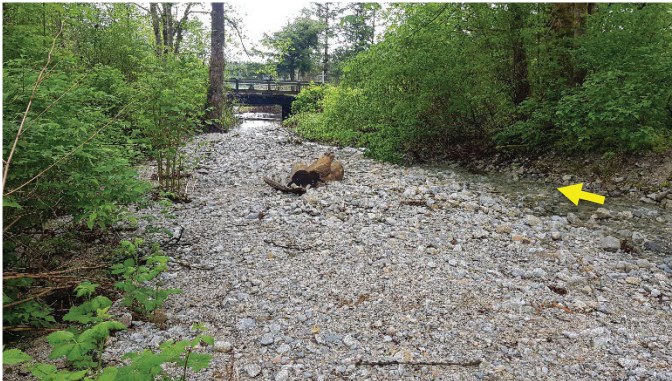
Eng Creek  
Between Sylvester Road Bridge and Hartley Road Bridge –  
Looking Downstream towards Hartley Road Bridge

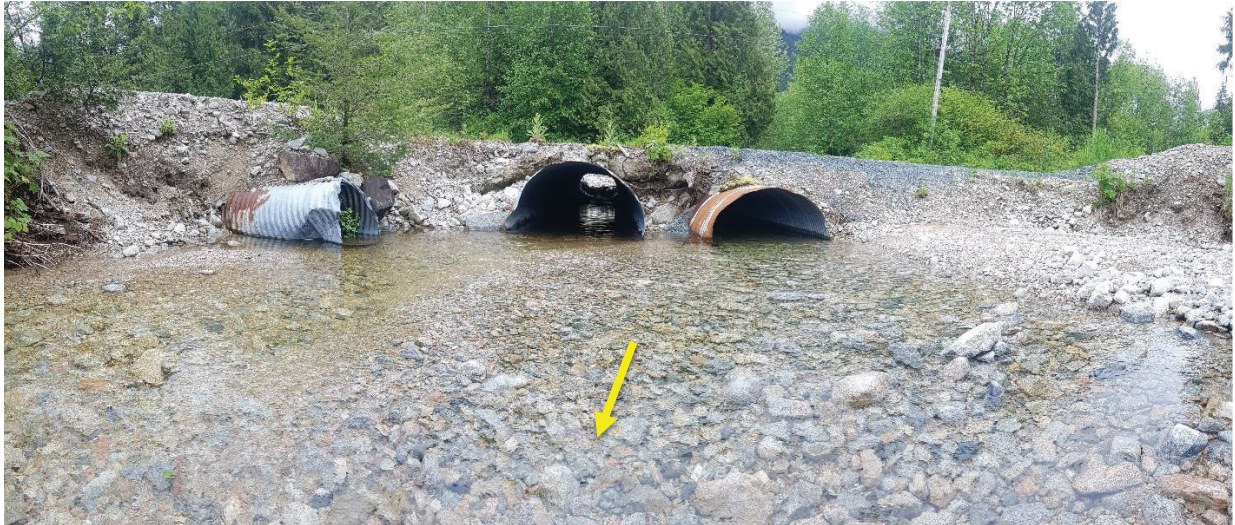
MacNab Creek downstream of Sylvester Road (looking east)

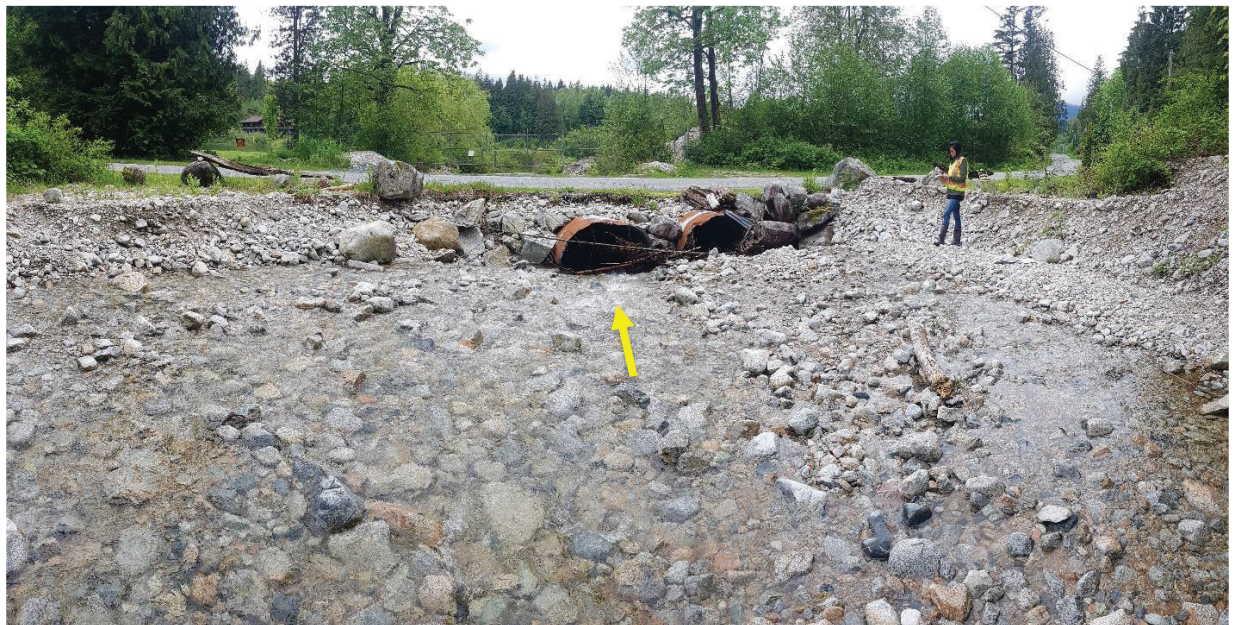
MacNab Creek upstream of Sylvester Road (looking west)

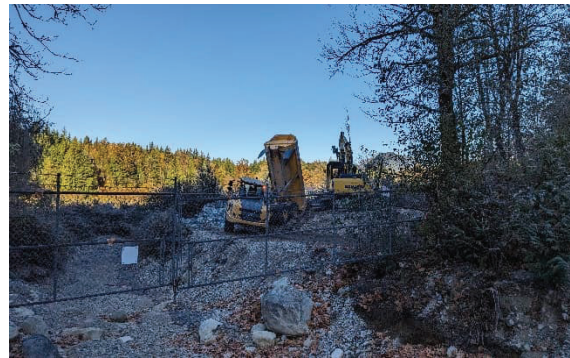
Figure - 2  
Facing NW – Hauling sediment to the laydown area next to Allan lake.

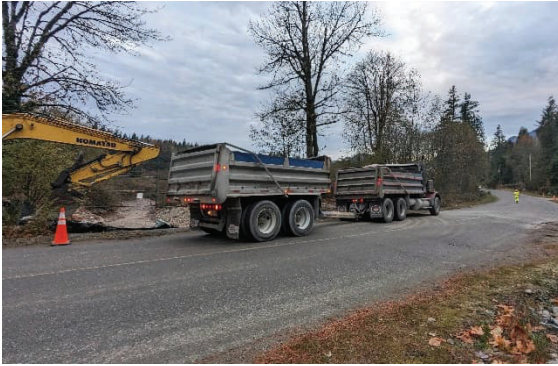
Figure - 1  
Facing W – Hauling sediment from McNab.

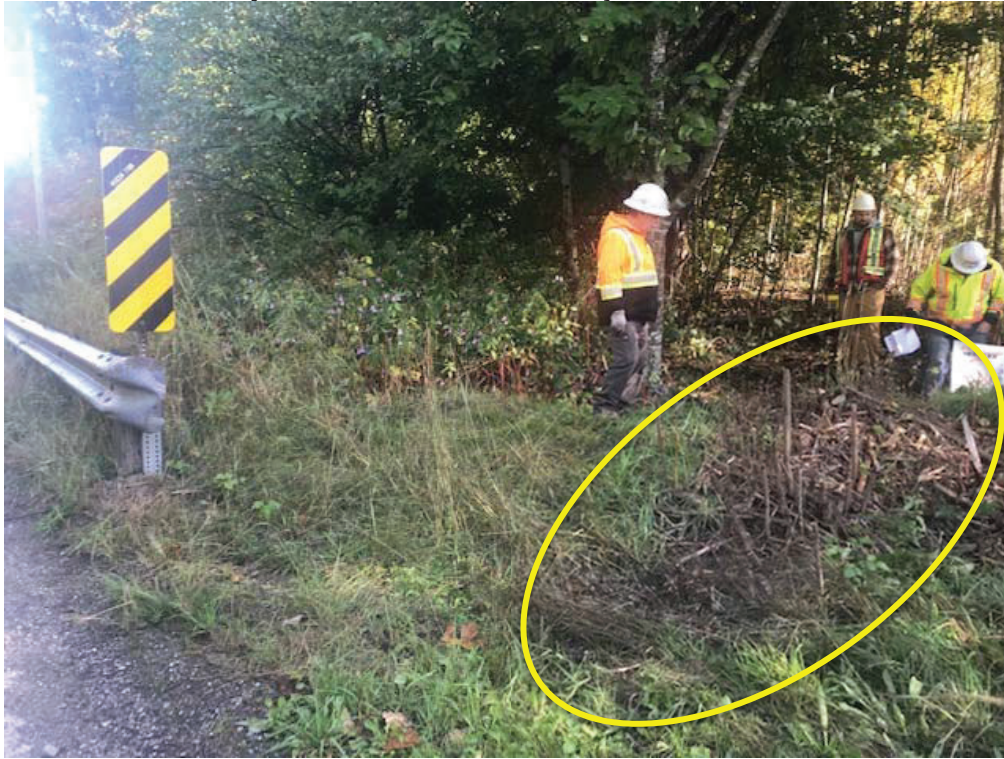
**Photo 2:** Previously treated knotweed area adjacent to the road.

1. During access clearing, if possible, try to retain the wildlife tree and stay outside of the dripline of the mature cedar to avoid disturbing roots.
2. Place geotextile material atop of treated knotweed area and atop of policeman's helmet to avoid excavator contact with soil.
3. It is recommended to have an environmental monitor (EM) on site during the construction of the access road to the creek. Avoid the (live) Knotweed infested areas and within 5 m of infestation areas, and access the project area via the creek, as long as no water was present in the creek.

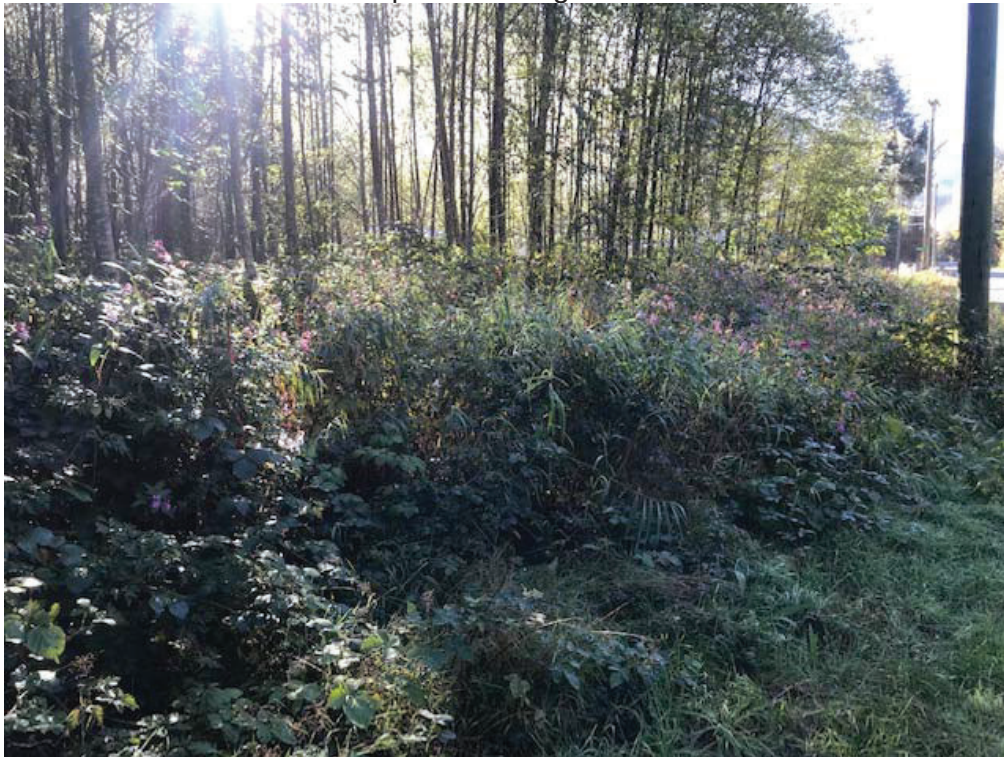
- Policeman’s helmet was observed within the clearing boundary along the road (approximately 5-10 m wide strip off of the road). Sparse observations of Policeman’s helmet along the creek were noted.

**Photo 3:** Policeman's helmet present along the road.

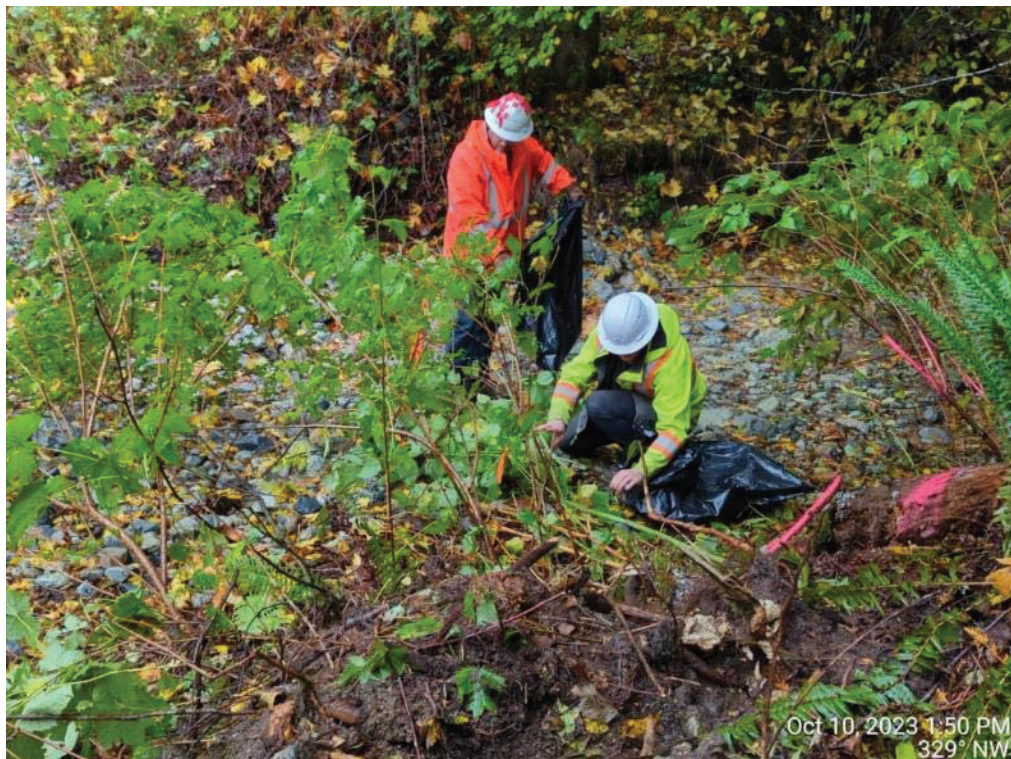
stem, leaves, and root ball were bagged for proper disposal offsite. No seeds were noted on the plant. The root area on the bank was spray painted red, to avoid disturbance.

**Photo 3:** Japanese knotweed removal from the creek, by hand.

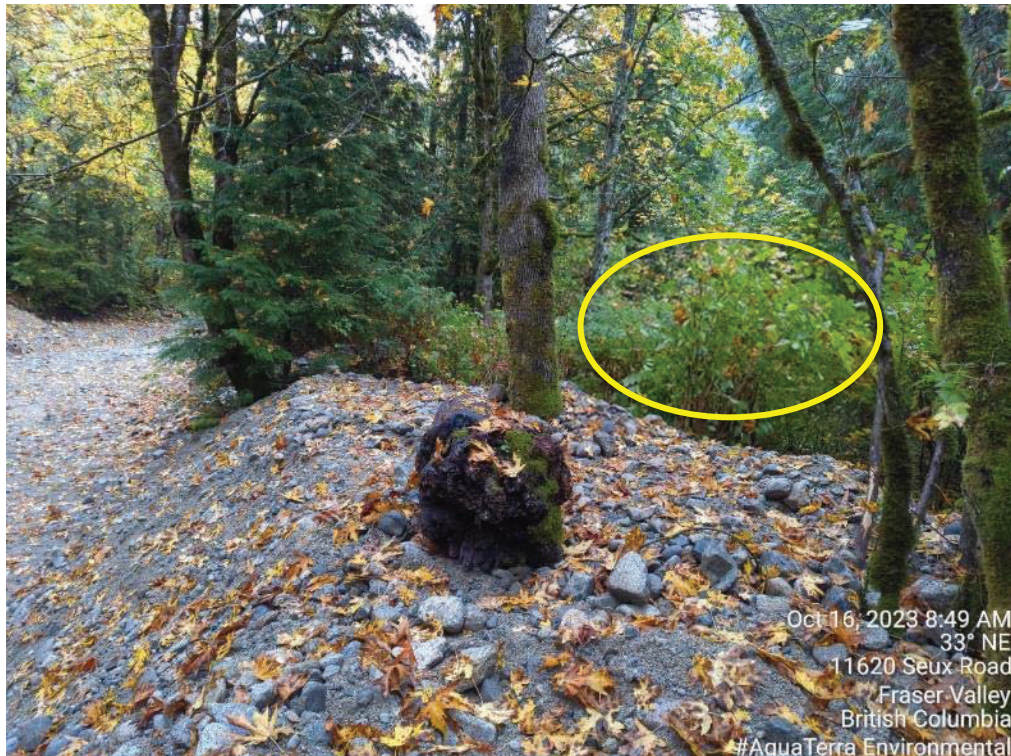
**Photo 2:** Japanese knotweed backfilled approximately 5 m in from bank.

The AquaTerra PM (Chris Lee) discussed Japanese Knotweed management and CEMP compliance with Mission Contractors on 12 October 2023 including maintaining a minimum 5 m buffer and typical distance of rhizome/root migration from plants, and appropriateness of vegetation removal for laydown areas in the vicinity of observed knotweed infestations, coupled with ensuring appropriate disposal off-site and preventing the spread of knotweed. Mission advised AquaTerra that they had recommended to AE that the laydown area and access could be temporarily capped with inorganic gravel/cobble from the dry excavated watercourse to reduce the potential for spread and was assured that no knotweed contaminated material was to be disposed of off-site.

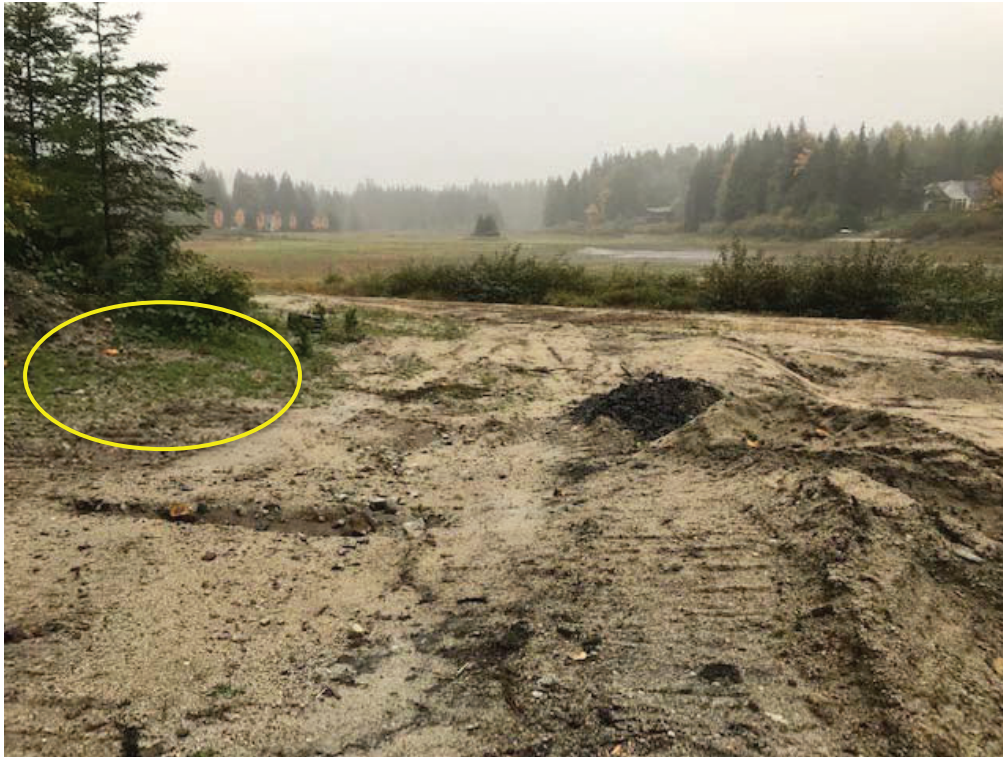
- EM, AE Engineer and Site Superintendent walked the lower reaches of Eng Creek. Japanese Knotweed (undisturbed) was noted on the northeast shore of Allan Lake, near an access road.

**Photo 1:** Japanese Knotweed near access road to Allan Lake.

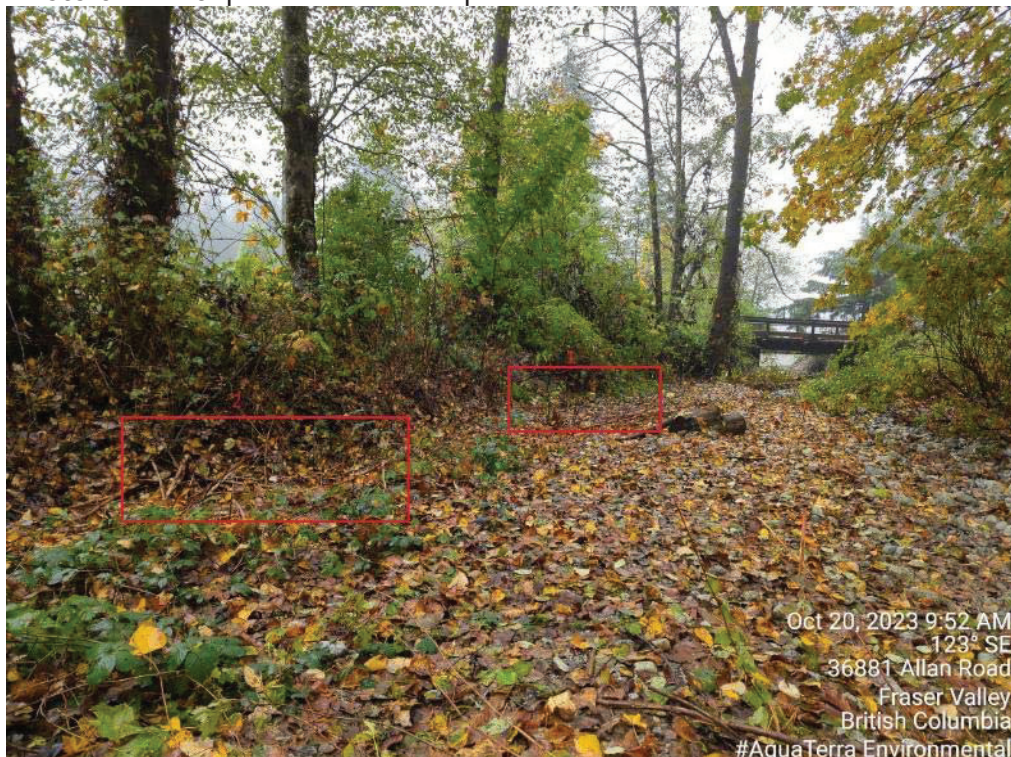
**Photo 7:** Dead Japanese knotweed (patch one) with live regrowth stems present.

1. Contact the EM if water is observed in the creek. Stop works until a bypass is installed.
2. The stockpiled Japanese knotweed infested material can be buried 3-5 m below ground or removed off site for disposal at an appropriate disposal facility.
3. Inspect equipment regularly for leaks or excess grease.

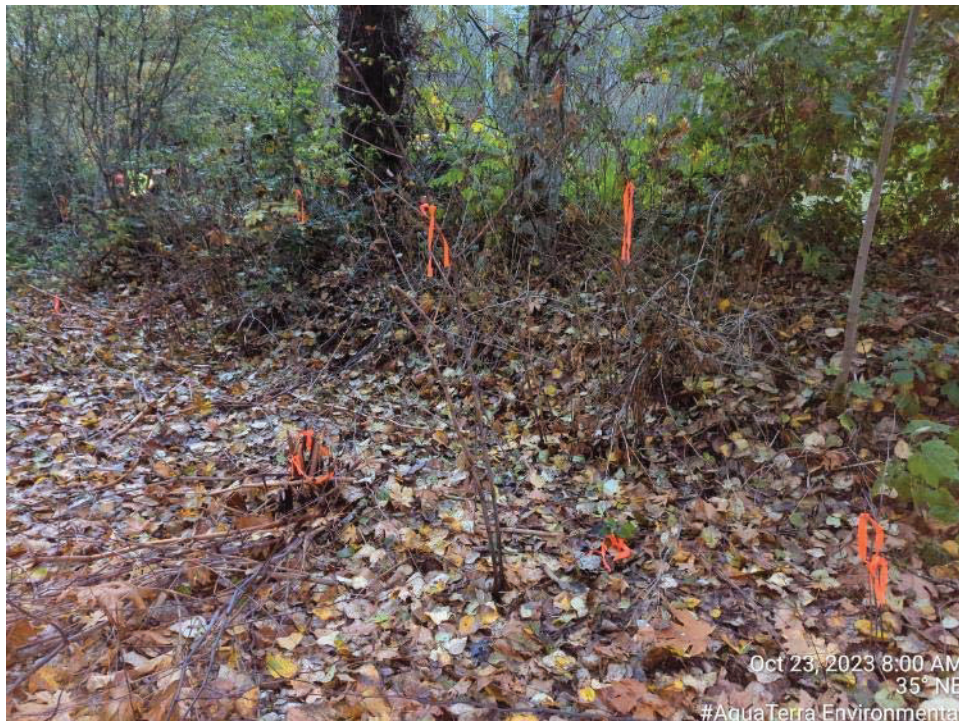
**Photo 1:** Japanese knotweed perimeter flagged.

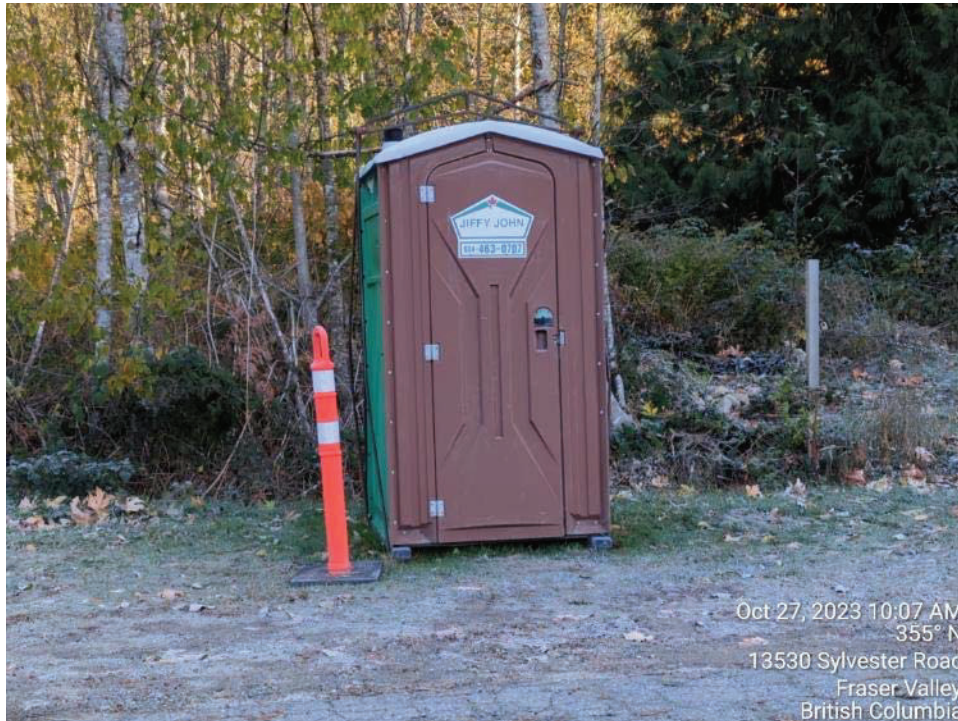
**Photo 19:** No effluent leakage or spills were observed from the portable toilet.

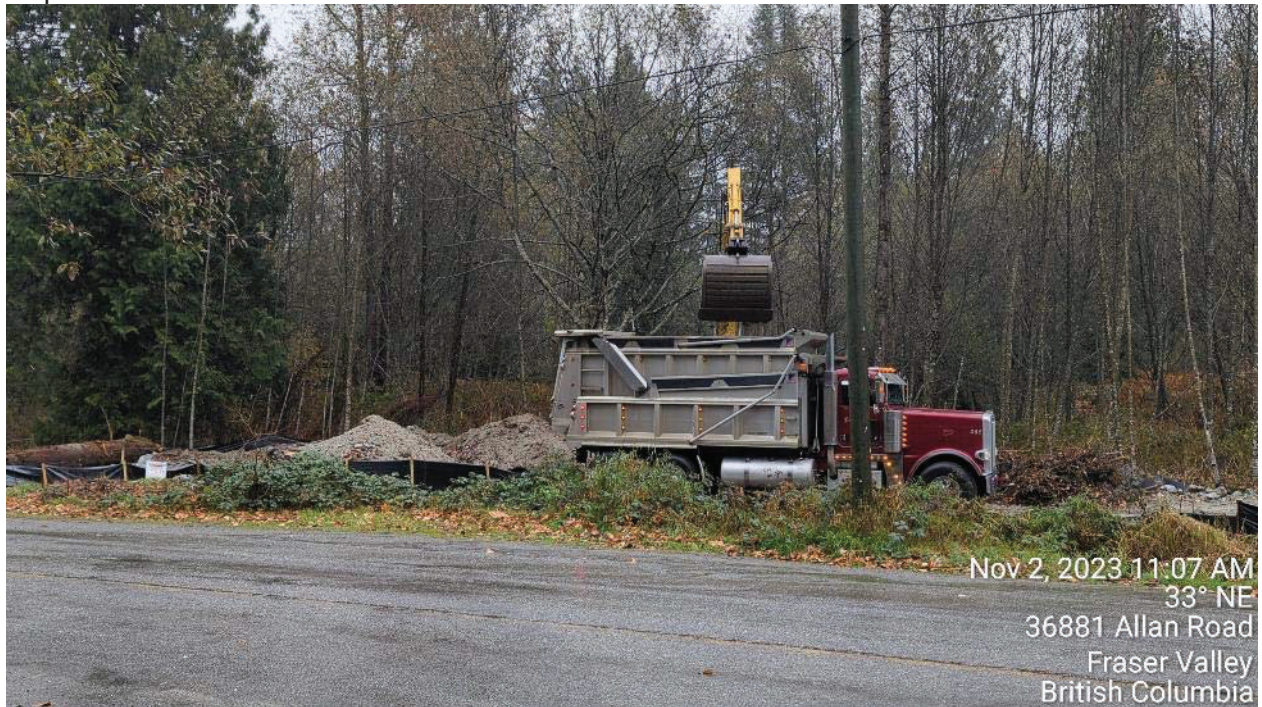
**Photo 17:** Japanese knotweed infested material loaded into BC Earth Exchange truck for offsite disposal.

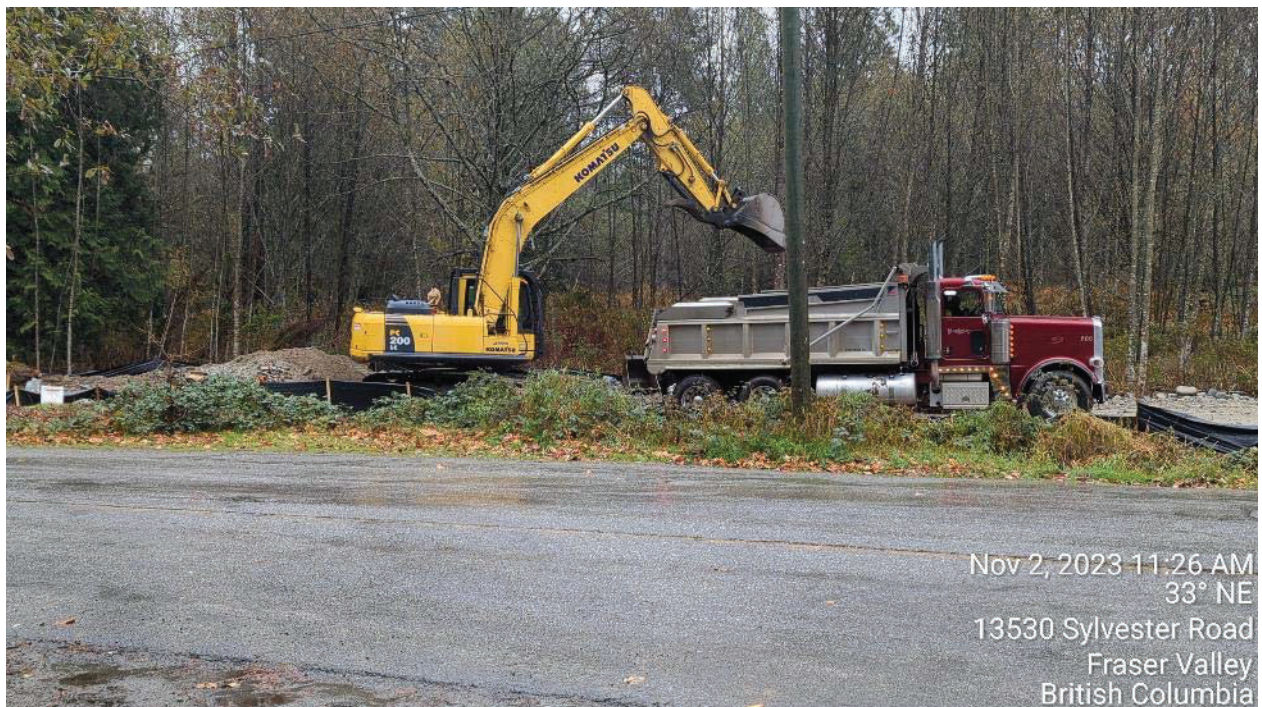
**Photo 19:** Additional brush loaded into a truck.

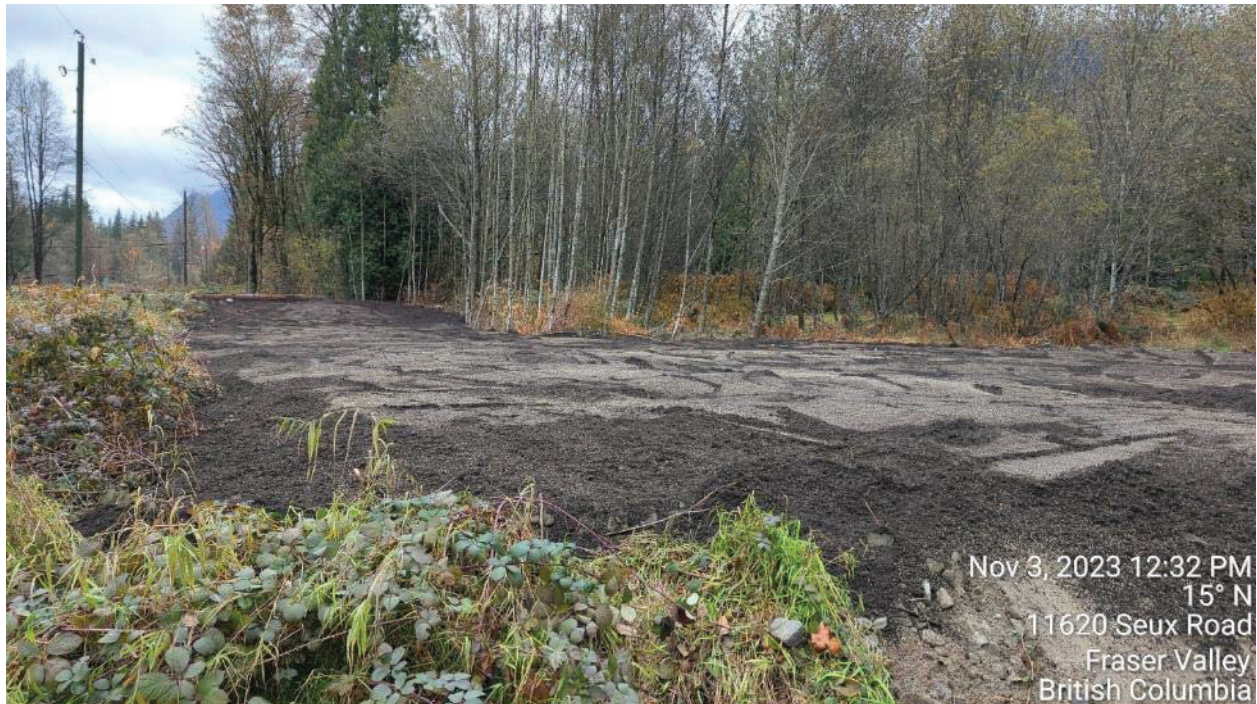
**Photo 22:** Eng Creek laydown area was capped with topsoil and seeded with a grass mix.

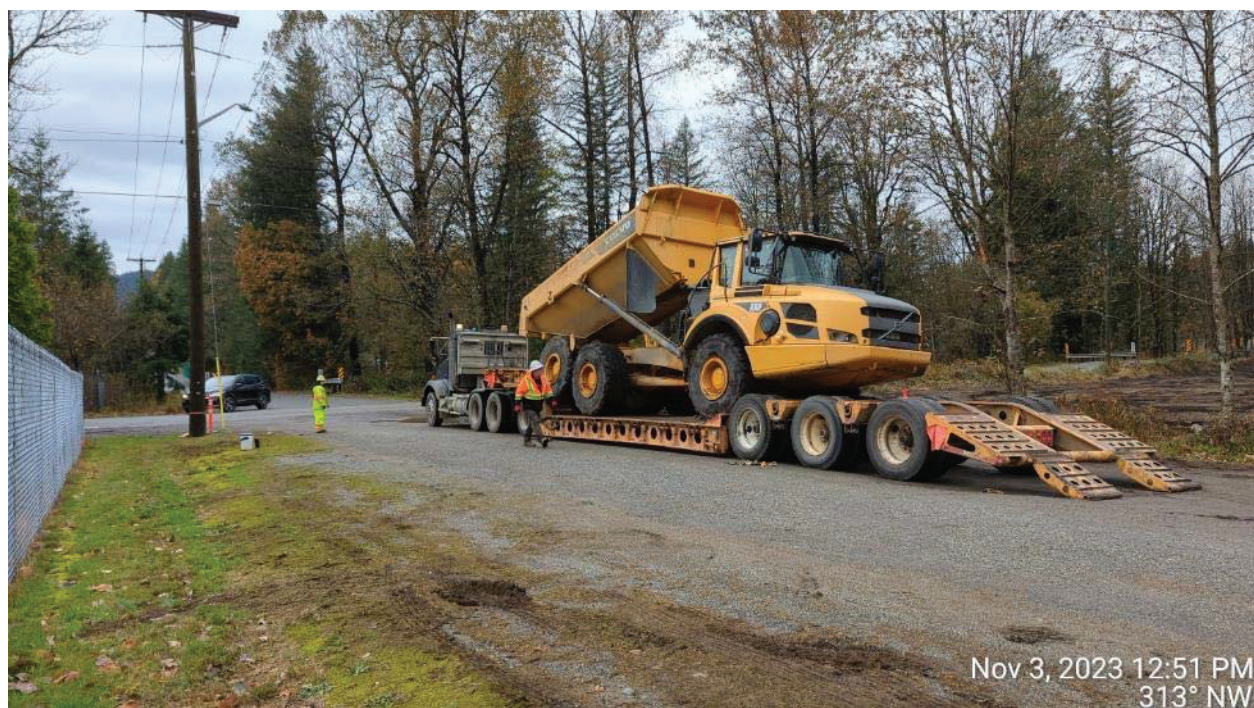
**Photo 25:** One (1) rock truck loaded onto the flatbed for removal.

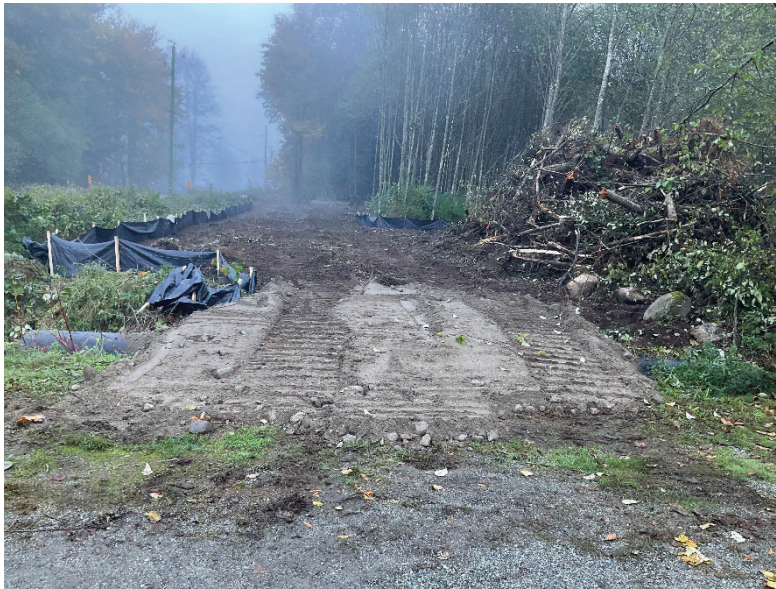
*Figure 1 Entrance to Laydown area Hartley Rd.*

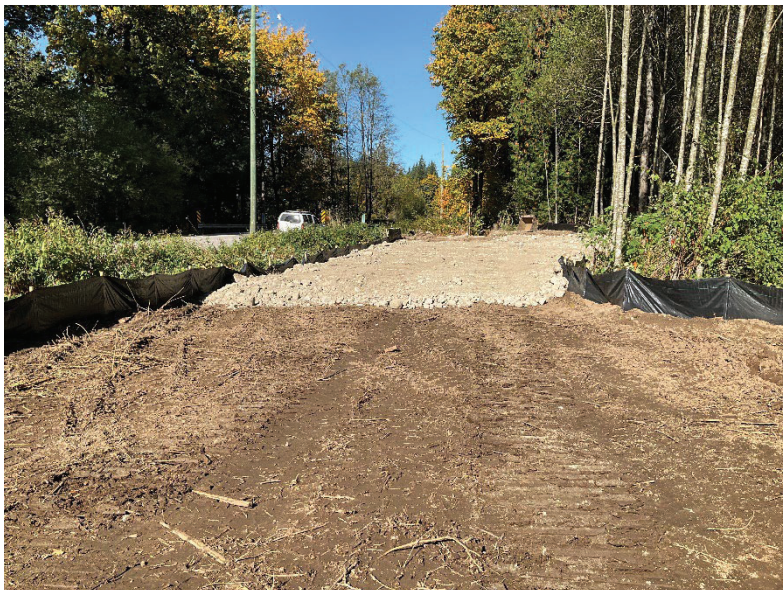
*Figure 2 Beginning of Bedload as buffer pad in laydown are.*

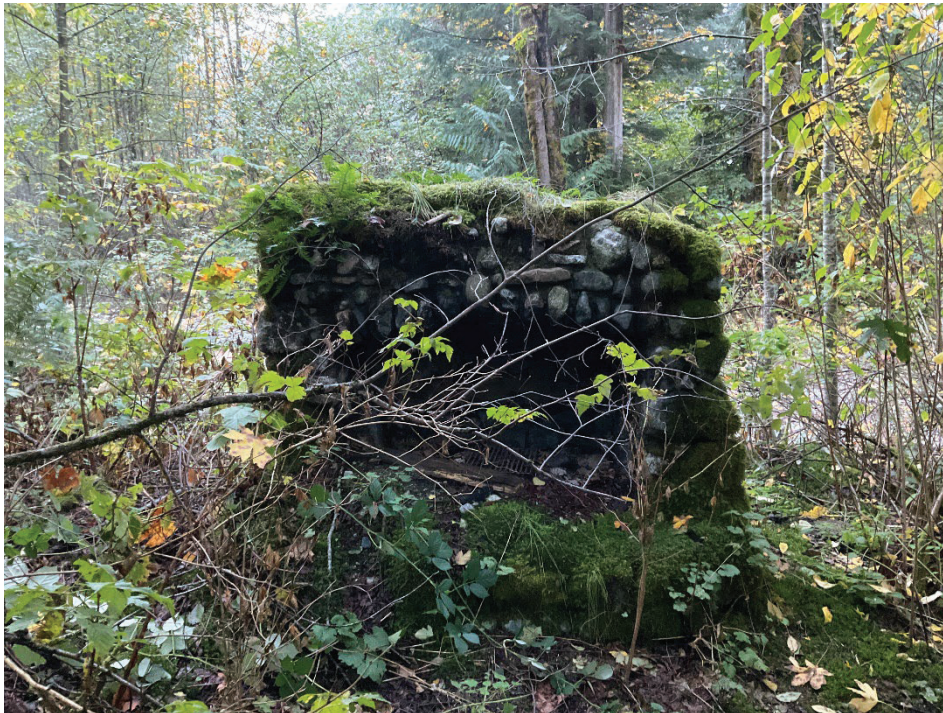
*Figure 4 Colonial style hearth ~50m upstream of Sylvester Rd. MoTi structure on N. bank.*

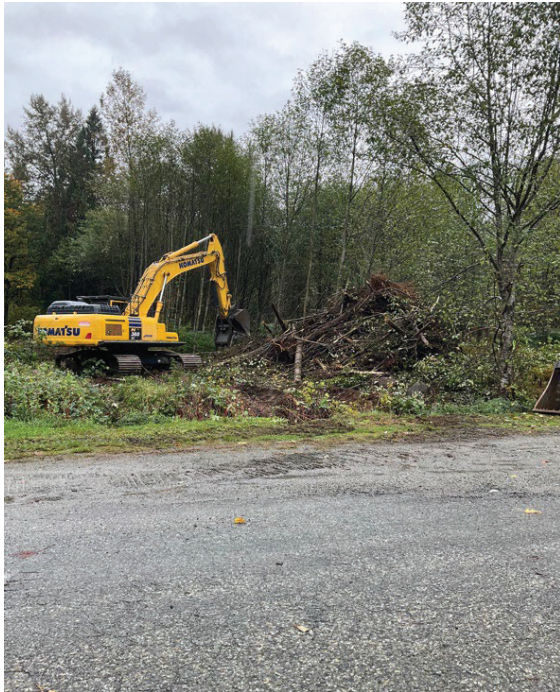
*Figure 2 Clearing vegetation at laydown pad Hartley Rd.*

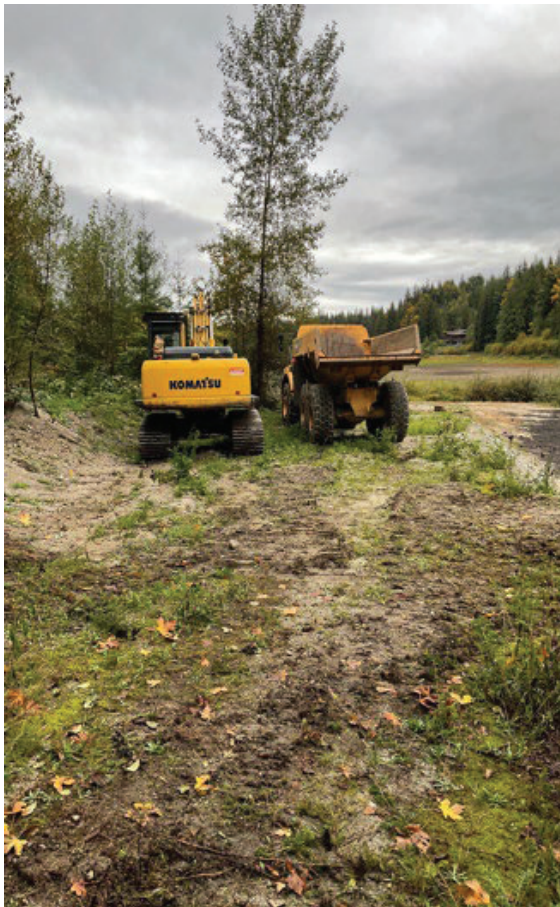
*Figure 1 Machines parked at Allan Lake entrance Hartley Rd.*

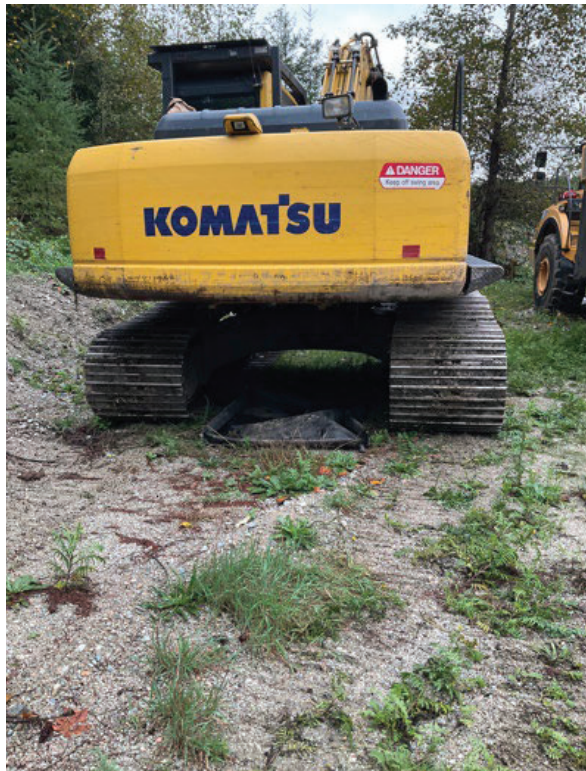
*Figure 4 Drip trays being used under machines.*

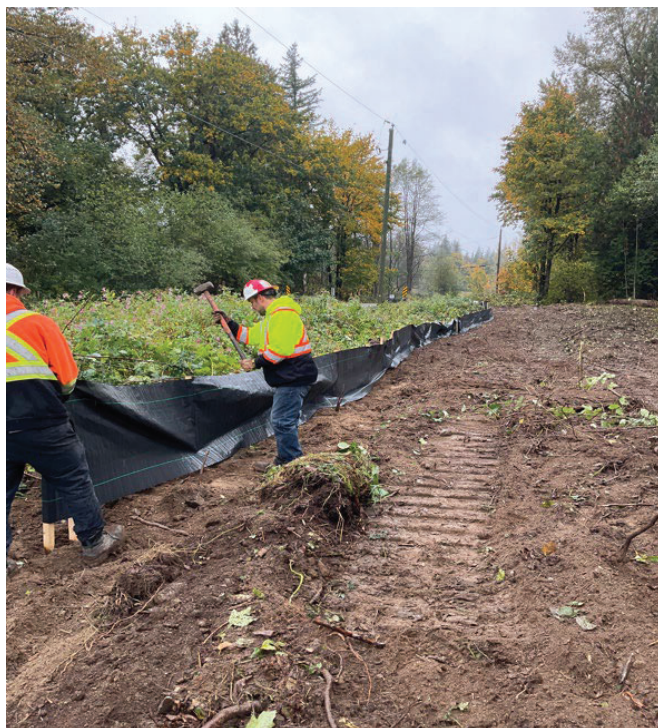
*Figure 3 Installing isolation/sediment fence around laydown pad  
Hartley Rd./Eng Creek entrance.*

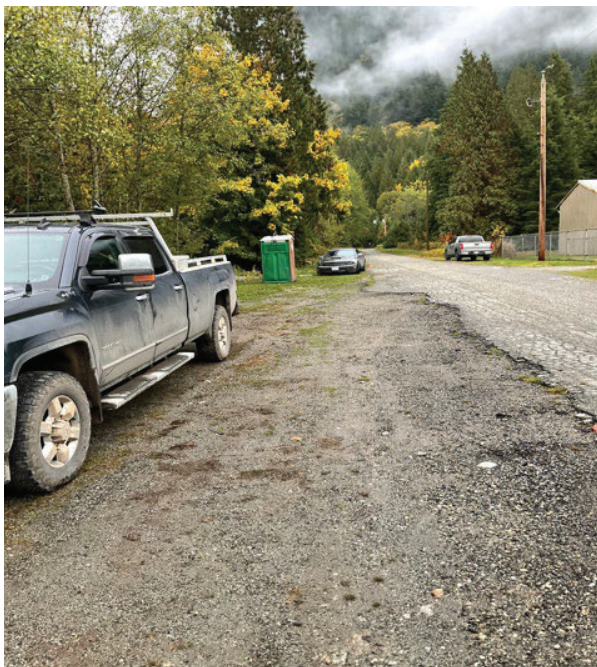
Figure 6 Porta potty Hartley rd.

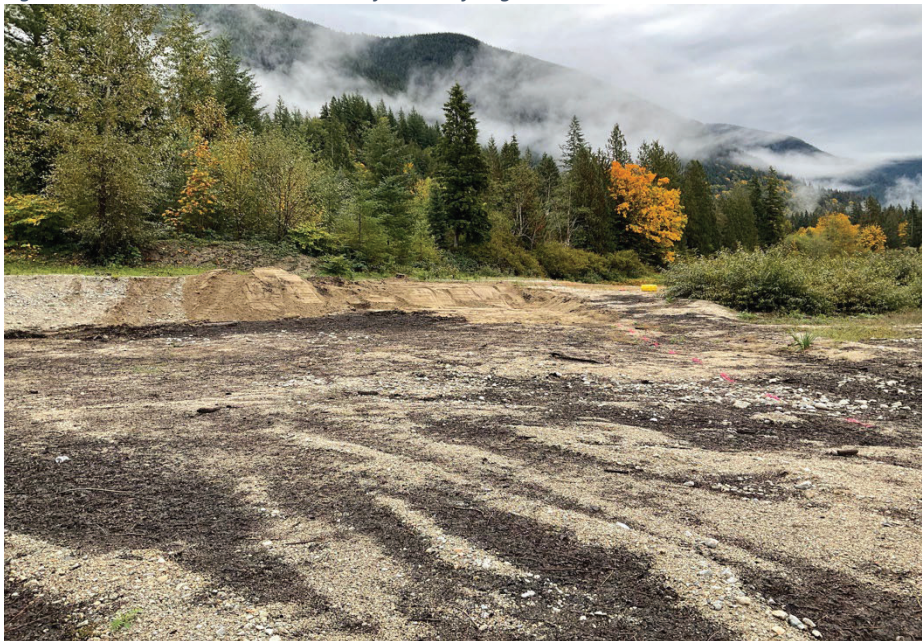
*Figure 2 Post sediment removal at confluence of Eng creek and Allan Lake.*

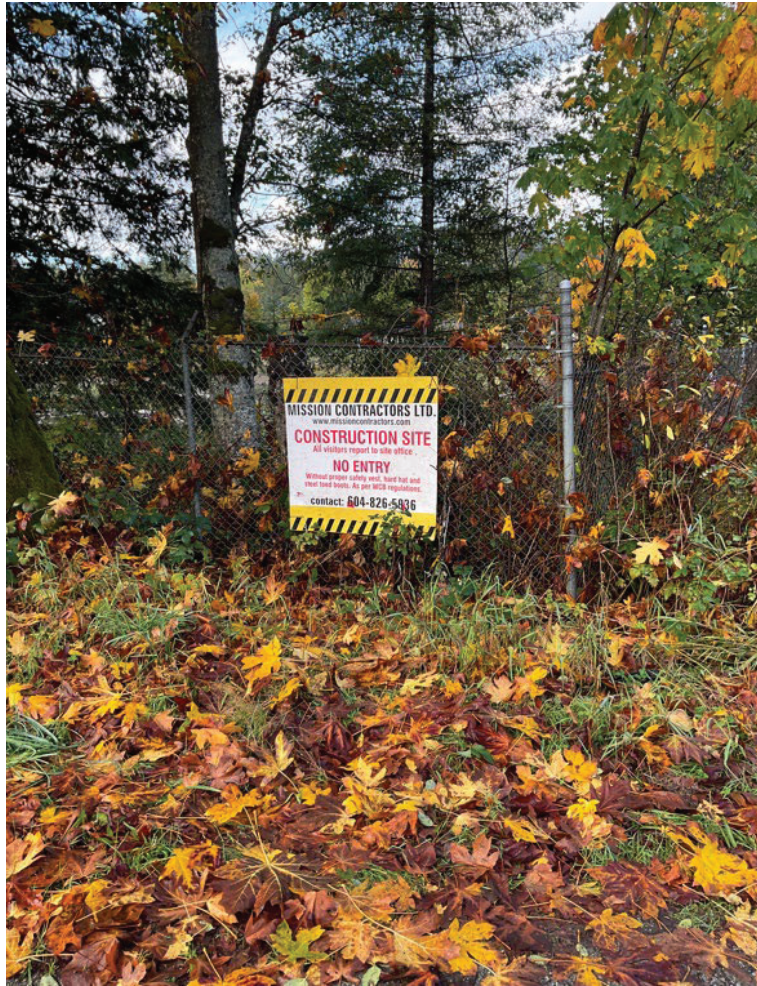
Figure 3 Signage at Sylvester Rd. and Hartley Rd. intersection.

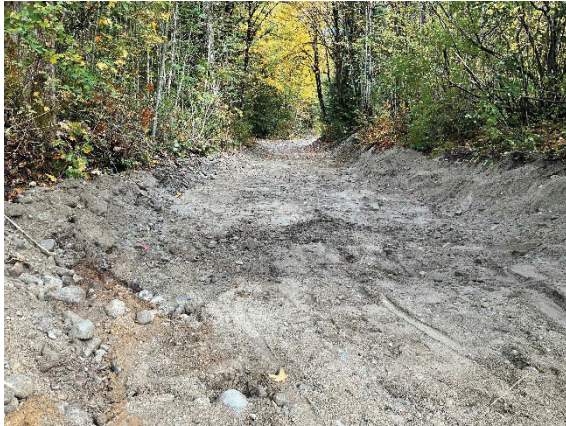
Image One: Lower portion of Eng Creek above MoTi structure, looking East.

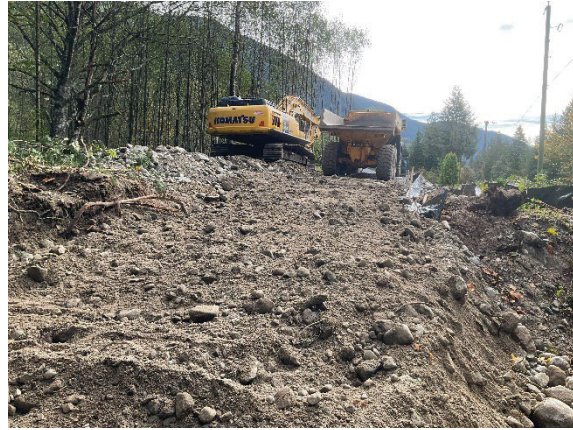
Image Two: Looking South Eng creek entrance to laydown.

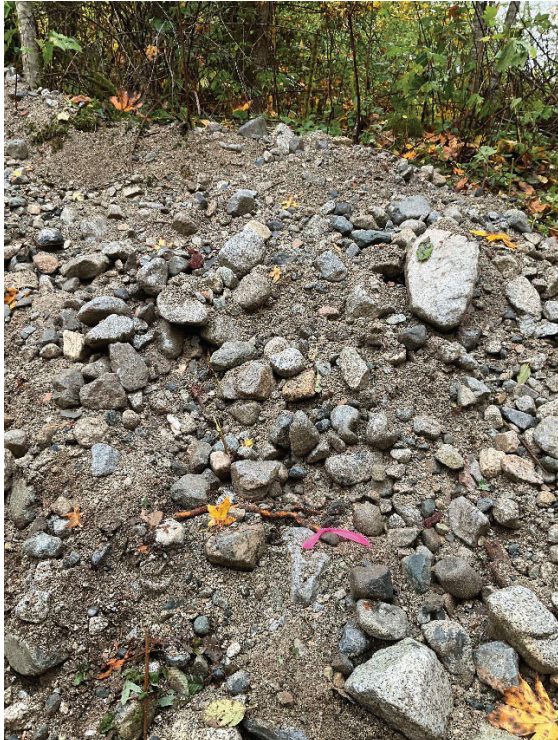
Photo Three: Probable artifact location, North side of creek.

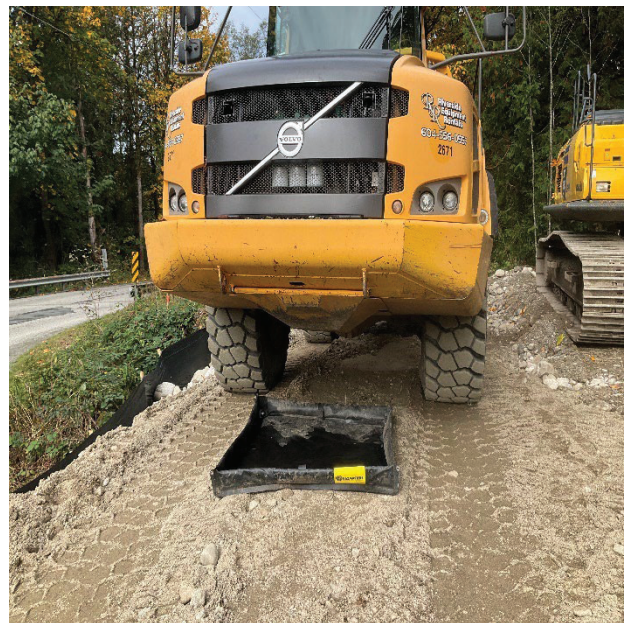
Photo four: Haul truck w/ drip tray inside Eng creek laydown area.

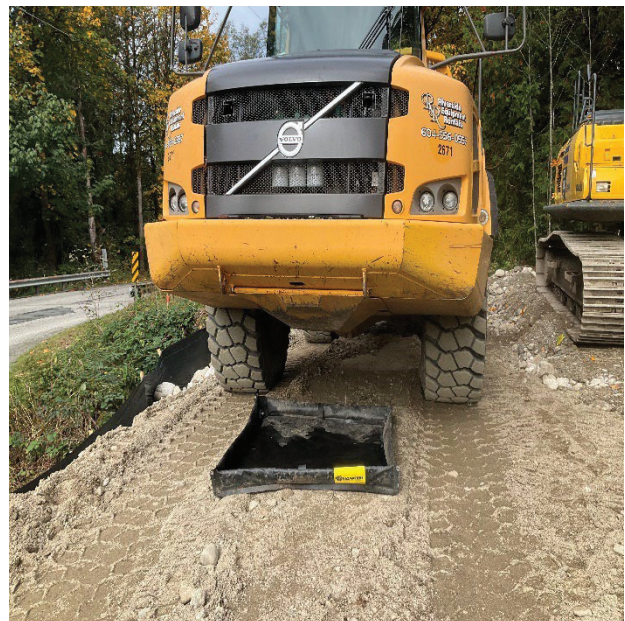
Photo four: Haul truck w/ drip tray inside Eng creek laydown area.

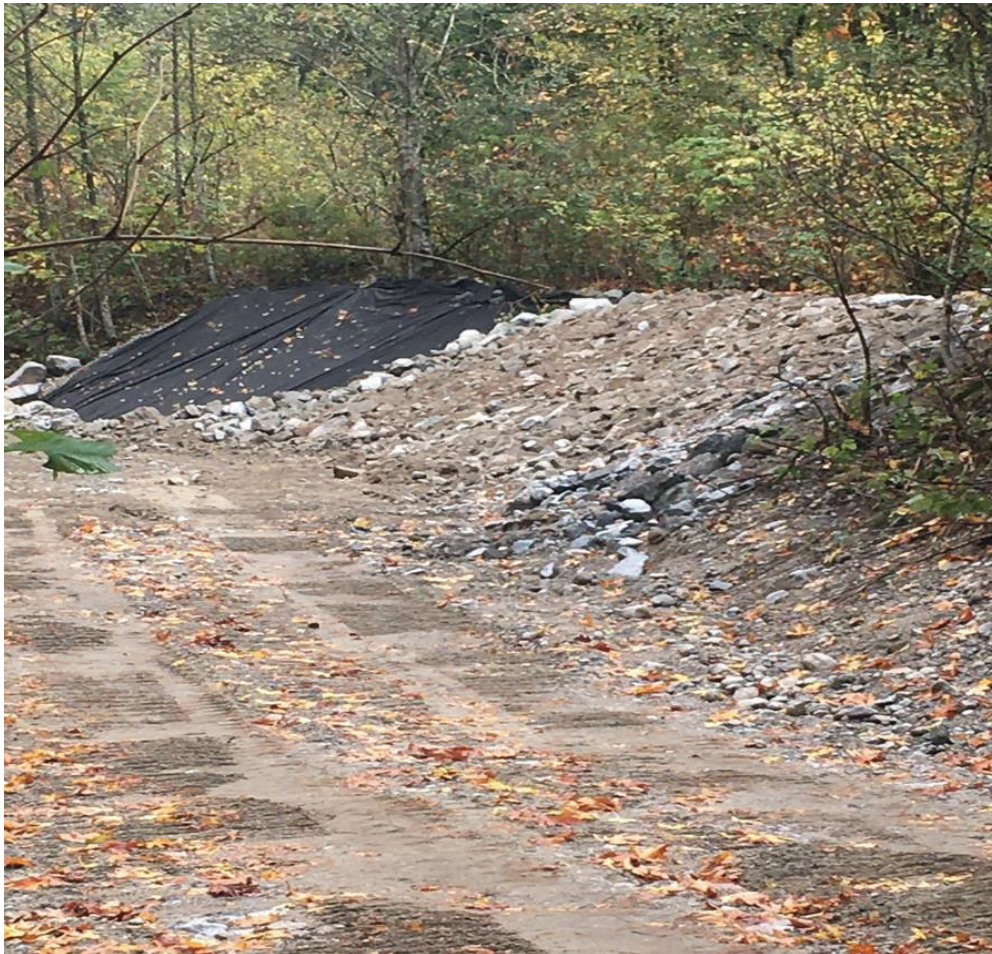
Image 1 – South bank stabilization and riprap installation.

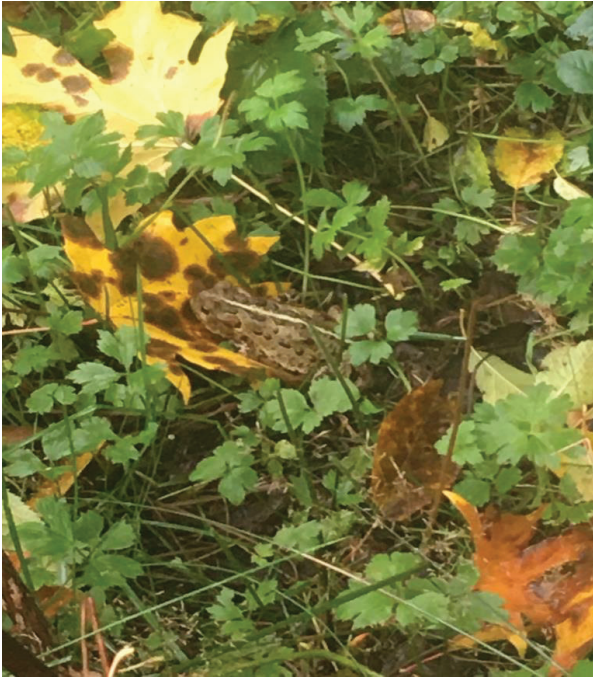
Image 2 – Western Toad

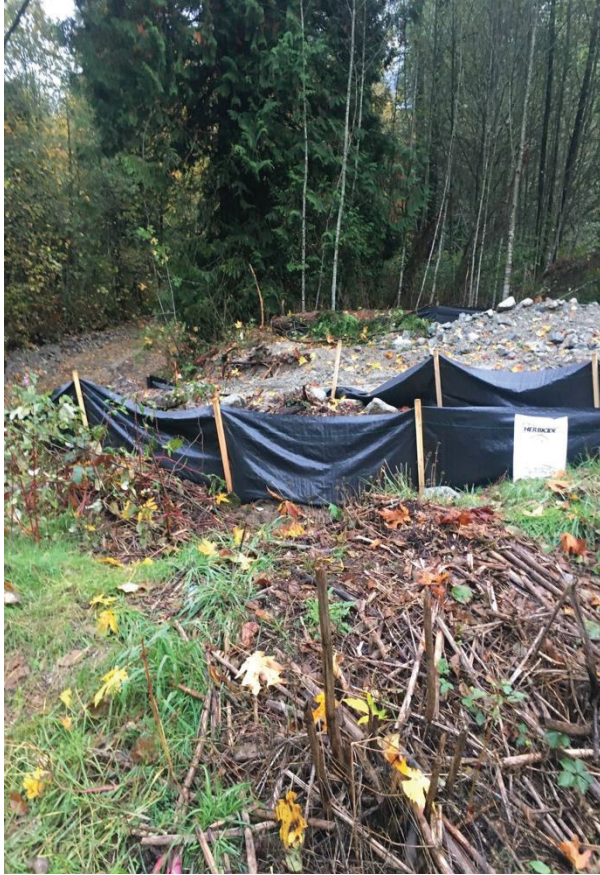
Image 4 – Silt isolation fencing.

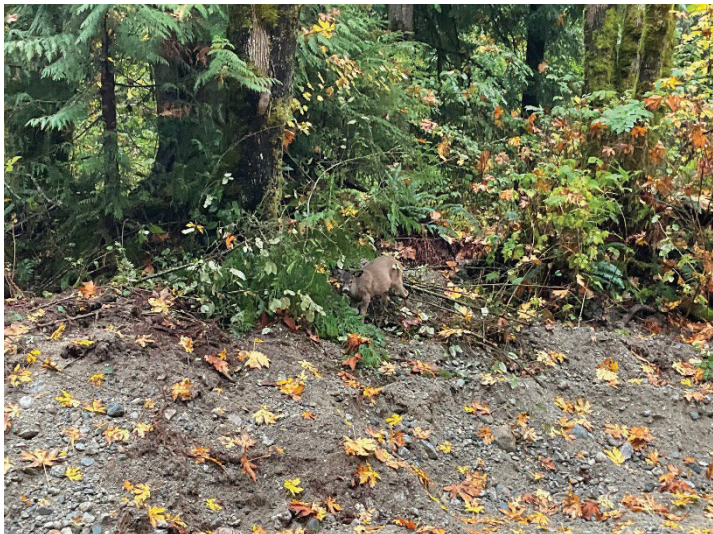
*Figure 2 Doe on bank of Eng creek outside active work zone.*

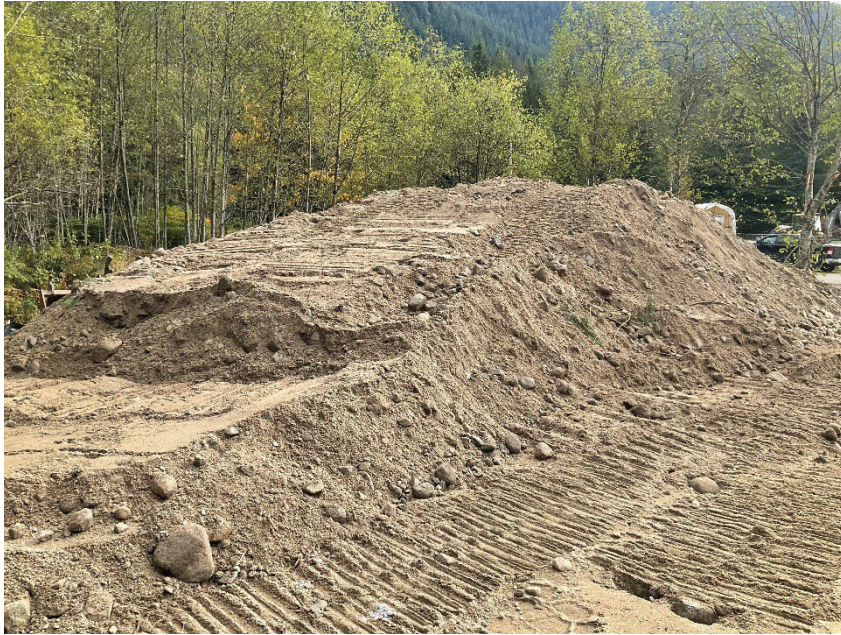
*Figure 3 Stockpile Eng creek laydown/Hartley rd.*

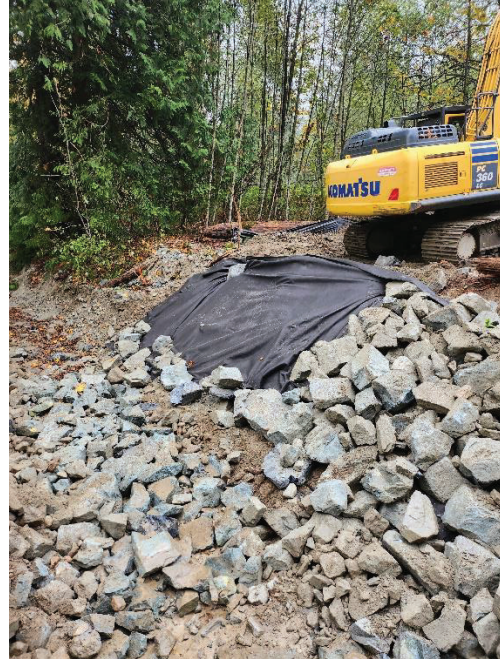
Figure 6 - Last of armoring before site ran out of rip-rap
