# Ministry of Environment and Climate Change Strategy

## Hatzic Emergency Works Program Eng Creek and McNab Creek

## Post Construction Report

APRIL 2024

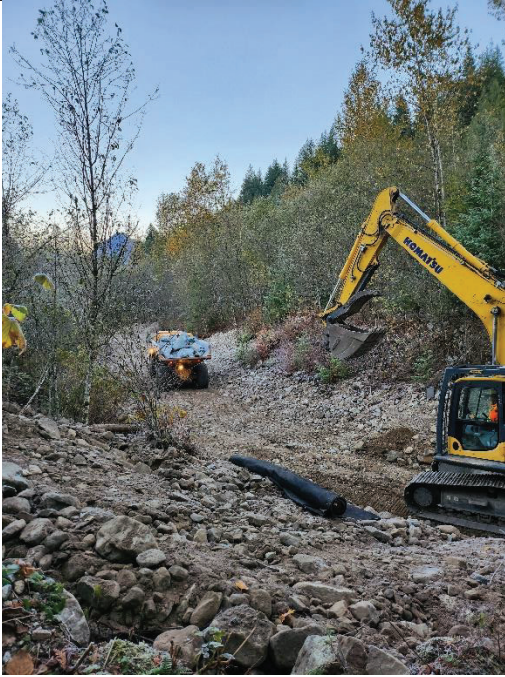
Figure 1 – Eastern bank of upper reach with Geo-Fabric/Armor

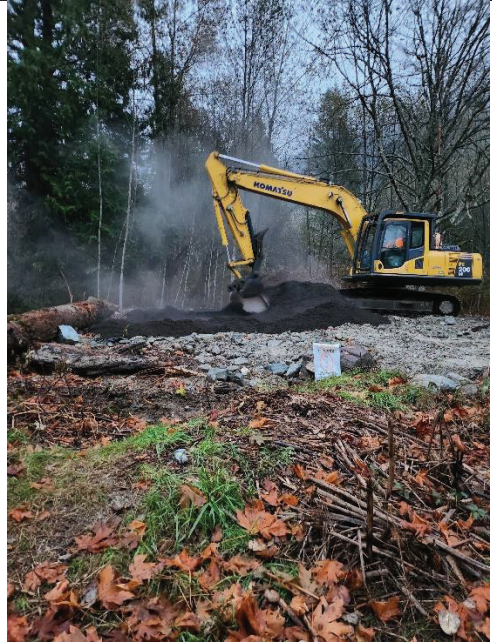
*Figure 2 – Topsoil spreading*

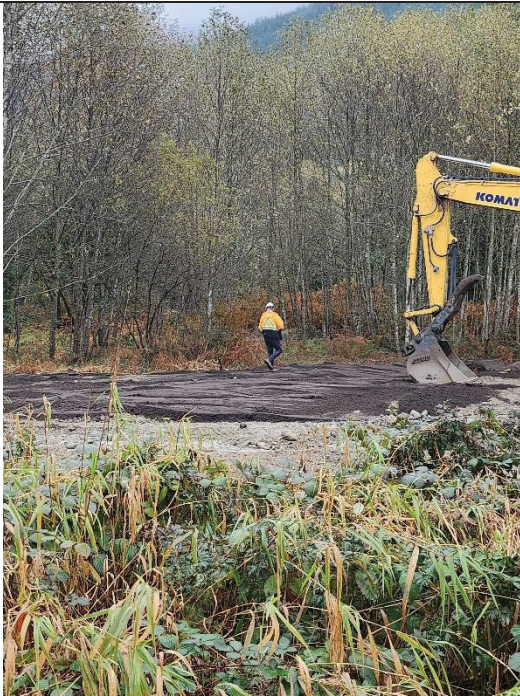
*Figure 3 – Native blend seeding at Eng laydown area*

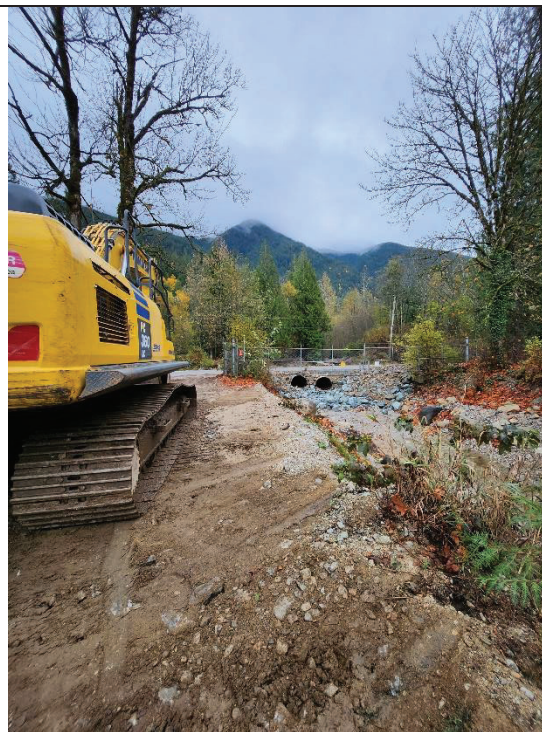
*Figure 6 Final look at McNab Creek*

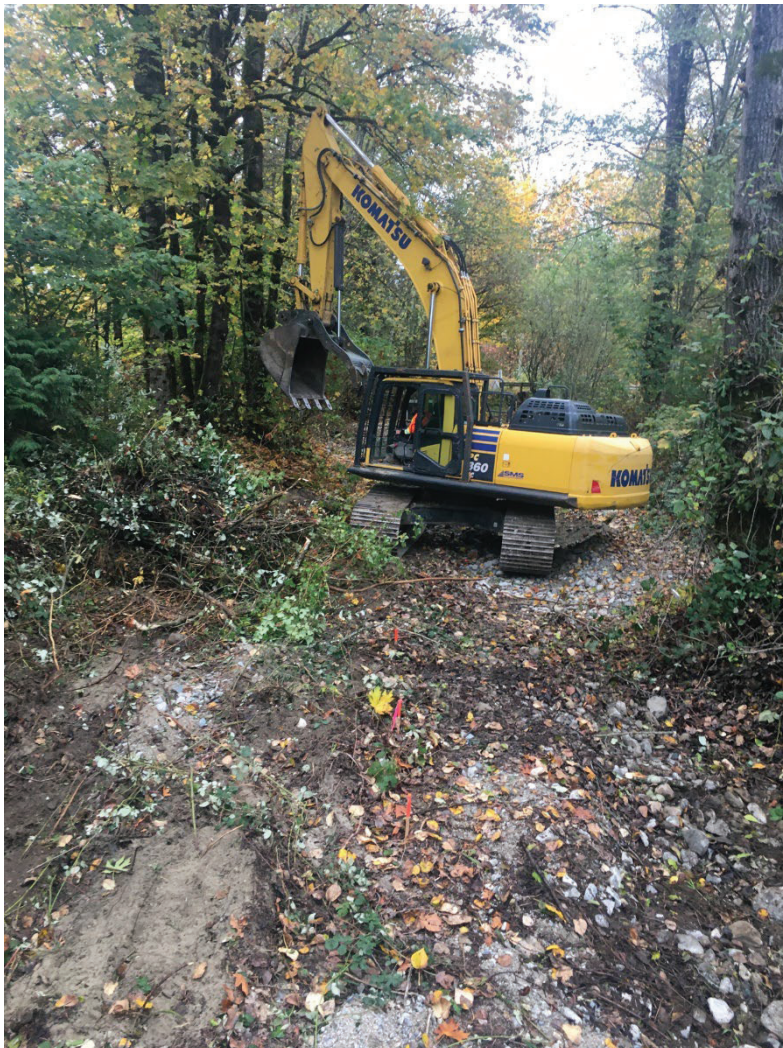
Jim (operator) starting bedload removal west side of Sylvester Rd

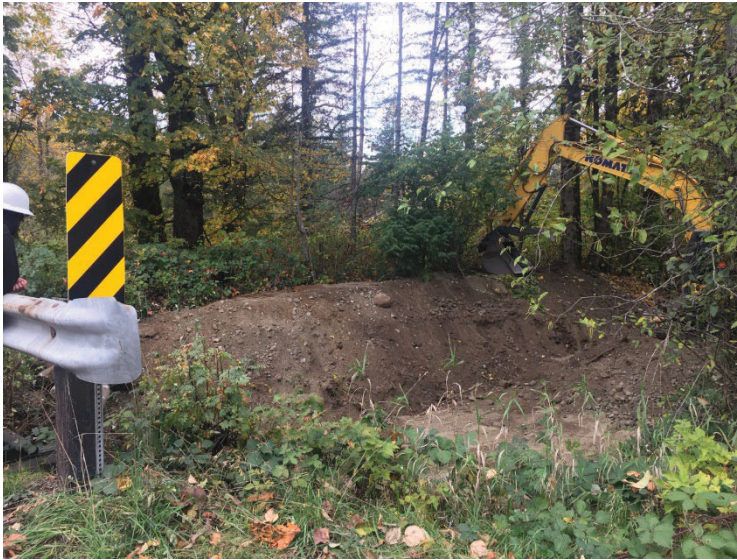
Reinforcing bank, prepping the rip wrap placement.

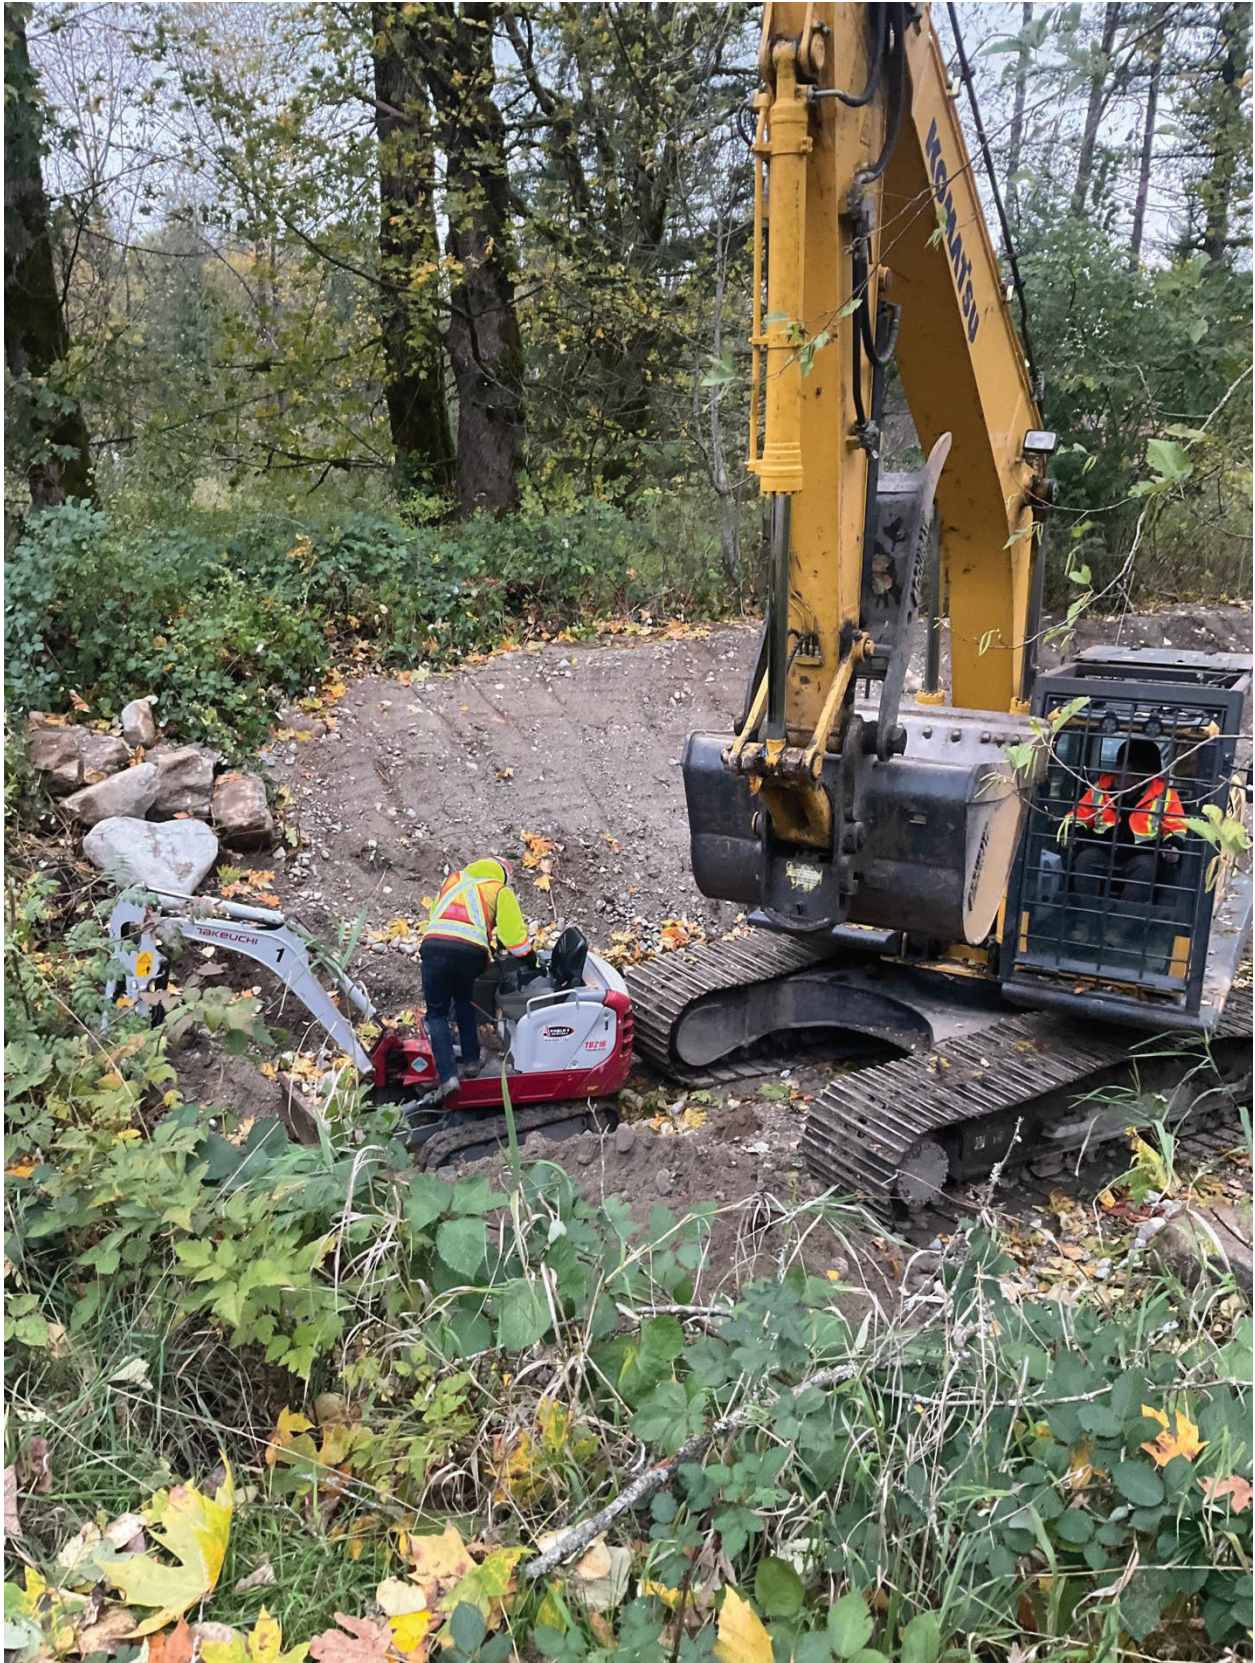
Removal of bed-load under Hartley bridge
