# Chemainus River Right Bank Recovery below Highway #1 Bridge

## 2024 Construction Completion

**Final Report**  
**December 30, 2025**  
**KWL Project No. 3427.025**

**Prepared for:**  
**BC Ministry of Environment and Climate Change**

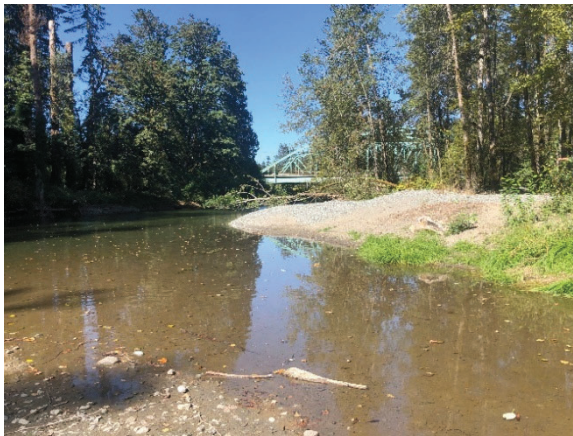
**Photo 1: Gravel Accumulation at U/S End of Point Bar on Right Bank of Chemainus River**

Some of the trees growing on the point bar have eroded and are now partially spanning the channel (Photo 1).

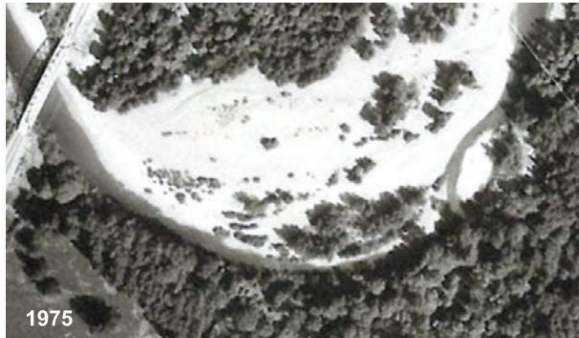
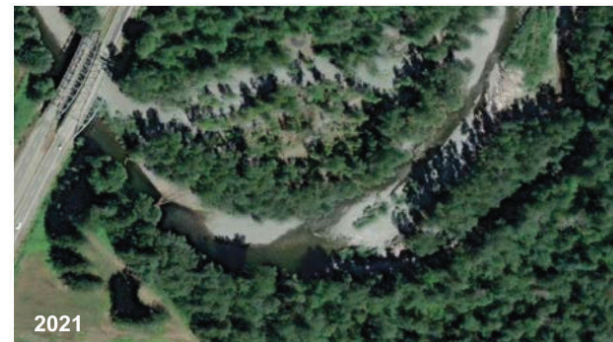
Airphoto review in the Geomorphic Atlas indicates that the point bar and side channel area has become more vegetated since 1975 (see Photo 5) indicating the bar is becoming more stable and at higher elevation over time.

**Photo 5: Changes in Vegetation Cover on Point Bar d/s of Highway 1 Bridge (Source: NHC, 2002)**

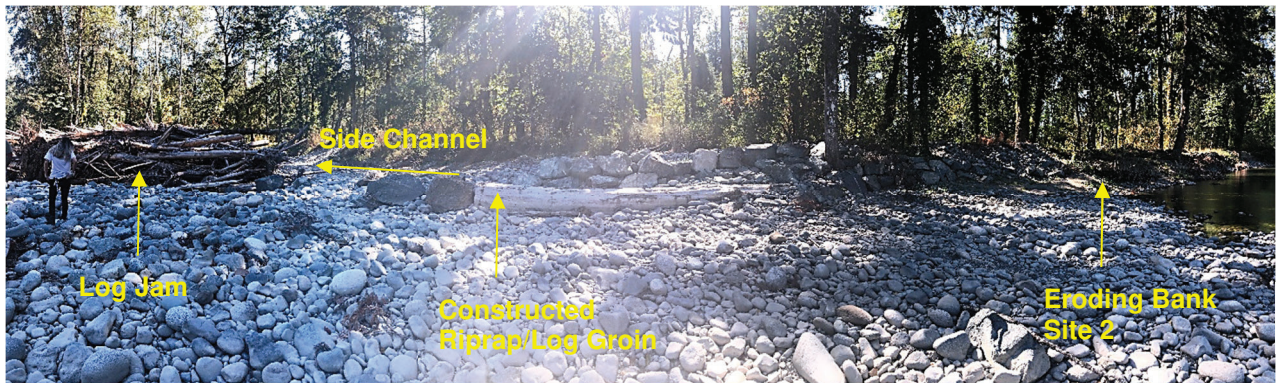
**Photo 8: Entrance to Right Bank Side Channel Showing Eroding Bank, Riprap/Log Groin, and Log Jam**

Both the logjam and the groin limit the amount of water that flows into the active side channel in this location. However, ongoing erosion upstream (Site 2) could outflank the groin structure and result in additional water flowing into the active right bank side channel during large flood events.

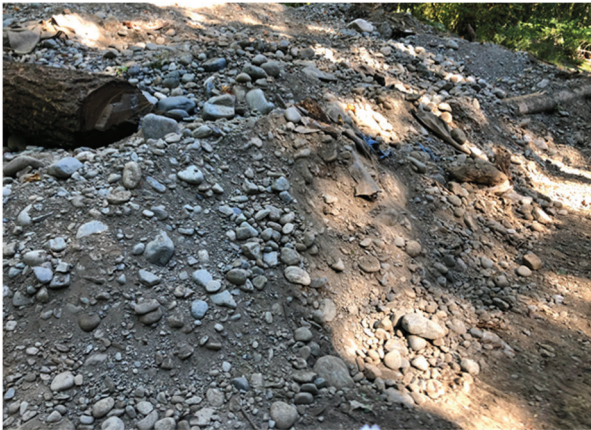
Two temporary gravel berms were constructed across the relic side channels in the floodplain within Halat FN reserve lands (see Photo 9). A trapezoidal channel has been left in the berm at the location of the relic side channel (see Photo 10). These were constructed as emergency measures during the 2021 flood. They limited flow across the floodplain and concentrated flow in the two side channels.

**Photo 9: Berm constructed within Halat FN across the relic floodplain side channels on right bank of Chemainus River**

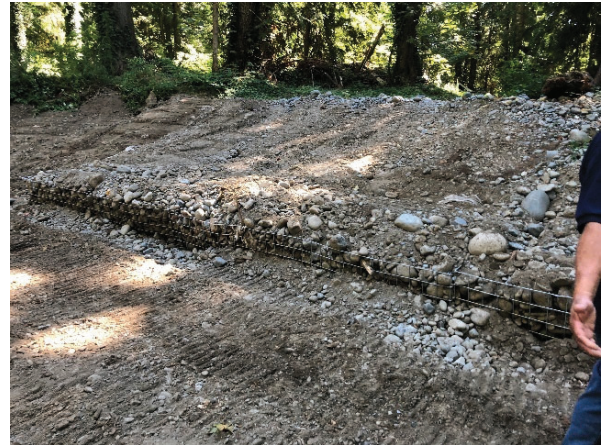
**Photo 10: Opening Through the Berm for Smaller Right Bank Side Channel**

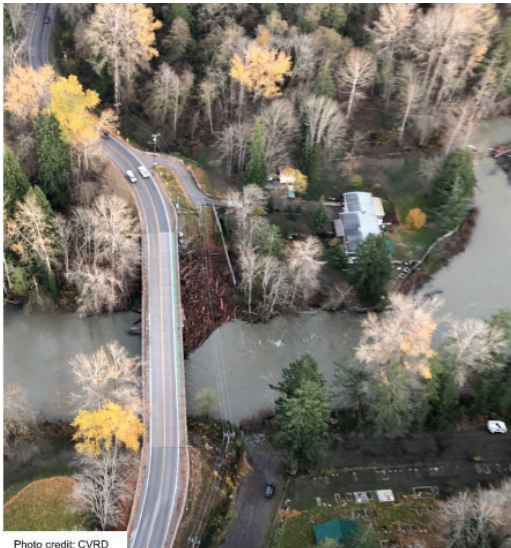
In November 2021, a large amount of wood debris accumulated on the right abutment of the Chemainus Road Bridge (Photo 15). This debris has since been removed. However, it remains a location where debris accumulates and may require removal at this location again in future.

**Photo 15: Large woody debris on right abutment of Chemainus Road Bridge after November 2021 flood which has since been removed (Source: NHC 2022)**

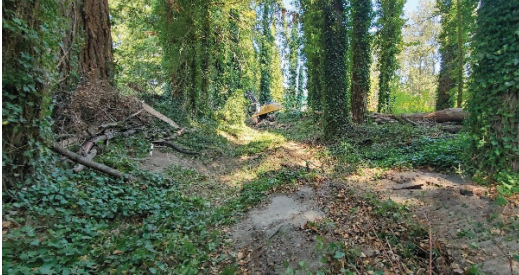
| Site Photos: | | | |
|---|---|---|---|
| Photo 1:<br>Access clearing | | Photo 2:<br>Site signage | |

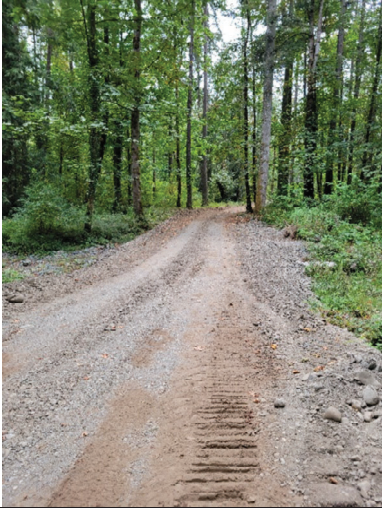
| Site Photos: | | | |
|---|---|---|---|
| Photo 3:<br>Access road | | Photo 4:<br>Tree removal | |

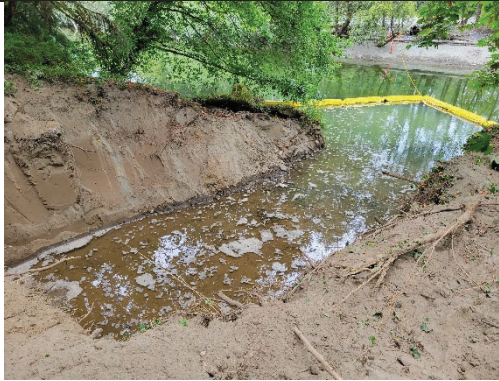
Photo 1:  
Weir #1  
isolation and  
excavation

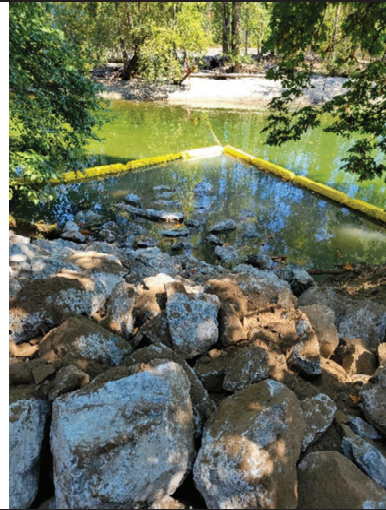
Photo 2:  
Weir #1  
nearing  
completion

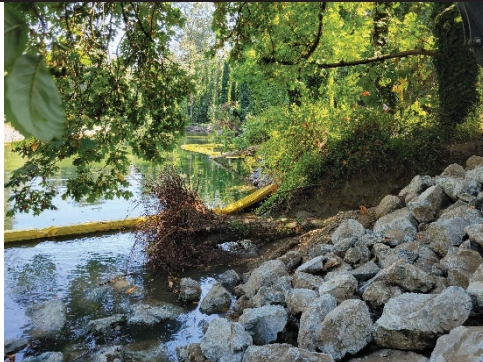
Photo 3:  
LWD install

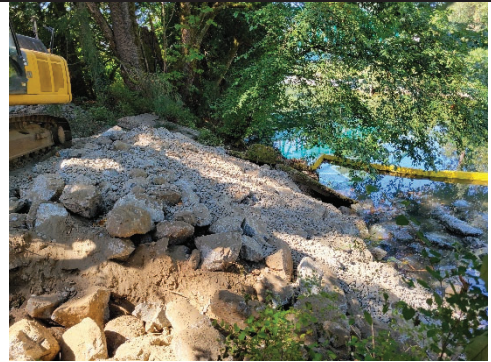
Photo 4:  
D84  
material  
install

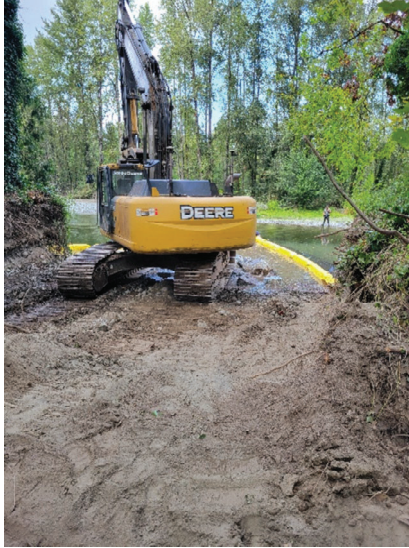
Photo 1:  
Weir #3  
underway

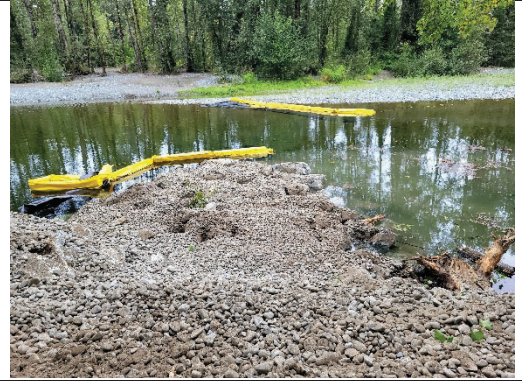
Photo 4:  
Weir #3  
completed  
with D84  
and LWD,  
isolation  
being  
removed

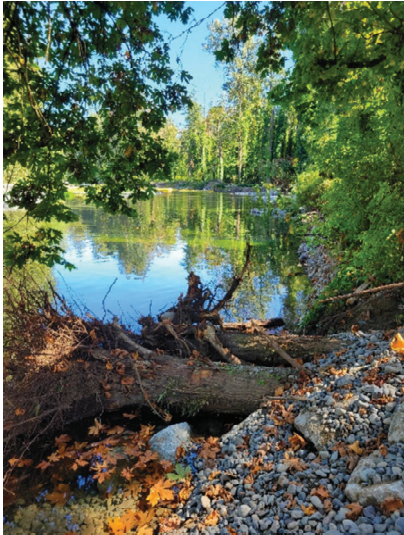
| Photo 5:<br>Progress at end of week (looking downstream) | | | |

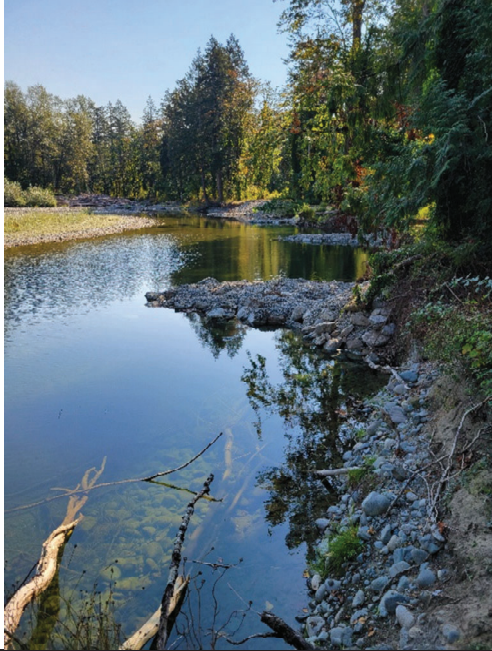
Photo 1:  
All weirs  
completed  
and  
isolations  
removed

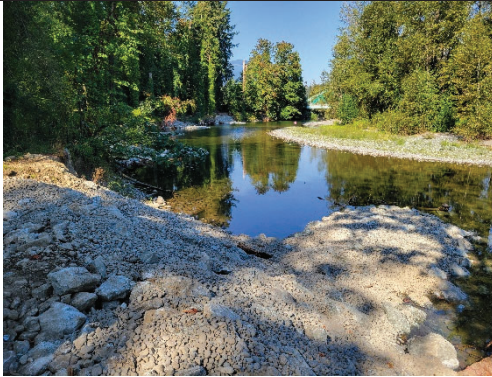
Photo 3:  
Completed  
weirs looking  
upstream

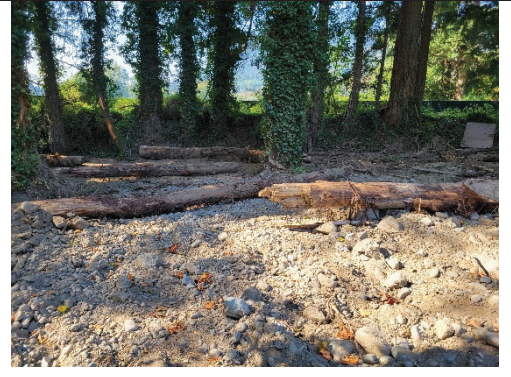
Photo 4:  
Wood debris  
for floodplain  
restoration

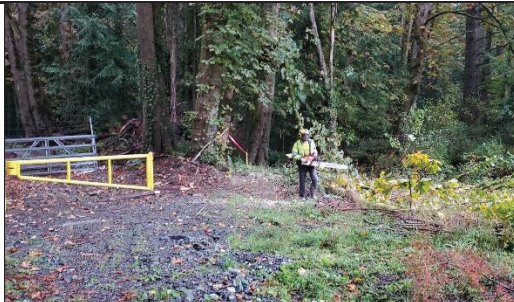
Photo 1:  
Installed gate and tree removal for fence install

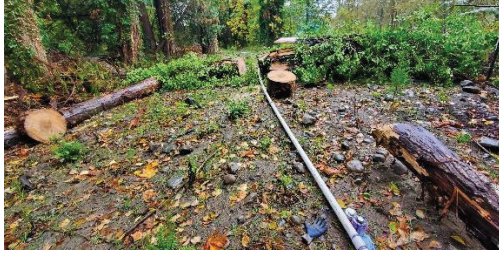
Photo 3:  
Cottonwood  
felled and  
bucked

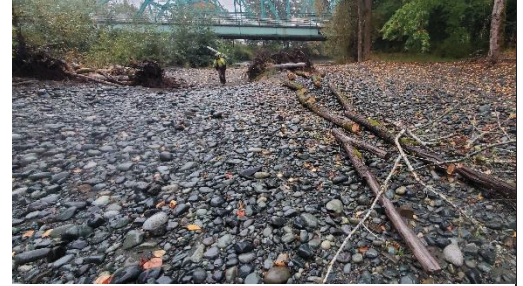
Photo 4:  
Bucked  
trees in left  
bank side  
channel

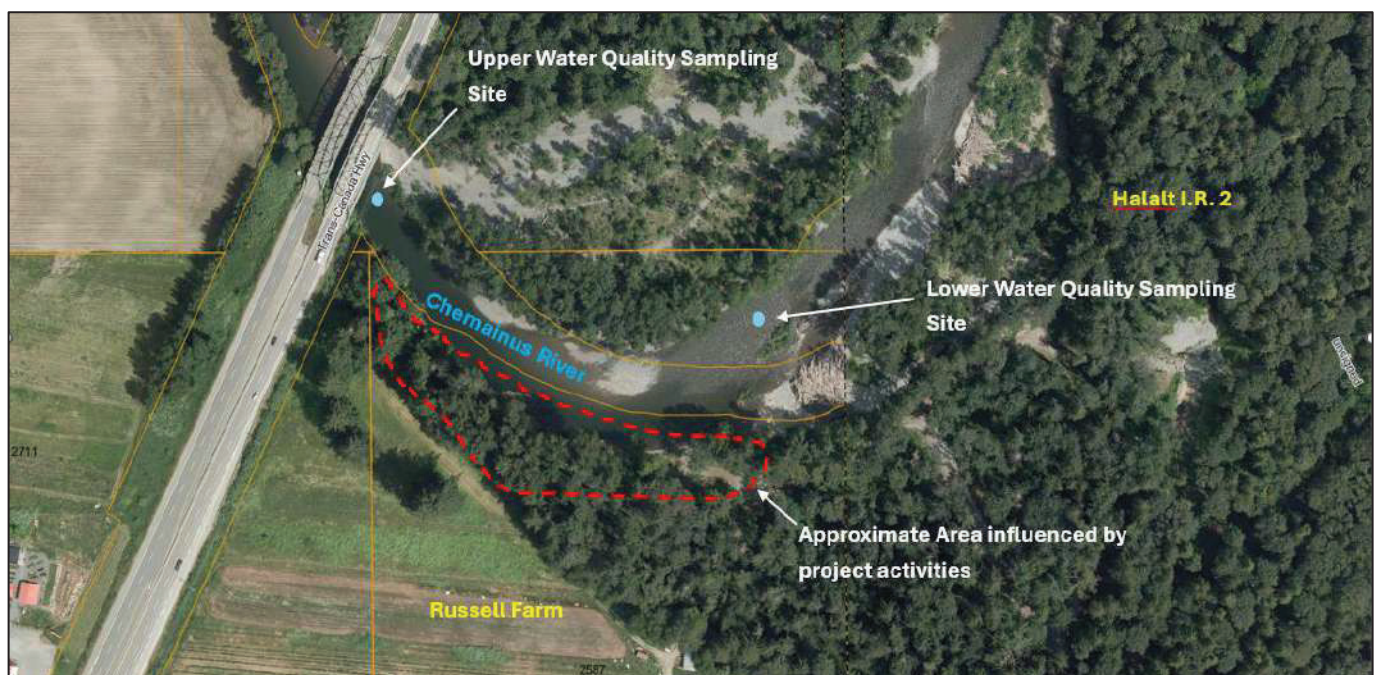
Figure 2. Water quality monitoring sites relative to project area.

No specific criteria or thresholds were formulated for dissolved oxygen, temperature, or conductivity. These parameters were still collected to help provide a general overview of water quality. All water quality parameters remained within specified limits for the duration of the project. It should be noted that pH levels were relatively high, especially at the upstream water quality site, prior to initiation of project activities. Reasoning for these high background pH levels are unknown, but pH decreased to more neutral levels for the duration of the project. **Appendix B** provides results of water quality sampling.

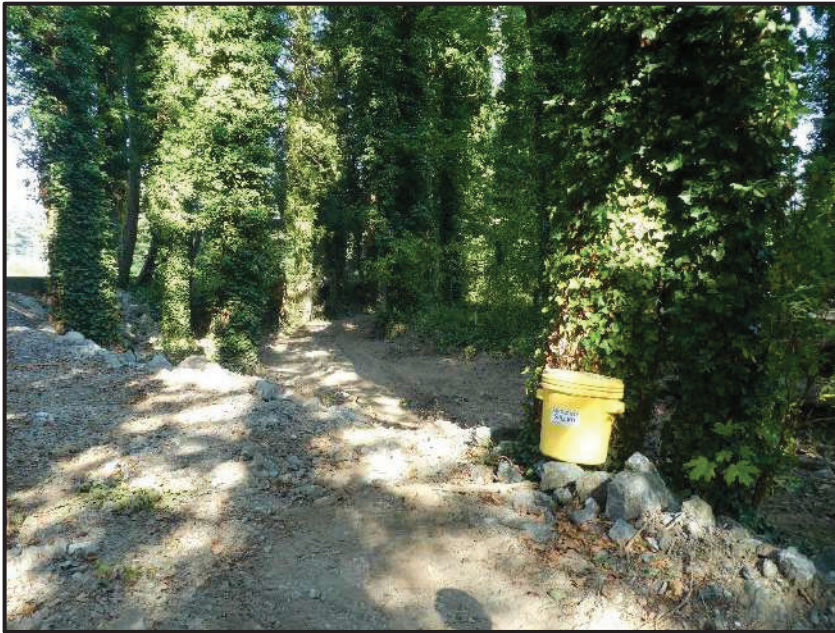
**SPILL KIT LOCATED IN A CENTRAL PROJECT AREA LOCATION FOR DURATION OF THE PROJECT.**

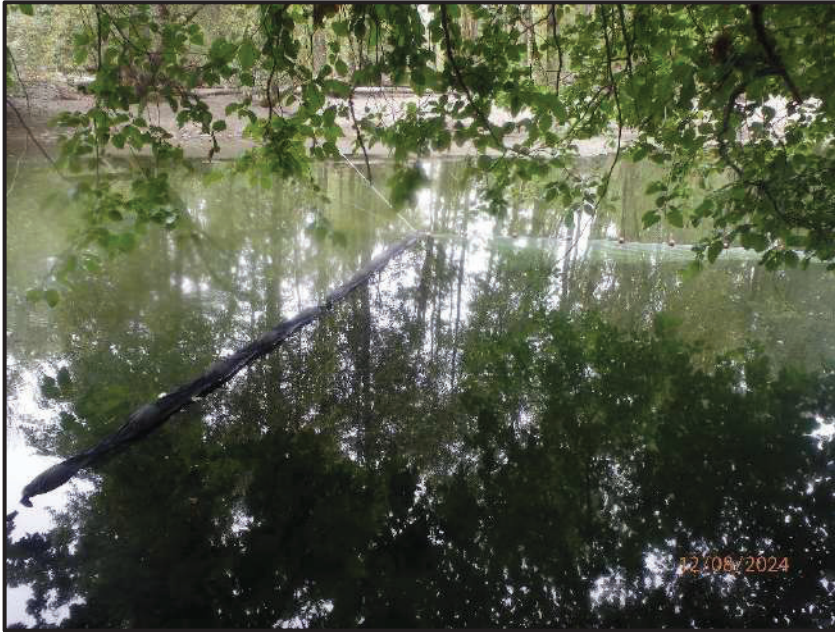
**ISOLATED WORK ZONE OF WEIR 1. THE SEINE NETS WERE PUT IN PLACE TO ENSURE FISH DID NOT ENTER THE WORK ZONE DURING SALVAGE OPERATIONS.**

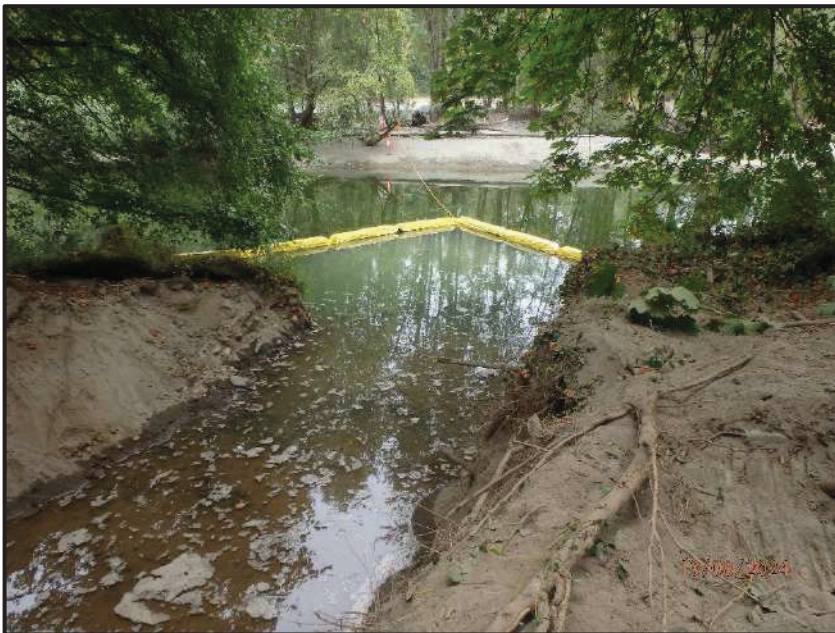
**LOOKING DOWN AT THE WORK ZONE OF WEIR 1. NOTE THE SILT CURTAIN (YELLOW BOOMS), WHICH WAS PUT IN PLACE TO CONTAIN SEDIMENT. IT WAS NECESSARY TO EXCAVATE BACK FROM THE EDGE OF THE RIVER TO PROPERLY KEY IN RIPRAP.**

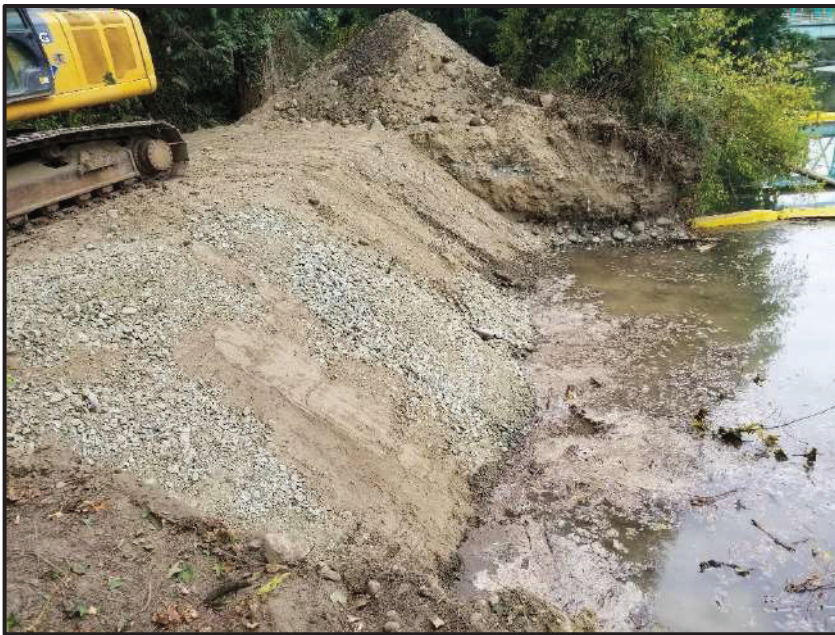
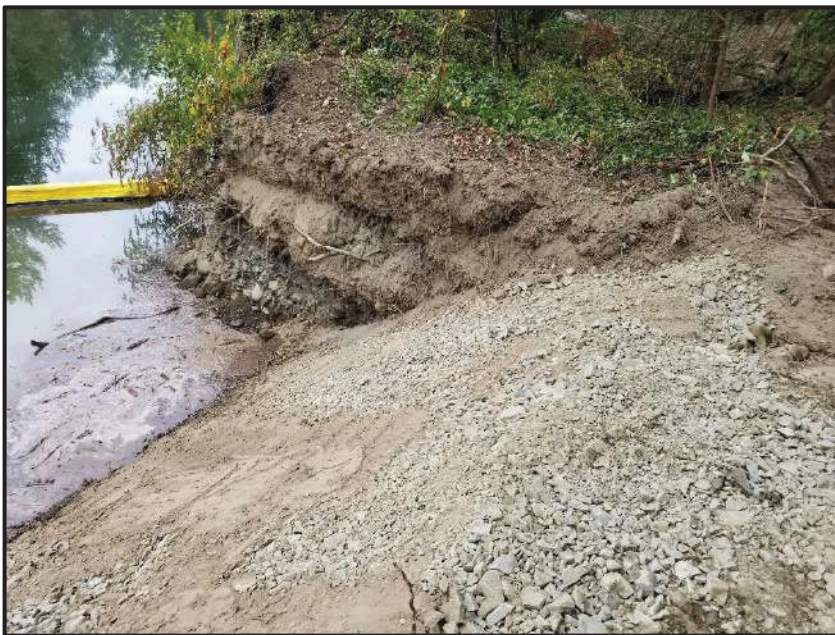
**ABOVE AND BELOW: PHOTOS OF THE BANK AFTER DRAIN ROCK HAD BEEN SPREAD AND PRIOR TO PLACEMENT OF RIPRAP.**

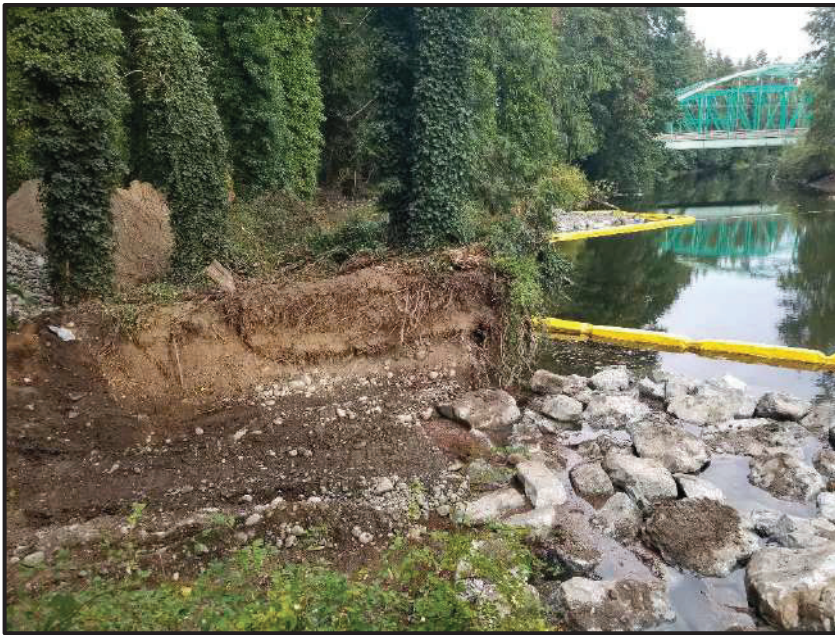
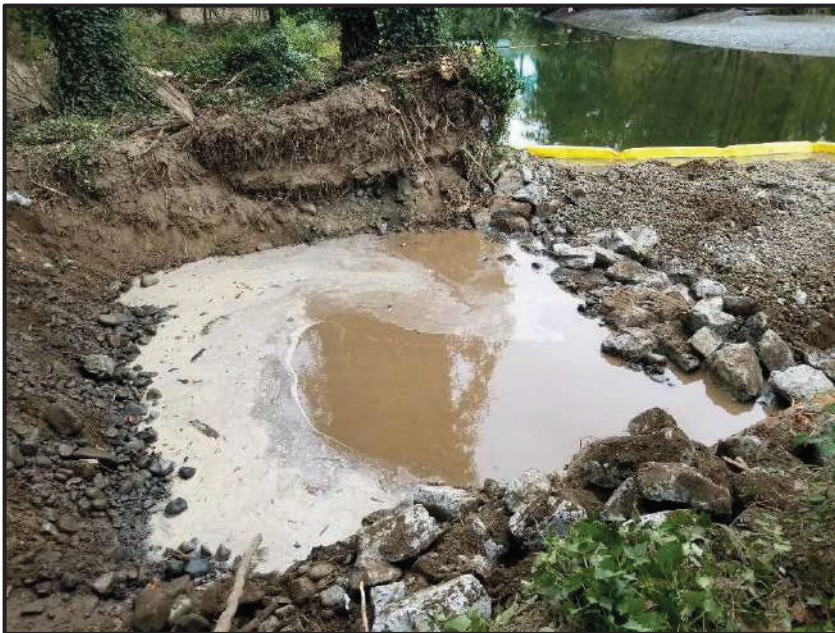
**ABOVE AND BELOW: WEIR 3 RIPRAP PLACEMENT AND WEIR CAPPING USING D95 COBBLES.**

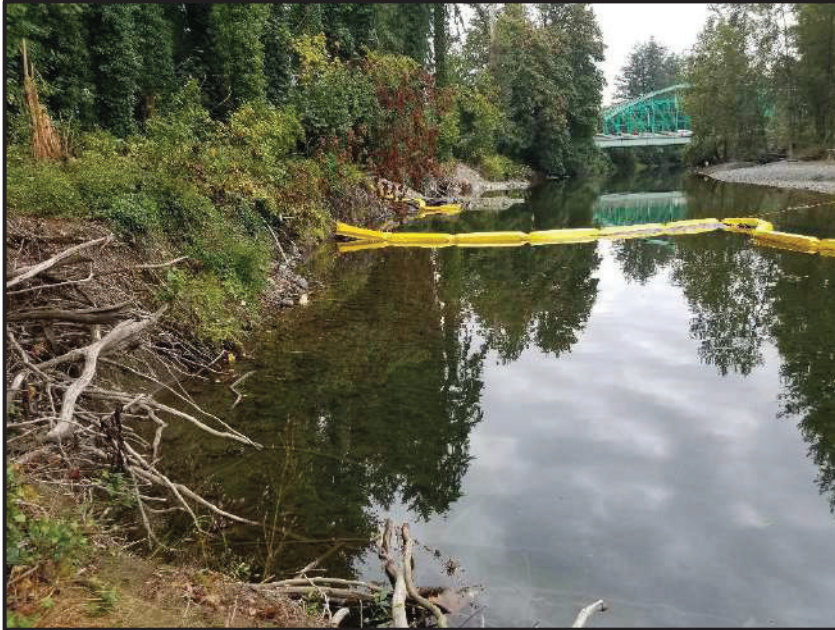
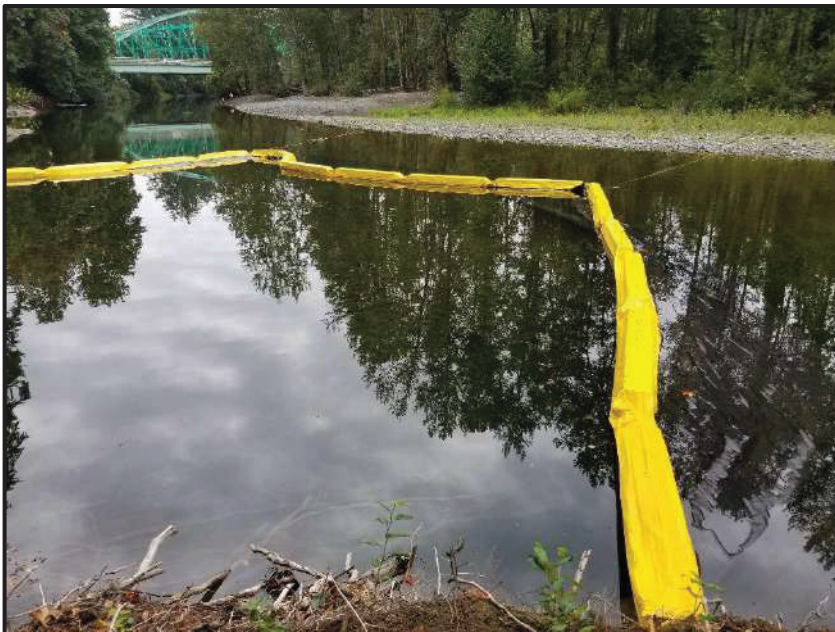
**ABOVE AND BELOW: THE ISOLATED WORK ZONE OF WEIR 4. THE LENGTH OF THIS WEIR REQUIRED A LARGER ISOLATION ZONE.**

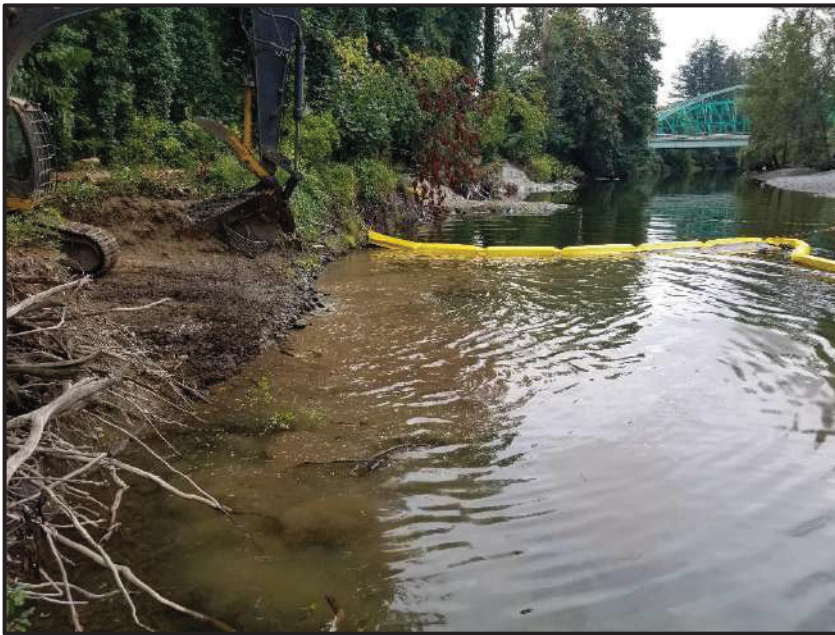
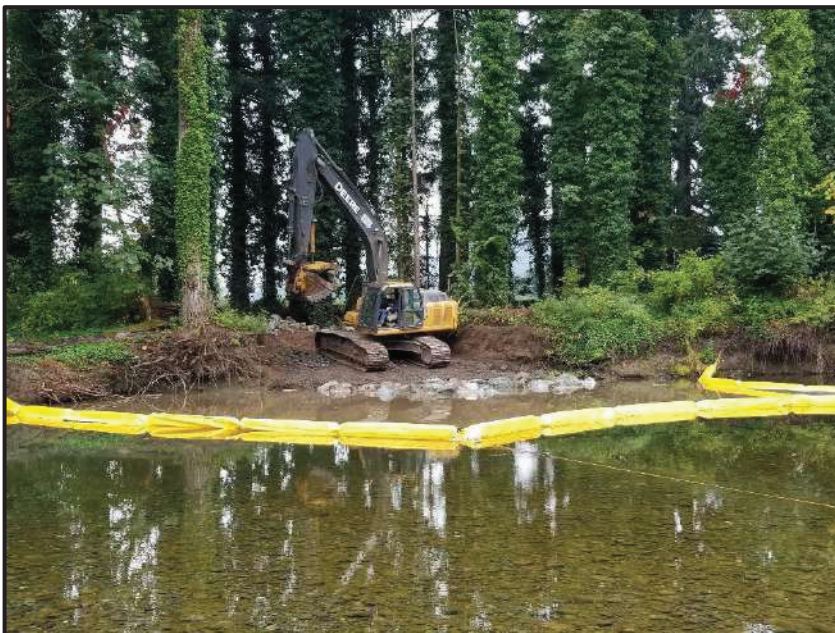
**ABOVE AND BELOW: BANK EXCAVATION FOR WEIR 4 AND PLACEMENT OF RIPRAP IN THE CHANNEL.**

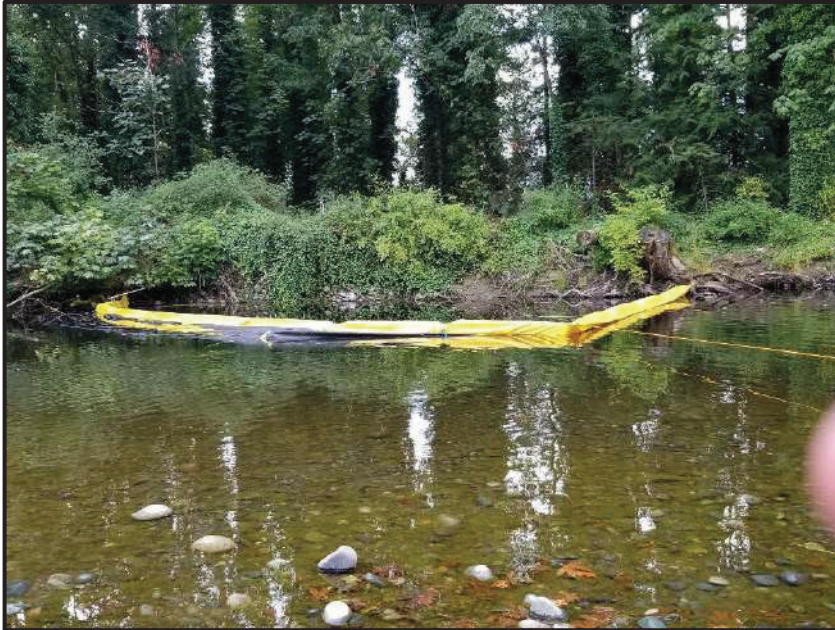
**ABOVE AND BELOW: LOOKING FROM THE LEFT BANK OF THE RIVER AT THE WEIR 5 ENCLOSURE AND INITIAL BANK EXCAVATIONS.**

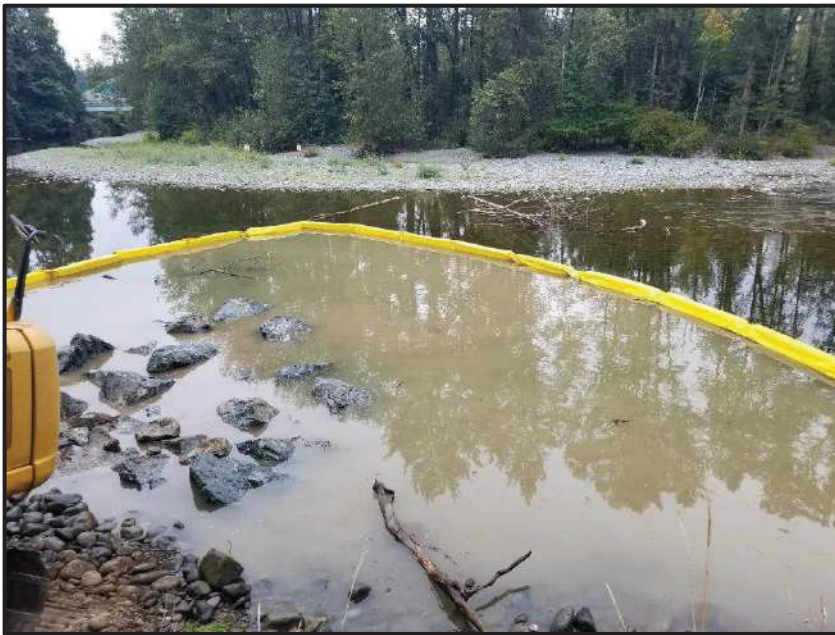
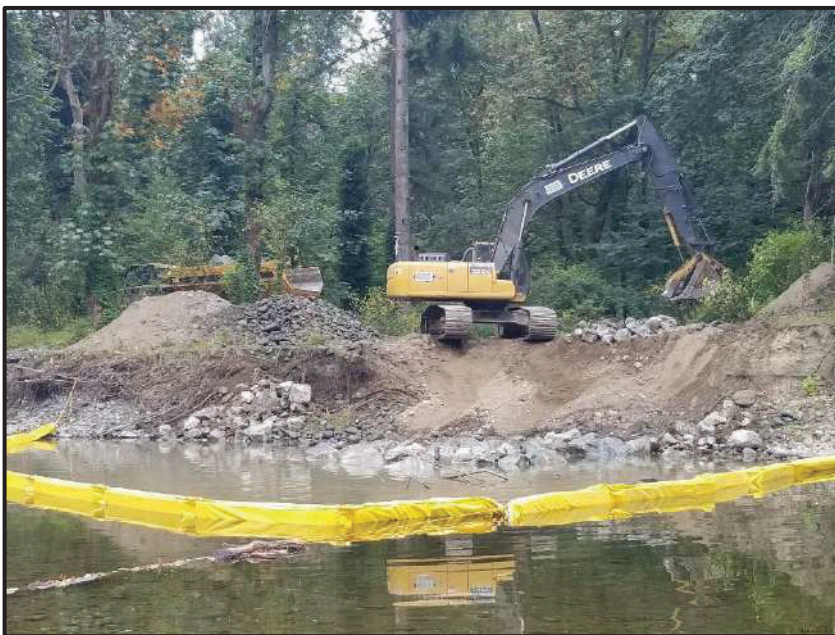
**ABOVE AND BELOW: WEIR 6 DURING CONSTRUCTION. THE SILT CURTAIN WAS GENERALLY EFFECTIVE DURING CONSTRUCTION OF WEIR 6.**

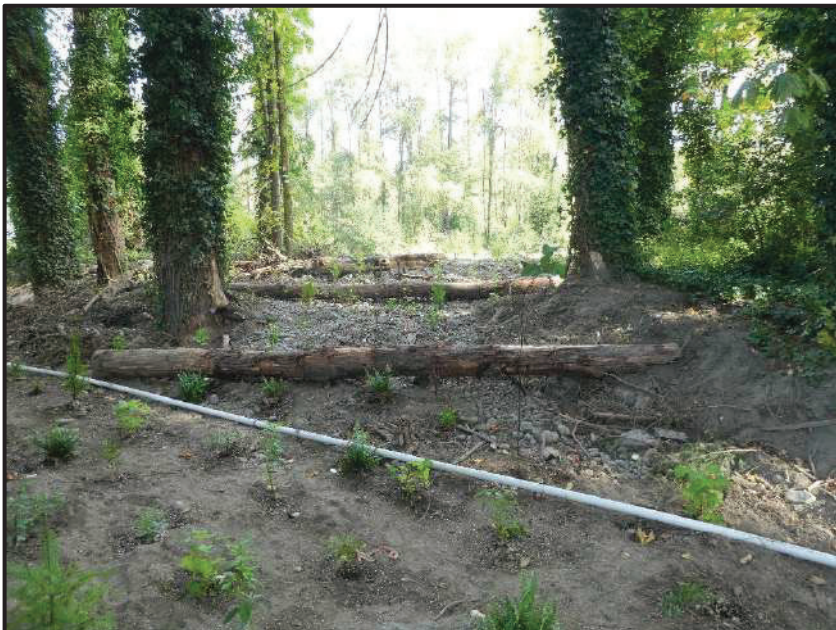
**WEIR 5 AFTER UPON COMPLETION OF REPLANTING.**

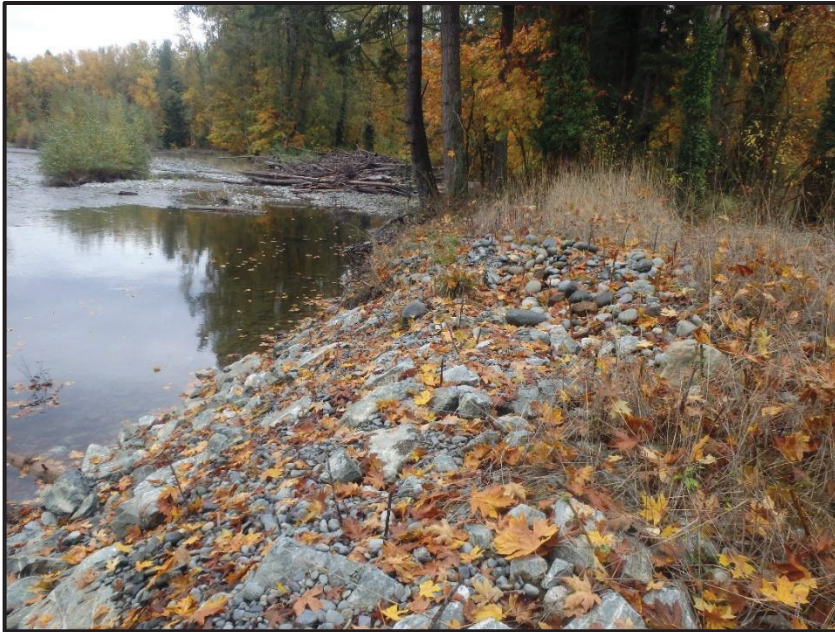
Looking downstream along the top of bendway weir #6. Note that live stakes were inserted into the riprap and successful growth is limited.

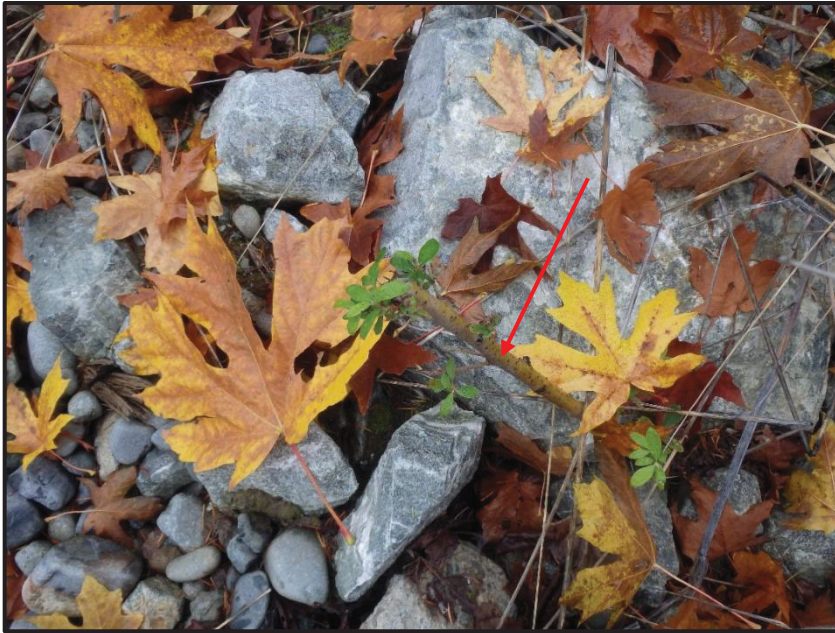
Most of the live stakes placed in the riprap did not survive; however, this is an example of a surviving live stake, with new growth.

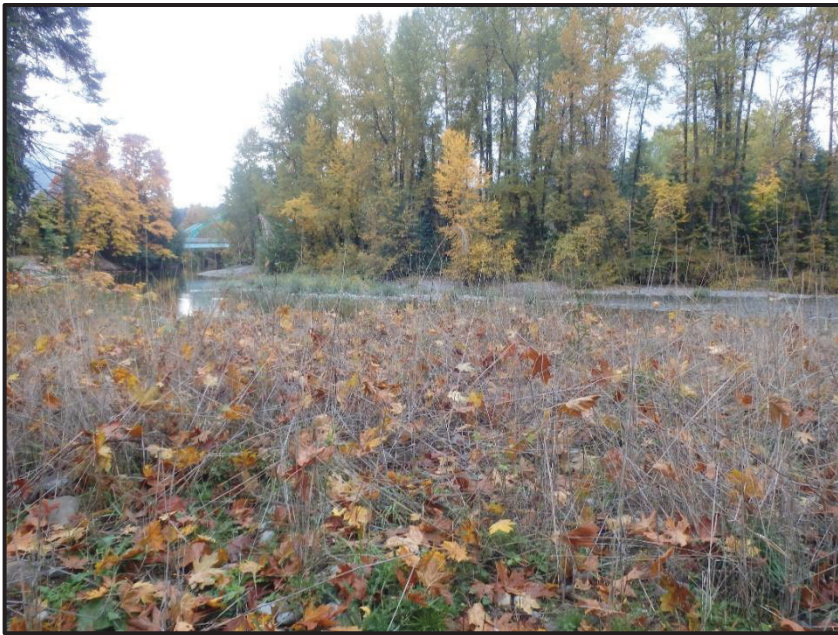
Looking upstream at one of the disturbed zones adjacent to the river and weirs. Several planted western redcedar and red alder are growing amongst the grass and appeared to be in good health.

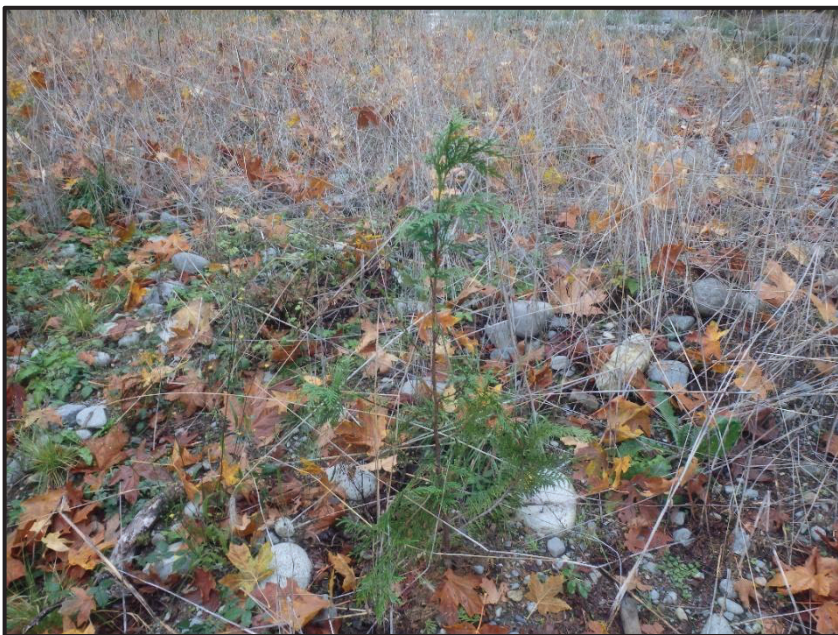
An example of a healthy western redcedar in a disturbed zone adjacent to the river and bendway weirs.

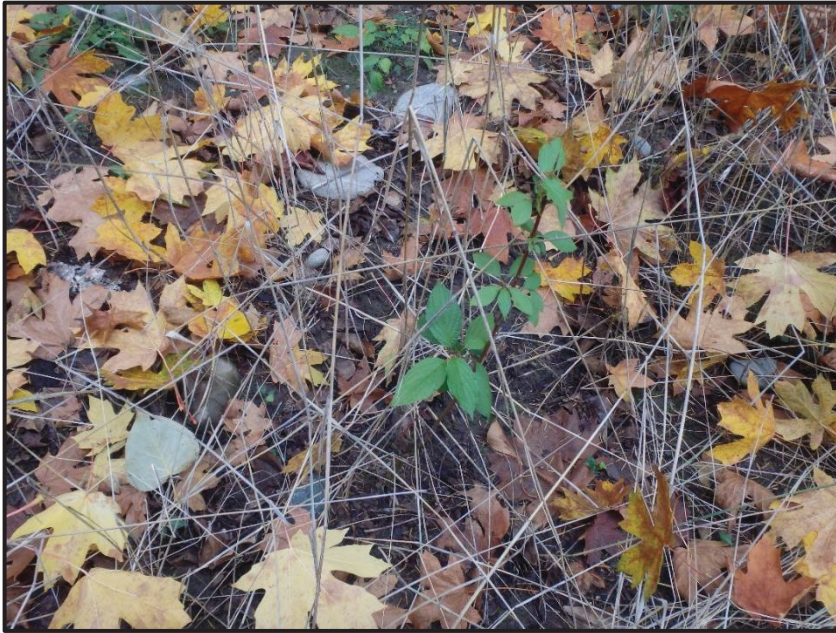
A healthy planted red osier dogwood in a disturbed planting zone.

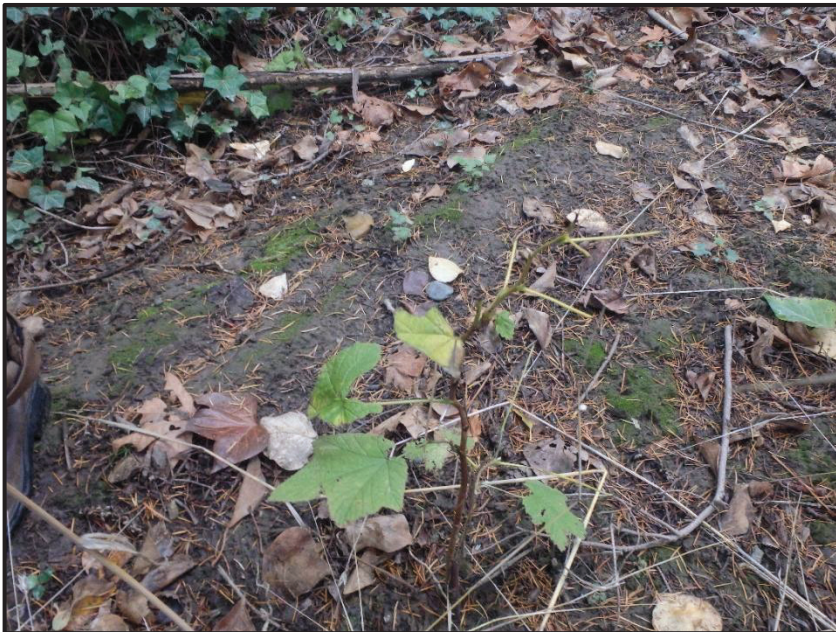
A planted thimbleberry plant exhibiting some signs of browsing. Some plants had been browsed, but it did not appear to be a significant concern throughout the Project area.

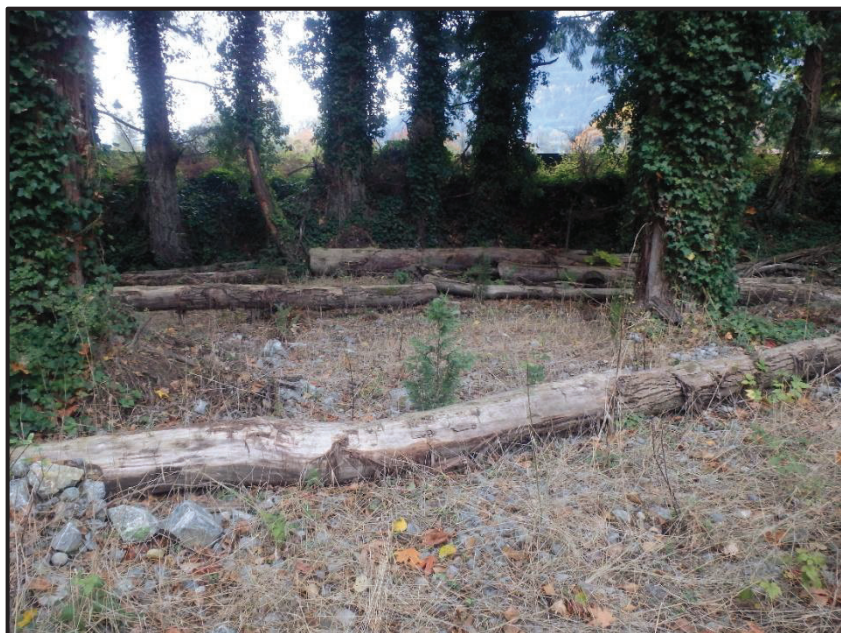
Above and below: a disturbed planting zone, showing Coarse Woody Debris placement and success of grass establishment. Several deciduous trees have been subjected to browsing pressure, but at the time of the assessment it was noted that the level of browse does not warrant additional planting measures.

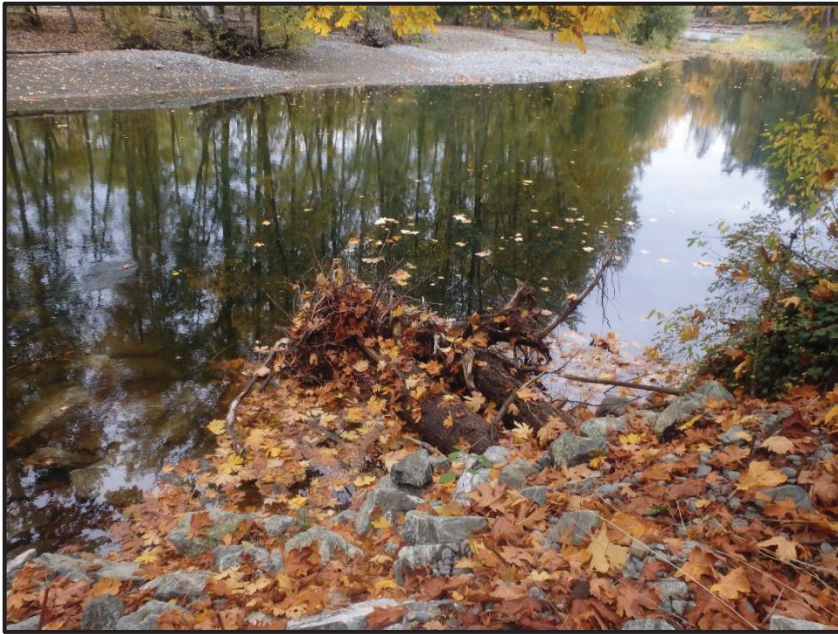
Looking downstream at the tree stems/root balls that were put in as LWD adjacent to bendway weir #1. This feature remains intact and is contributing to instream cover, particularly for juvenile salmonids.
